**Re: Newfoundland and Labrador Hydro – Request to File Report on Frazil Ice at Bay d'Espoir
Hydroelectric Generating Station – Hydro's Reply**

Frazil Ice at Bay d'Espoir Hydroelectric Generating Station

April 30, 2026

A report to the Board of Commissioners of Public Utilities

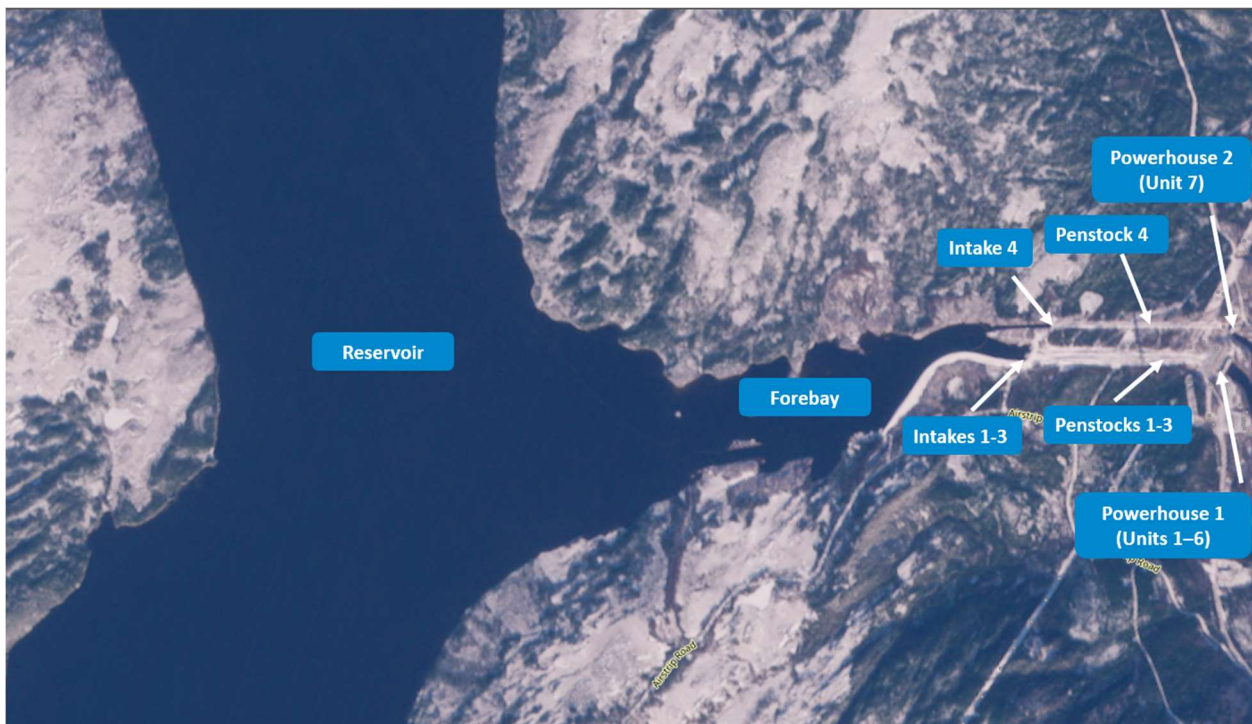
During a typical winter, the reservoir freezes over to reduce water turbulence and heat loss to the air above, creating conditions that are less favorable to the initial formation of frazil ice. In the month leading up to limited production at BDE, there was no stable ice cover on the reservoir or forebay, as illustrated in Figure 1.

Figure 1: Satellite Imagery of Ice Formation in the BDE Forebay – December 15, 2025^{1,2}

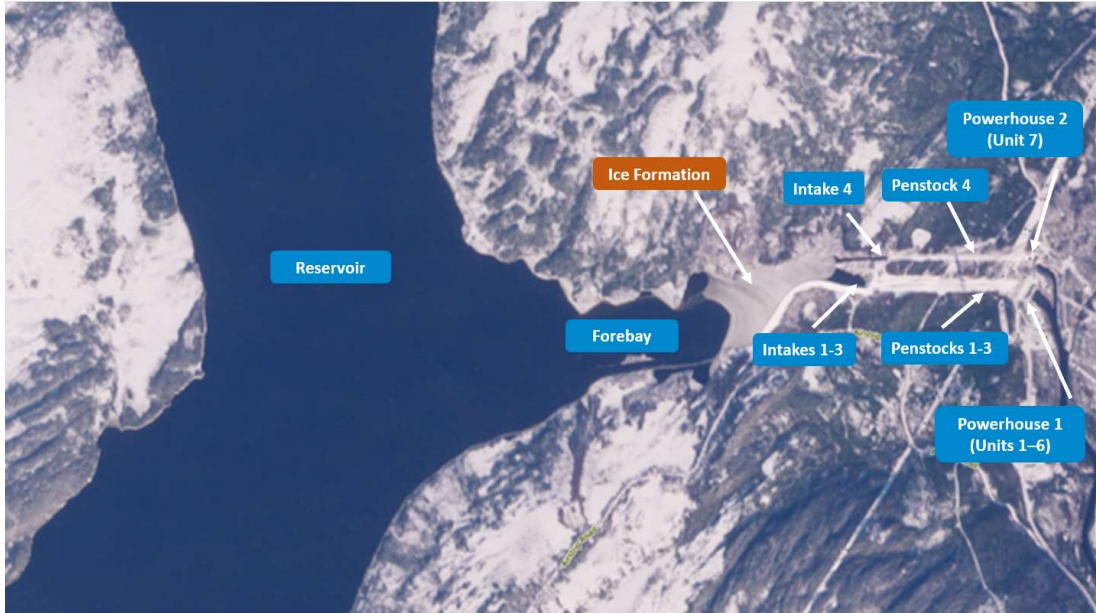
- 1 Over the course of the day on January 21, 2026, the weather patterns near BDE caused frazil ice to
- 2 collect within the BDE forebay, as outlined in Figure 2. This ice accumulated on the intake trash racks³ of
- 3 all four penstocks, which convey water to the seven generating units.

Figure 2: Satellite Imagery of Ice Formation in the BDE Forebay – January 21, 2026⁴

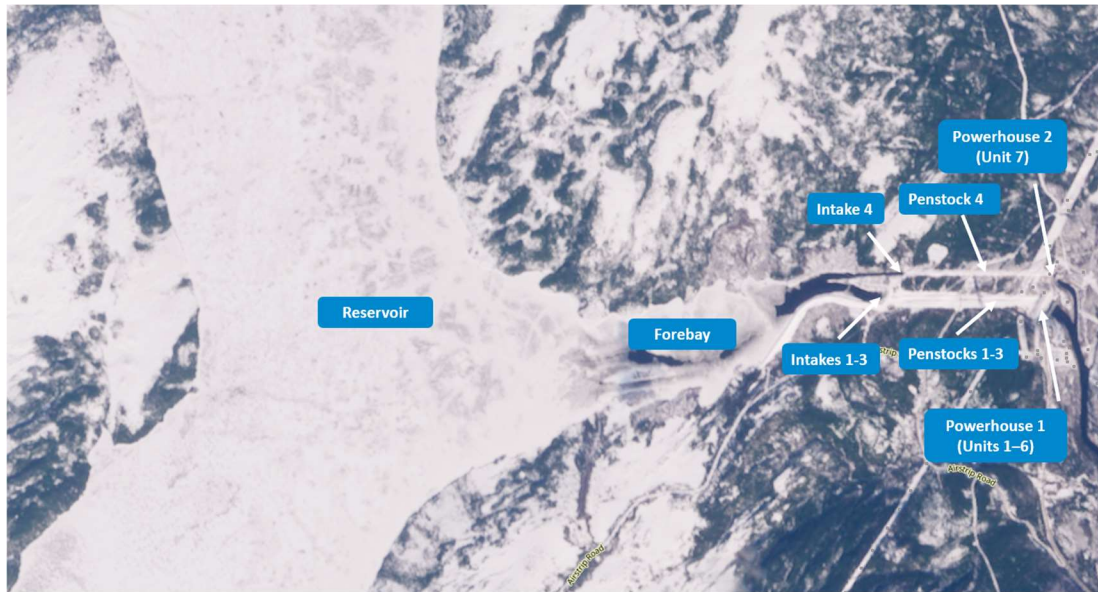
- 4 This was unusual as generally, the reservoir freezes over to form an ice cover; however, the area of the
- 5 forebay where water flows into the intake does not typically freeze over, as illustrated in Figure 3.

Figure 3: Typical Ice Cover in the BDE Forebay and Reservoir⁵

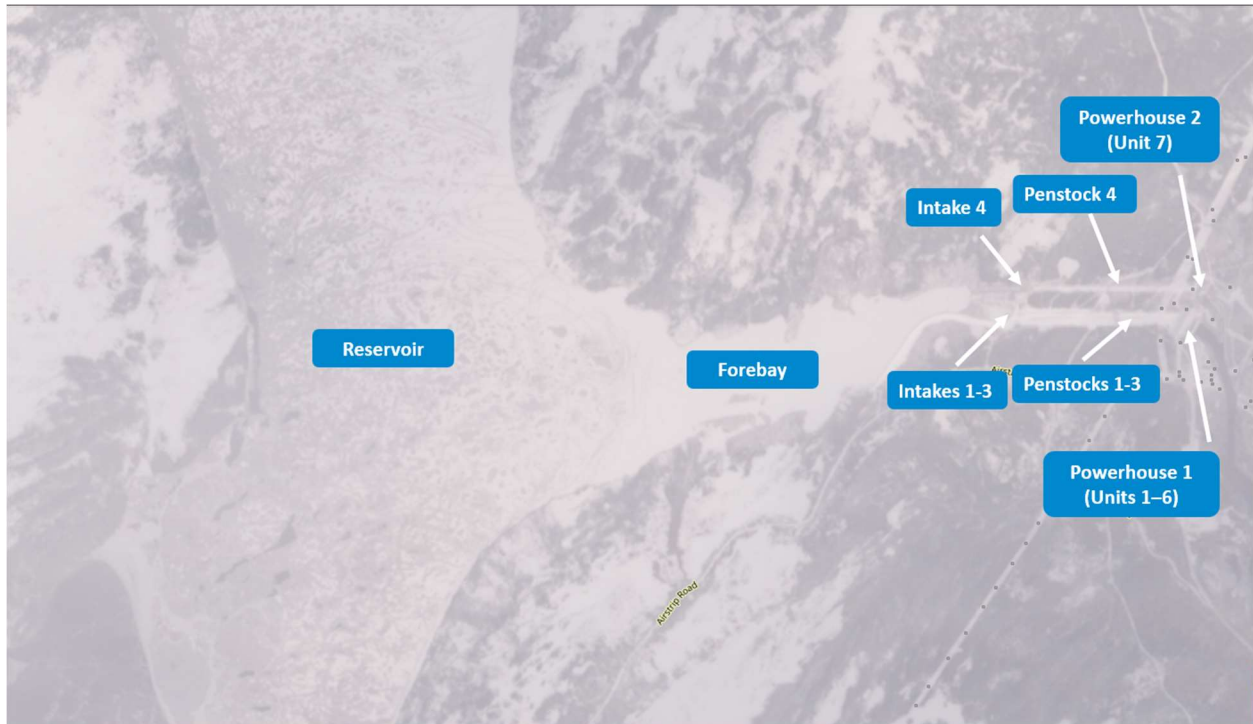
10 System.
11 Units 1–6 were returned to service on January 25, 2026, and the *Power Warning* was lifted later that
12 evening. The *Power Watch* remained in effect until January 26, 2026, at which time, available generation
13 from BDE was sufficient to meet the system demand. At this time, ice cover had formed on the reservoir
14 and forebay, as illustrated in Figure 4. Unit 7 was returned to service on January 31, 2026.

Figure 4: Satellite Imagery of Ice Formation in the BDE Forebay and Reservoir – January 26, 2026^{9,10}

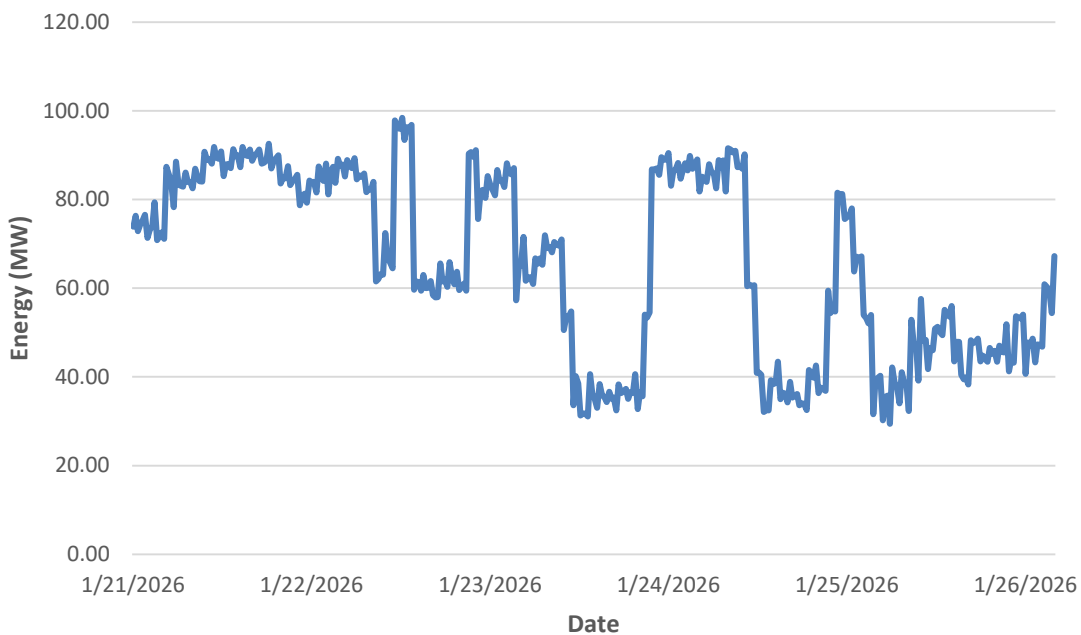
Chart 1: Kruger Power Purchases – January 21–26, 2026²⁵

²⁵ CBPP was also experiencing frazil ice conditions during this period of time, which affected its ability to deliver full power to the system. This explains the reduced deliveries overnight and on January 25th, as shown in the graph.
