1 Q. The response to PUB-NLH-065 in Hydro's 2026 General Rate Application indicates that the long-  
2 term plan for supplying Paradise River has not yet been determined.

Condition Assessment Final Report

Condition Assessment of Ten Diesel Plants

H333005-0000-10-236-0001

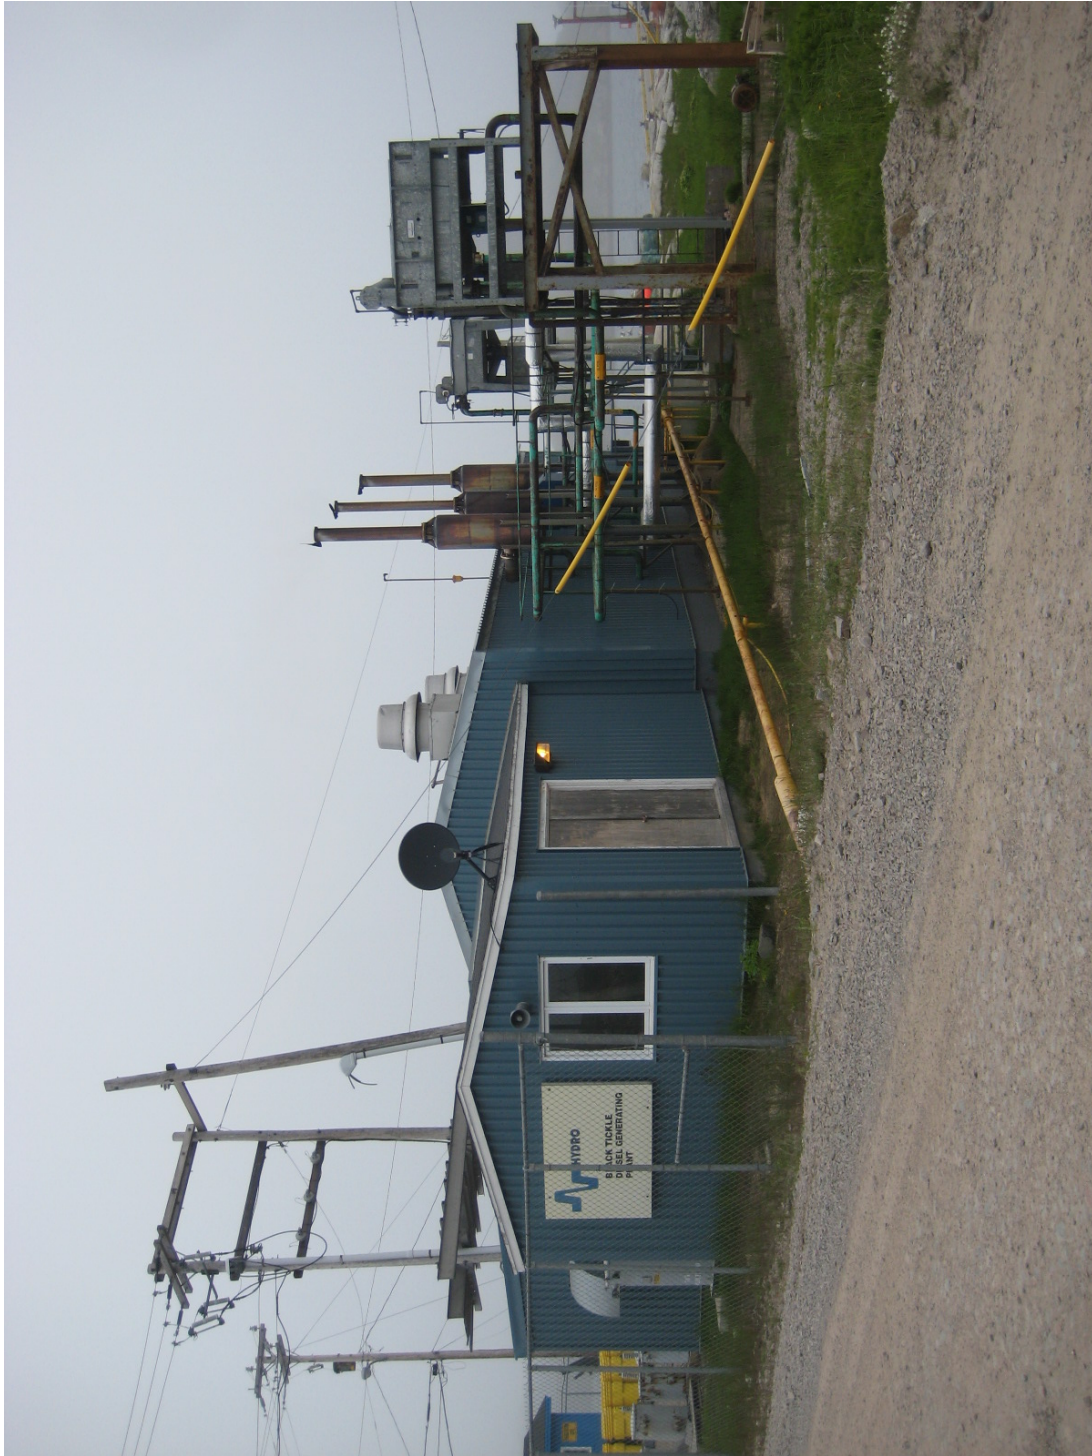
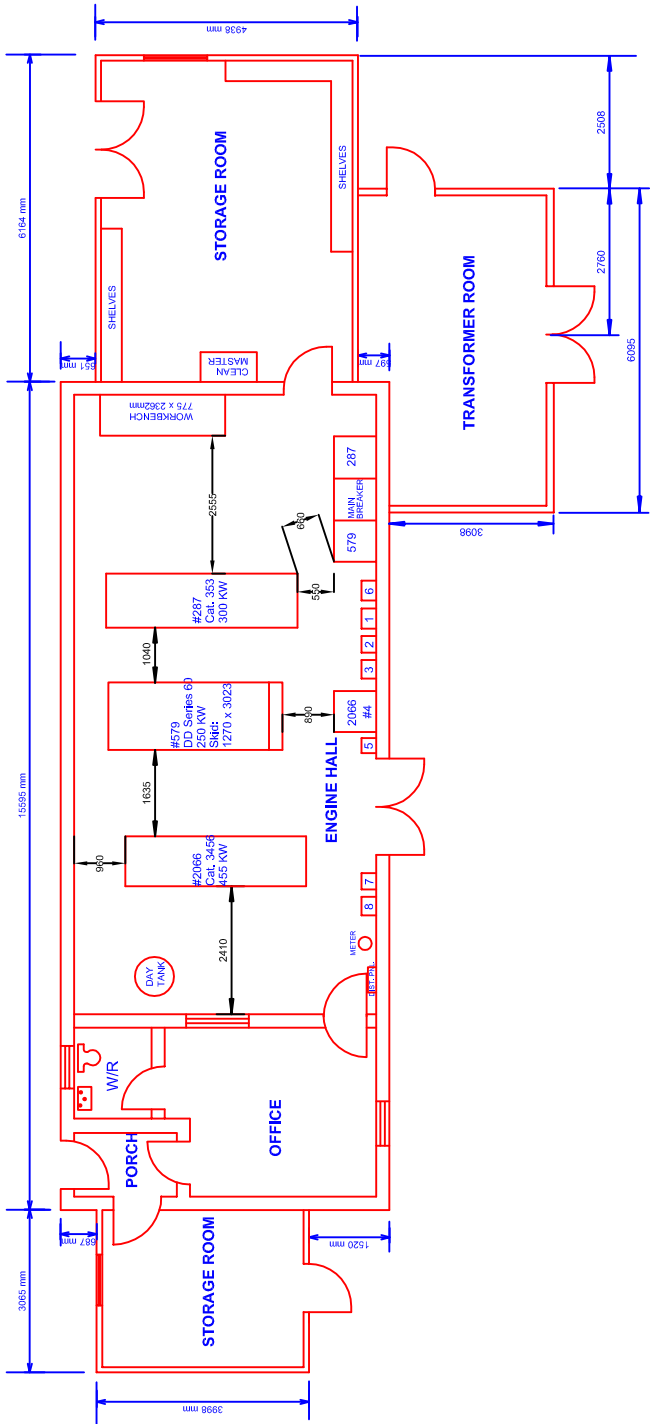
## Black Tickle, Labrador

New engine (Unit #2066) installed in November 2002.  
New engine (Unit #579) installed in September 2007.

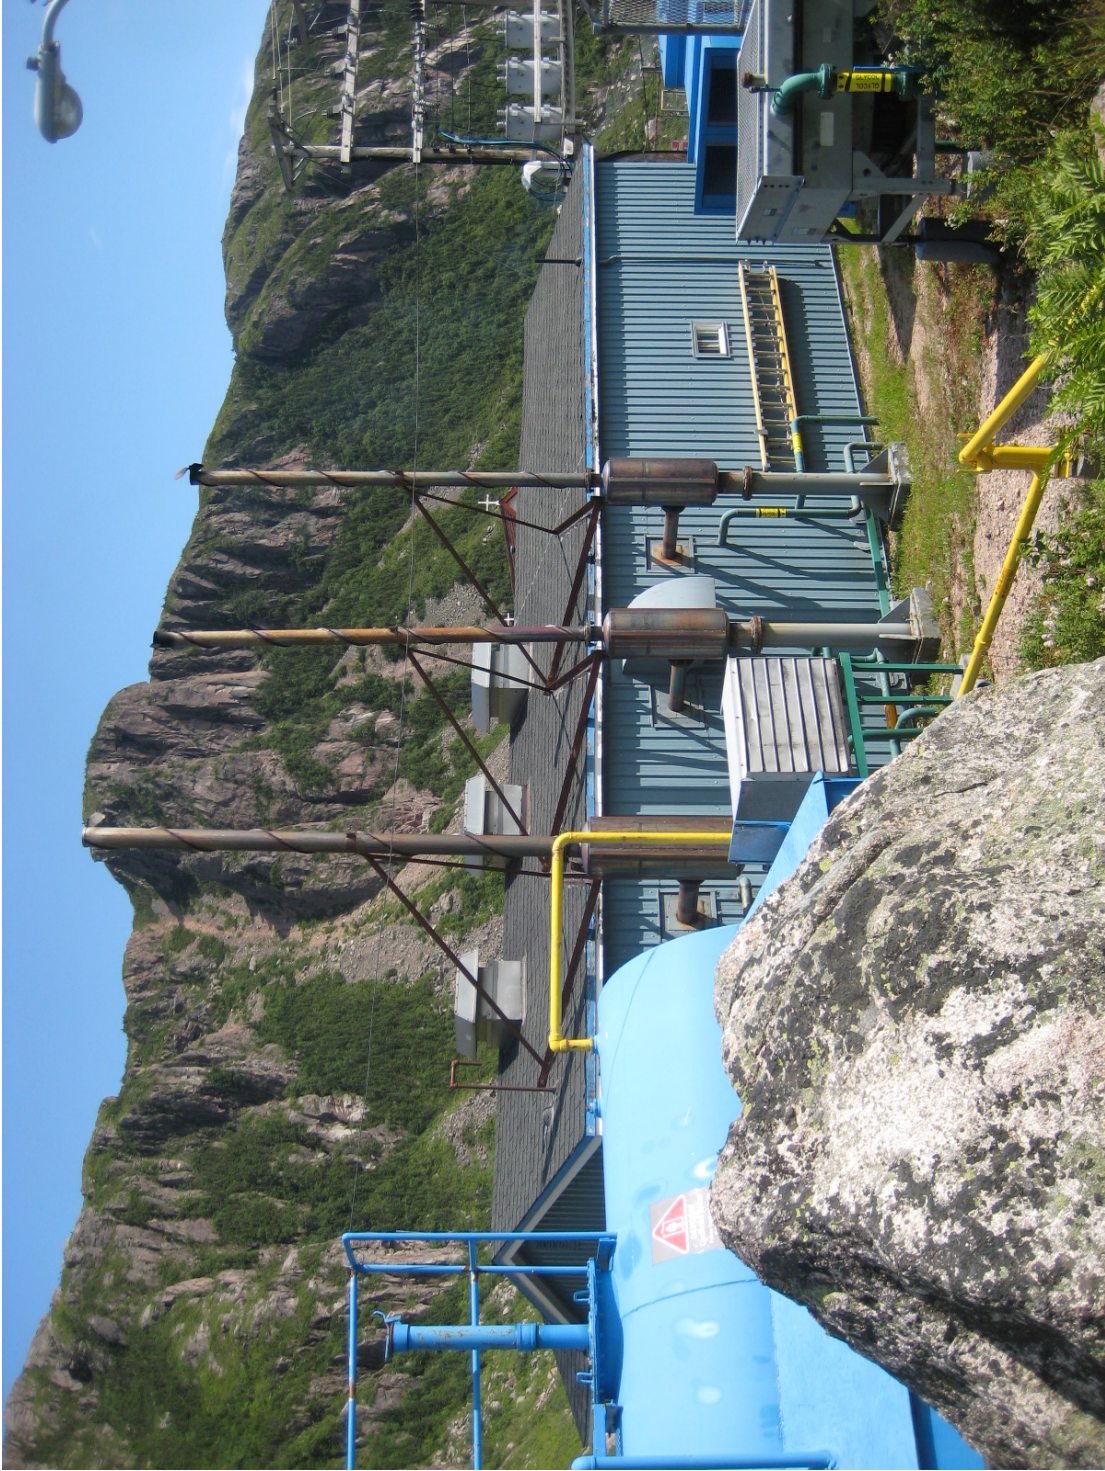
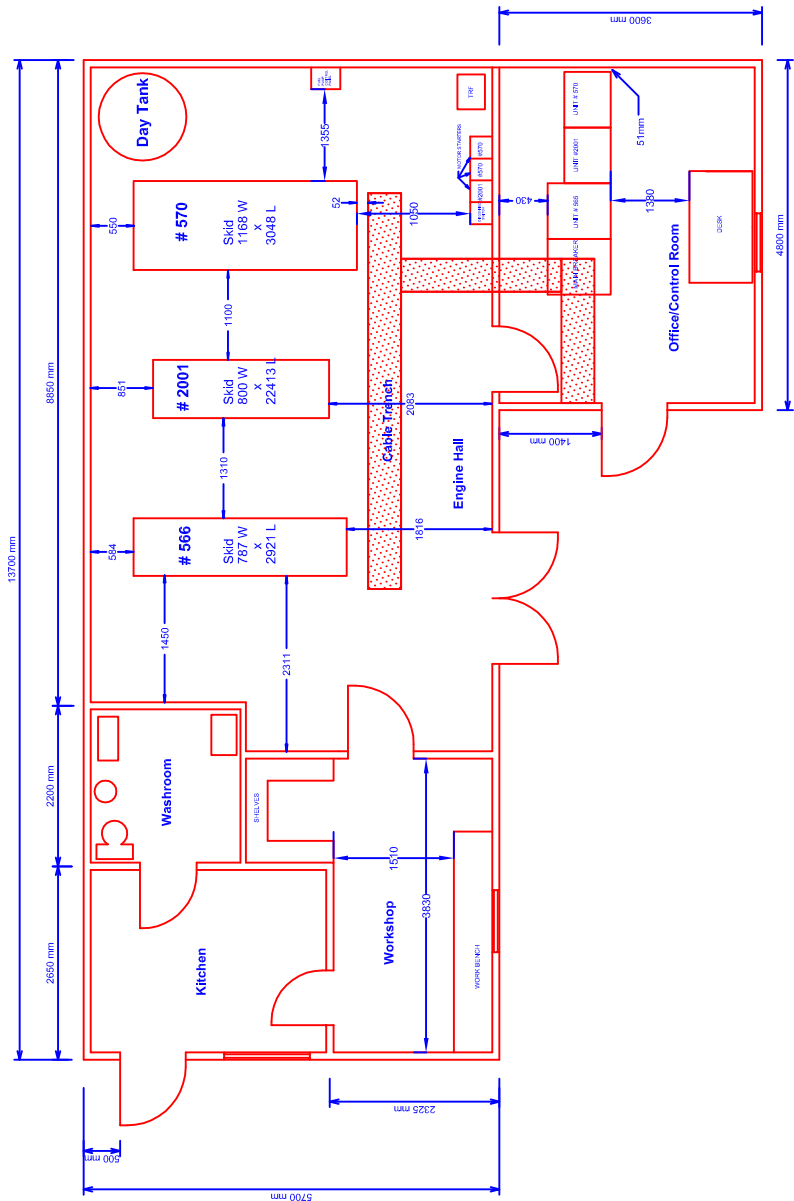
**Francois, Newfoundland**

- 1. Main breaker - 762mm width x 864mm depth x 1981mm height.
- 2. Unit #565 Control Panel - 762mm width x 864mm depth x 1981mm height.
- 3. Unit #2001 Control Panel - 762mm width x 835mm depth x 1829mm height.
- 4. Unit #570 Control Panel - 762mm width x 864mm depth x 1829mm height.
- 5. The new standard size control panel per St. Brendan's are 1016mm width x 737mm depth x 1829mm height.
- 6. To install the standard size control panel in the Francois Plant, would have to shift the main breaker, #565 Panel, & #2001 Panel toward the engine hall door min. 254mm (6 hour outage).
- 7. The existing control panels are accessed thru the back for maintenance.
- 8. Maximum width of the new panel without having to move the existing equipment is 813mm.

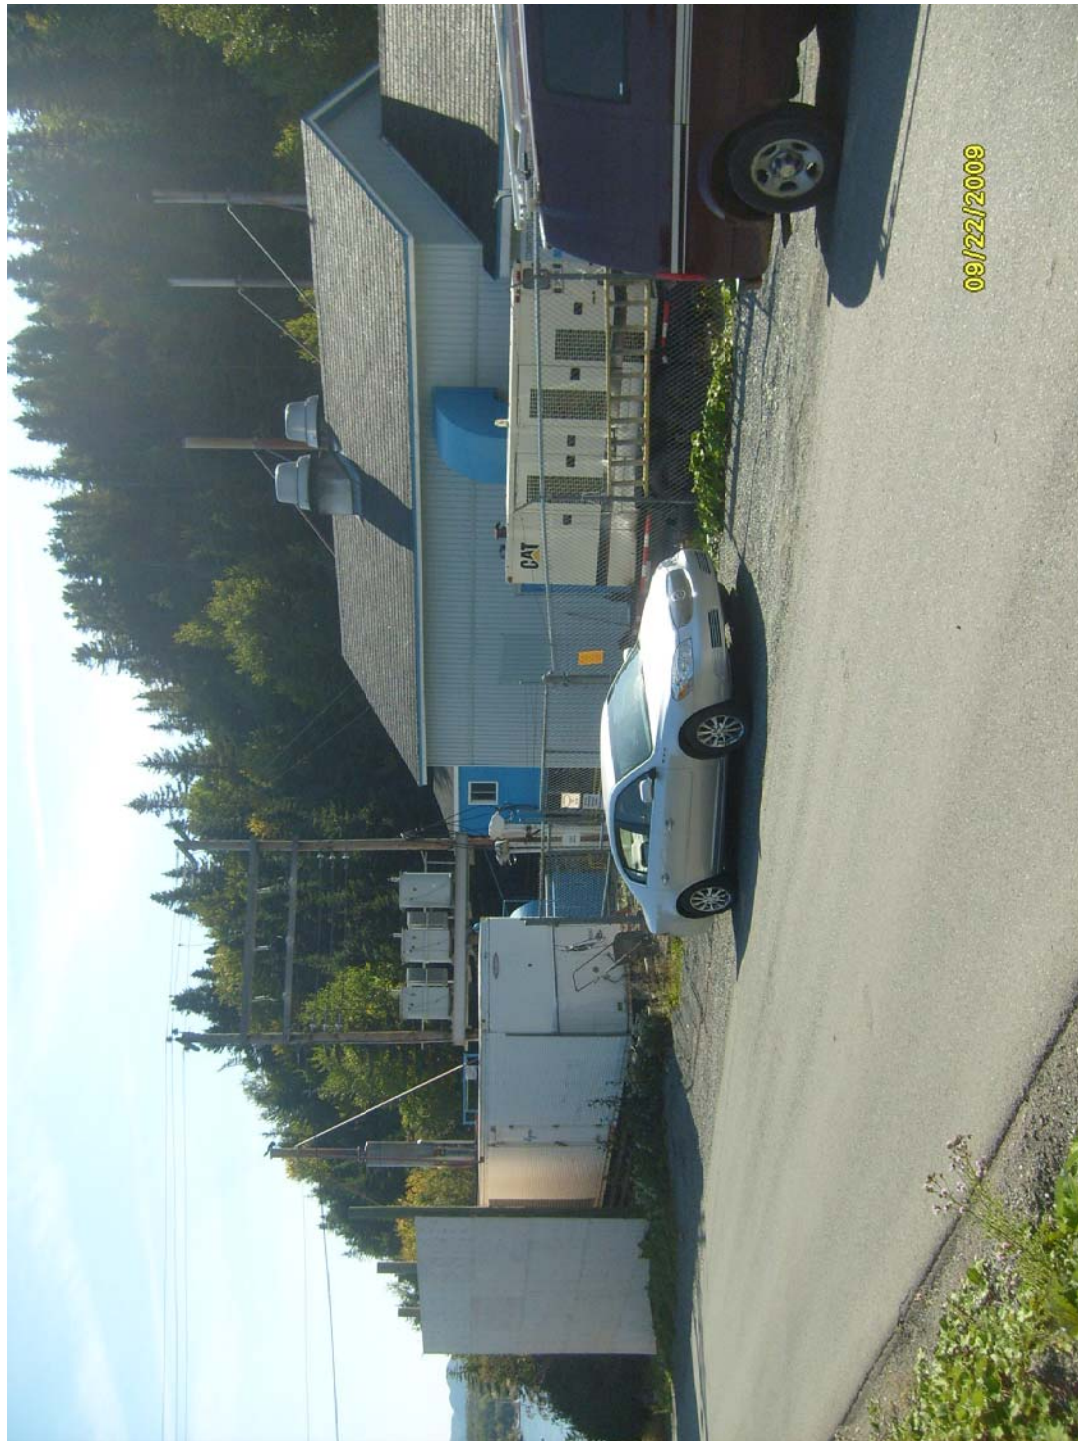
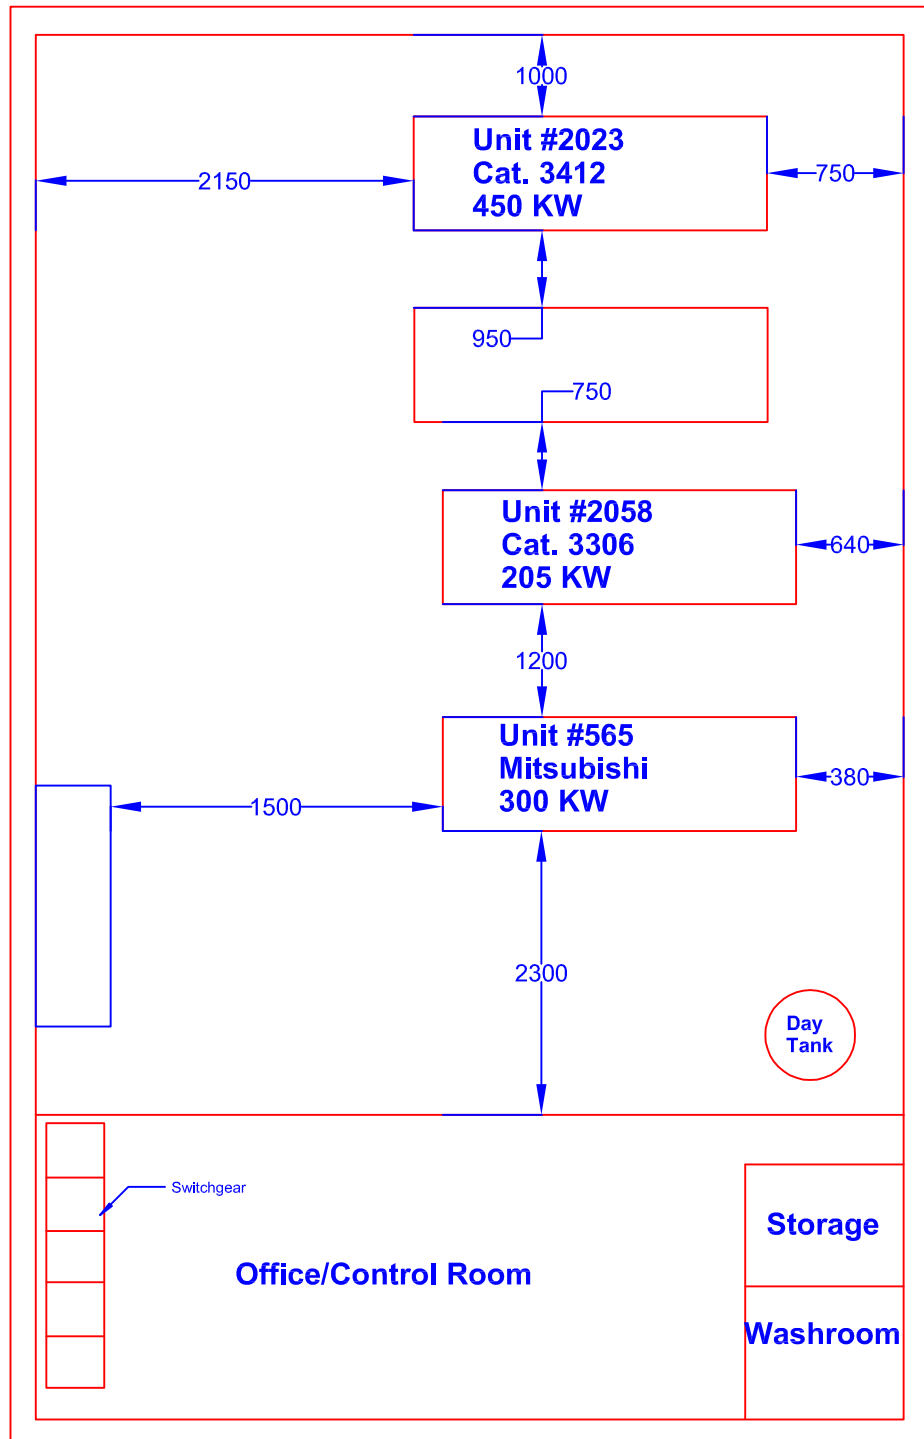
## Little Bay Islands, Newfoundland

1. There is a Mobile at this site - Caterpillar 3412, 450 KW
2. This is permanent to replace Unit #297 inside the plant.
