ATTACHMENT A:

Photographs of Transmission Line 55L

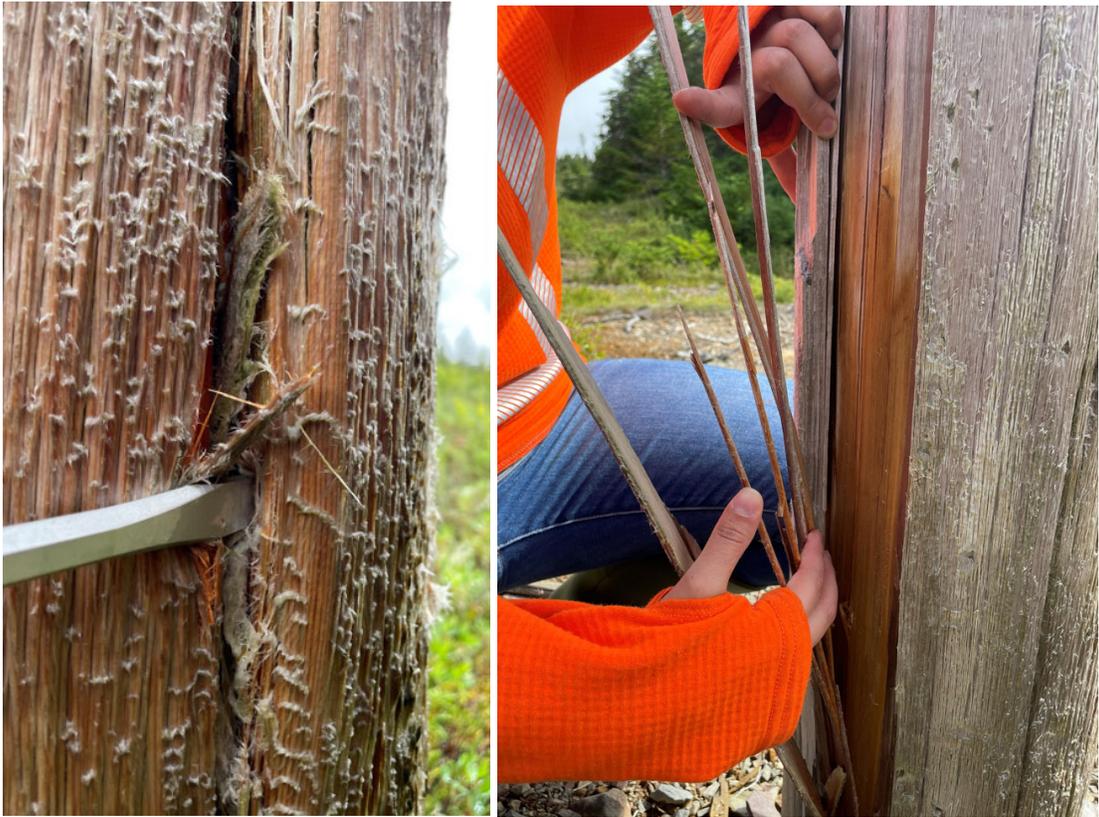
Figure 1 - Shell Separation

Shell separation occurs when the pole shrinks over time and the outer shell separates from the core of the pole. Leaving the untreated core exposed will allow moisture and fungus to enter and over time will compromise the strength of the pole resulting in pole failure.

Figure 1 shows examples of shell separation occurring on the wood pole structures of Transmission Line 55L.

The wood pole structures on Transmission Line 55L are experiencing significant shell separation, with many poles in a condition where they can no longer be climbed safely by Powerline Technicians.

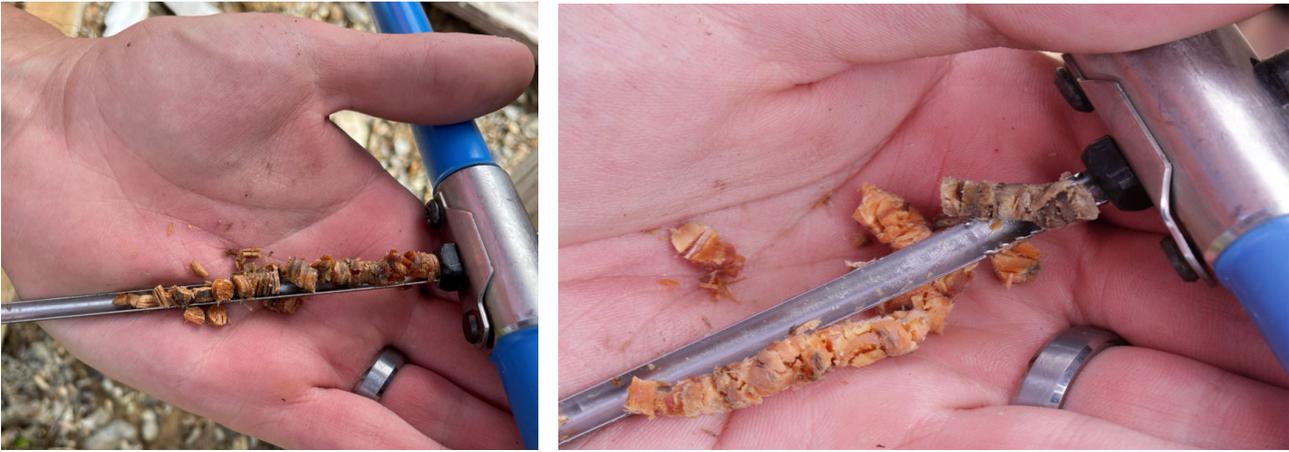
Figure 2 - Pole Core Sample

2
3 Core sampling is completed by drilling through the centre line of a pole and extracting a
4 sample of the wood. A healthy pole would have a core sample that has a light wood
5 colour, fresh wood scent and firm texture. A poor core sample would have black and
6 dark brown coloured wood, a moldy smell and soft texture indicating decay.

7
8 Figure 2 shows examples of the core sampling tests completed to assess the presence of
9 decay within the wood pole structures on Transmission Line 55L.

10 The core sampling tests revealed internal decay on the wood pole structures of
11 Transmission Line 55L.
