Q. NLH-NP-003 Reference: "2024 Capital Budget Application," Newfoundland Power Inc., June 22, 2023, sch. B, Gander Building Renovation, pp. 126–127.

General Properties Building Condition Assessment – Gander

Roof Condition Assessment

Report No. 1904860.00

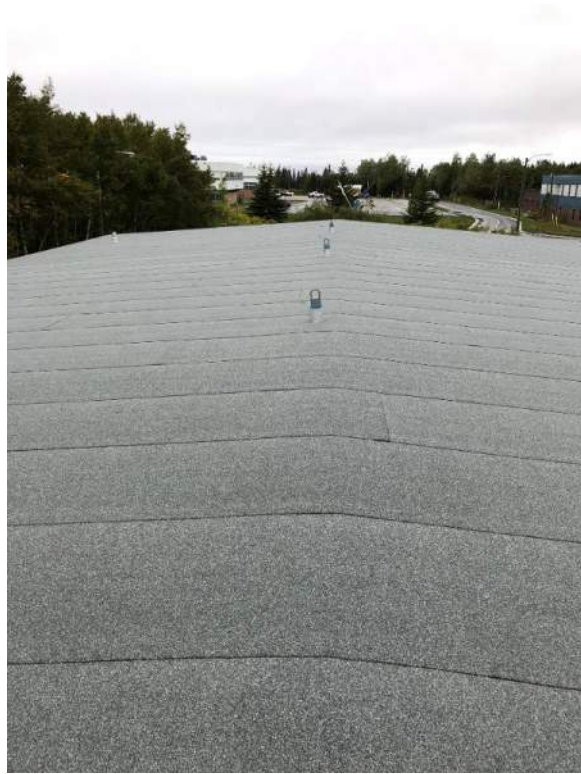
1. The modified bitumen membrane of Roof #1 appeared to be in good condition. The cap sheet of the modified bitumen membrane did not have any blisters or debonding of the sheet from the base sheet. Laps were sample measured to be approximately 75mm; which is standard roofing practice for this material assuming the architectural drawings specified the material used on the roof. Bitumen bleedout of the seams confirmed that the laps were bonded and it did not appear as though they were over or under torched.

PHOTO 1: ROOF #1 SINGLE-PLY MODIFIED BITUMEN GABLE ROOF WITH ROOF ANCHORS

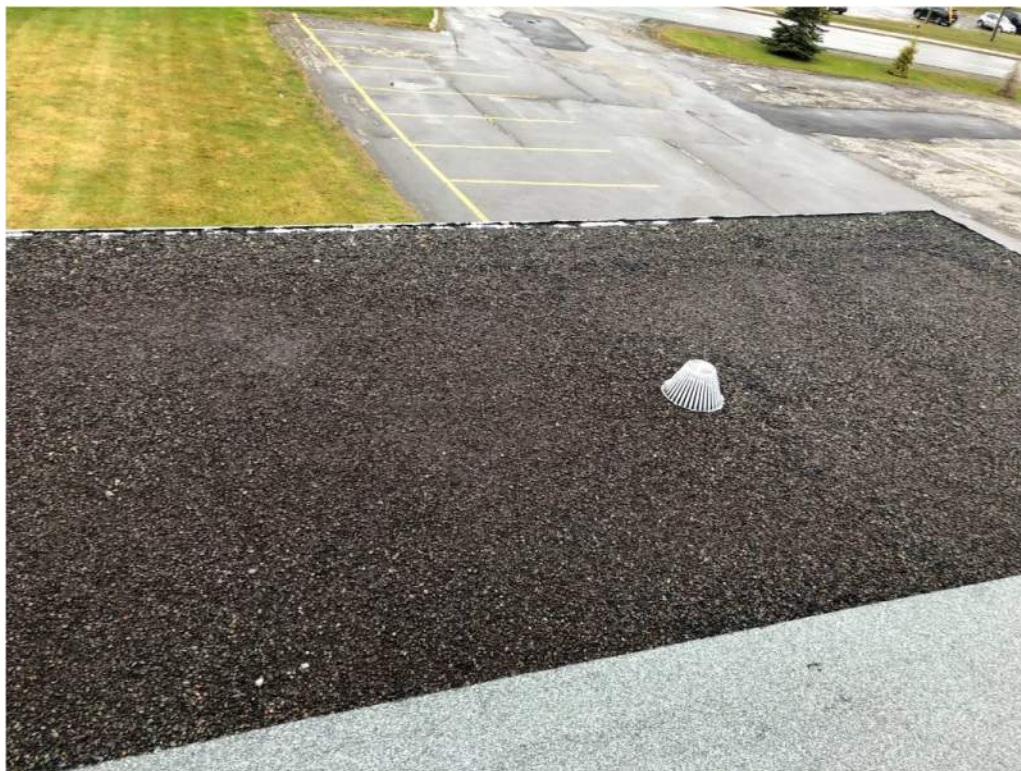
3. Roof #4 appeared to be in fair condition, moss and vegetation growth was noted at localized areas of the vestibule roof; most vegetation was noted along the joining wall of the main office building roof. No soft spots were detected below the roofing membrane that would indicate accumulated moisture in the roofing system.

PHOTO 2: ROOF #4 BUILT-UP ROOF.

1. **Safety Items** – Items that require immediate attention for health and safety reasons:
 - a. No related items noted during the site review.
2. **Capital Repair** – Recommended items to address life expectancies and existing conditions:
 - a. (G-CR-A) - Replace Roof #3 and Roof #4 in the next 2 years.
 - i. Estimated cost for replacement is \$100,000.00 + HST
 - b. (G-CR-B) - Replace Roof #2 in 8 years.
 - i. Estimated cost for replacement is \$125,000.00 + HST
 - c. (G-CR-C) - Complete roof review for Roof #1 in 3-5 years for condition assessment.
3. **Annual Maintenance** – Ongoing upkeep for assemblies:
 - a. (G-AM-A) - Clean out eavestroughs and downspouts at Roof #1.

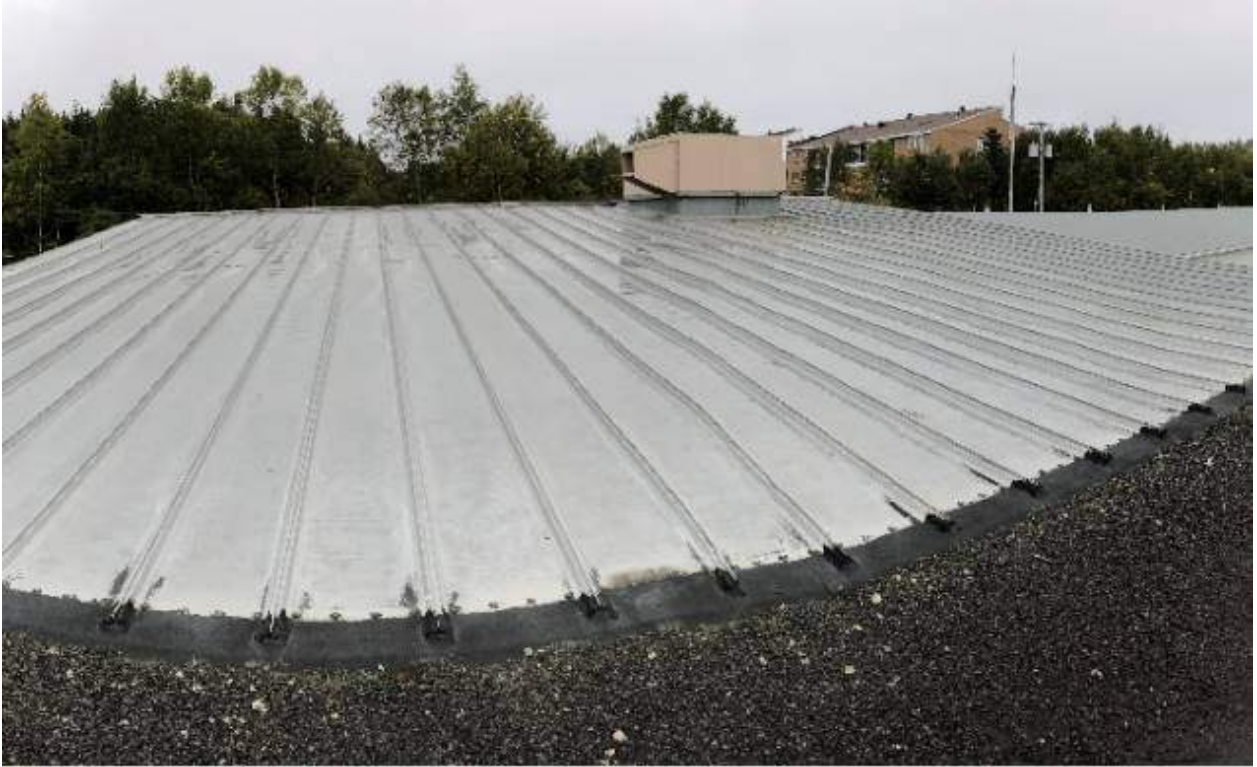
6. The Roof #2 metal roof sheets were shingled to shed water down towards the eaves trough at the north. The finishing for the metal panels was in good condition with no major deficiencies that would affect performance. The ridge metal cap joints were covered with a 300mm wide strip of modified bitumen membrane.

PHOTO 3: ROOF #2 - PITCHED STANDING SEAM METAL ROOF.

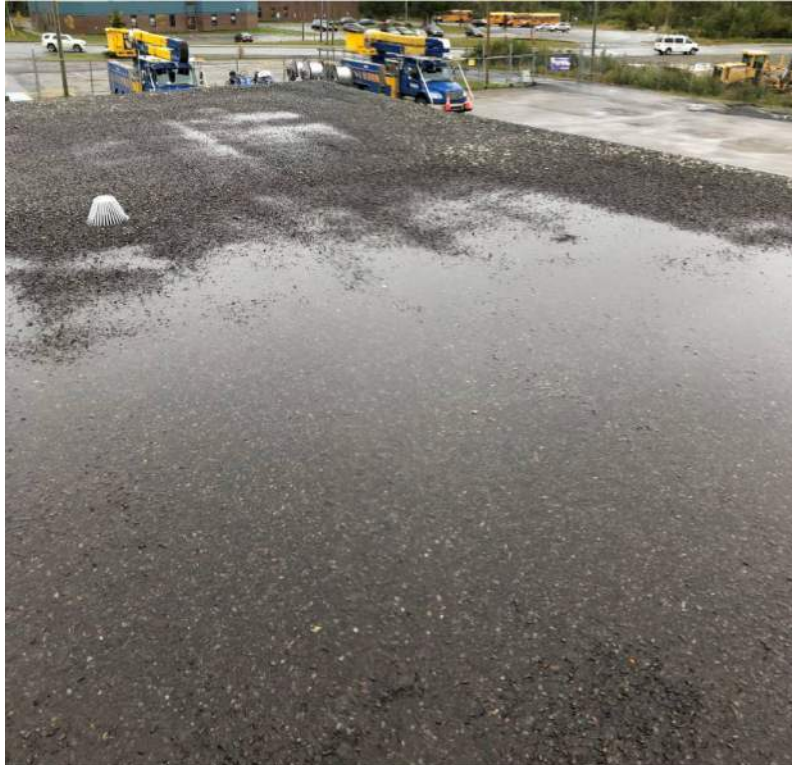
5. Minor ponding of water was noted on Roof #3 and Roof #4. Ponding was concentrated between the two roof drains at Roof #3. Ponding of water (with a light precipitation at the time of review) was noted to be approximately 12mm deep.

PHOTO 4: ROOF #3 BUILT-UP ROOF.

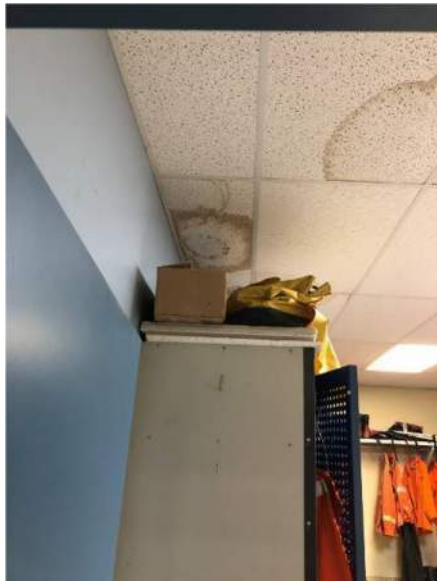
- The occupants indicated that a leak was present at the women's washroom of the main office building. The occupants reported that leak was found to not be a cause from the original roof of the building since the roof was replaced in 2004, but from a vent at the wall.
- Roof repairs were conducted at the pitched standing seam metal roof of the storage and parking bay due to reported leaks. The occupants indicated that prior to the repairs there was "considerable" water penetration and that it would run above the ceiling tiles. Water leaks have not been resolved since repairs have been completed on the roof.

PHOTO 5: REPORTED LEAKS IN THE LINE PERSON DRYROOM.

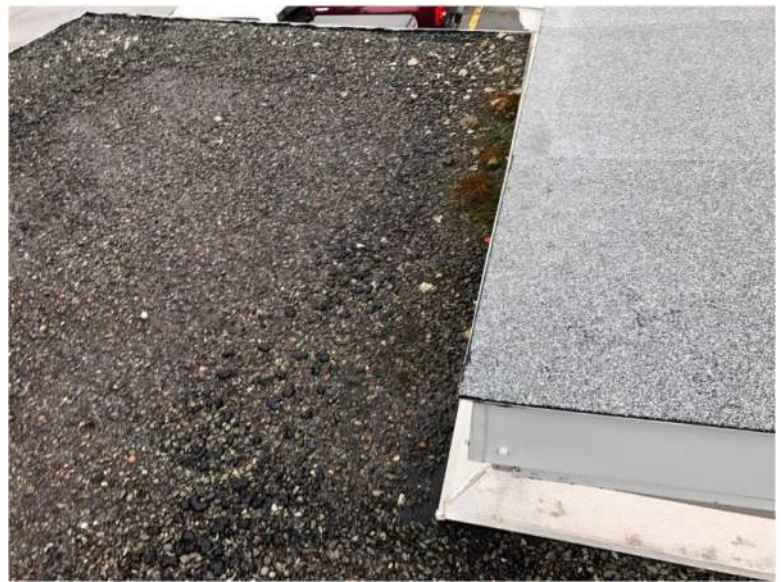
PHOTO 6: VESTIBULE BUILT-UP ROOF WITH LOCALIZED MOSS AND VEGETATION GROWTH.

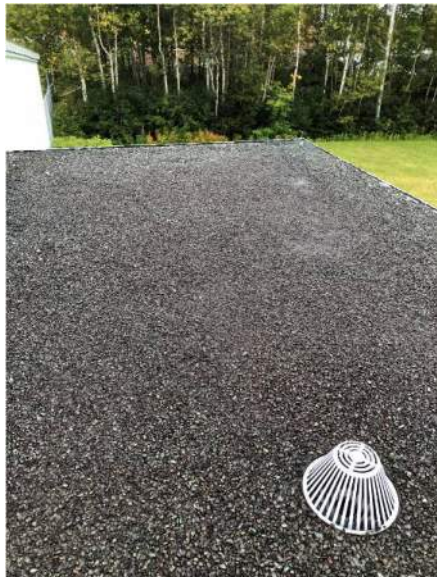
PHOTO 7: VESTIBULE BUILT-UP ROOF WITH ROOF DRAIN.

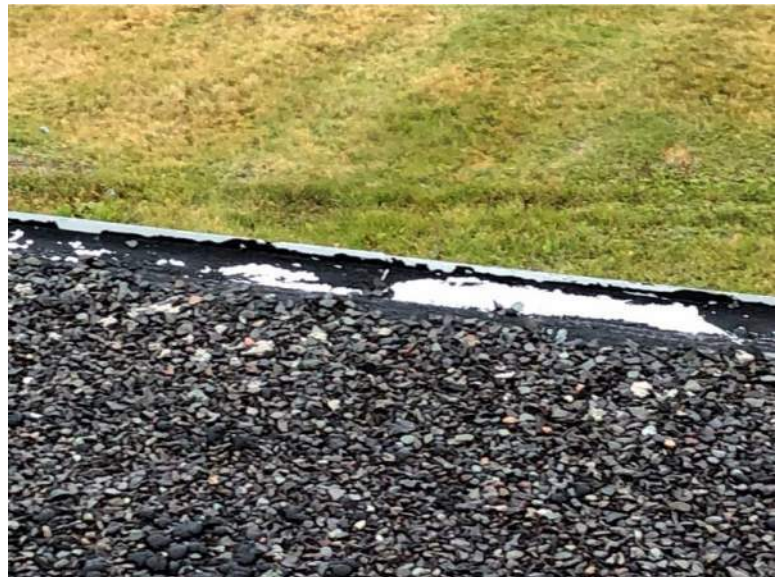
PHOTO 8: VESTIBULE ROOF EDGE AT THE METAL FLASHING/FASCIA.

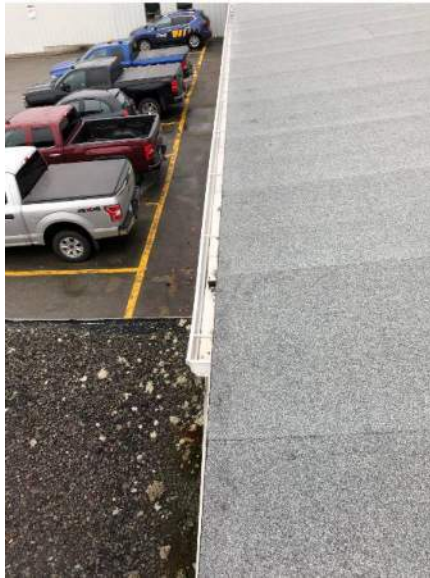
4. The eaves trough at the north and south ends of Roof #1 were draining water to the eaves; drainage was noted from the rain at the time of site review. There didn't appear to be any leaf build-up at the reviewed eavestroughs. The downspouts and eaves trough should be checked and cleared, and debris removed as a means of maintenance so that it can drain freely.

PHOTO 9: EAVES THROUGH AT GABLE SINGLE-PLY MODIFIED BITUMEN ROOF.

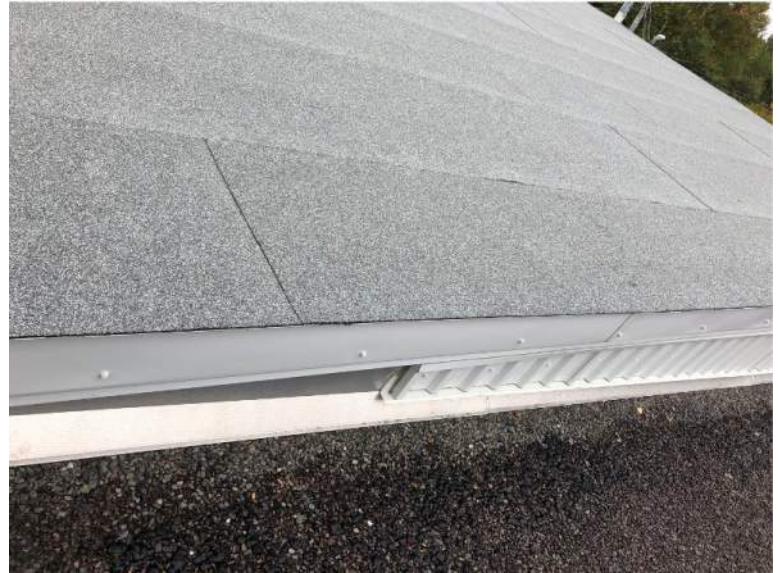
PHOTO 10: TRANSITION WALL AT VESTIBULE ROOF AND MAIN OFFICE BUILDING ROOF.

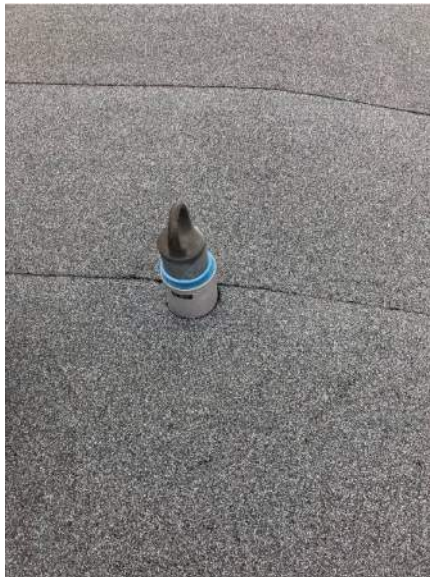
PHOTO 11: ROOF ANCHOR INSTALLED ON THE SINGLE-PLY MODIFIED BITUMEN MEMBRANED ROOF.

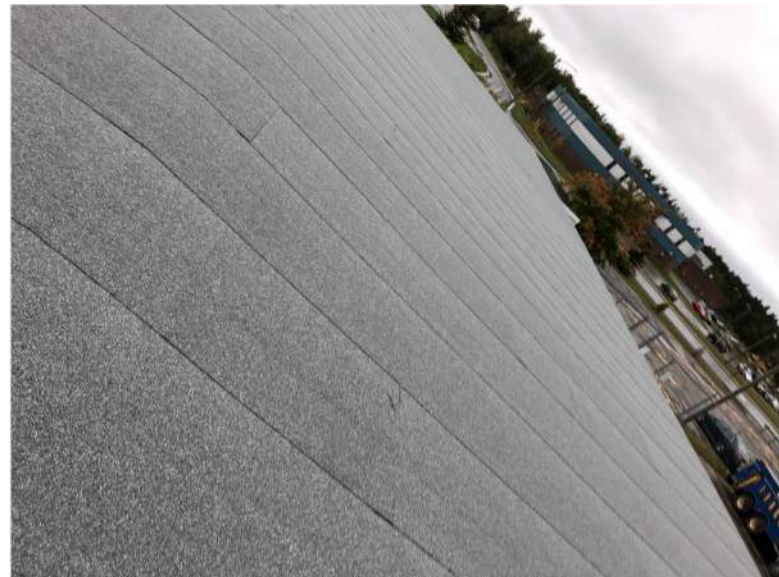
PHOTO 12: CAPP SHEET OF SINGLE-PLY MODIFIED BITUMEN ROOF.

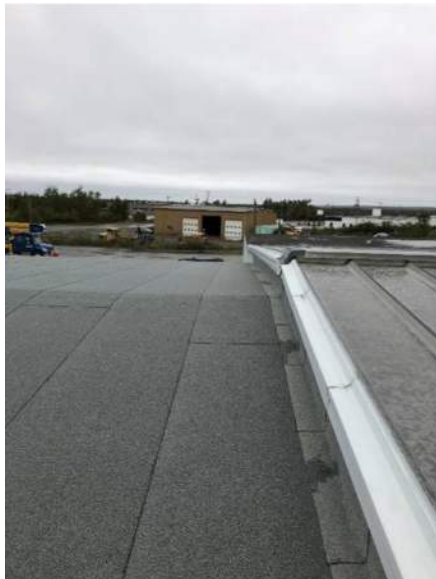
PHOTO 13: TRANSITION WALL BETWEEN THE MAIN BUILDING ROOF AND STORAGE AREA METAL ROOF.

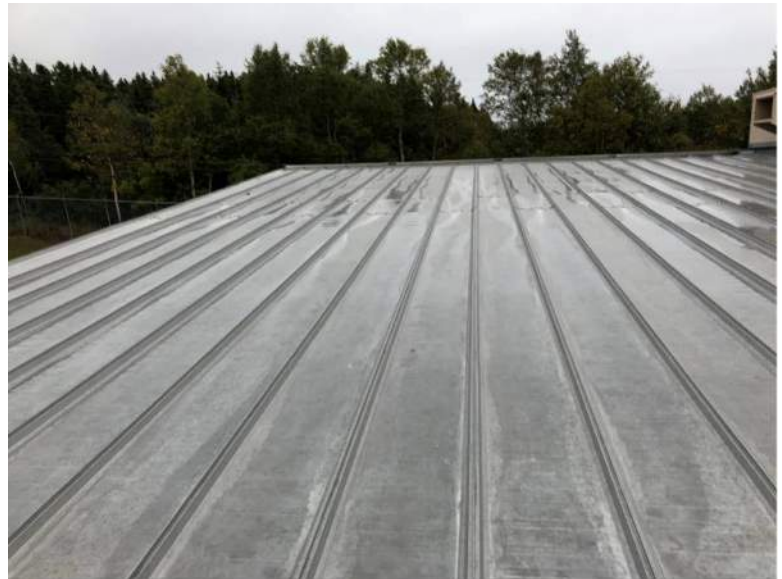
PHOTO 14: NORTH SIDE OF THE PITCHED STANDING SEAM ROOF.

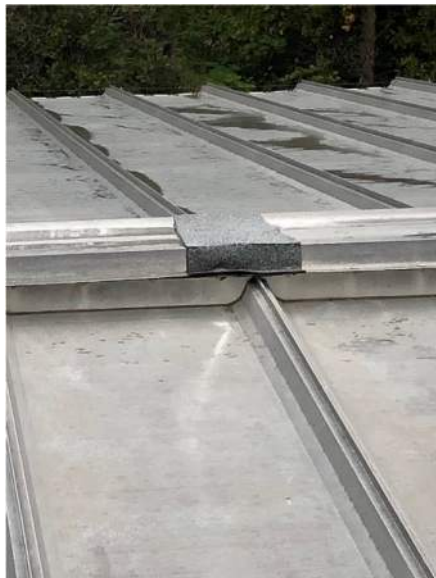
PHOTO 15: SEAM OF RIDGE FLASHING OF THE PITCHED STANDING SEAM ROOF COVERED WITH A STRIP OF MODIFIED BITUMEN MEMBRANE.

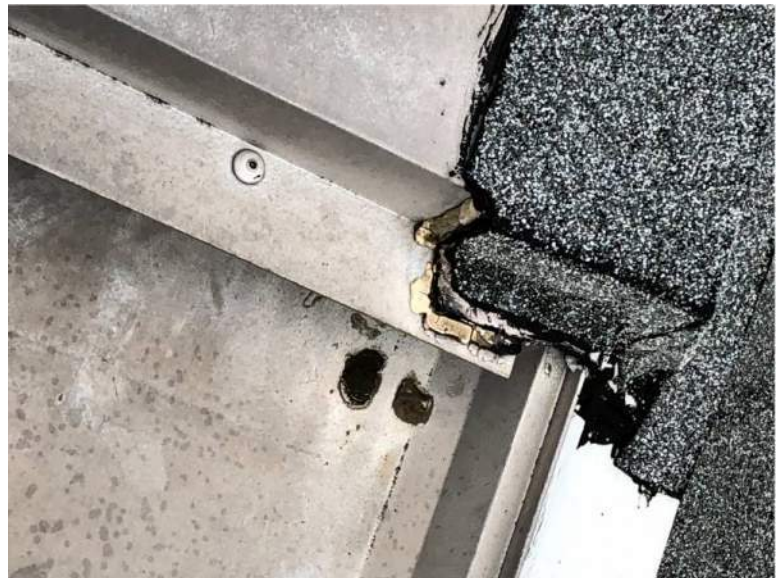
PHOTO 16: RIDGE SEAM MEMBRANE LAP.

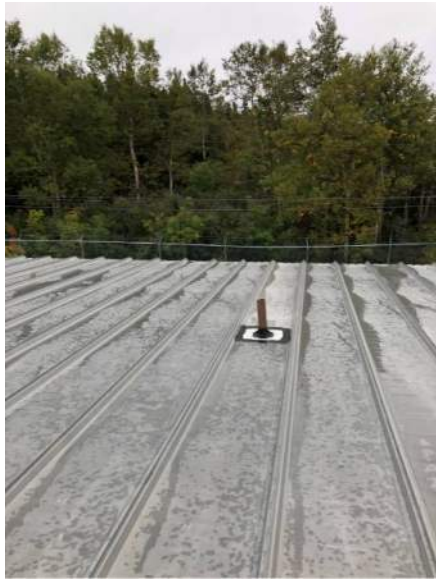
PHOTO 17: ROOF PENETRATIONS AT STORAGE METAL ROOF.

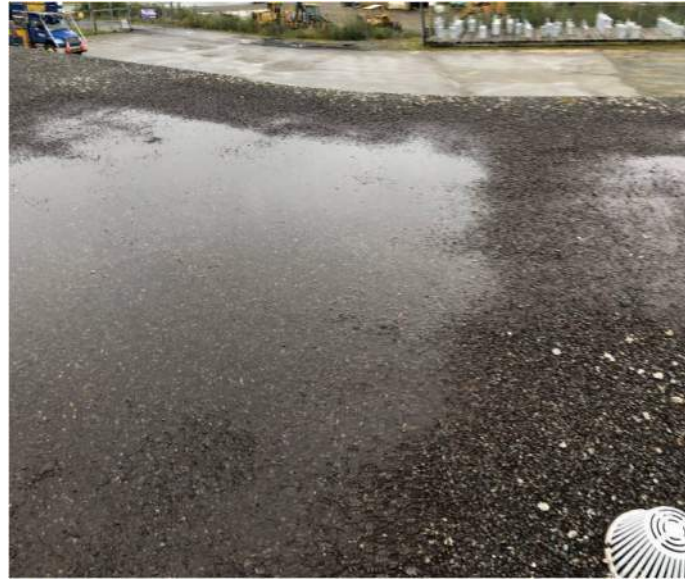
PHOTO 18: STAGGING AREA BUILT-UP ROOF WITH WATER PONDING.

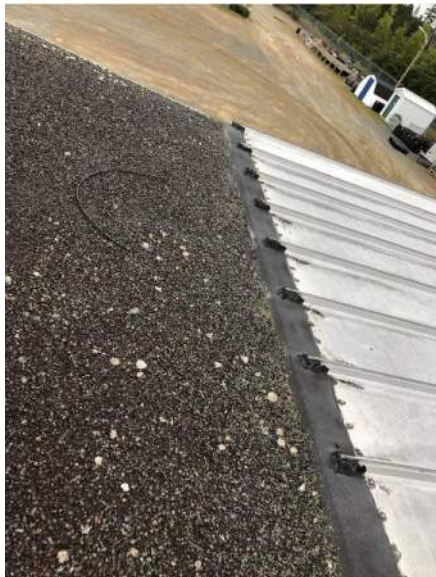
PHOTO 19: ROOF TRANSITION BETWEEN STORAGE METAL ROOF AND STAGGING AREA BUILT-UP ROOF.

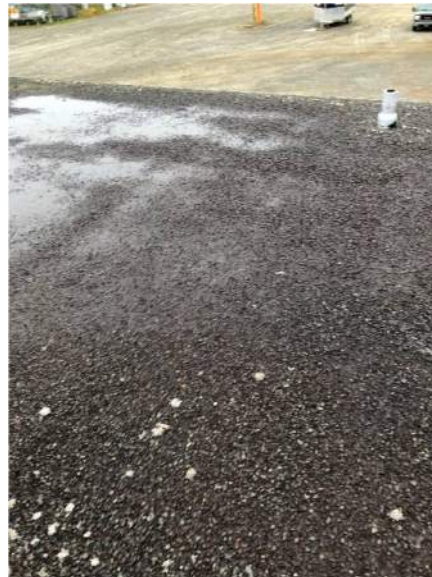
PHOTO 20: EAST END OF THE STAGGING AREA BUILT-UP ROOF WITH VENT.
