**Re: Quarterly Report on Asset Performance in Support of Resource Adequacy for the Twelve Months Ended September 30, 2025**

# Quarterly Report on Asset Performance in Support of Resource Adequacy

Attachment 1: L3501 Failure Investigation – Ice Storm Central Labrador – January 2025

## L3501 Failure Investigation

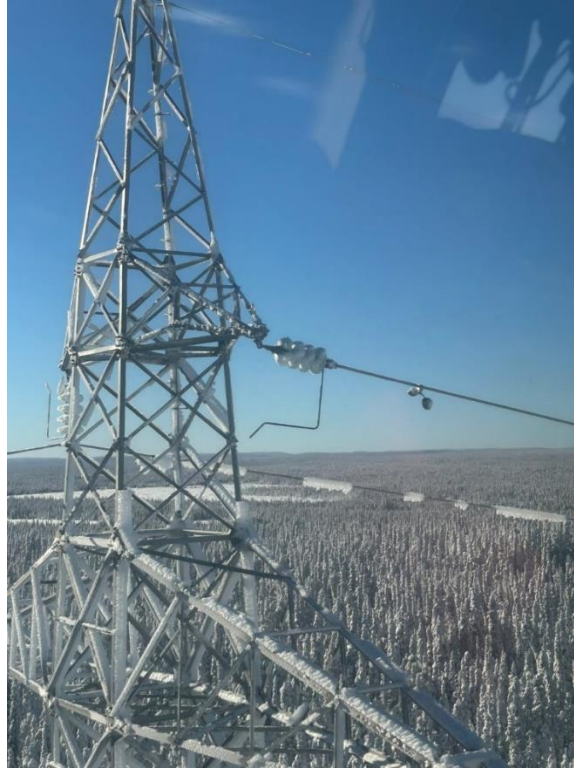
**Figure 3: S127 EL1 Cross Arm and Conductor Failure**

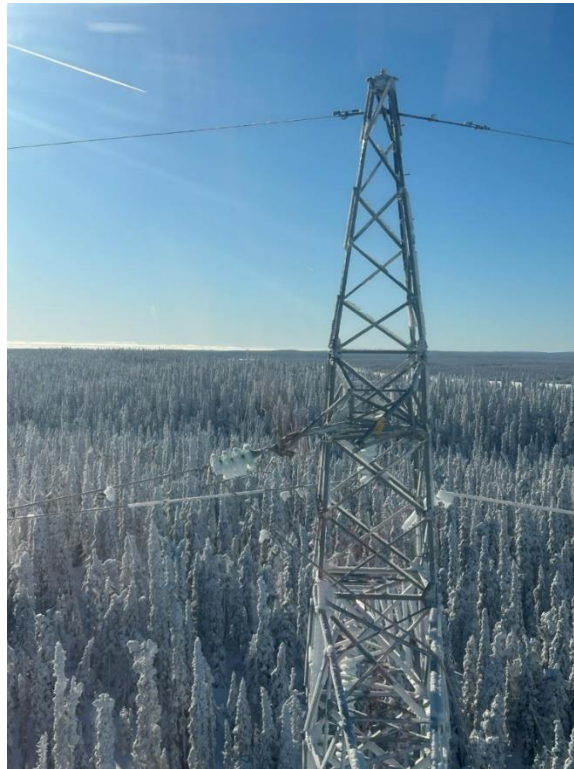
**Figure 4: S128 EL1 Cross Arm Failure**

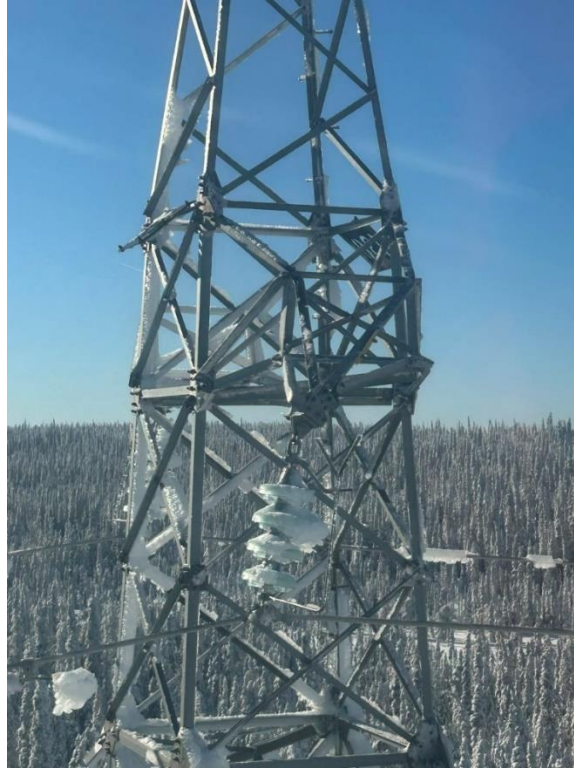
**Figure 5: S130 EL1 Cross Arm Failure**

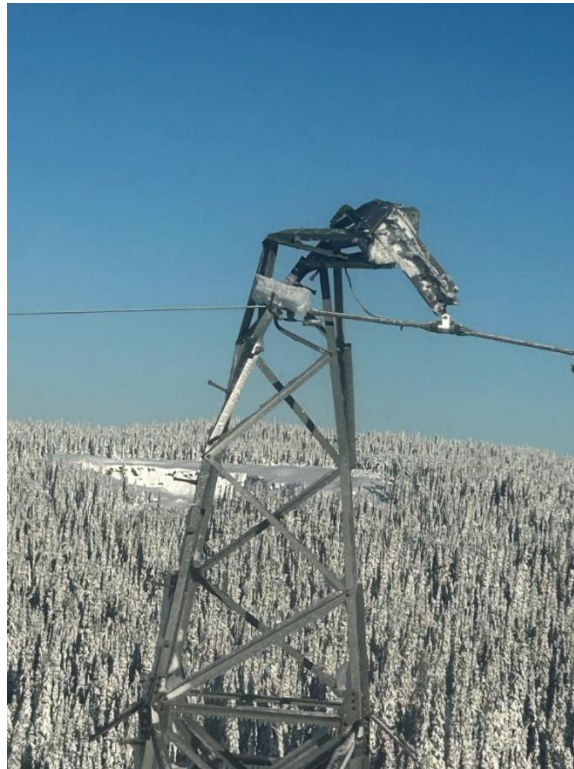
**Figure 6: S120/121 OPGW Peak Failure due to Ice Removal**

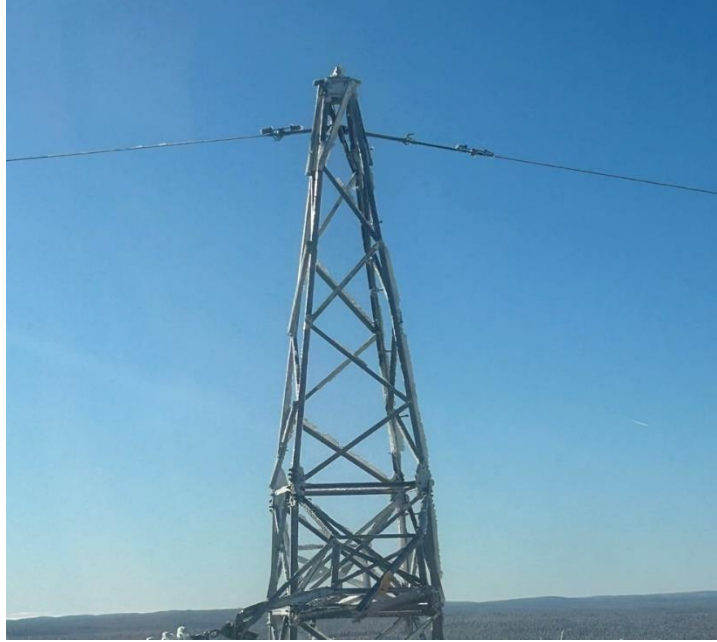
**Figure 7: Pulled OPGW due to Ice Removal**

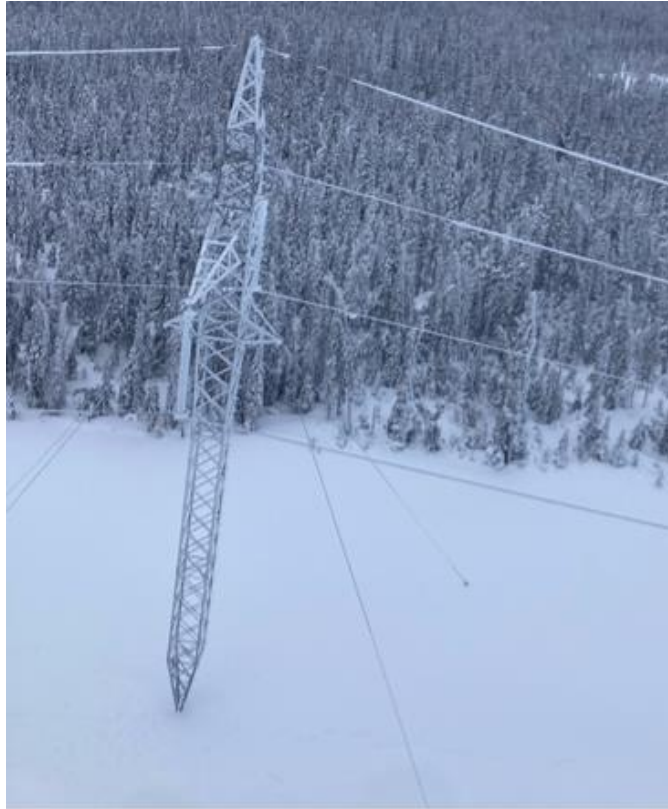
**Figure 10: Ice conditions at Time of Helicopter Patrol  
Discovering Damage**

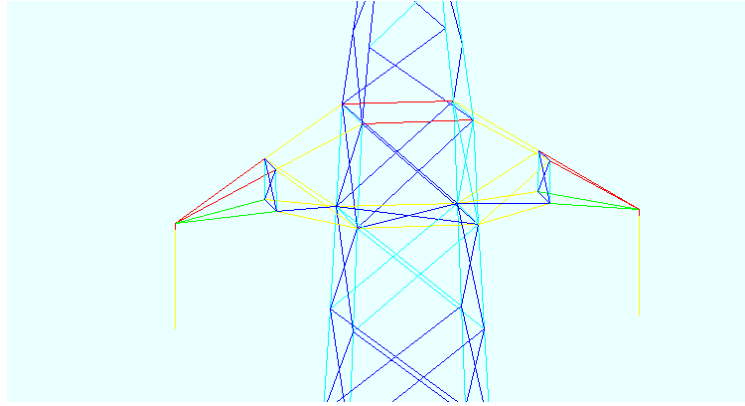
**Figure 22: Model of S127 with 80mm of Balanced Radial Ice – Electrode Cross Arm Failures**

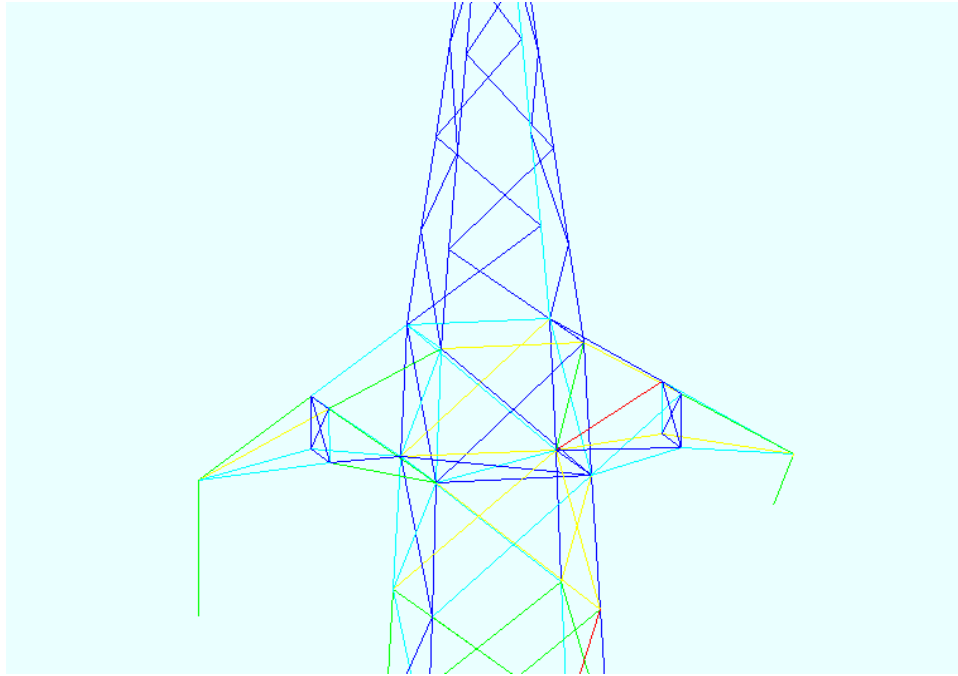
**Figure 23: Model of S127 Unbalanced Ice Load Case Showing Failed Members in the Electrode Crossarm Exceeding Capacity at 100/40% Unbalanced Loading**

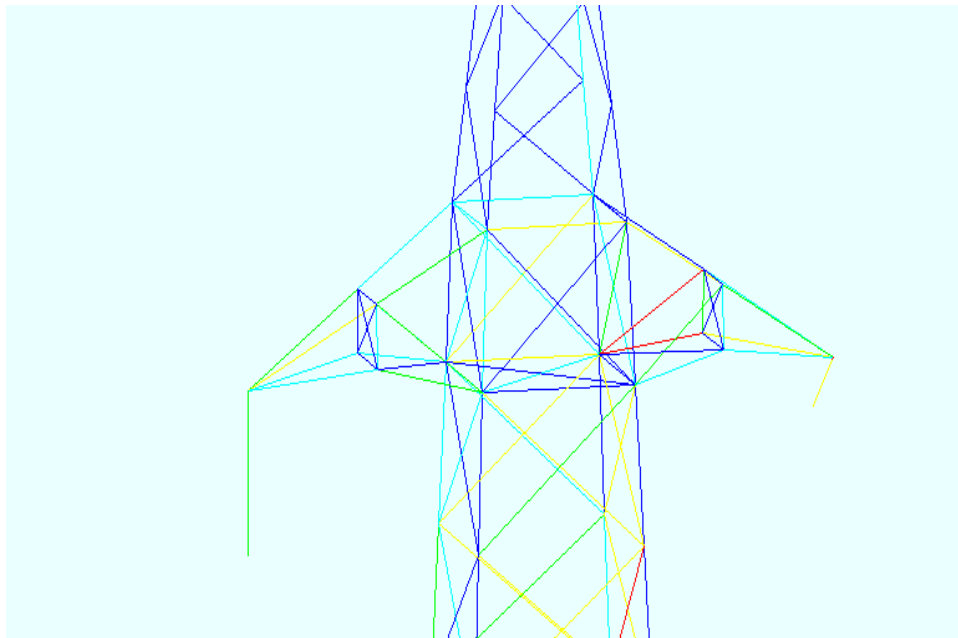
**Figure 24: Model of S127 Unbalanced Ice Load Case Showing Failed Members in the Electrode Crossarm Exceeding Capacity at 100/30% Unbalanced Loading**

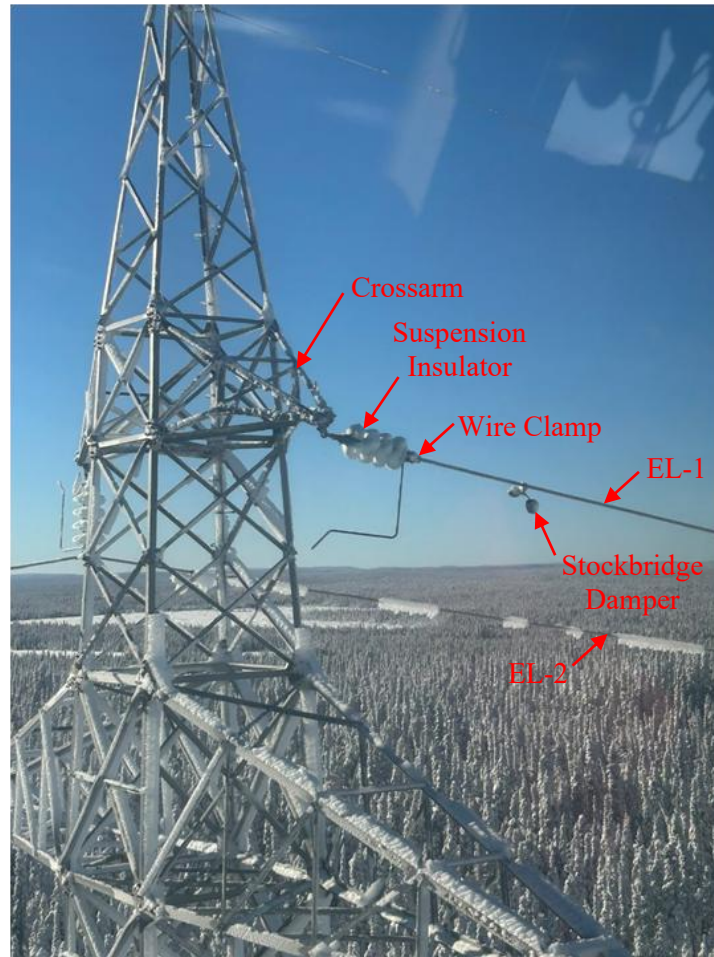
Figure I-1: Close-up view of suspension Tower #127 subsequent to the EL-1 conductor failure on January 11, 2025 [1]. The image shows the locations of conductors EL-1 and EL-2 (arrows), which were attached to the crossarms of the tower via suspension insulators.

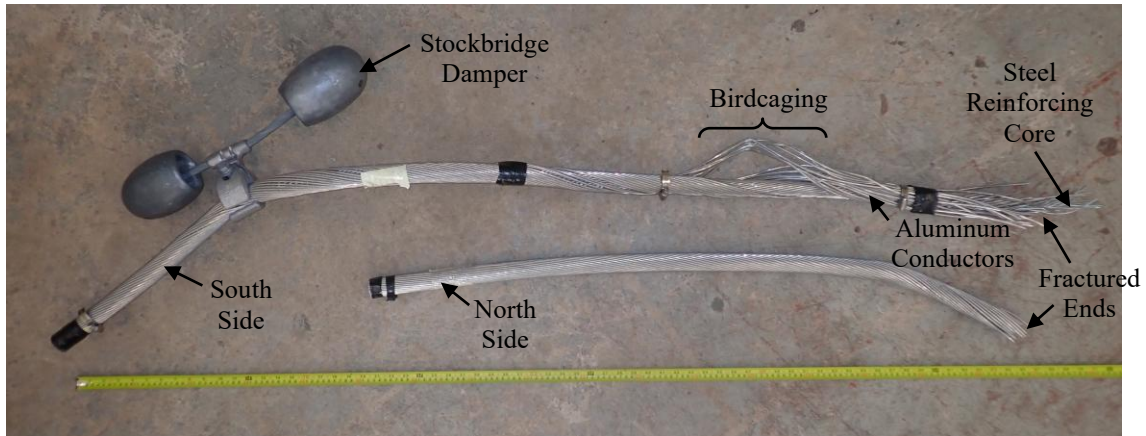
Figure 2-1: General view of the mating sections of the failed conductor EL-1 from suspension Tower #127 as received for analysis.

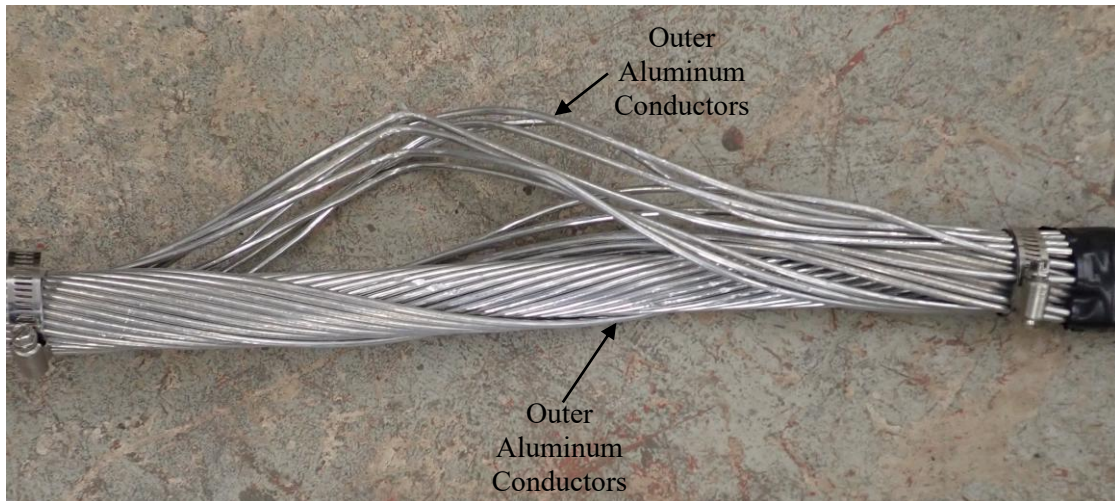
*Figure 2-3: Image showing the evidence of moderate birdcaging of the outer layer wire strands observed on the south side section at a distance of approximately 24 inches from the failed end of the conductor.*

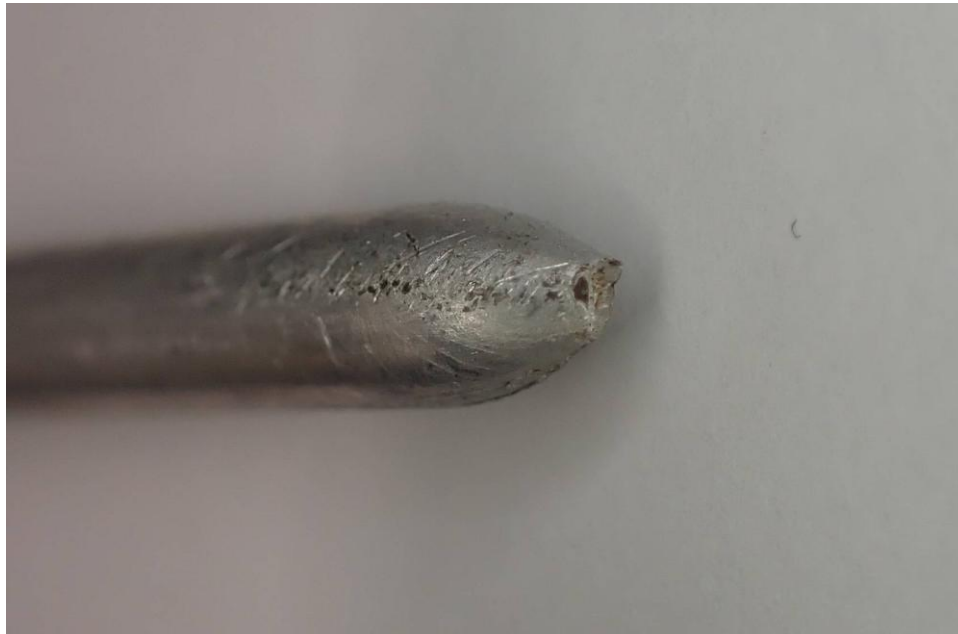
Figure 2-6: Close-up view of a representative example of the first fracture failure morphology observed for the aluminum strands associated with conductor EL-1. The first morphology was characterized by a tapered (necked) interval immediately adjacent to the strand fracture surface.

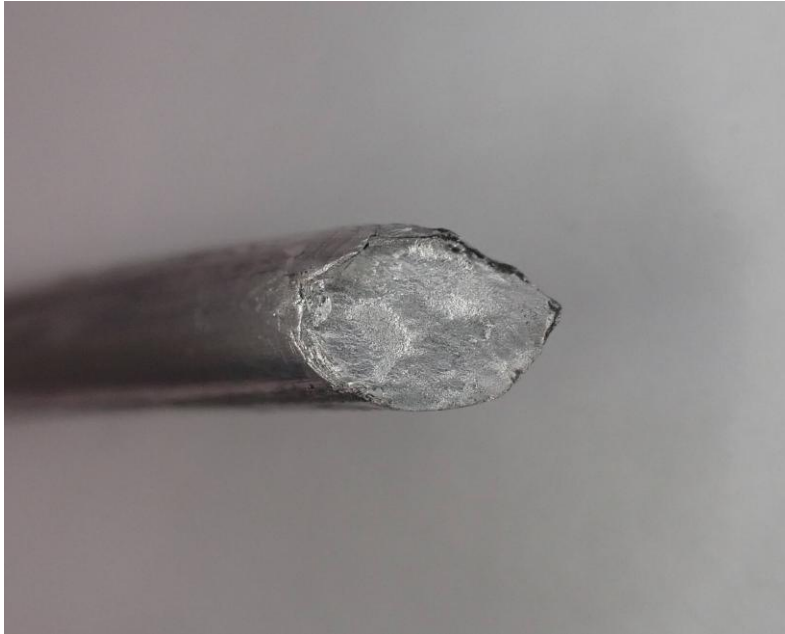
*Figure 2-7: Close-up view of a representative example of the second fracture failure morphology observed for the aluminum strands associated with conductor EL-1. The second morphology was characterized by an oblique fracture plane extending across the diameter of the strand.*

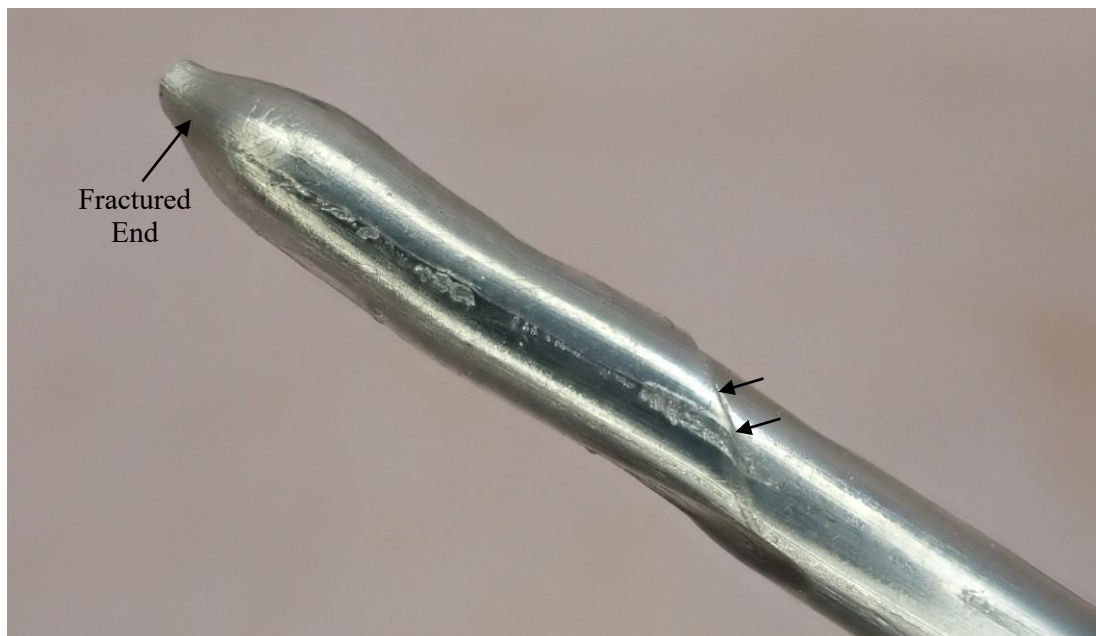
*Figure 2-8: Close-up view of a representative example of a partial through wire indication detected in an aluminum strand (arrows).*

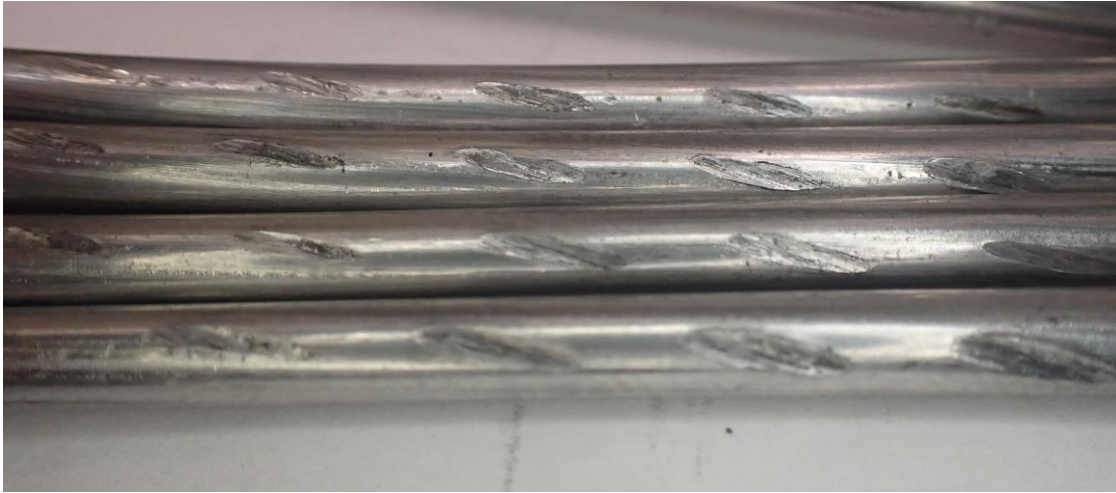
*Figure 2-9: Close-up view of a representative example of the strand on strand brinelling (localized deformation) observed on the individual aluminum wire strands.*

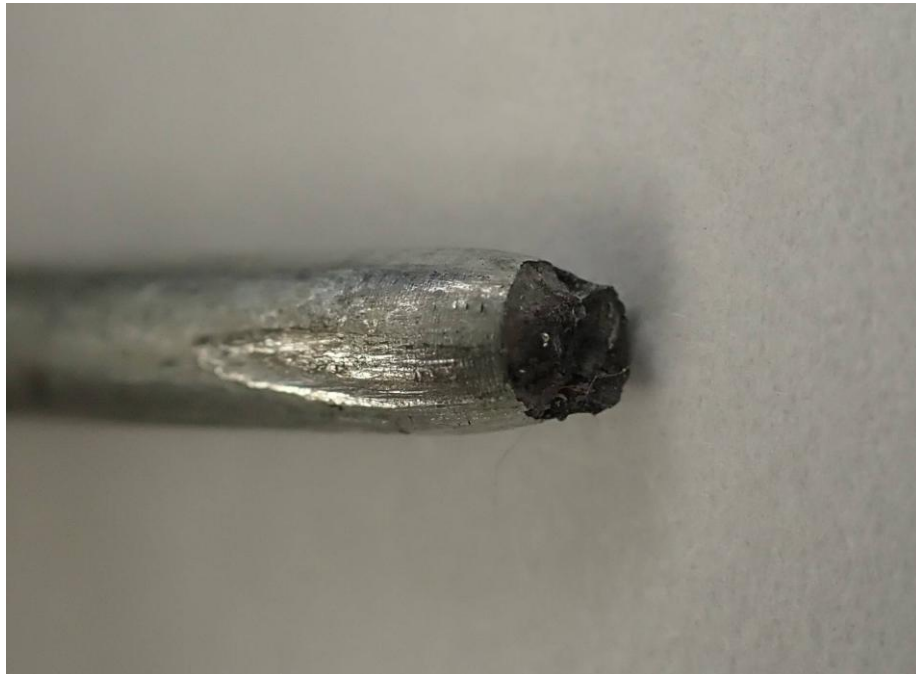
*Figure 2-10: Close-up view of a representative example of the fracture failure morphology observed for the steel reinforcing core strands associated with conductor EL-1. The morphology was characterized by a tapered (necked) interval immediately adjacent to the strand fracture surface.*

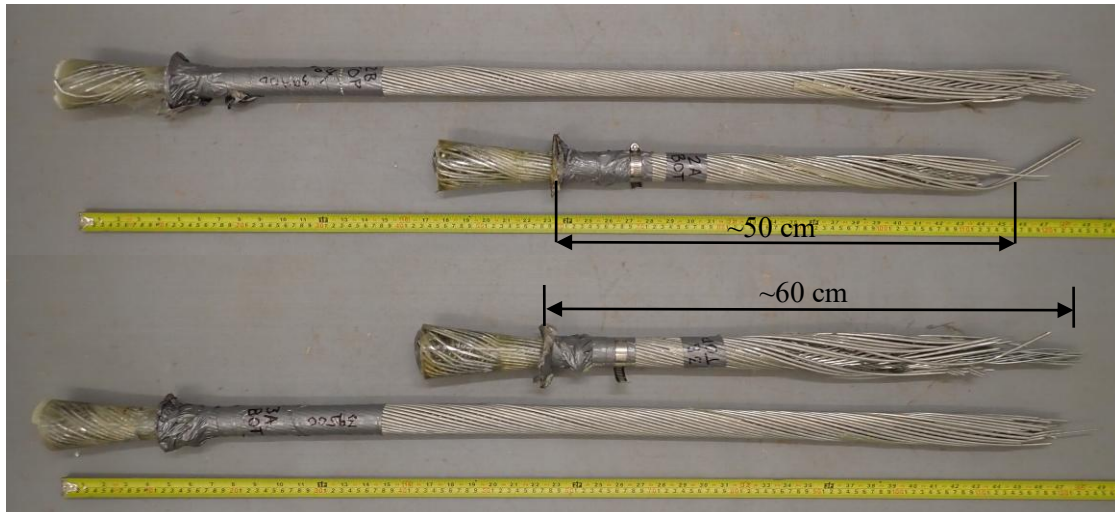
*Figure 3-4: Photograph showing the two tensile test samples subsequent to failure. The axial positions of the conductor failures ranged between approximately 50 cm and 60 cm from the beginning of one of the epoxy filled terminations.*

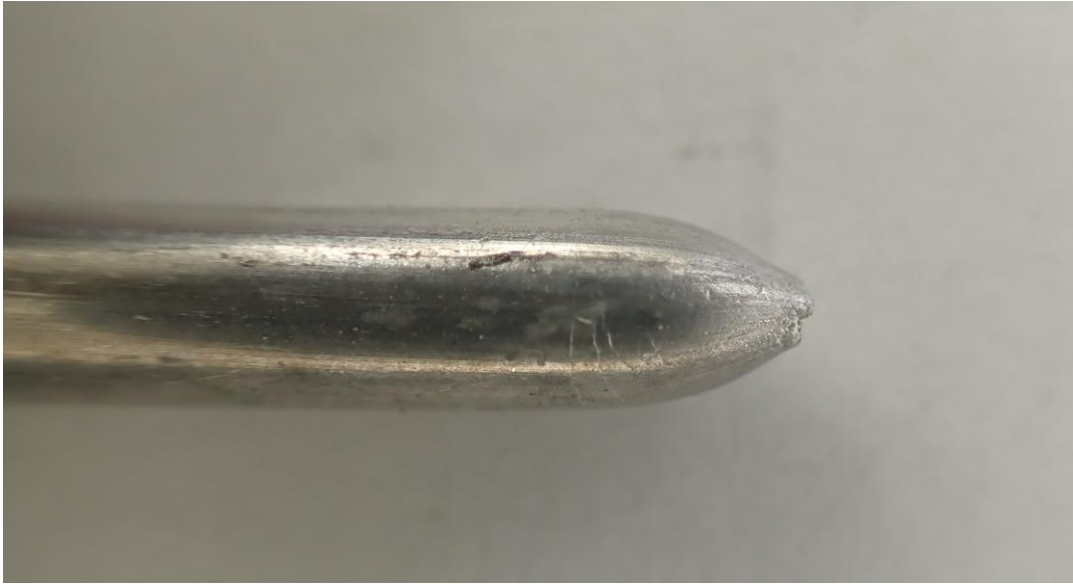
*Figure 3-6: Close-up view of a representative example of the first fracture failure morphology observed for the aluminum strands subsequent to uniaxial tension testing. The first morphology was characterized by a tapered (necked) interval immediately adjacent to the strand fracture surface.*

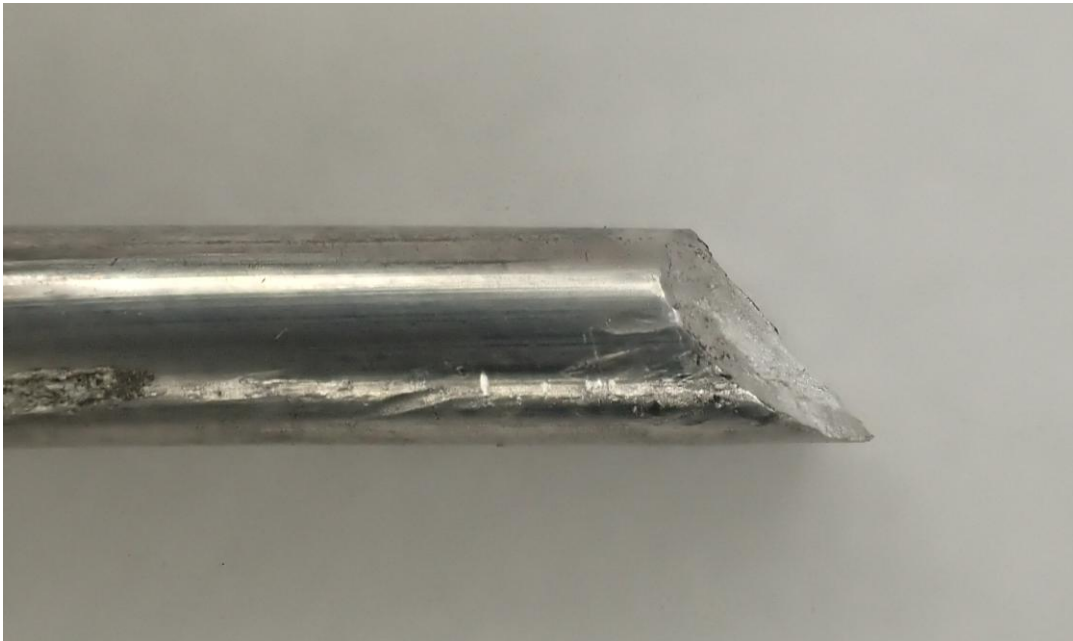
*Figure 3-7: Close-up view of a representative example of the second fracture failure morphology observed for the aluminum strands subsequent to uniaxial tension testing. The second morphology was characterized by an oblique fracture plane extending across the diameter of the strand.*

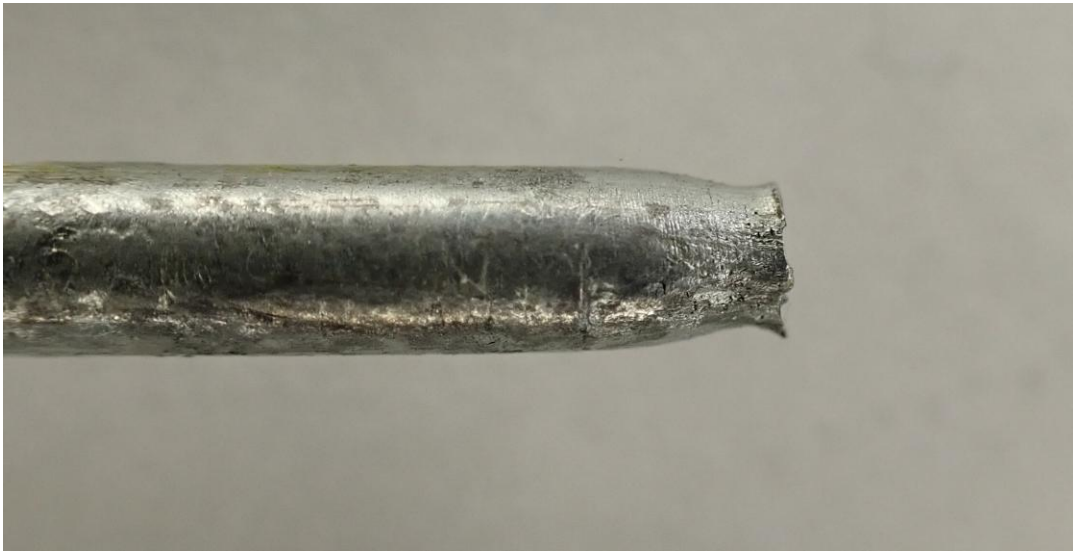
*Figure 3-8: Close-up view of a representative example of the fracture failure morphology observed for the steel reinforcing core strands subsequent to uniaxial tension testing. The morphology was characterized by a tapered (necked) interval immediately adjacent to the strand fracture surface.*

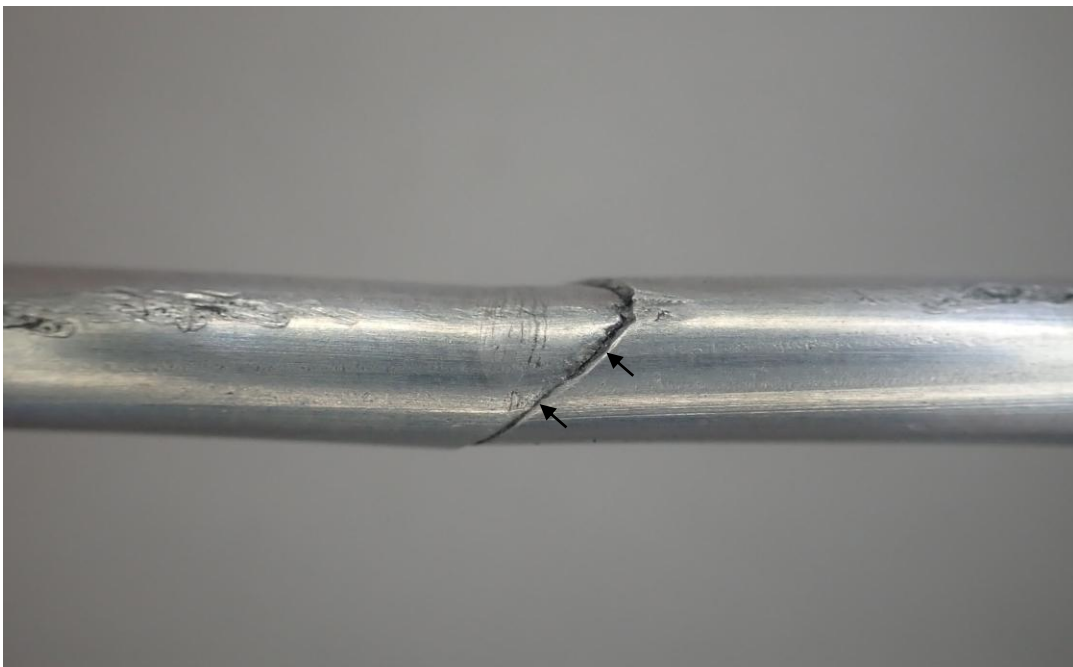
*Figure 3-9: Close-up view of a representative example of a partial through wire indication detected in an aluminum strand subsequent to uniaxial tension testing (arrows).*

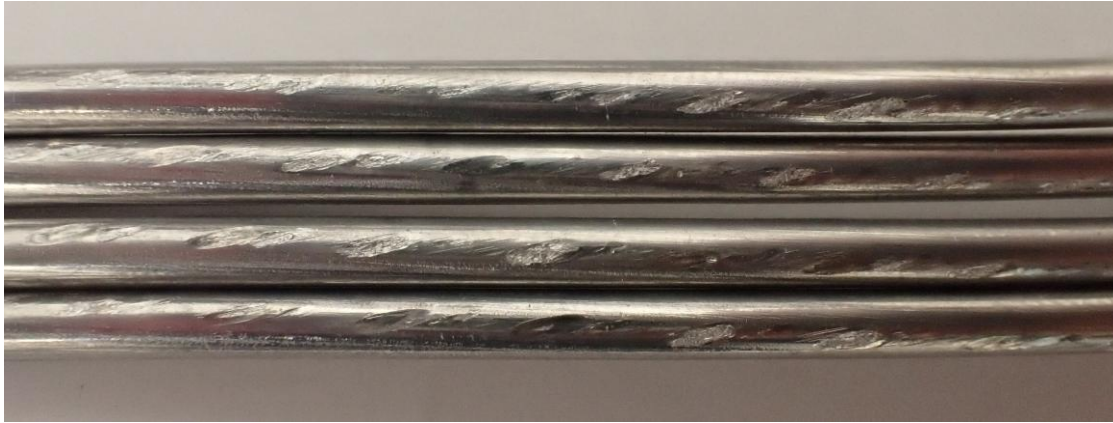
*Figure 3-10: Close-up view of a representative example of the strand on strand brinelling (localized deformation) observed on the individual aluminum wire strands subsequent to uniaxial tension testing.*

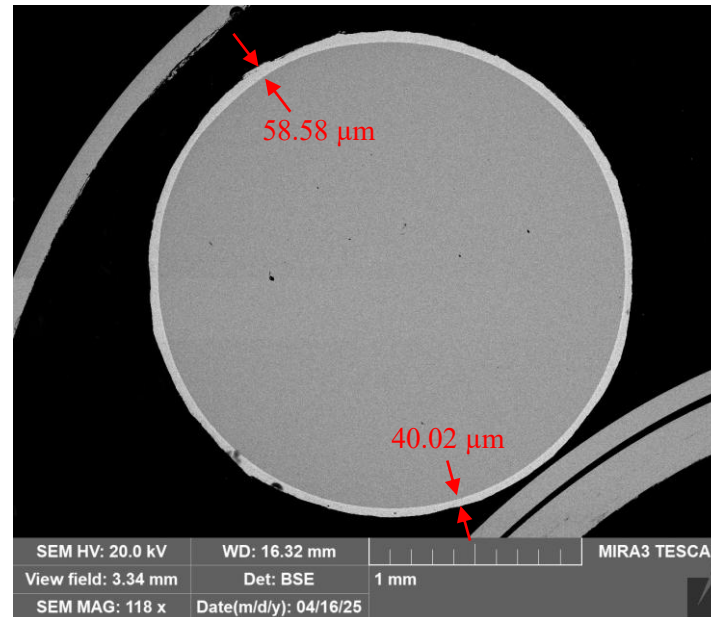
Figure 3-11: SEM backscatter image of a representative example of a zinc coated steel reinforcing strand for the failed conductor EL-1. The image shows the variation in the thickness of the zinc coating observed around the circumference of the steel reinforcing strand.

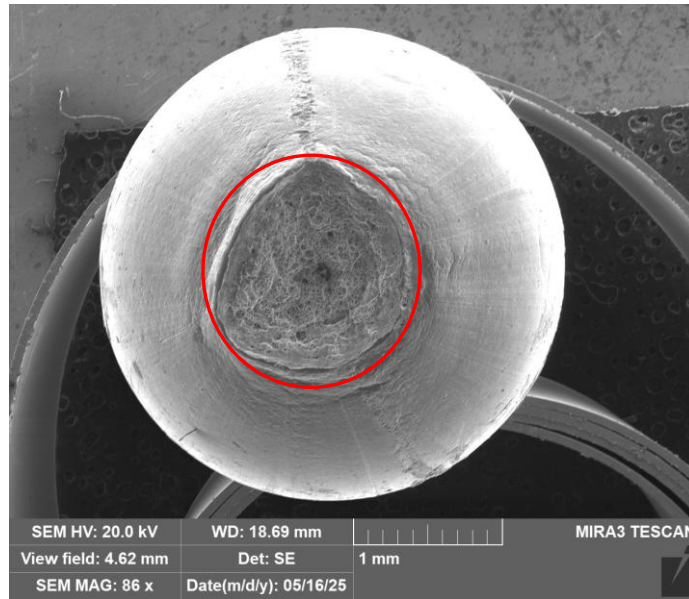
Figure 4-1: Low magnification SEM secondary image of a representative example of the fracture surface (ellipse) associated with the tapered-end (necked) geometry observed terminating the failed aluminum wire strands during the preliminary examination of conductor EL-1 (Figure 2-6). The image shows the general cup and cone morphology of the failed end of the wire strand.

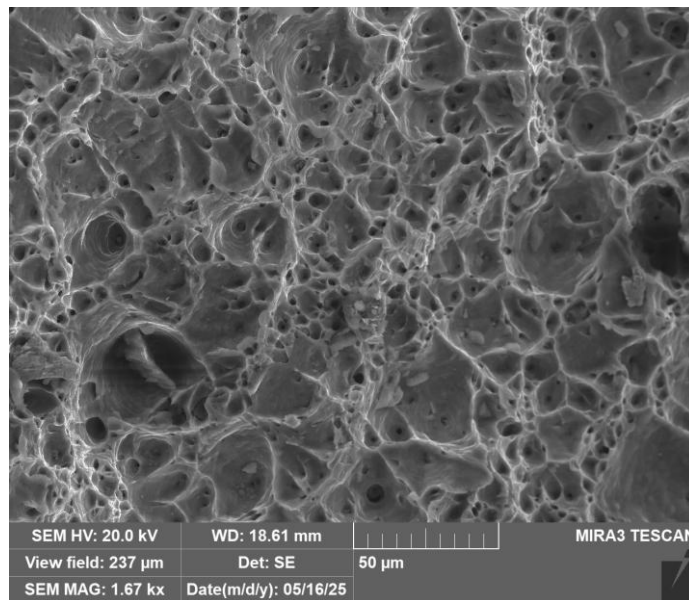
Figure 4-2: High magnification fractographic image within the proximity of the strand centroid shown in Figure 4-1. The image indicates that the strand fracture mechanism was dominated by void coalescence (i.e. ductile fracture) at the site.

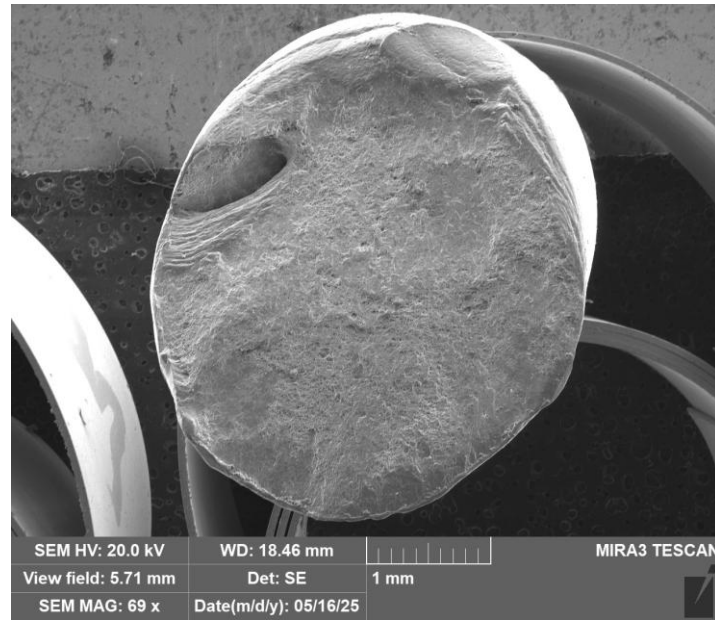
Figure 4-3: Low magnification SEM secondary image of a representative example of the fracture surface associated with the oblique geometry observed terminating the failed aluminum wire strands during the preliminary examination of conductor EL-1 (Figure 2-7).

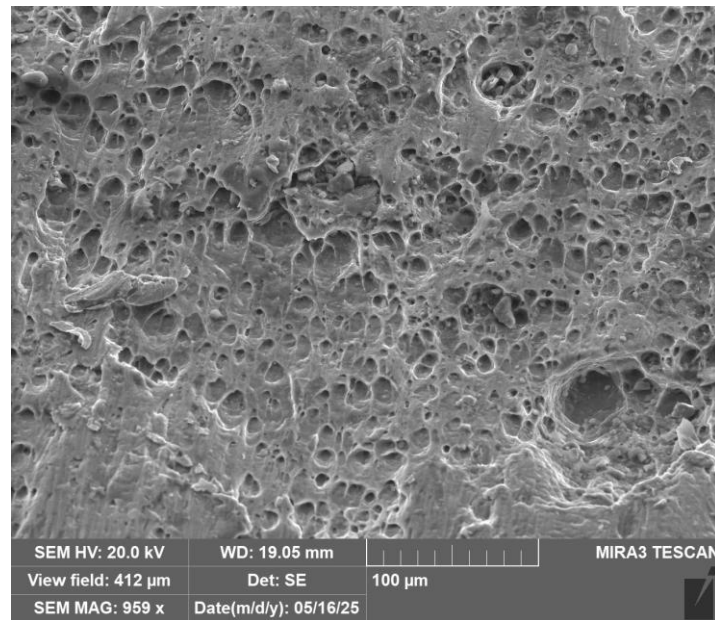
Figure 4-4: High magnification fractographic image within the proximity of the strand centroid shown in Figure 4-3. The image shows the topological features associated with the strand fracture mechanism. Similar to Figure 4-2, the image suggests that the strand fracture mechanism was dominated by void coalescence (i.e. ductile fracture) at the site.

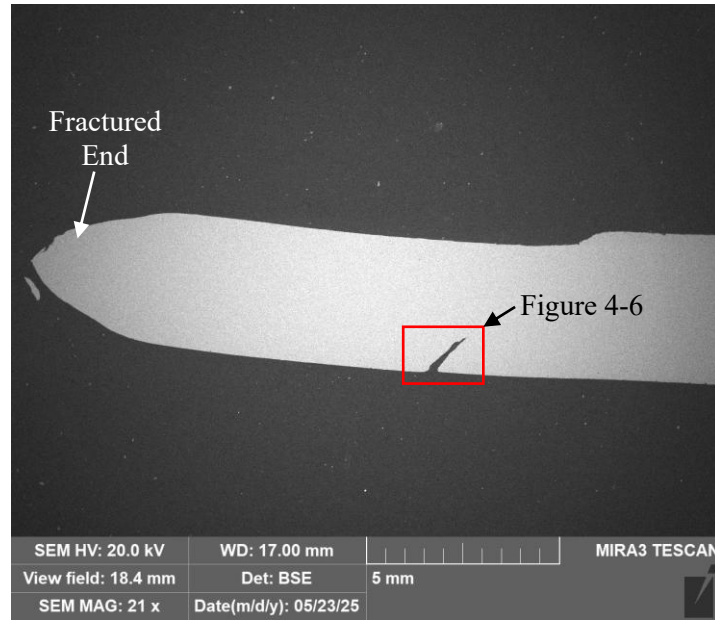
*Figure 4-5: Low magnification SEM backscatter image of a representative example of a partial through wire indication (rectangle). The image also shows the spacial relationship between the partial through wire indication and the fractured end of the wire strand.*

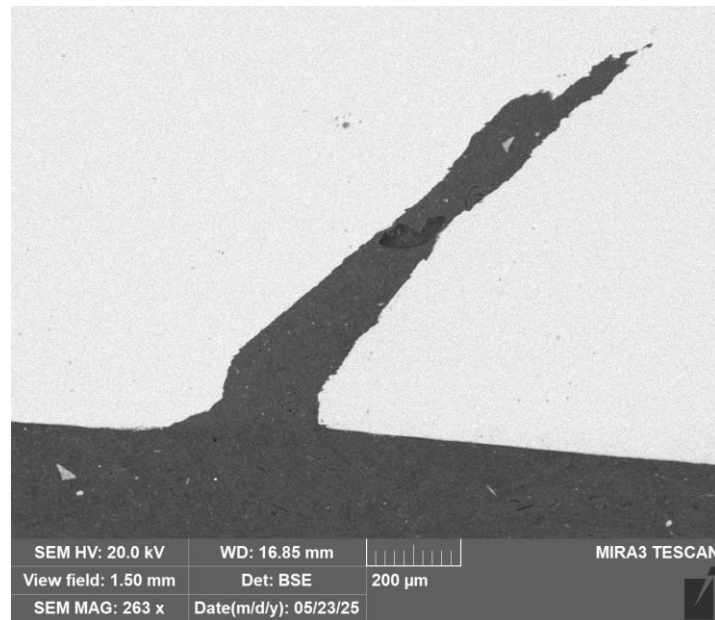
*Figure 4-6: Higher magnification SEM backscatter image of the partial through wire indication shown in Figure 4-5. The indication was characterized by a singular propagation morphology which was orientated at an oblique angle with respect to the longitudinal axis of the wire strand.*

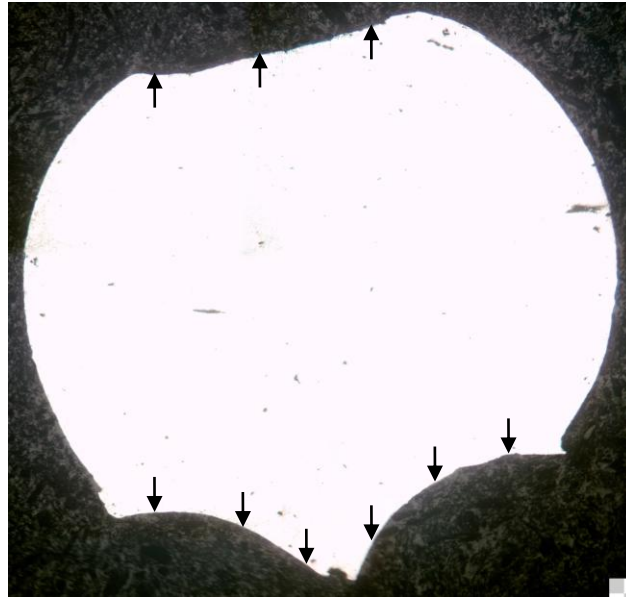
Figure 4-7: Sectional view micrograph of a representative example of the strand to strand brinelling observed in conductor EL-1. The image shows the localized severe distortion (plastic deformation) of the wire material observed at the sites where brinelling was observed on the external surface of the aluminum wire strand (arrows).

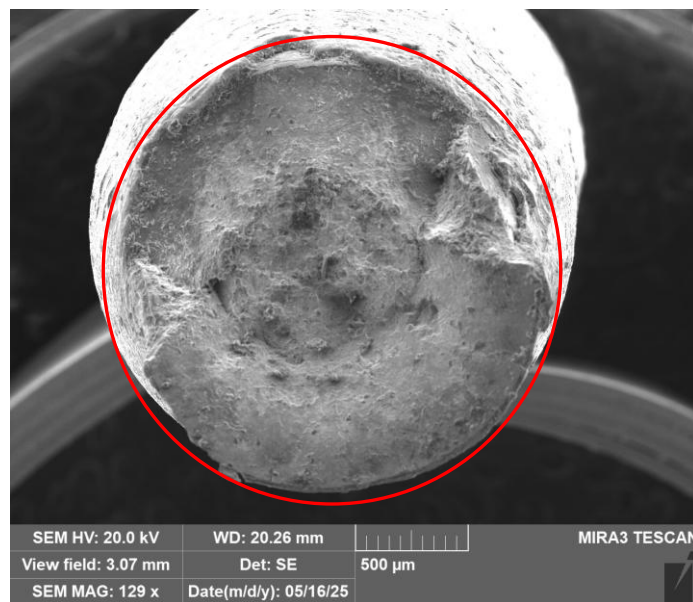
Figure 4-8: Low magnification SEM secondary image of a representative example of the fracture surface (ellipse) associated with the tapered-end (necked) geometry observed terminating the failed steel reinforcing wire strands during the preliminary examination of conductor EL-1 (Figure 2-10). The image shows the general cup and cone morphology of the failed end of the wire strand.

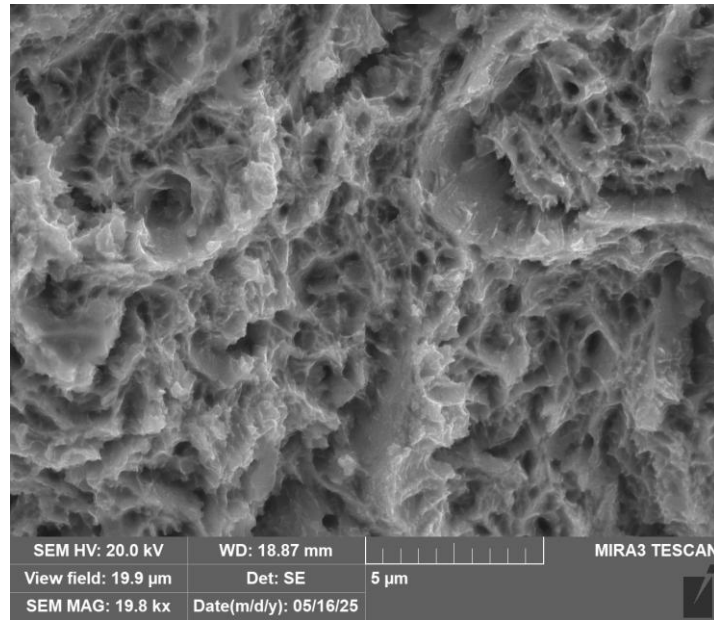
*Figure 4-9: High magnification fractographic image within the proximity of the strand centroid shown in Figure 4-8. The image indicates that the strand fracture mechanism was dominated by void coalescence (i.e. ductile fracture) at the site.*

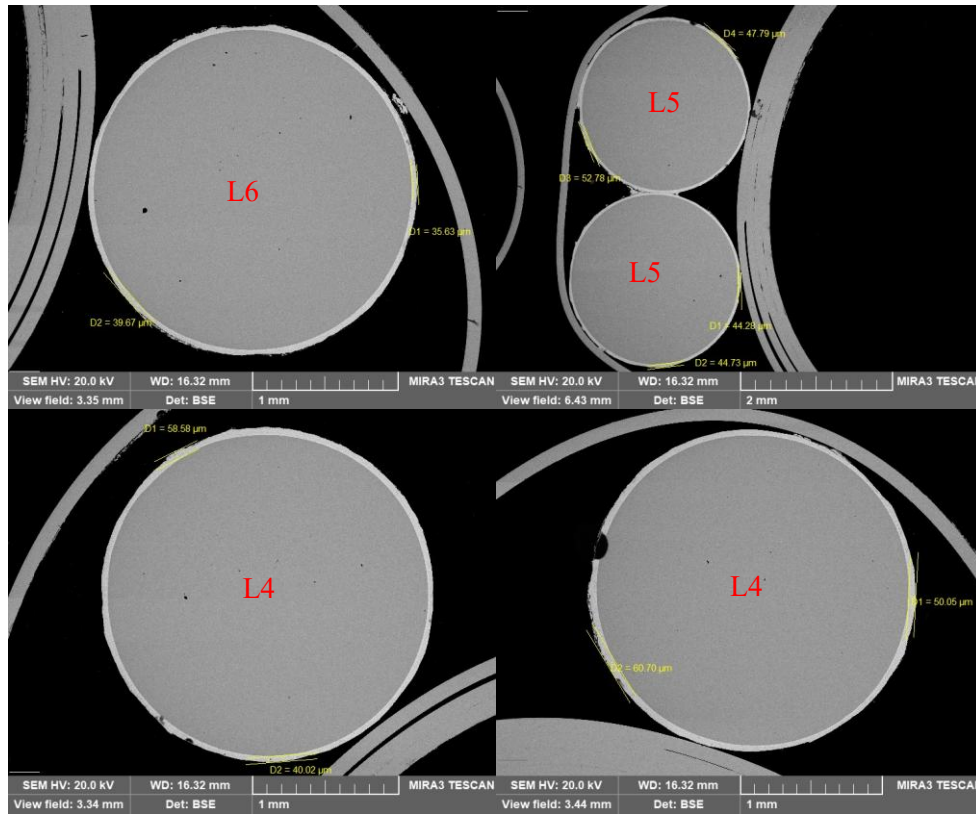
Figure B-1: SEM backscatter image of representative examples of the zinc coated steel reinforcing strands for failed conductor EL-1. The image shows the variation in the thickness of the zinc coating observed around the circumference of the steel reinforcing strands.
