**Re: Quarterly Report on Asset Performance in Support of Resource Adequacy for the Twelve Months Ended December 31, 2025**

# Quarterly Report on Asset Performance in Support of Resource Adequacy

For the Twelve Months Ended December 31, 2025

# LIL Strengthening Overview

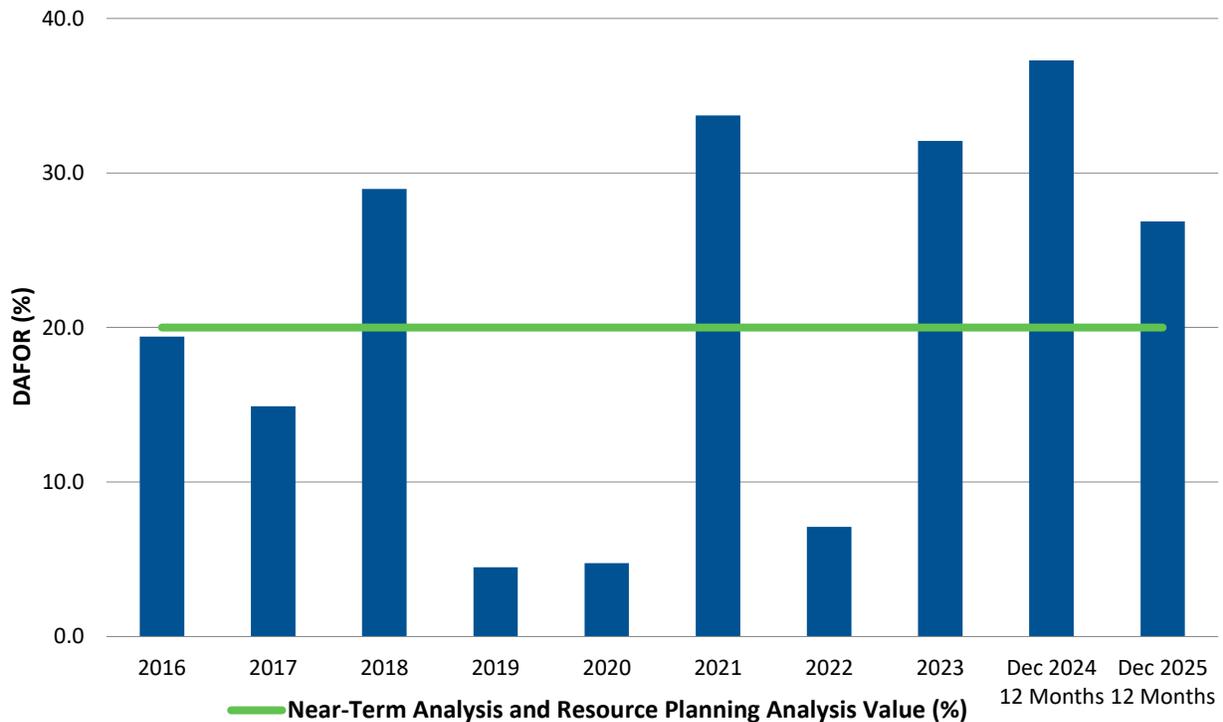
**Chart 3: Thermal DAFOR**

2    Considering individual thermal unit performance, the DAFOR of 39.12% for Unit 1 at the Holyrood TGS is  
3    above the near-term and resource planning analysis value of 20.00% for a unit at the Holyrood TGS;  
4    however, it shows an improvement in performance over the previous period. This elevated DAFOR is the  
5    result of a forced extension to the planned unit outage in 2024 to overhaul the Unit 1 turbine and  
6    replace the L-0 and L-1 blades at the General Electric shop in the United States.<sup>17</sup> The outage was  
7    extended until the unit was brought online on February 12, 2025. Following return to service, an issue  
8    with the main steam controls valves prevented movement beyond 56% opening, which resulted in a  
9    forced derating to 105 MW. This derating remained until March 10, 2025, when a planned outage was  
10   taken to investigate and correct the issue with the control valves. The unit returned to operation on

21   December, and investigation into this issue is ongoing, with a condenser vendor engaged to perform air  
22   in-leakage testing on the condenser in early February 2026.

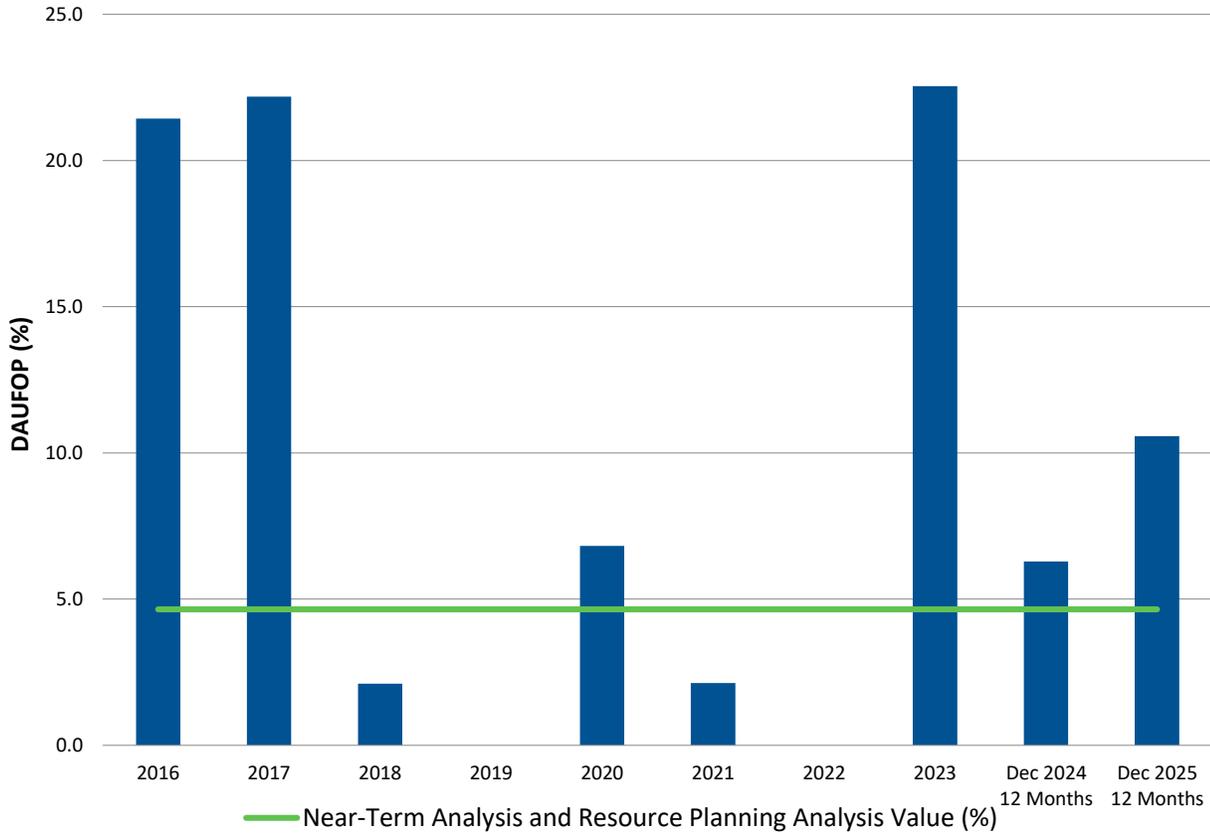
**Chart 5: GT DAUFOP: Happy Valley Unit**

2 The Happy Valley GT DAUFOP was 10.57% for the current period, which is above the near-term and  
 3 resource planning analysis value of 4.65%. This decline in performance is a result of outages experienced  
 4 on July 12, 2025. During start-up, the unit experienced two starting failures as previously reported,  
 5 which resulted in approximately four hours of outage time. Due to the low percentage of operating time  
 6 experienced by the Happy Valley unit, forced outages have a significant impact on the DAUFOP  
 7 performance.

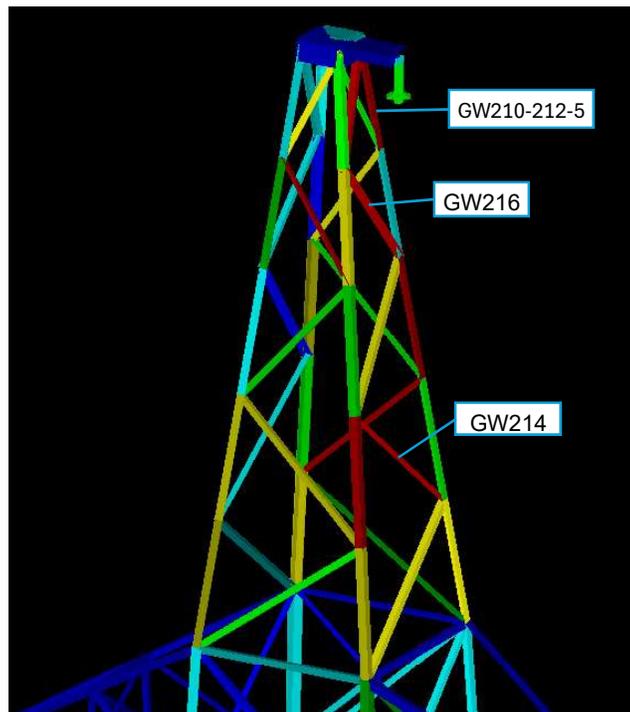
Figure 2: Overstressed Members Element Labels (No Electrode)

Load Case	Existing		One Mid-Span Structure		Reinforcing Existing Tower
	Maximum Usage %	Element Label	Maximum Usage %	Maximum Usage Difference	Maximum Usage %
F1 LC70 AS UBI G 50mm 50/100%,C NA+	149.6	GW216YR	122.4	-27.2	94.3
F1 LC71 BS UBI G 50mm 50/100%,C NA+	145.9	GW214YR	119.7	-26.2	86.3
F1 LC75 BS UBI G 70mm (50 mm on Pole) 100/80%,C NA+	107.3	GW210-212-5Y	83.1	-24.2	74.2
F1 LC72 AS UBI G 55mm 70/100%,C NA+	105.6	GW216YR	85.2	-20.4	69.6
F1 LC73 BS UBI G 55mm 70/100%,C NA+	103.0	GW214YR	83.5	-19.5	74.6

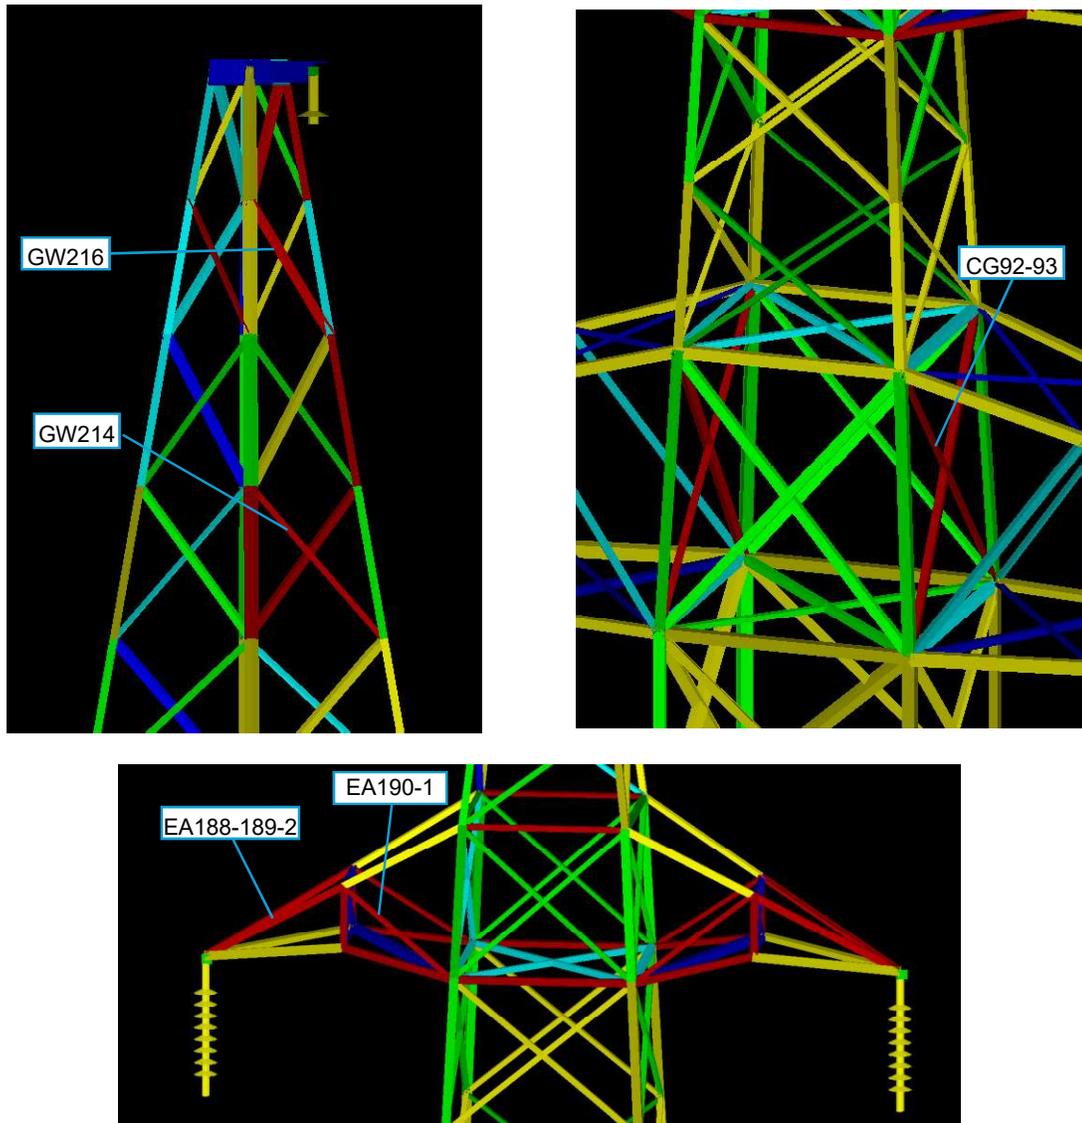
Figure 6: Overstressed Members Element Labels (Electrode Strung)

The existing configuration shows overstressed members in the peak, electrode cross arms, and cage diagonals, as shown in Figure 6. Overstressed load cases are for unbalanced ice loading on the OPGW and electrodes, heavy ice event, or electrodes broken wire scenario. Although adding mid-span structures will reduce overstresses, reinforcement will still be required. No overstresses were observed with the reinforced A1 tower.

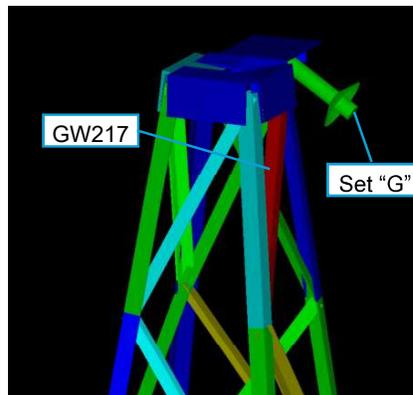
Figure 9: Reinforced Overstressed Member Element for S4-576 (2543)

As shown in Table 5, the reinforced model shows overstresses with a ratio of 100.2%. This scenario is encountered if no mid-span structures are added and only reinforcing of the existing tower A1 is implemented. The overstresses are seen due to the discrepancy between the envelope load cases provided for tower A1 reinforcement scope and the as built load cases obtained from PLS CADD. As shown in Figure 9, overstresses are seen in one of the peak diagonals (GW217).

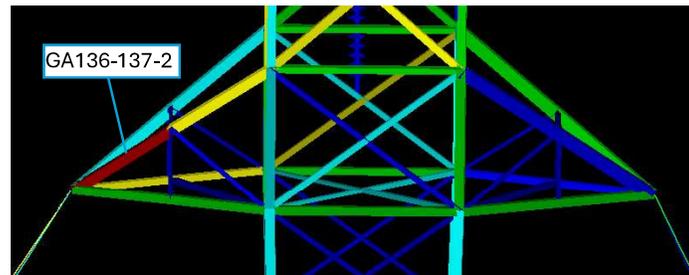
Figure 10: Reinforced Overstressed Member Element for S1-307 (308)

As shown in Table 13, the reinforced model shows overstress with a ratio of 102.3%. Similar to tower S4-576 (2543), the overstresses are seen due to the discrepancy between the envelope load cases and the as built load cases. Figure 11 shows the overstress occurs in the upper chord of the guy cross arm (GA136-137-2).
