March 29, 2019

**Re: An Application by Newfoundland and Labrador Hydro ("Hydro") for approval of capital expenditures to complete a Level 2 condition assessment on Penstocks 1 and 2, and a report on Penstocks 1, 2, and 3 at the Bay d'Espoir Hydroelectric Generating Station – Bay d'Espoir Condition Assessment and Refurbishment Options for Penstocks No. 1, 2, and 3, Report 2 of 3.**

Condition Assessment and  
Refurbishment Options for Penstocks  
No. 1, 2 and 3

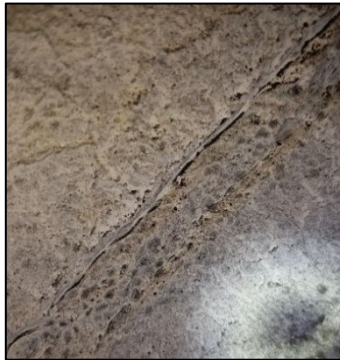
The initial inspections and major refurbishments of all three penstocks did not occur within the same year. Penstock No. 1 (2016), Penstock No. 2 (2017) and Penstock No. 3 (2018) found cracking in the form of linear indications along the top and bottom edge of the weld seams. In addition to the linear weld cracking, the weld seams had noticeable deterioration of the weld cap in the form of general corrosion (weld metal loss), localized pitting corrosion of varying degrees throughout the sections of penstocks, and preferential corrosion of the heat affected zone (HAZ) resulting in areas of low material thickness, edges and therefore high stress concentrations or “notches” in the upper and bottom portion of the weld edge. All three penstocks exhibited cracking and linear indications of weld seams. These indications were predominantly located in the longitudinal seams.

**Figure 3-1: Sample of Deteriorated Longitudinal Weld Seam**

Where refurbishment was required, the indications identified by MT inspection were removed by gouging the full profile of the weld seam and HAZ with care not to remove the full thickness of the weld metal. Following the completion of gouging and subsequent grinding for cleanup of the seam, the seams were inspected visually and by MT to ensure no cracks or indications remained and sound weld metal was present prior to the start of refurbishment. The seams were then welded and after a hold time of 48 hours they were inspected by VT and MT methods to verify weld quality.

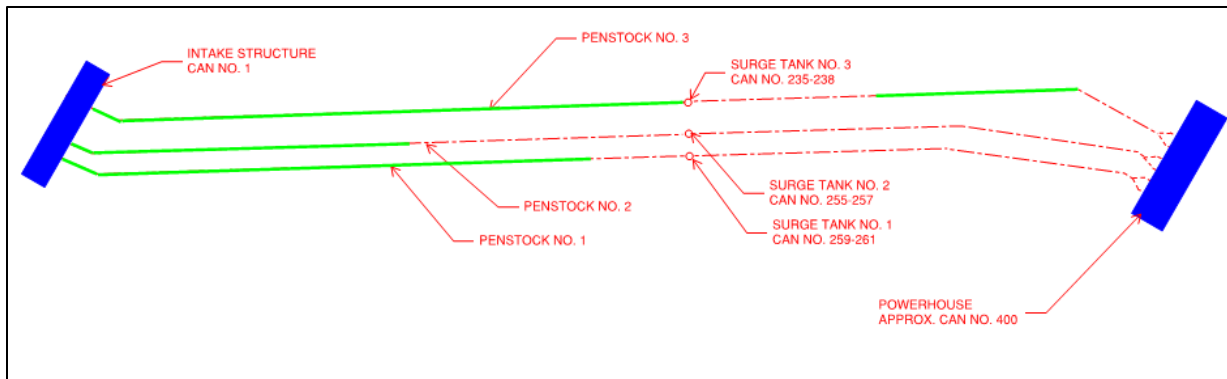
An overview of the refurbishments can be seen in Figure 3-2. For a detailed breakdown of inspections, repairs and general locations per penstock refer to P1 CA Tracker, P2 CA Tracker and P3 CA Tracker provided in Appendix C.

**Figure 3-2: Concept Sketch of Penstock Refurbishment Overview  
 (Green Indicates Refurbished Areas)**

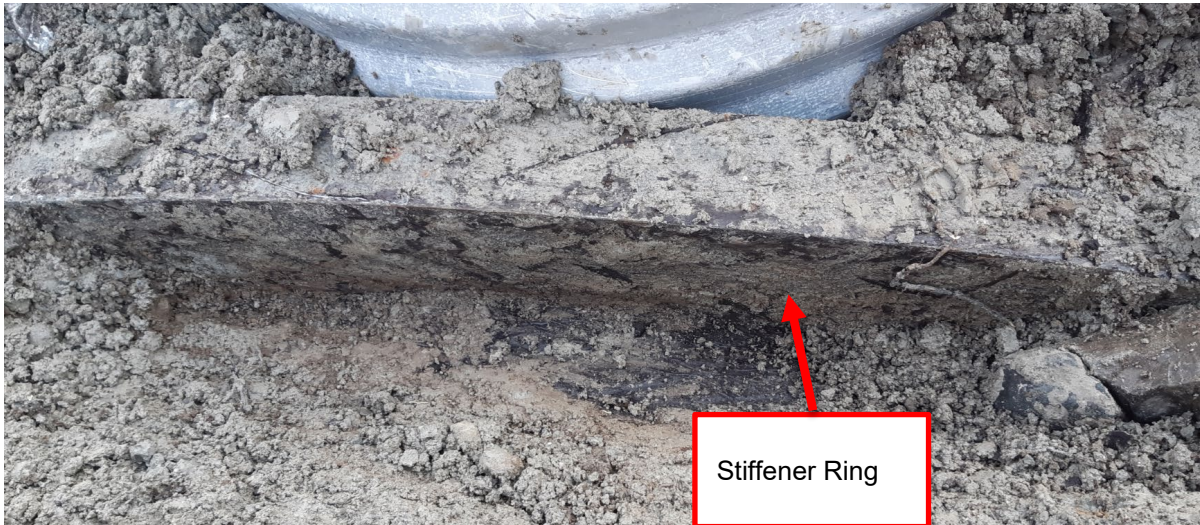
Penstock No. 2 was noted to have "stiffener" rings present on the upstream sections; an excavated stiffener ring can be seen in Figure 3-3. The stiffener rings were fabricated by rolling a 5"x3"x3/8" angle spaced roughly every 3.66 m (12 feet). These rings are not of sufficient size or spacing to act as pressure retaining elements. As previously discussed, in Section 2 of this report, these rings were likely used to assist in field erection and weld fit up.

It should be noted that the quality of the penstock fit up was noted to be superior to that of Penstock No. 1, likely due to the use of external rings during assembly.

**Figure 3-3: Excavated Stiffener Ring – Penstock No. 2**

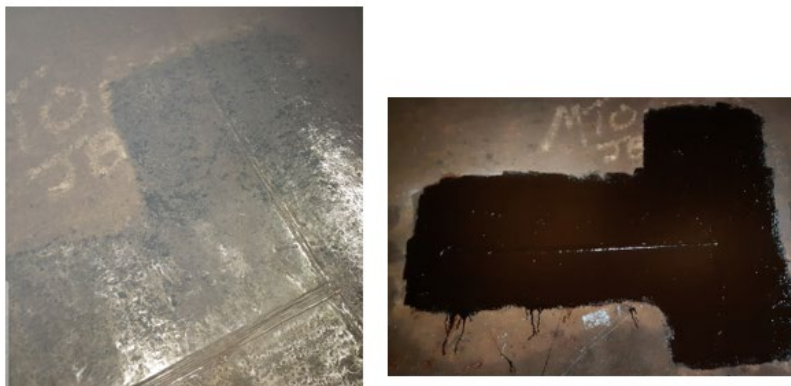
The Bay d'Espoir Operations group had scheduled the application of two coating samples to determine how they would respond over time to exposure to the penstock's interior environment. The two samples to be tested were originally intended to consist of a Galvatech 2000 Primer/MC Tar and a Mio Zinc Primer/MC Tar. The samples were to utilize two different primers as noted above and be applied on a tee section (capturing the intersection of a longitudinal and circumferential weld). During the assessment, the required curing time and application environmental conditions (humidity, dry bulb and wet bulb temperatures) for the Galvatech 2000 primer were not met, and this primer was not applied. Based on this issue, instead two locations were selected for application of the Mio Zinc primer coat and two top coats of MC Tar. The coating preparation and MC Tar finish coat can be seen in Figure 3-4.

**Figure 3-4: Coating Prep (Left) Final MC Tar (Right) – Penstock No. 2**

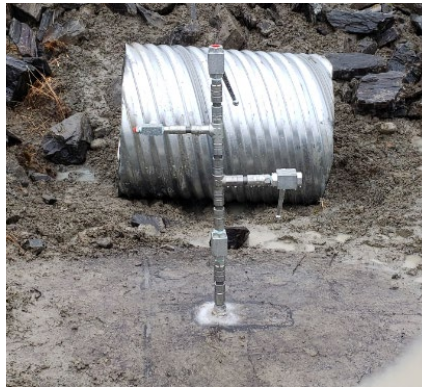
During the inspection, three new instrument trees were installed on Penstock No. 2. Each instrument tree consisted of a pressure transducer connection, a drain, and a high point vent. The pressure transducers were installed on Penstock No. 2. to determine if there are any pressure transients occurring within the penstock and to provide data to be used for further analysis provided in a later document. A typical pressure transducer tree is shown in Figure 3-5.

**Figure 3-5: Pressure Transducer Instrument Tree – Penstock No. 2**

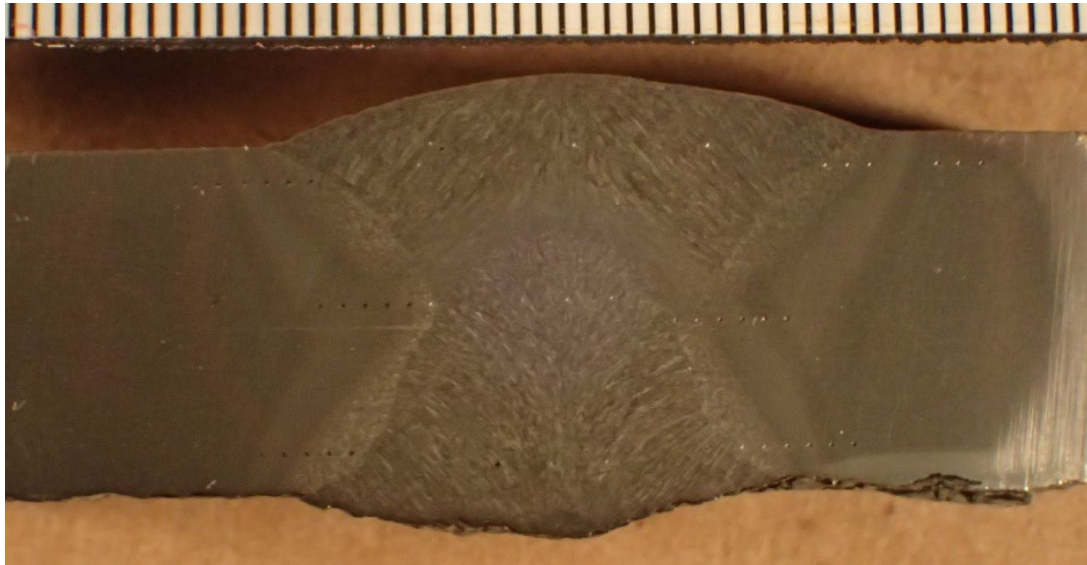
The photomacrograph in Figure A-1 below shows the appearance. The macro shows a clean weld exhibiting columnar weld grains with good fusion, no cracking or weld defects.

**Figure A-1: Weld Macro Examination – Penstock 3**

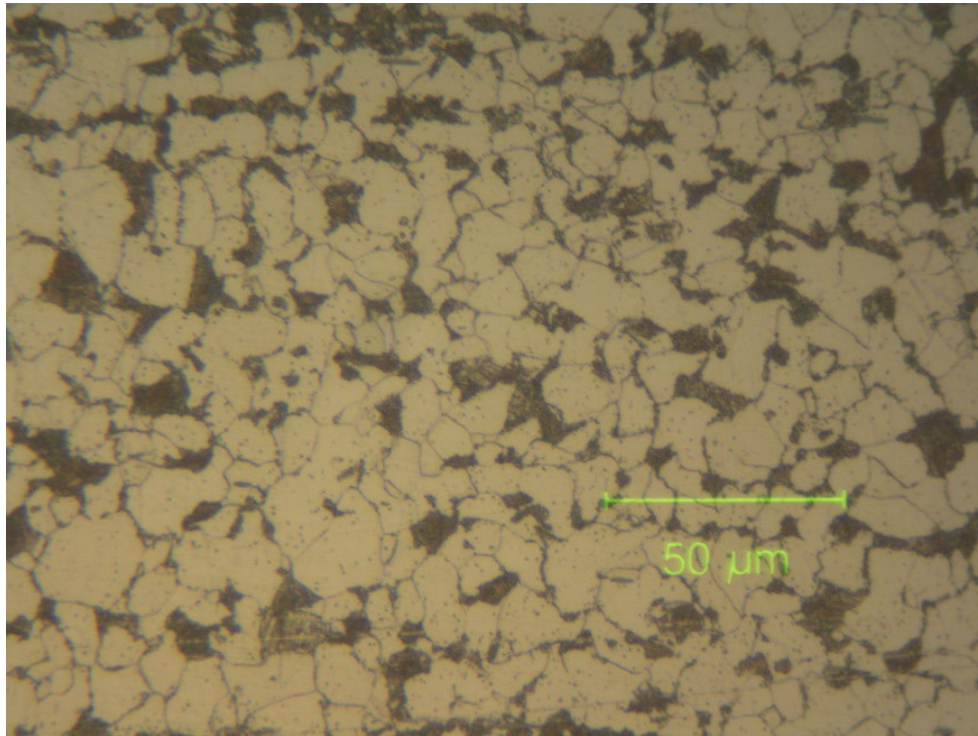
A cross section of the weld was cut and prepared for a micro examination, polishing the cut to a 1 $\mu$ m finish and etched with a 5% Nital solution according to ASTM E3-11 standards. The micro examination revealed a fine grain, low carbon steel with few inclusions, typical of a structural quality steel.

**Figure A-2: Weld Micro Examination - Penstock 3**
