Re: Holyrood Thermal Generating Station Unit 2 Stack Movement Assessment

Holyrood Thermal Generating Station Unit 2 Stack Movement Assessment

A Report to the Board of Commissioners of Public Utilities

Unit 2 Stack Condition Assessment Memo by Hatch - November 26, 2018

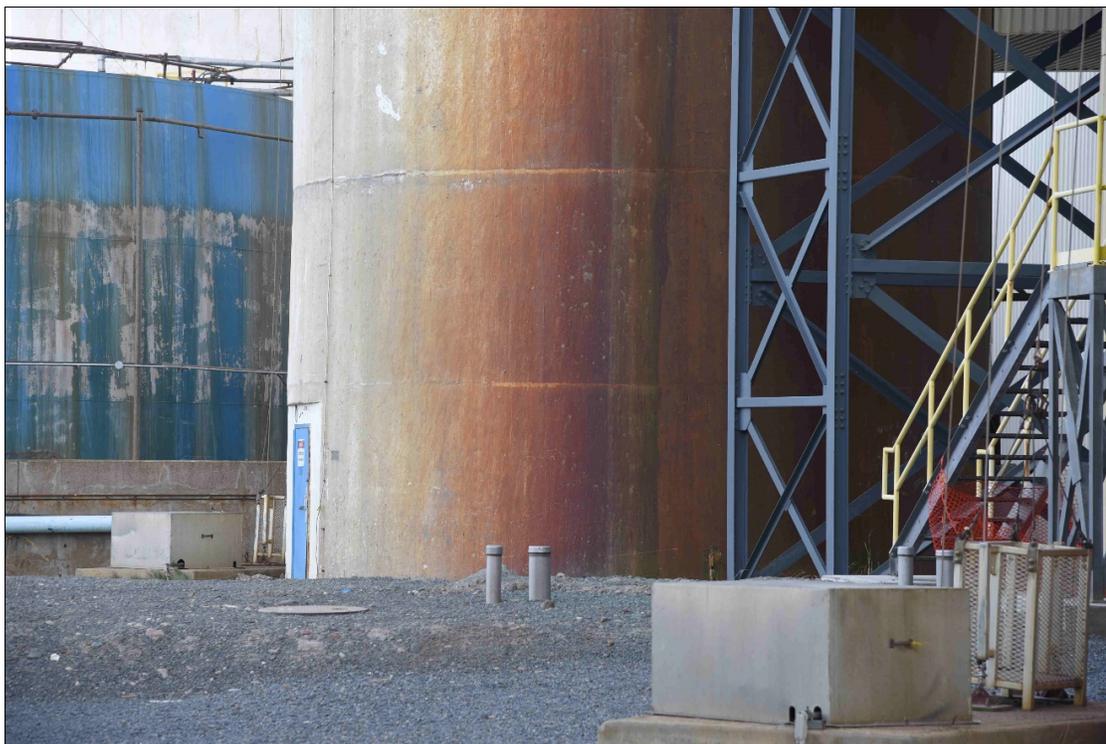
Photo 1: Stack No. 2 Lower Section

1. No obvious new cracks or displaced concrete at any of the joints, that could be seen from the two vantage points, were visible.
2. There was no evidence of significant concrete missing from the surface or large pieces on concrete on the ground at the base of the stack.

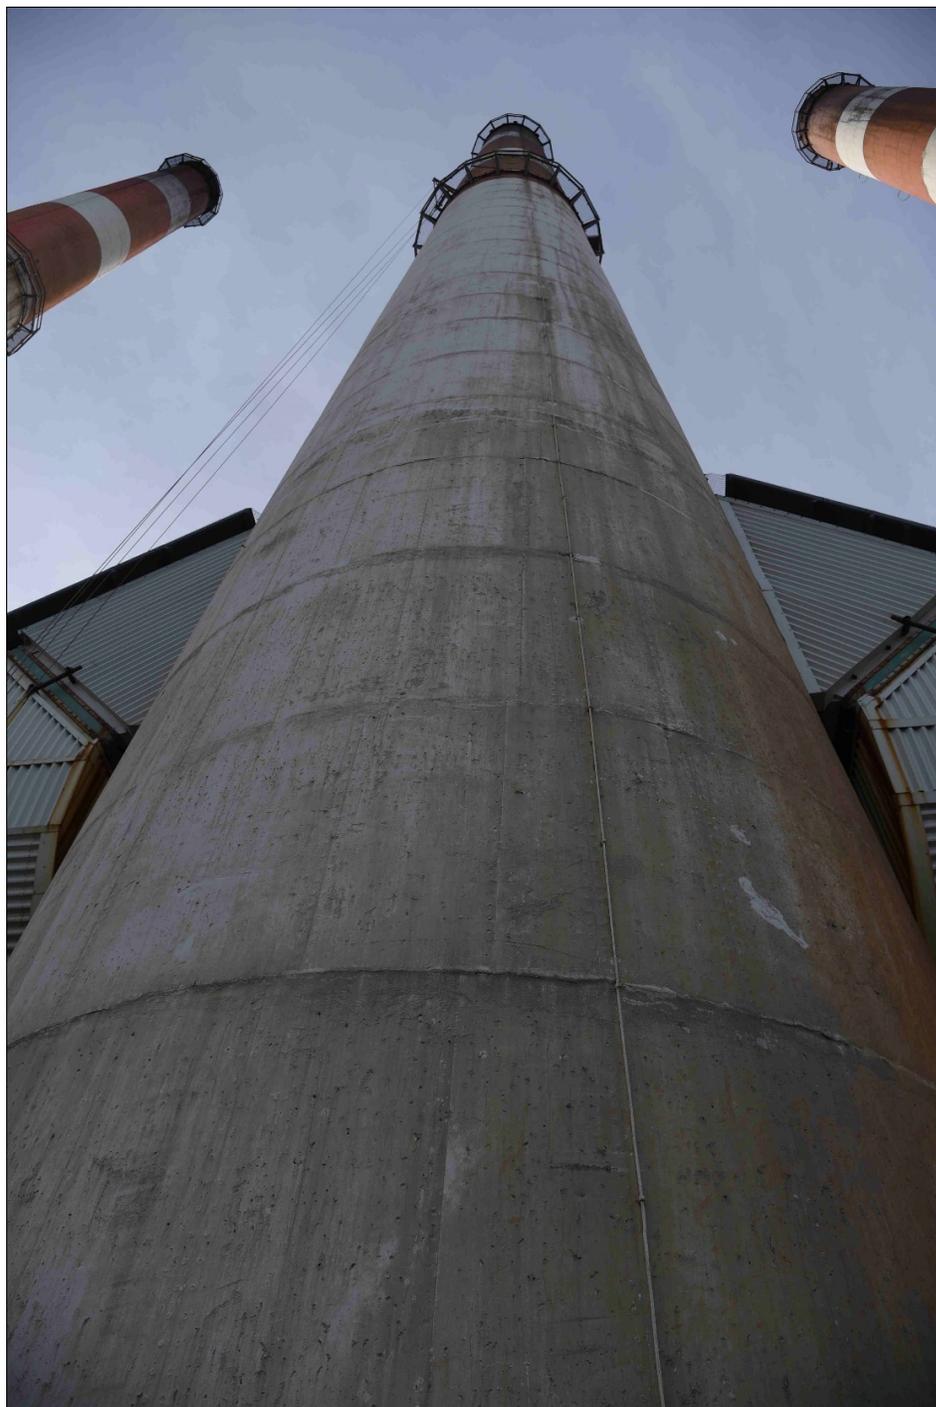
Photo 2: Stack No. 2 Looking Upward from the Ground – View on Opposite Side from Powerhouse

Based on the observations from the ground, there appeared to be no cracking or displacement at any of the circumferential construction joints, no new vertical cracks formed on the exterior or significant patches of missing or spalled concrete. The stack movement appeared to start approximately one quarter to one third up from the base. The majority of the movement was perpendicular to the direction of the wind and had a constant period. The sway appeared to be a simple single order fixed cantilever movement similar to a musical metronome.

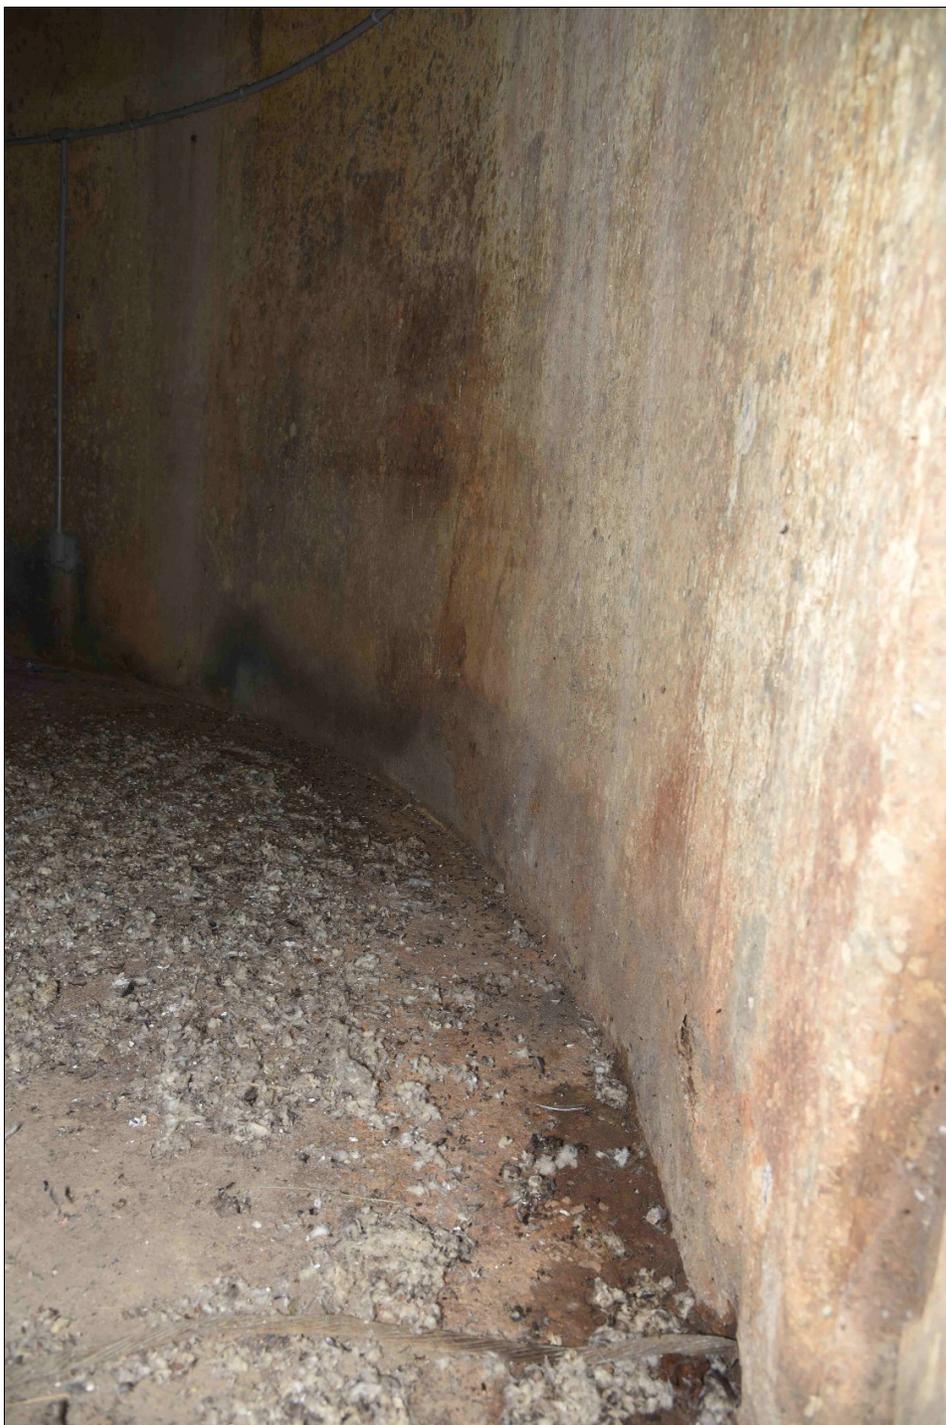
Photo 3: Tank No. 2 Interior View of Base Slab and Stack Interface

3. There was no obvious displacement of the vertical ladders, platforms or electrical cables.
4. The interior access at ground level required confined entry. Observations were made from the doorway and there was no evidence of fallen concrete or issues with the liner foundation. We understand Hydro personnel entered this area and walked around the liner and inside diameter of the stack and found no evidence of distress i.e. cracks or fallen concrete. Pictures were taken from the ground of the concrete stack to base slab and looking vertically upward from the base slab. One area has an interior profile that is non circular in appearance similar to an inward bulge. This same area on the exterior is close to or opposite a brace from the breaching. Visually from the ground the exterior does not appear to be bulged and there are no visible signs of cracking or concrete failure.

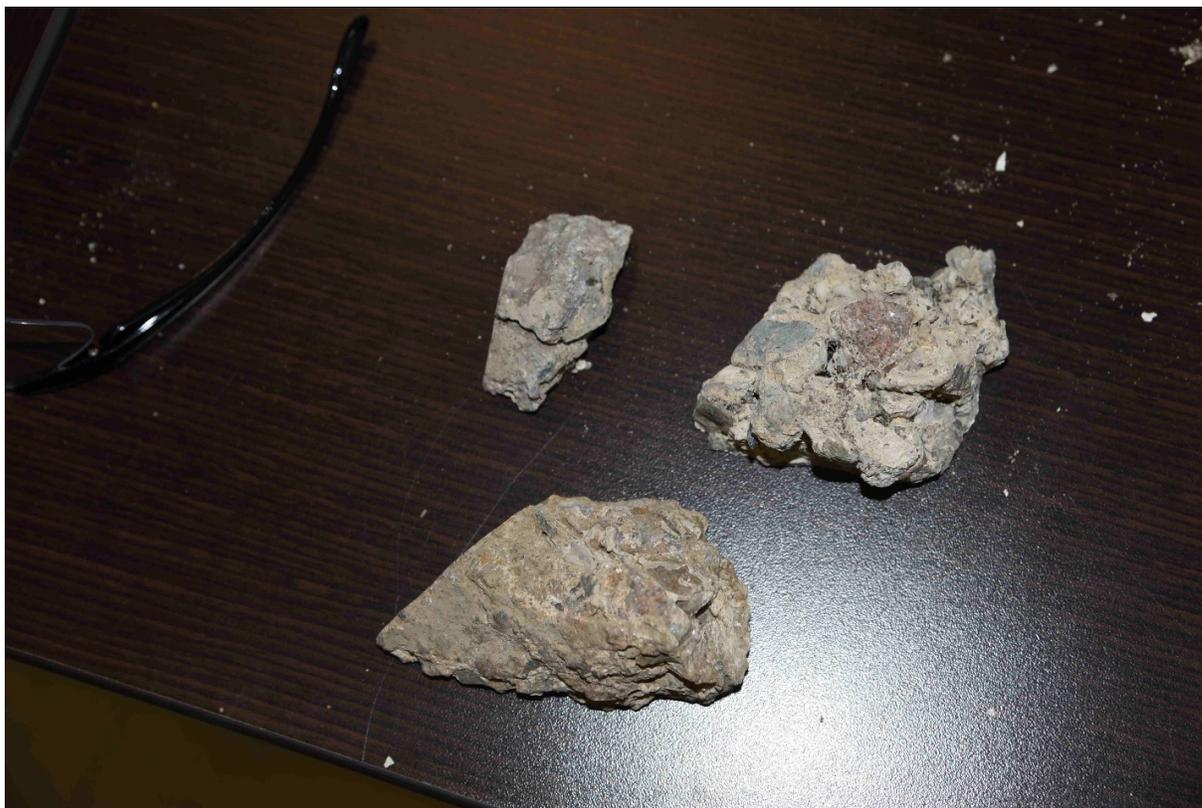
- 24 • Hydro personnel ascended the stack to access the first platform level and found three
25 small pieces of concrete on the platform grating. Upon inspection, it did not appear that
26 these pieces were from new cracks. Photos of the concrete pieces are included in
27 Appendix B;

5. Hydro personnel climbed the ladder to access the first platform level. Three small pieces of concrete were found on the grating. In looking at these pieces they do not appear to be from new cracks. One had a flat face from a concrete saw blade and another contained caulking which likely came from one of the circumferential joints.

Photo 9: Stack No. 2 Small Pieces of Concrete Found on Lower Platform
