Re: Holyrood Thermal Generating Station Unit 2 Stack Movement Assessment

Holyrood Thermal Generating Station

Exhaust Stack No. 2

H358827-00000-240-230-0002

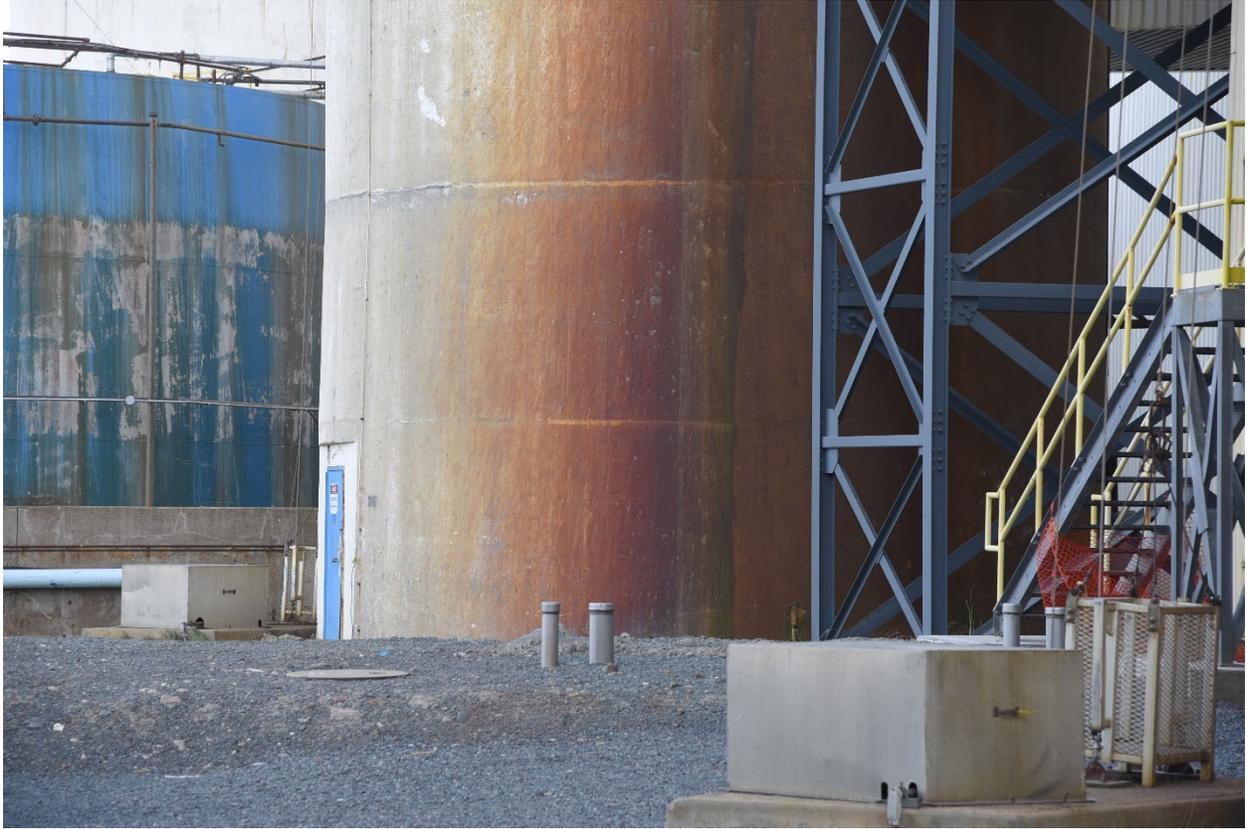
Base of Exhaust Stack No.2

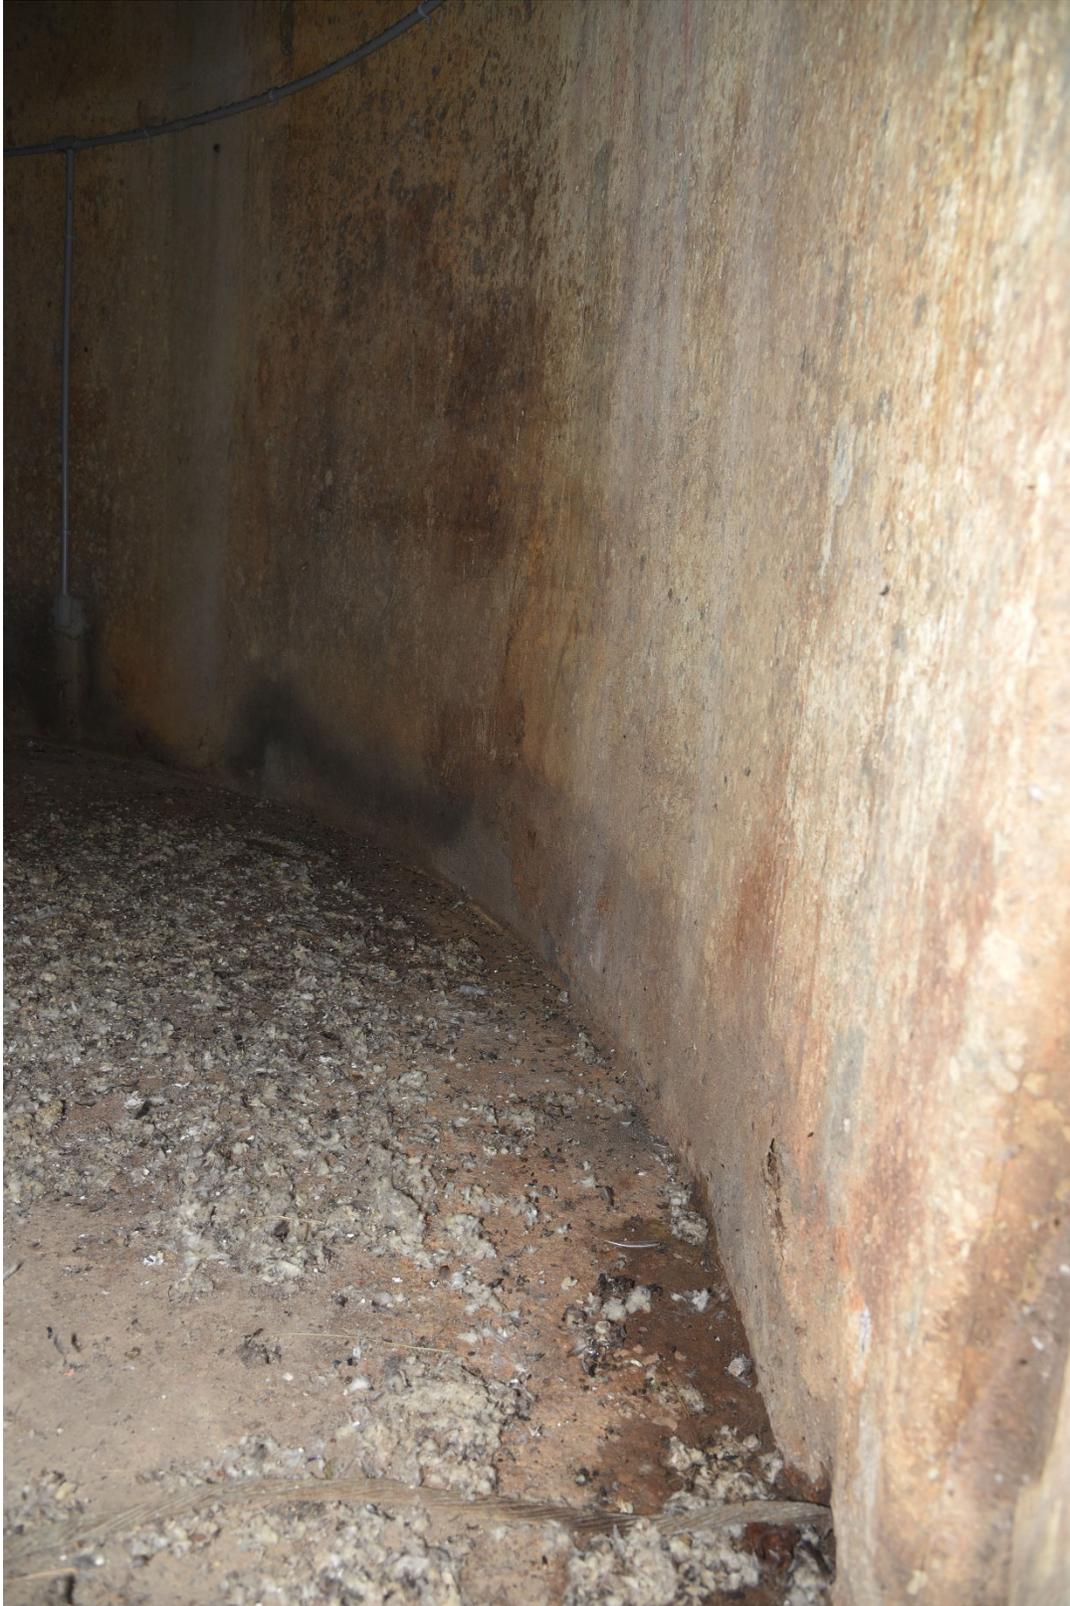
Exhaust Stack No. 2 Internal View of the Concrete Shell to Foundation Connection

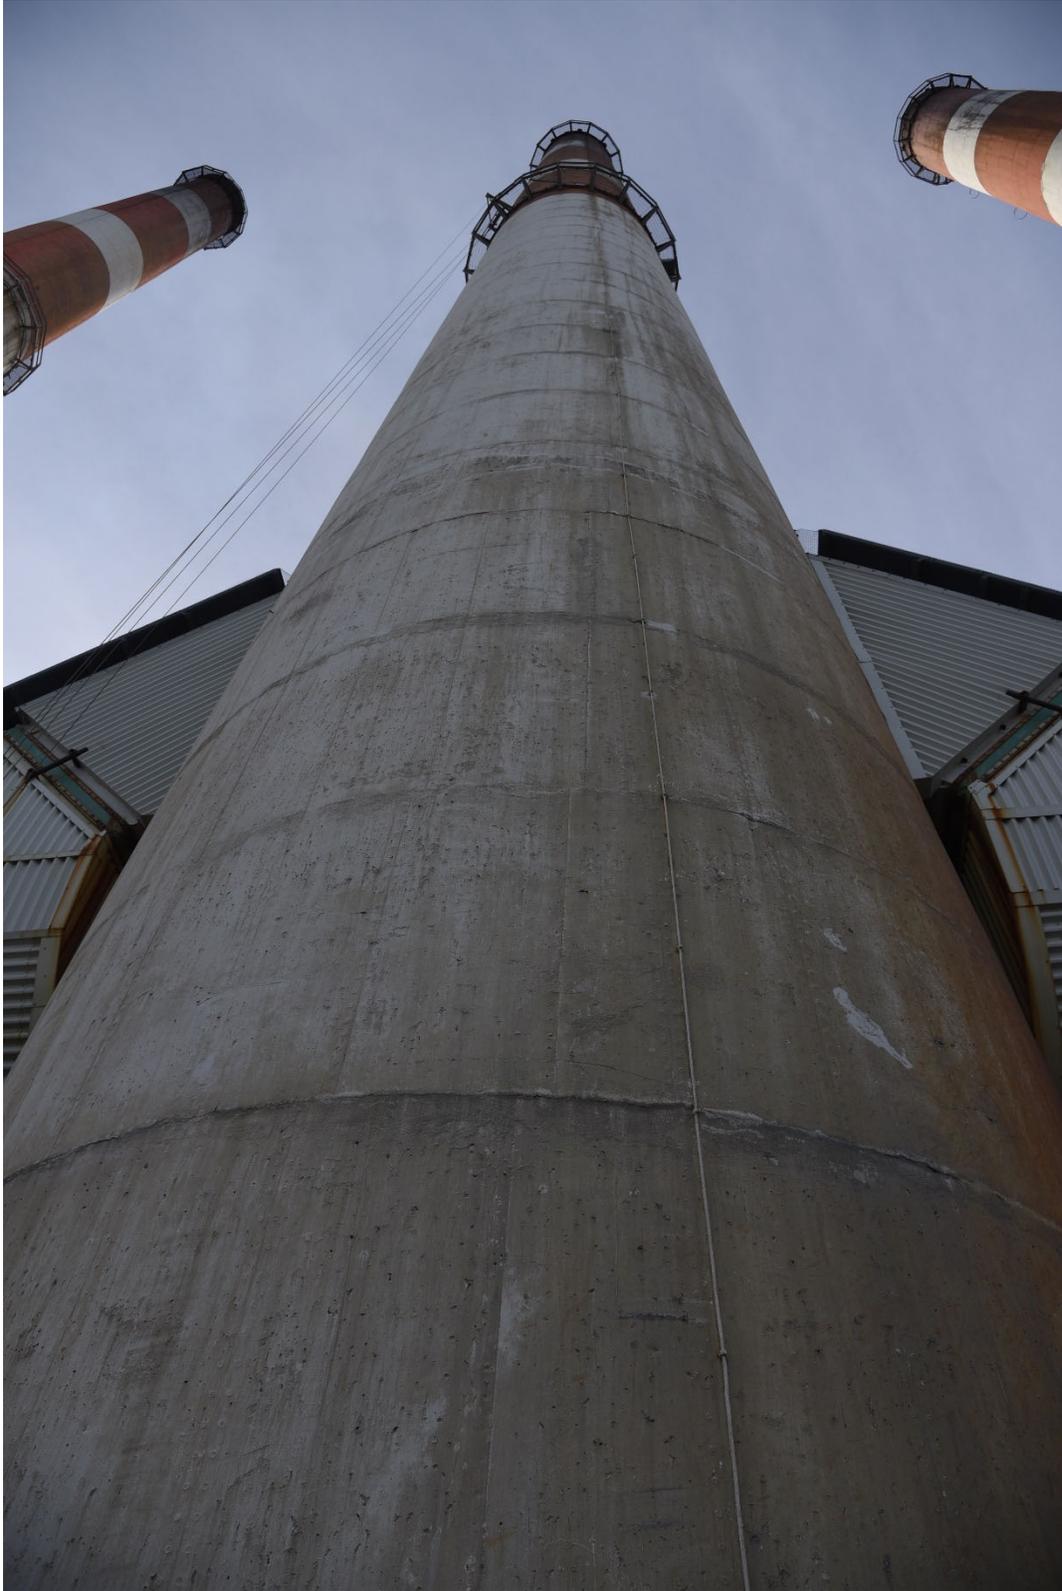
View of Exhaust Stack No. 2 Looking Upward from East Side. – Circumferential Construction Joints are Visible

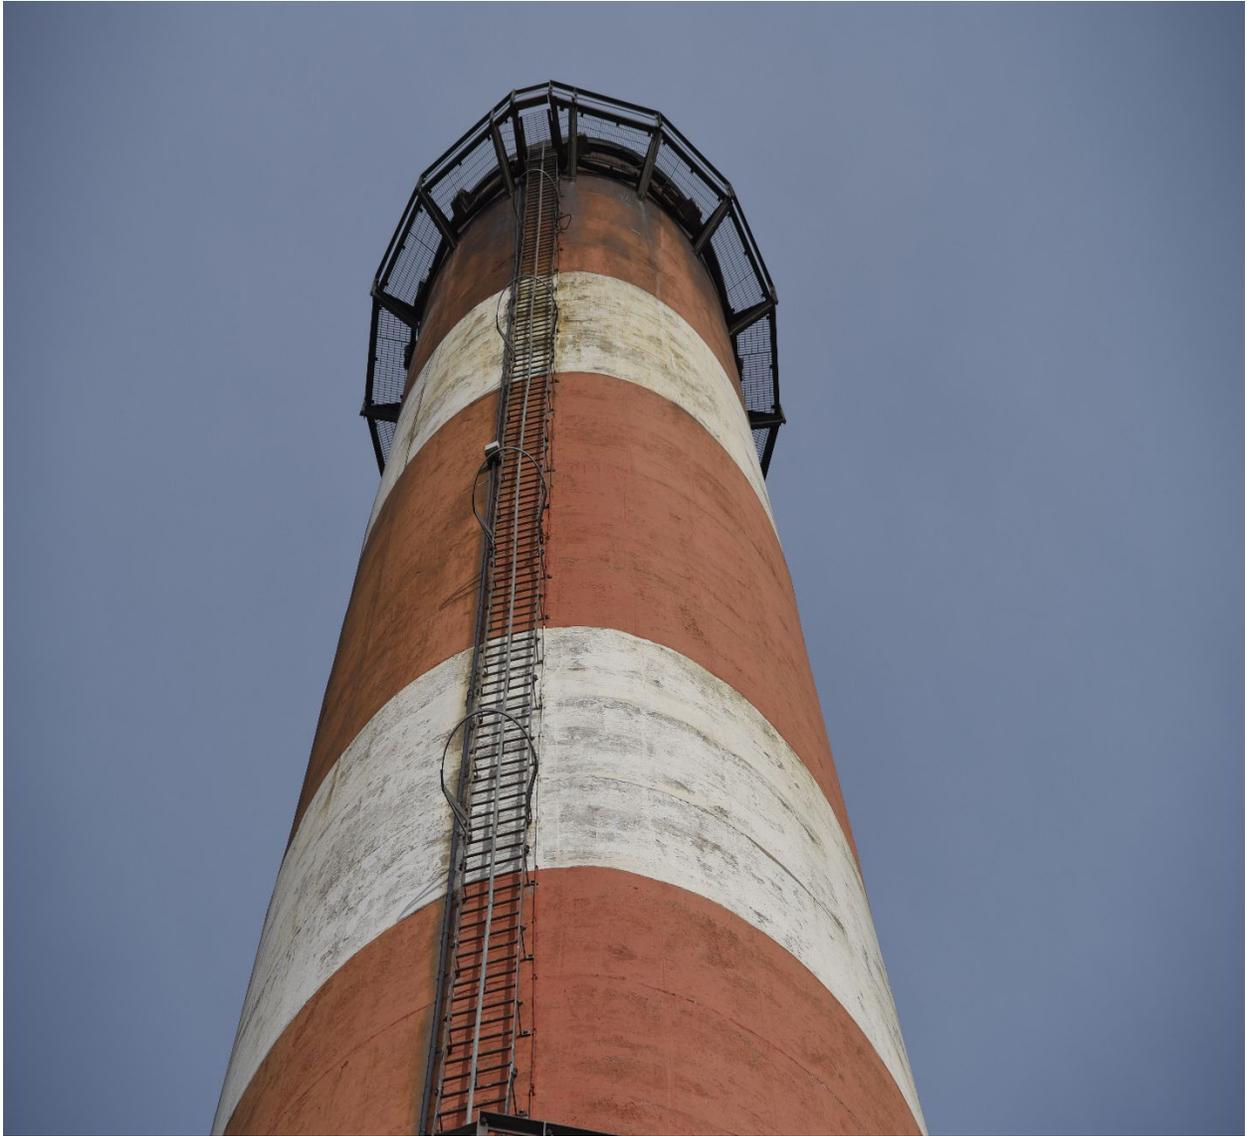
Exhaust Stack No. 2 View Looking Upward from the West Side

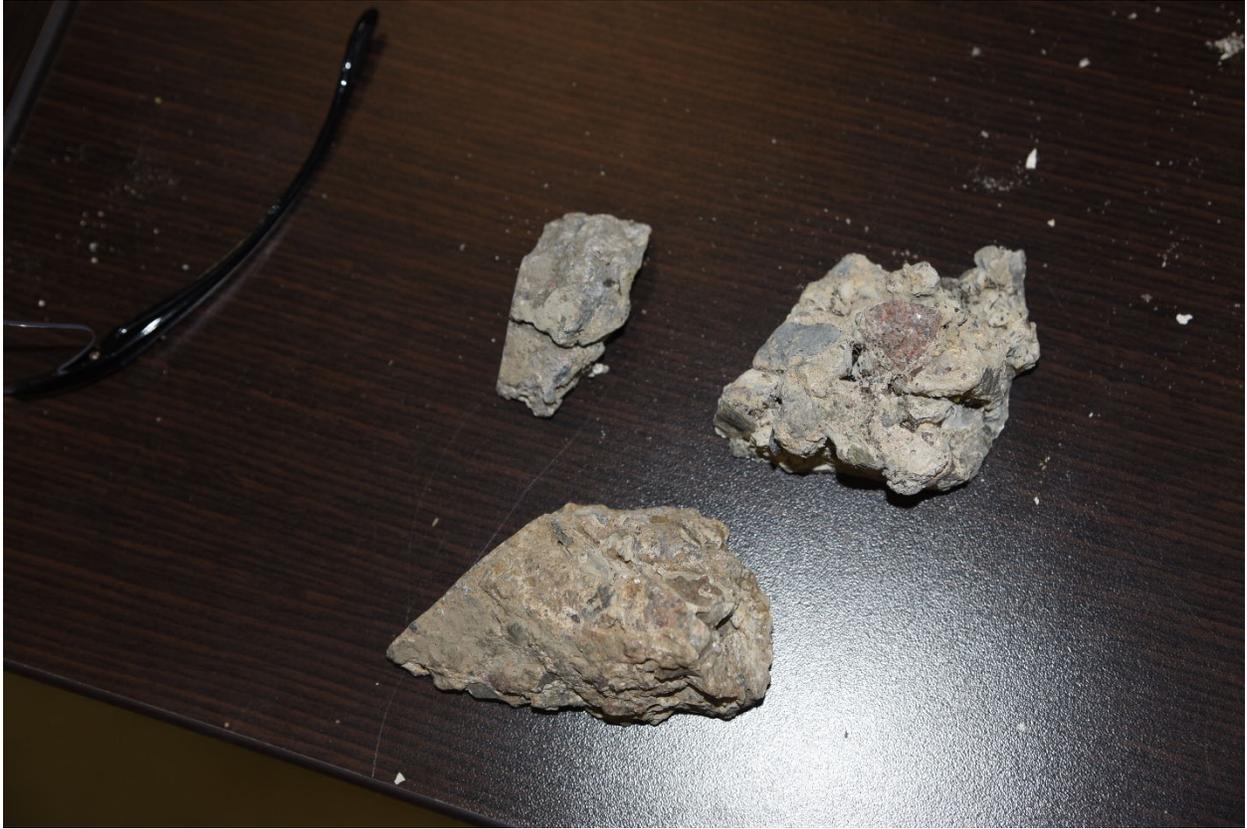
- Hydro personnel climbed the vertical ladder and accessed the first platform level. Three small pieces of concrete were found on the platform grating. A visual inspection was made of these pieces and it was concluded they did not appear to be from new cracks. One had a flat face from a concrete saw blade and another contained caulking which likely came from one of the circumferential construction joints.

Small Pieces of Concrete found on the Lower Platform

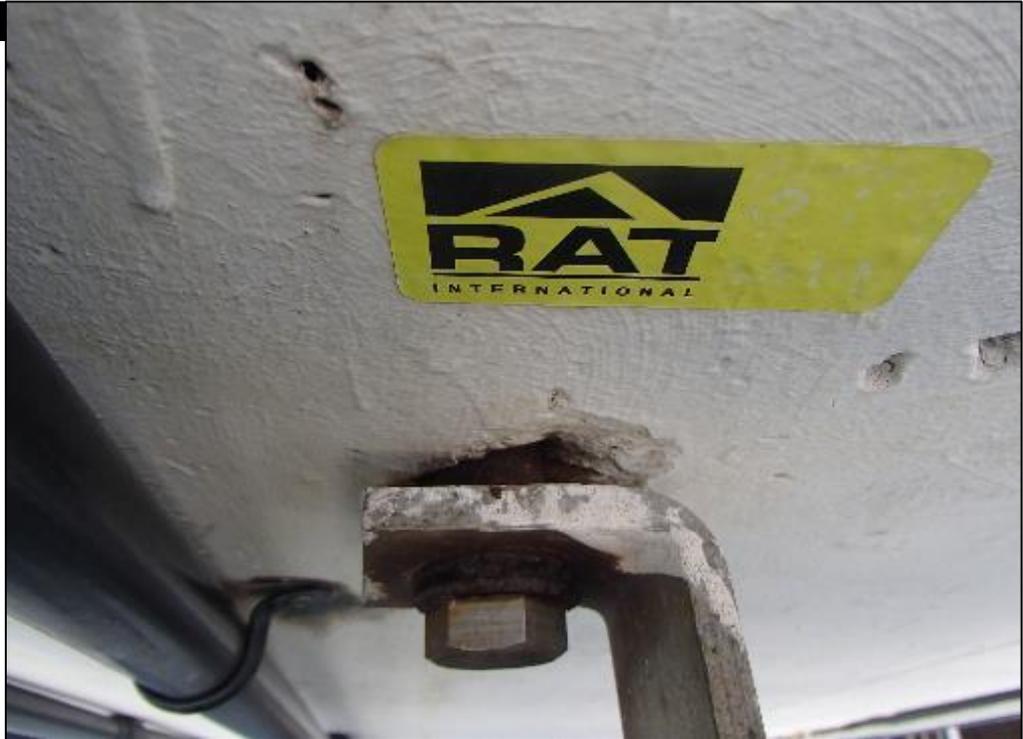
The access ladder was found to be in good condition. There were a few areas where the ladder supports were not fully seated on the concrete shell.

Location:
External Ladder

Description:
Shows ladder support
not fully seated to
concrete shell

- Ladder supports not in contact with concrete surface (Section 7.01). These should be tightened or repaired during the next inspection.
- Vertical cracks 30' to 50' long in the annular space up from the breaching (Section 7.03). Tacten identified the cracks are pre-existing thus they only require monitoring during normal inspections.
- Caulking from a previous repair has come loose on the cold joints (Section 7.05). These should be repaired during normal inspection.

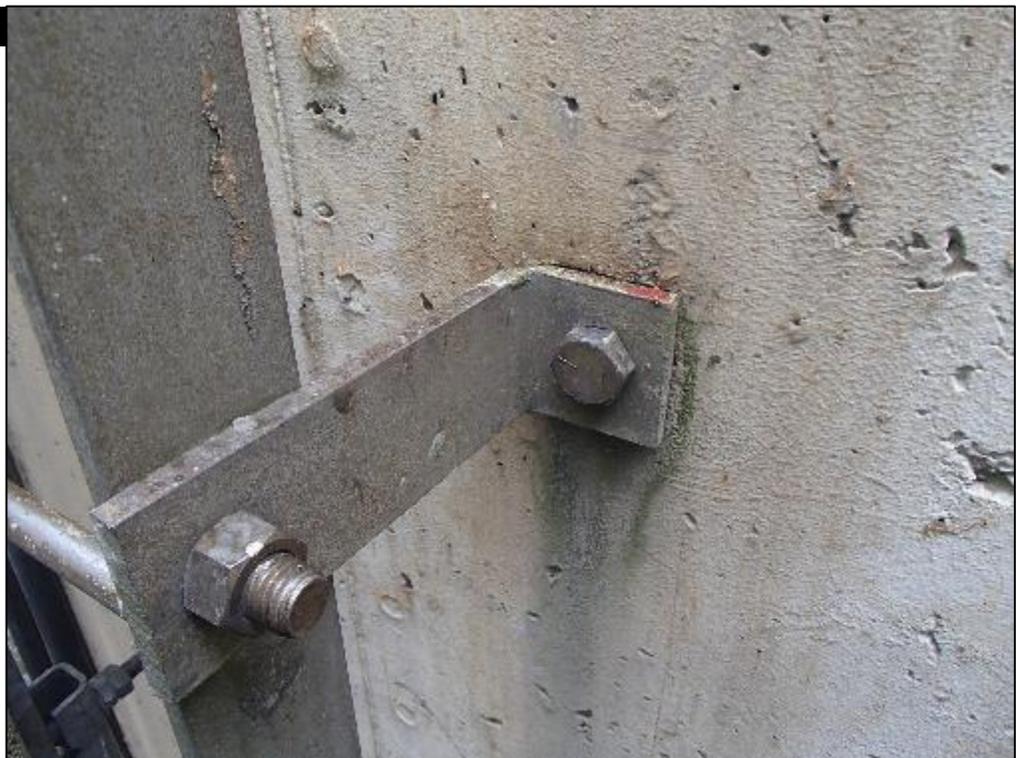
Photo: 2

Description:
General of ladder
support connection.

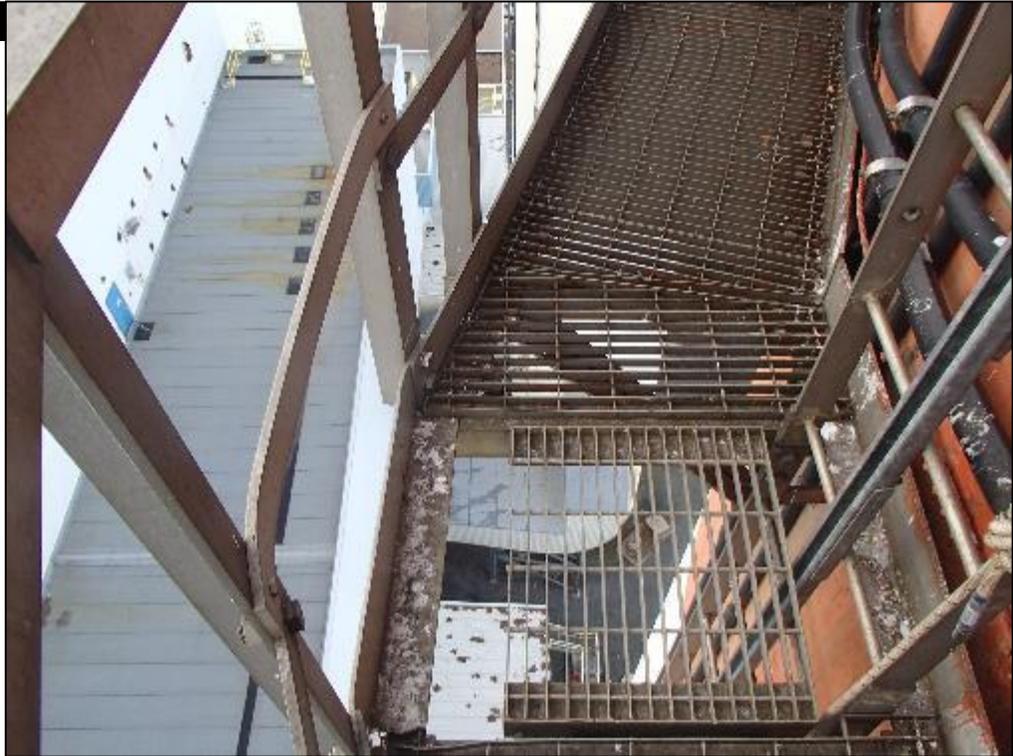
Photo: 3

Description:
General of lower platform showing no signs of concrete debris.

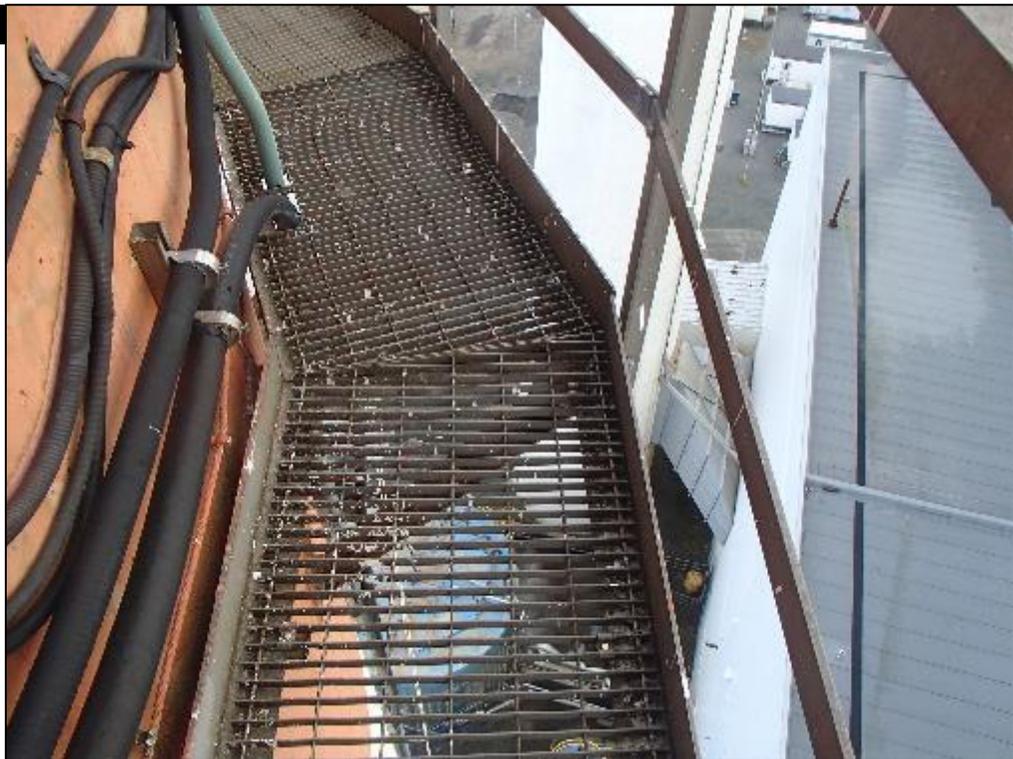
Photo: 4

Description:
General of lower platform showing no signs of concrete debris.

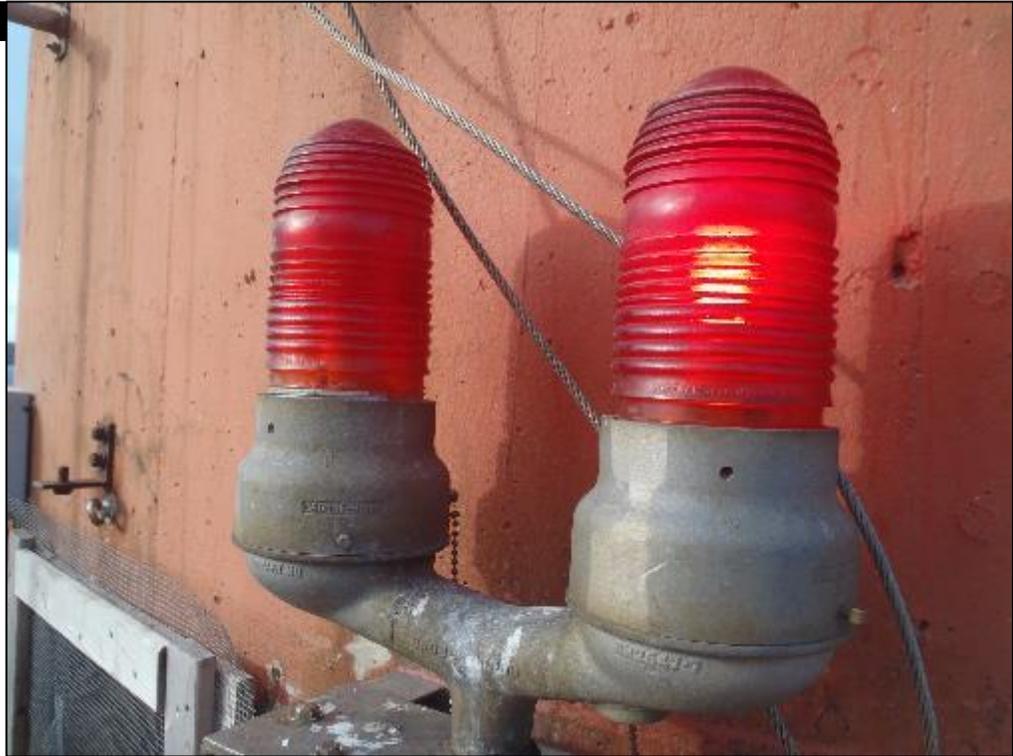
Photo: 5

Platforms are in good condition, no signs of debris found anywhere on walkways. All connection points to concrete are in good condition. Note that one bulb of the east aviation lighting is burnt out.

Description:
Northeast aviation
light. One bulb burnt
out.

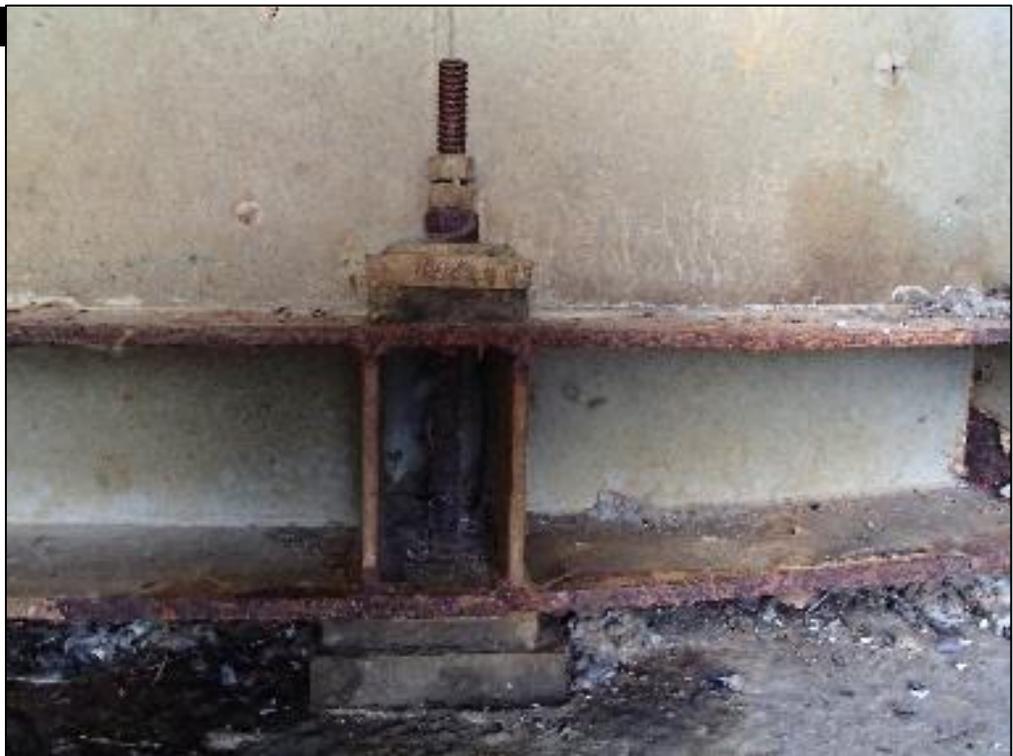
Photo: 6

Description:
General of liner
ground anchors.

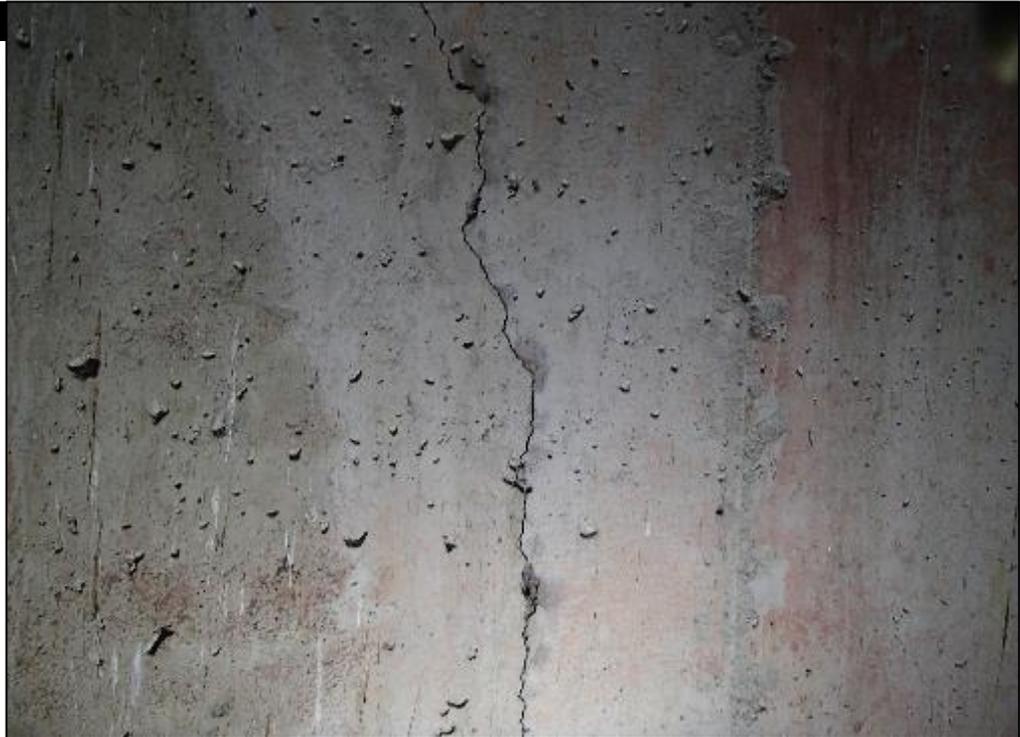
Photo: 7

Annular space inspection took place from 150' to the base of the stack. No signs of damage due to high winds was found. There were vertical hairline cracks noticed above both breeches extending 30'-50' upwards. Both cracks appear to be previously existing.

Description:
Hairline cracks
extending 30-50'
above breeches. East
side.

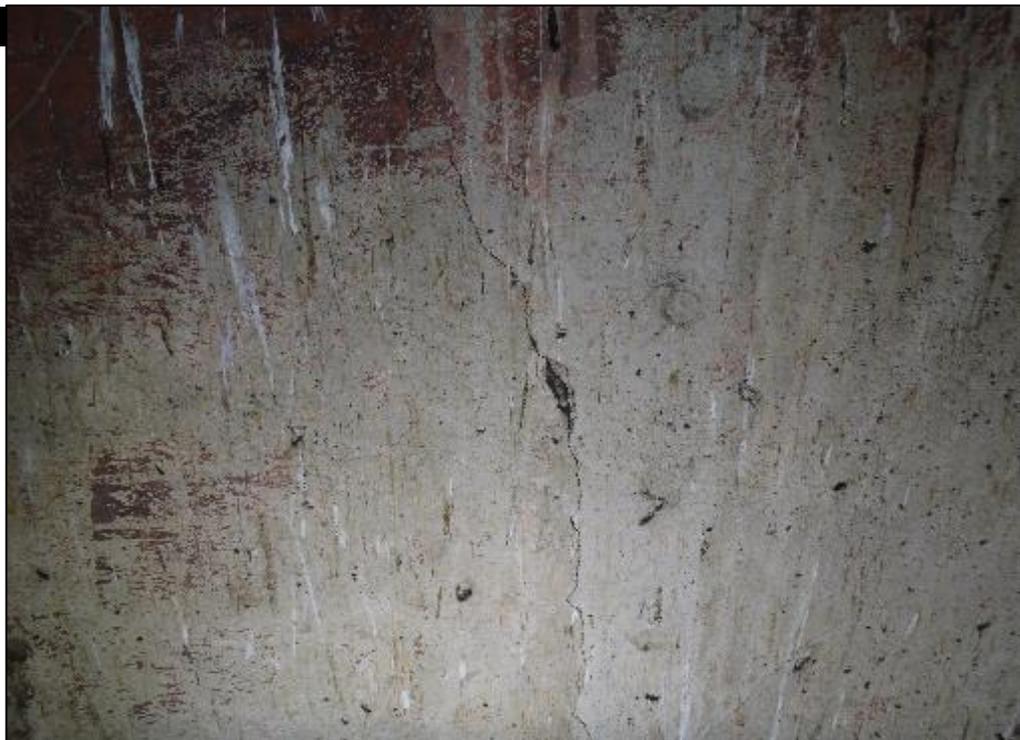
Photo: 8

Description:
Hairline cracks
extending 30-50'
above breeches.
West side.

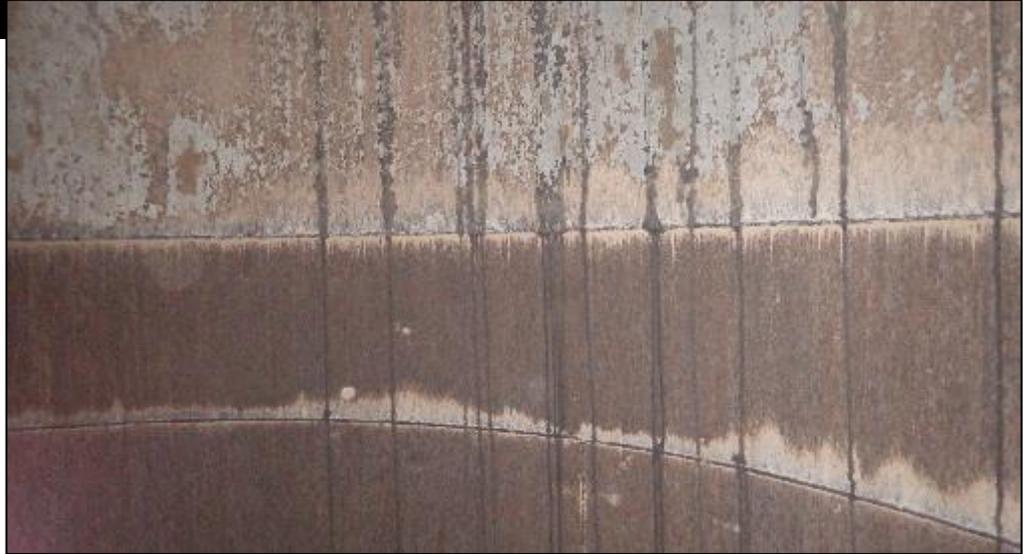
Photo: 9

Description:
General of liner
transition showing
good condition.

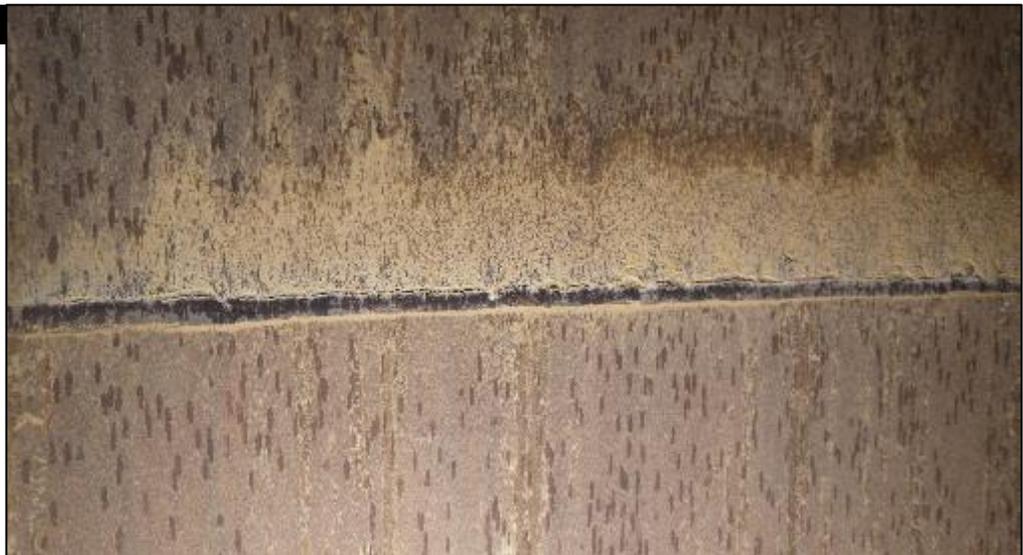
Photo: 10

Description:
General of weld seam
condition inside liner.

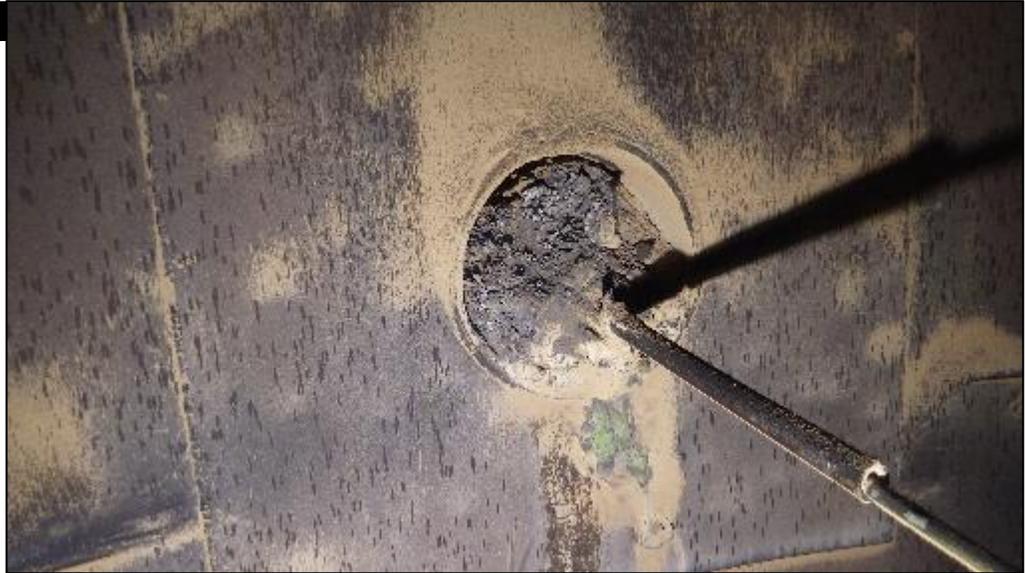
Photo: 11

Internal liner was found to be in good condition throughout entire length with no cracks, bulges or deformations found. Transition from stainless to carbon was in good condition. Small amount of flyash debris was found on the weld seams and the testing ports.

Description:
Debris build up inside
test ports

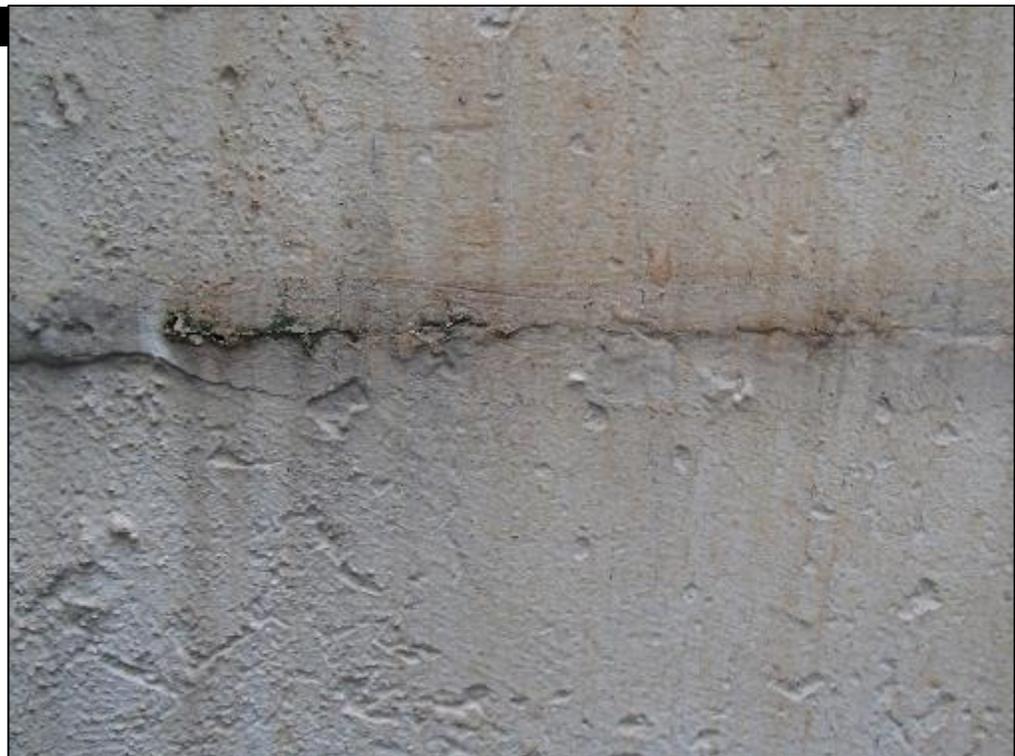
Photo: 12

Description:
General of area
requested to be
inspected by client at
25' East of ladder.

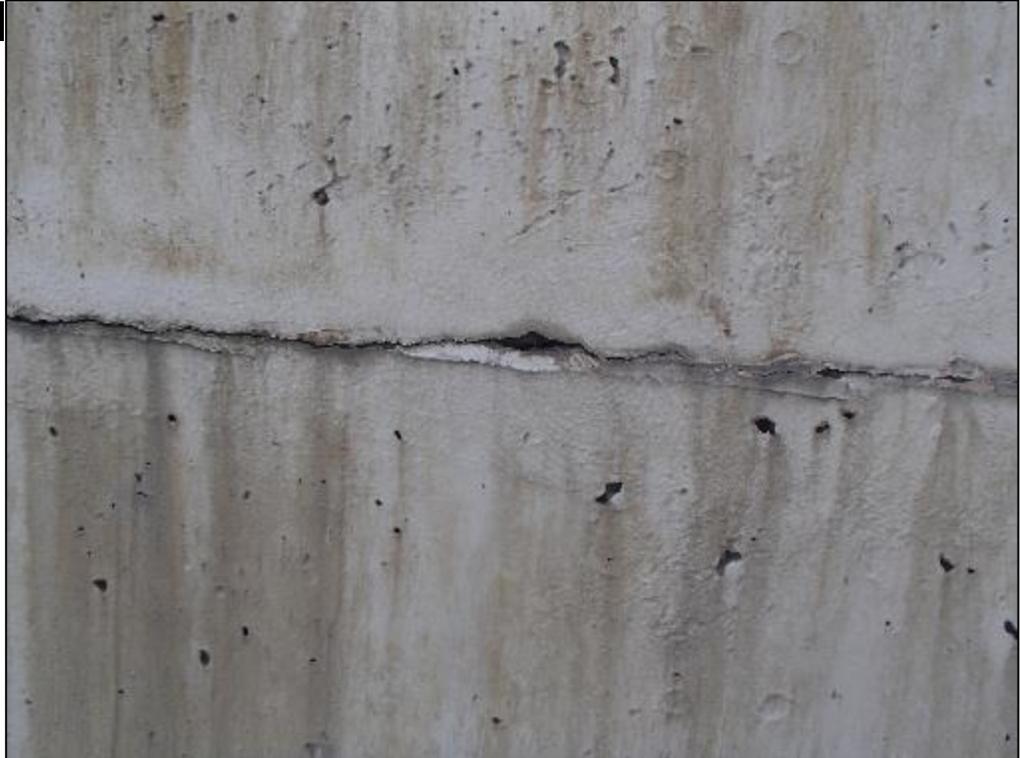
Photo: 13

General photo of cold
joint elevation 60'
West side.

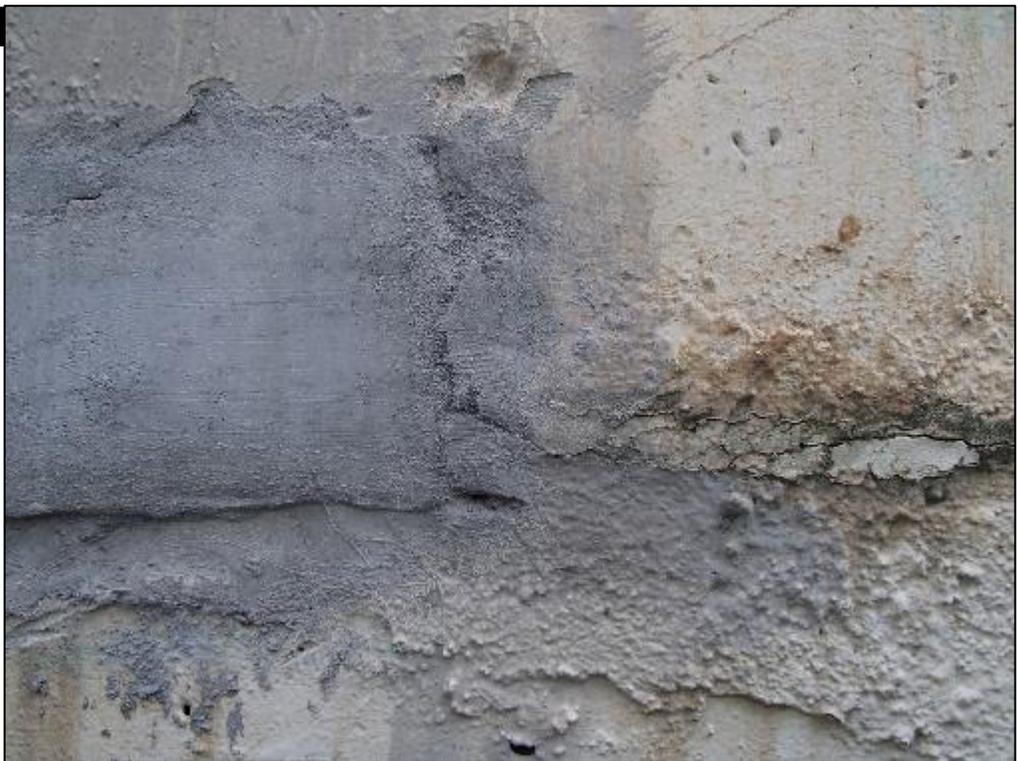
Photo: 14

Previous repair in
good condition, no
further or new
damage noticed.
Elevation 30' south
side.

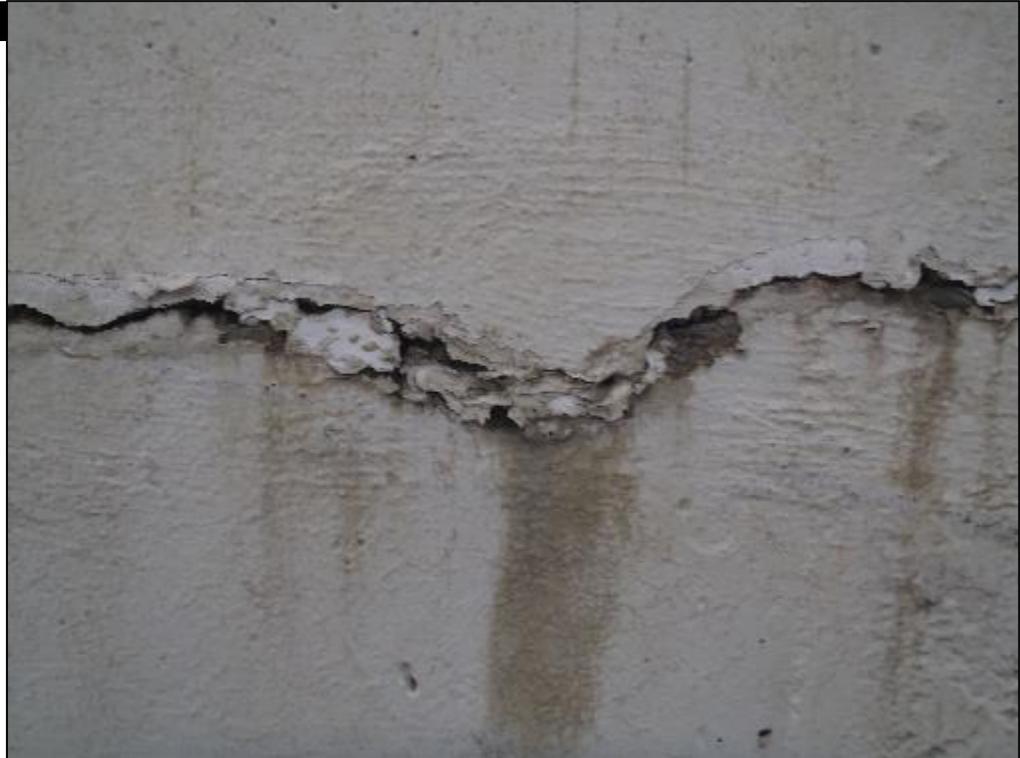
Photo: 15

Previous repair using
caulking on cold
seam to prevent
seeping of water.
Caulking falling out
and or missing.
Elevation 100' North
East side.

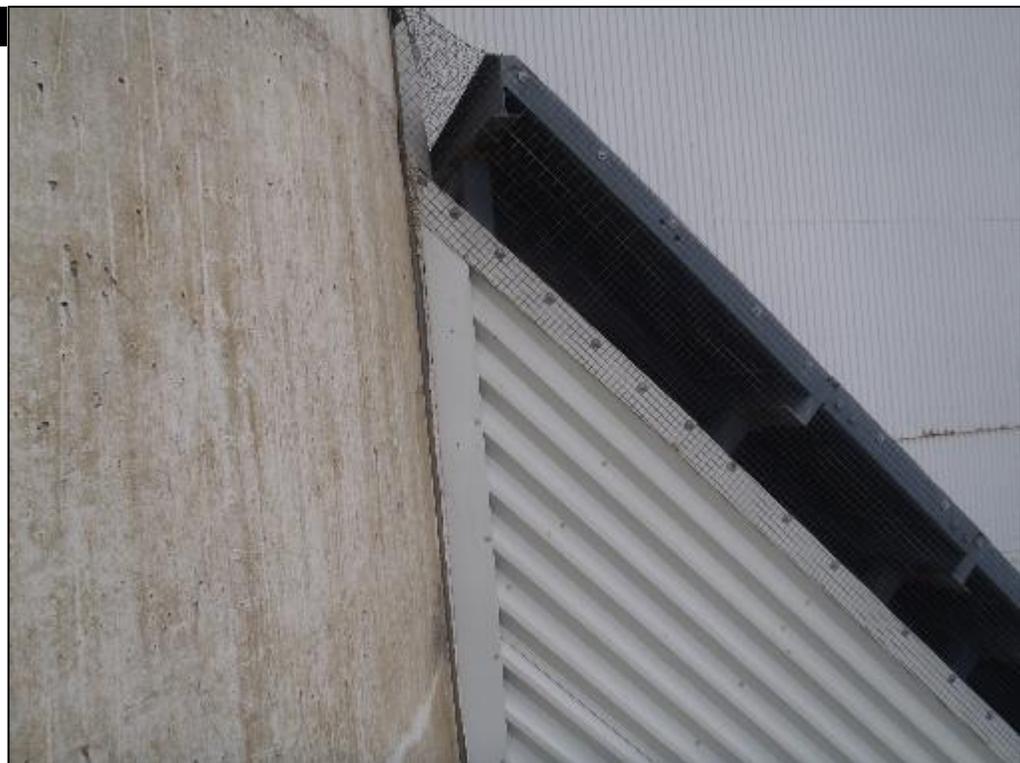
Photo: 16

West breech, general
photo, good
condition. Elevation
50' North West side.

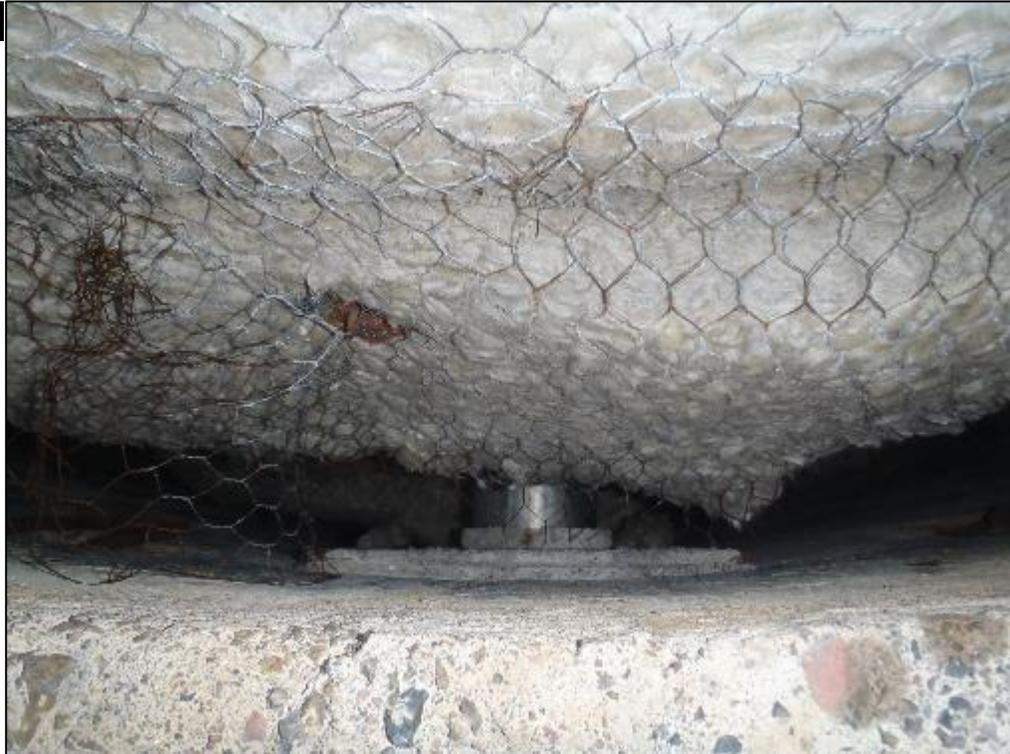
Photo: 17

Description:
Top down view of NE bumper, restricted visibility and access, no signs of any damage to bumper system liner or concrete

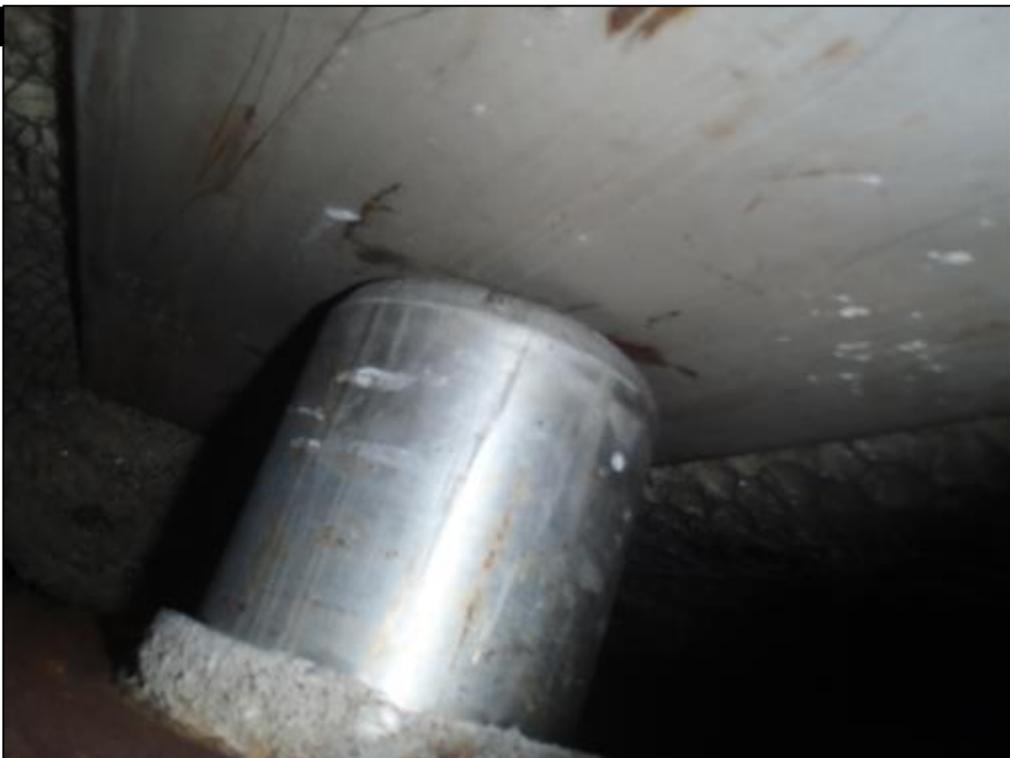
Photo: 18

Description:
General photo of NE bumper in contact with liner. No damage.

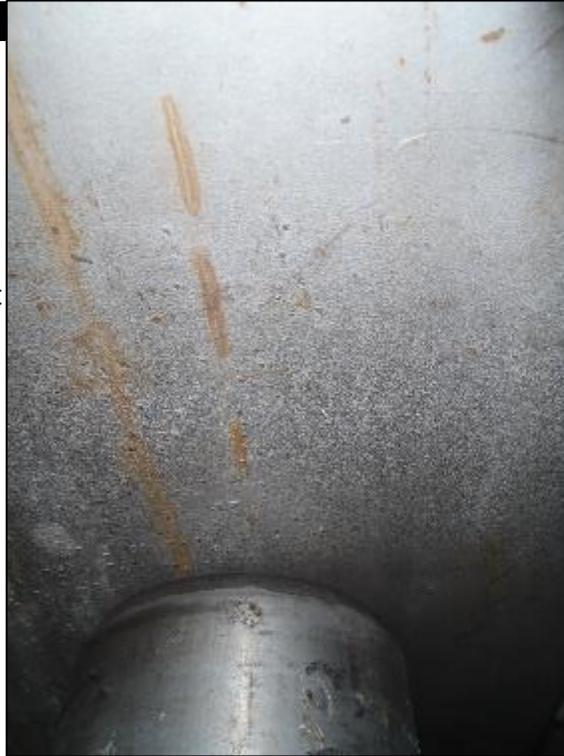
Photo: 19

Description:
General photo of East bumper, no damage to shell or liner.

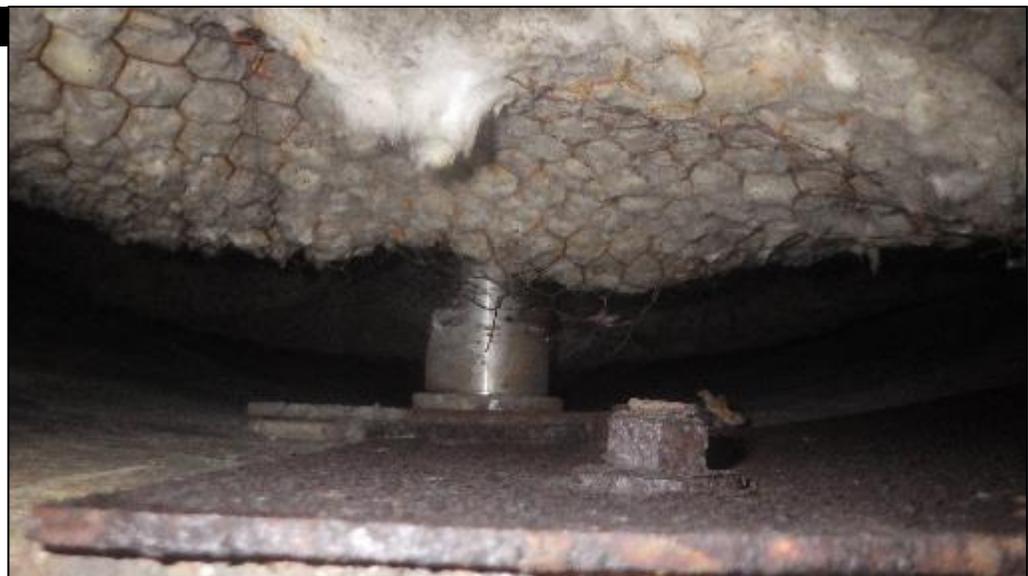
Photo: 20

6/8 liner bumpers were visually inspected from upper inspection ports on the rain cap. No damage was found to the liner or bumper system. All interior bumper connections to concrete shell were found to be in good condition. Liner favors NE side of stack.

Description:
General photo of SW bumper. More room which indicates liner is favoring the NE bumper.

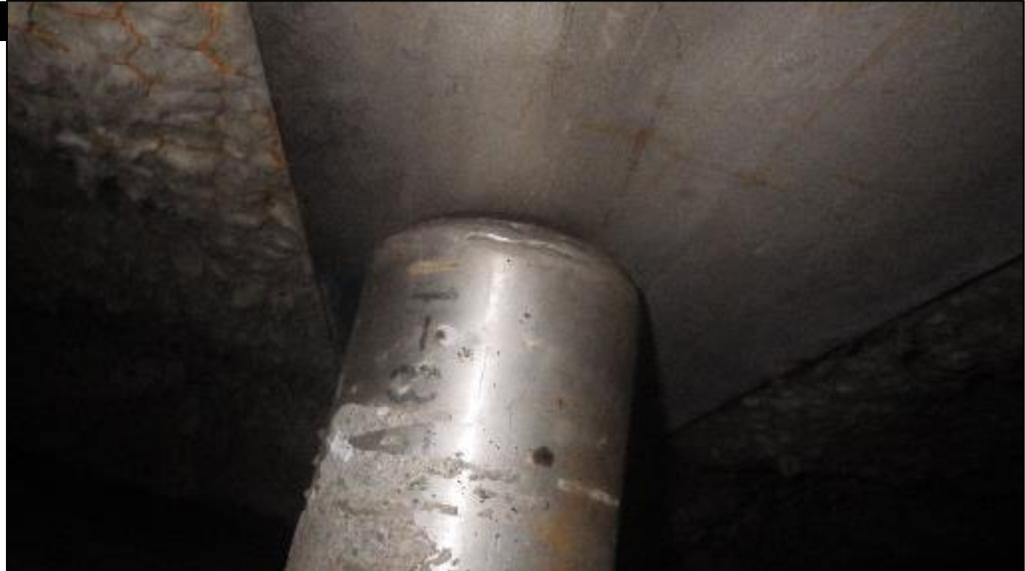
Photo: 21

Description:
General photo of
West bumper
showing no signs of
damage to liner or
concrete.
