Re: Holyrood Thermal Generating Station Unit 2 Stack Movement Assessment

Holyrood Thermal Generating Station

Exhaust Stack No. 2

H358827-00000-240-230-0002

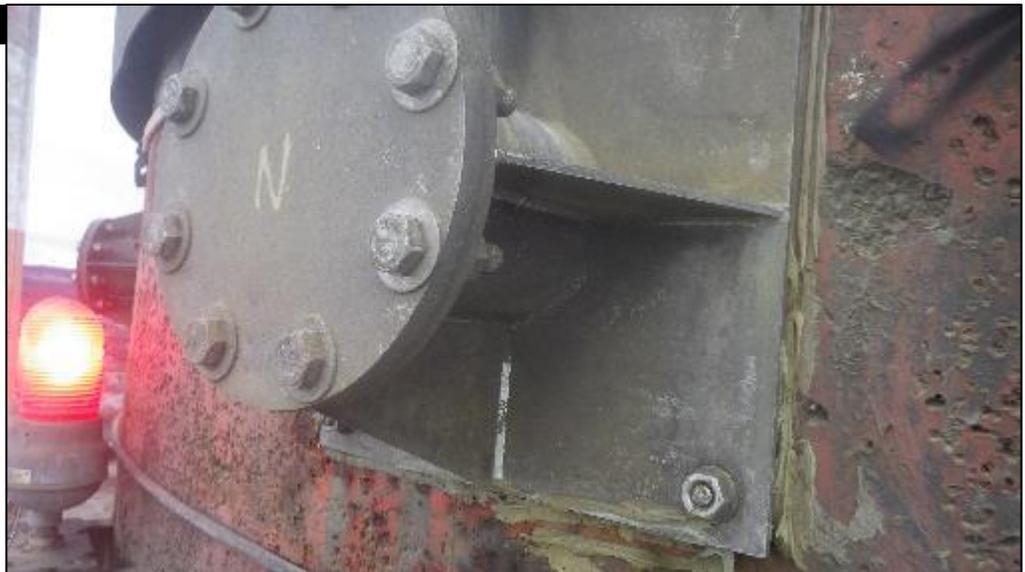
Photo: 22

Description:
General photo of
North external
bumper system, no
new signs of damage.

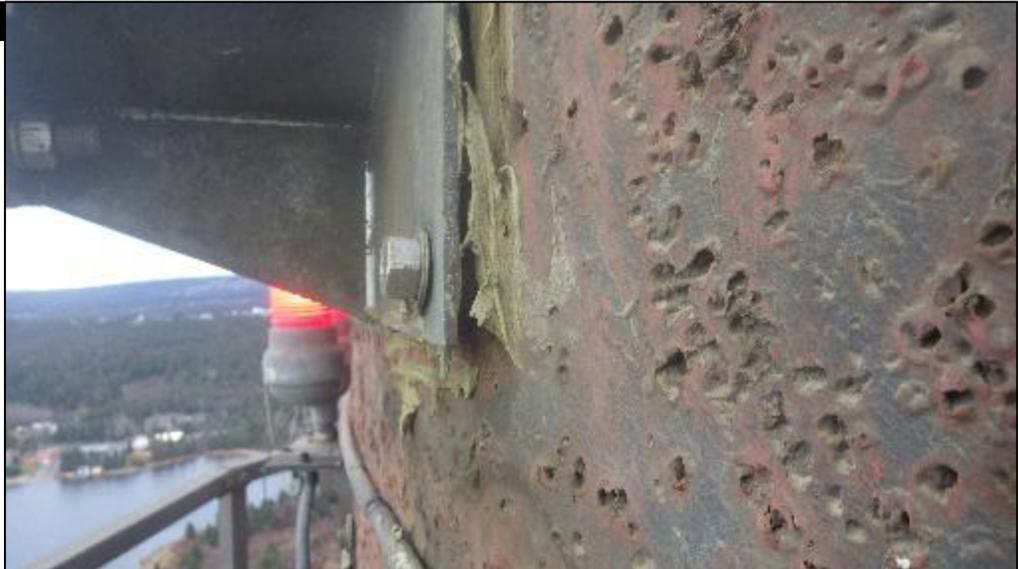
Photo: 23

Description:
General photo of N bumper shows gap filled with caulking from bumper installation.

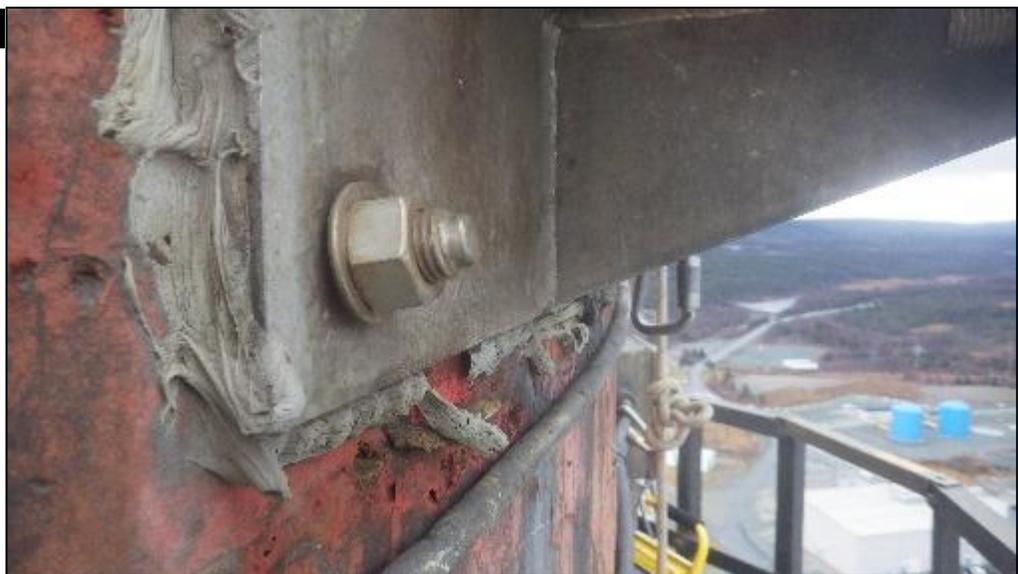
Photo: 24

Description:
Picture shows bolts not square with shell, from installation.
