**Re: Use of the Allowance for Unforeseen Items
Water Damage Mobile Diesel Generator**

Allowance for Unforeseen Items
Mobile Diesel Generator Water Damage

January 17, 2019

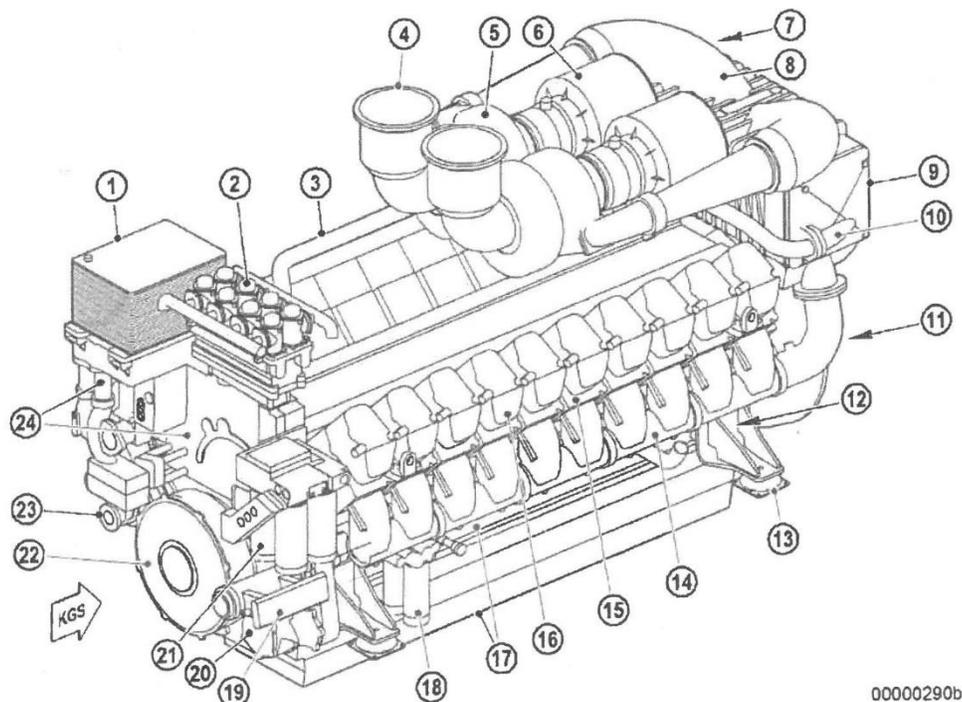
Figure 1 – MD3 Engine Schematic

Figure 1 is a schematic illustration of the MD3 diesel engine. Water entered the engine through the exhaust system at the top of the engine, identified as item 4 in Figure 1.

The water entered the engine through the roof exhaust flap, and filled the exhaust stacks, exhaust turbochargers and engine exhaust manifolds located at the top of the engine (see Figure 1). From the exhaust manifold, water was able to migrate to the cylinders.

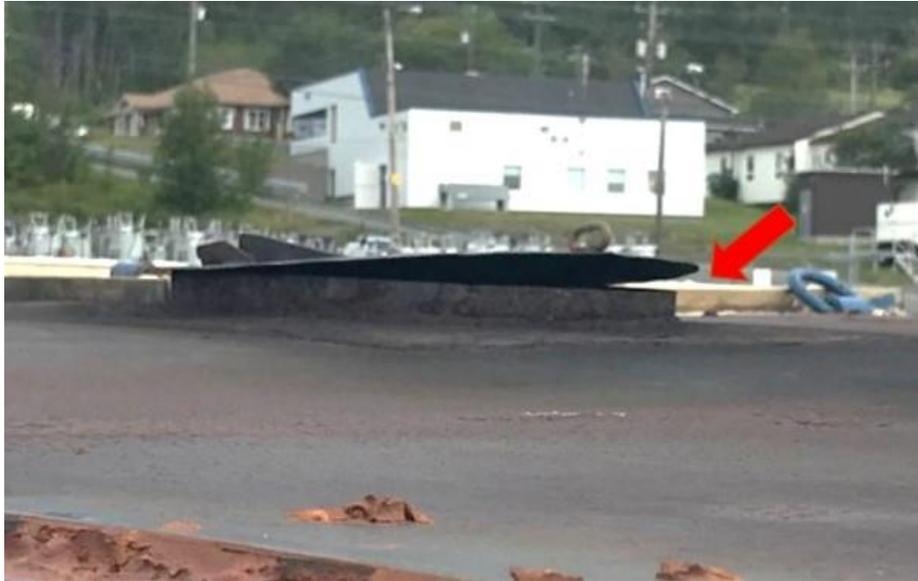
It was apparent that water had entered the engine during the time the unit was stored at the EMC awaiting refurbishment of the power transformer. It was surmised that rainwater had infiltrated the exhaust stack through the exhaust cover or flap, which was discovered to have sustained

damage that had gone undetected.³ It appeared that the damage had allowed the flap to be lifted by strong winds, enabling rainwater to enter the exhaust stack.

³ A photograph of the exhaust flap can be found in Appendix A as Figure 1. The damage was not detected because the flap is located on the roof of the enclosure, and is not visible from the ground.

Figure 1 - Damaged/Warped Exhaust Flap

To prevent the recurrence of water infiltration through the exhaust system, the exhaust flap was replaced with one of modified design. To ensure the flap will return to the closed position when the unit is offline, mechanical stops were added to restrict the open position to less than 90 degrees. In addition, a mechanical latch was added to ensure the flap remains closed when the unit is not in use.¹⁵ The requirement to manually unlock the latch before starting the unit and lock it when the unit is shut down should eliminate the risk of recurrence.

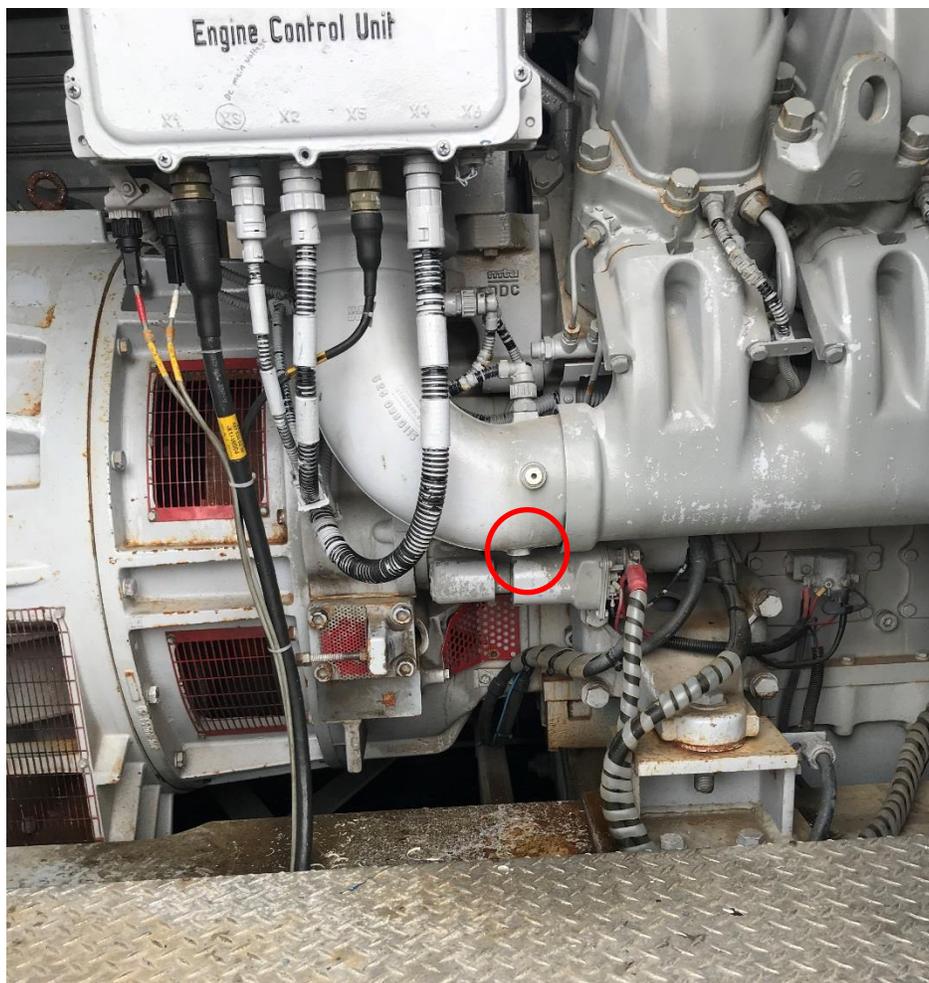
An unusual amount of water was observed dripping from the small condensate drain on the air intake manifold. This indicated that water had infiltrated the air intake side of the engine through the intake valves on some cylinders. Upon inspection, the air intake manifold pipes

showed signs of water ingress; however, the water had since drained. A boroscope inspection of the after-cooler confirmed that the volume of water experienced in the intake piping was not enough to reach the after-cooler or compressor side of the turbochargers. All components on the intake side of the engine were found to be undamaged and suitable for continued use.

Figure 2 - Intake Manifold. Excess Water was Observed Draining from Condensate Drain.

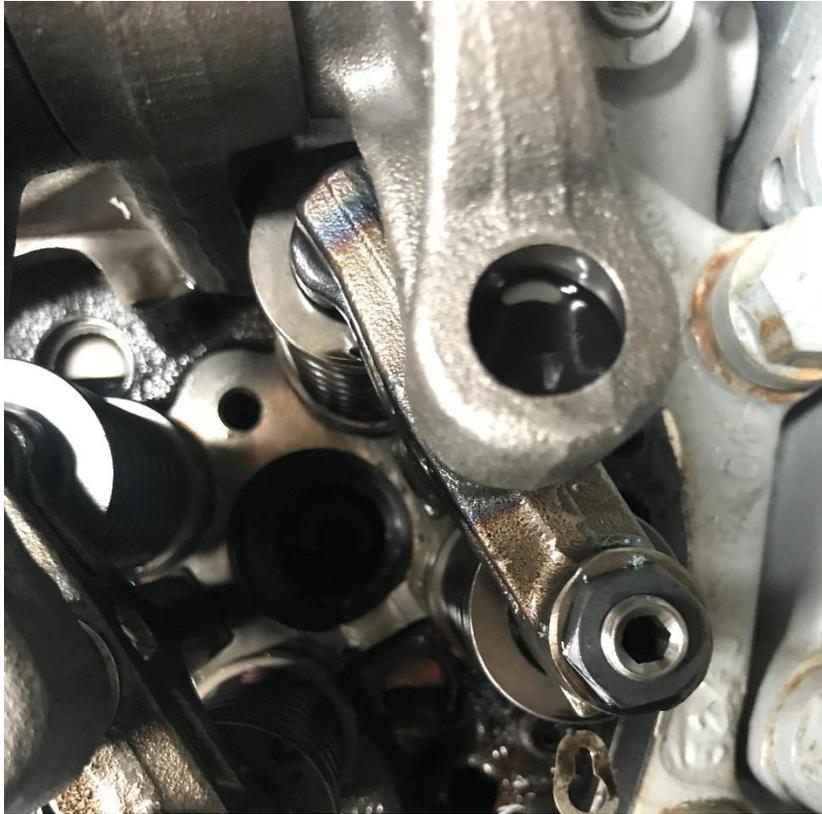
Figure 3 - Water Observed to Top of Cylinder Head

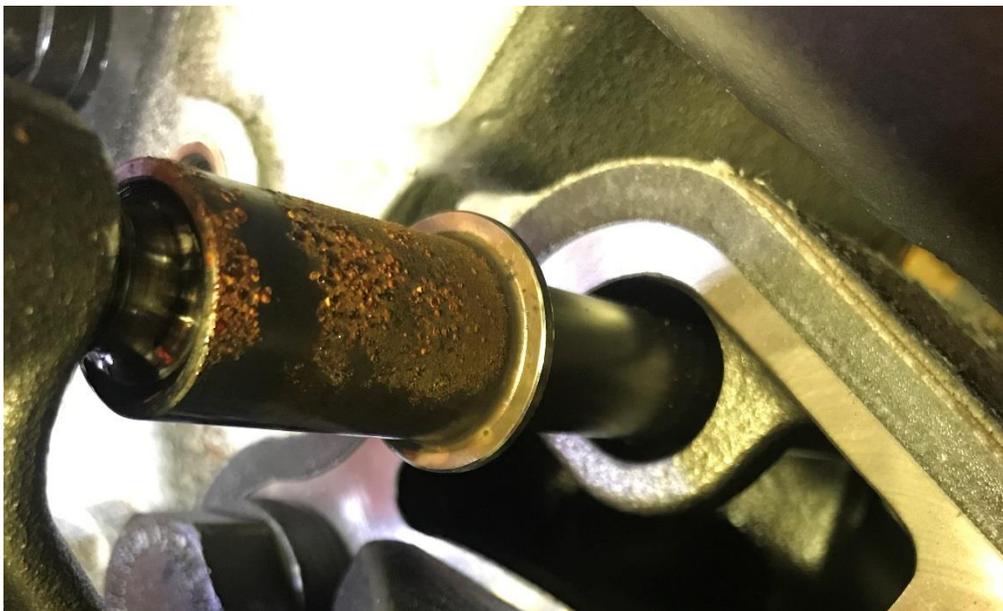
Multiple connecting rods were found to have slight surface corrosion.¹² All 20 connecting rods were removed, inspected and measured for damage. It was determined that all connecting rods were suitable for reuse. The connecting rods were cleaned and reinstalled. The crank shaft was visually inspected and corrosion was observed on multiple webs.¹³ When the connecting rods were removed, it was confirmed that the journal surfaces for the connecting rods were not damaged by water. The crank shaft was determined to be suitable for continued use. To avoid more extensive disassembly, the crank shaft was cleaned in place through the engine inspection covers.

¹² Water damage to the connecting rods can be seen in Figure 4 of Appendix A.

Figure 4 – Surface Corrosion Observed on Push Rod

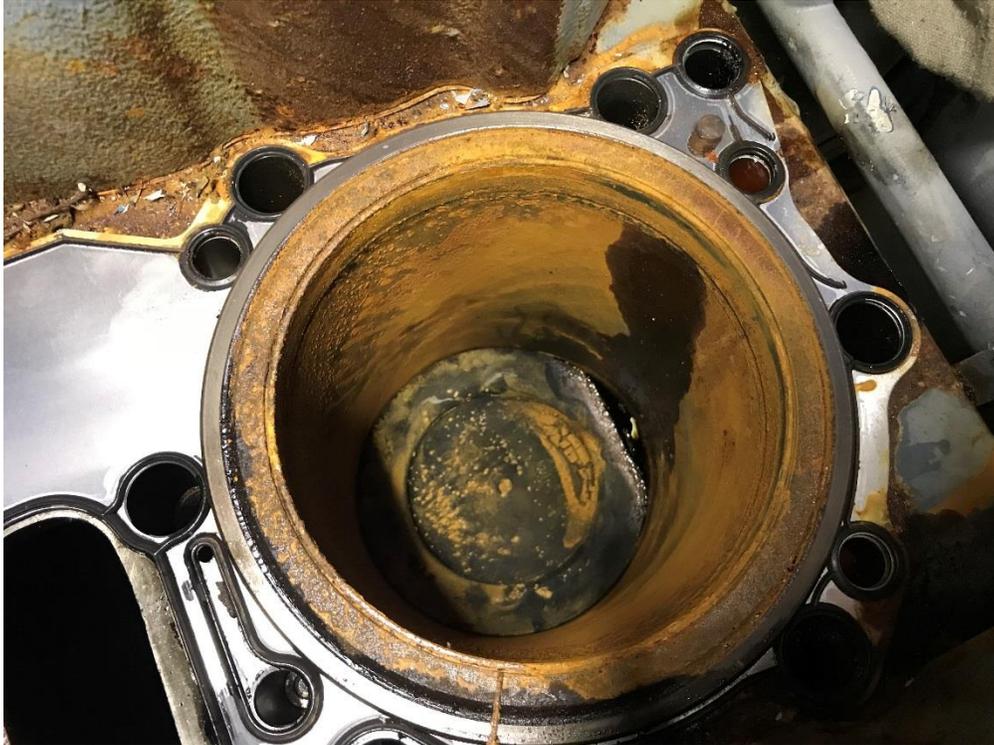
All 20 cylinder heads were removed from the engine and found to have significant corrosion damage. Damage was noted on the intake and exhaust valve faces, stems and seats.⁸ Because it was determined to be unfeasible to rebuild these onsite, they were replaced with OEM refurbished cylinder head assemblies.⁹ Likewise, all 20 cylinder liners were observed to have significant corrosion damage.¹⁰ Wajax determined that all 20 cylinder liners should be pulled out and replaced with new OEM cylinder liners.¹¹

All 20 pistons were found to have corrosion on their heads, sides and rings. OEM refurbished piston assemblies were determined to be the least cost option for addressing the corrosion damage. The refurbished piston assemblies included factory restored pistons with new rings and wrist pins.

¹⁰ Water damage to the cylinder liners can be seen in Figures 5 and 6 of Appendix A.

Figure 5 - Typical Cylinder Liner Condition. Corrosion Also Visible on Pistons

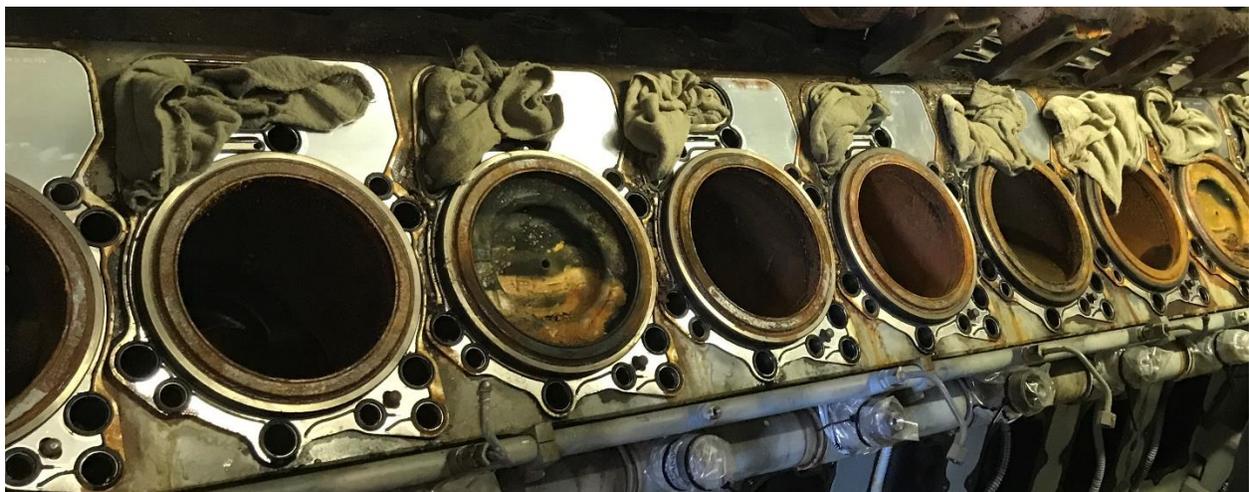
Figure 6 - Cylinder Liner and Piston Condition Observed During Disassembly

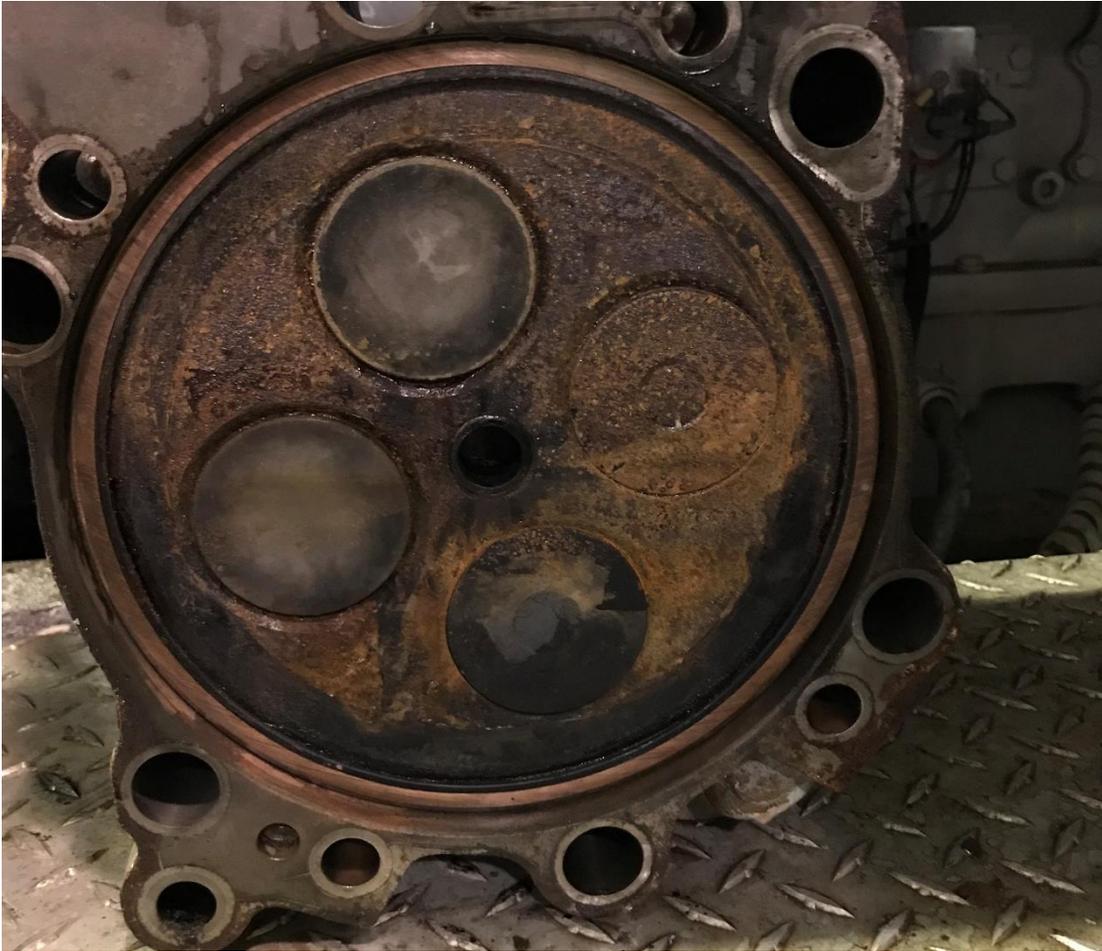
⁸ Water damage to the cylinder heads can be seen in Figures 7 and 8 of Appendix A.

Figure 7 - Cylinder Head Condition with Intake and Exhaust Valves Installed

⁹ The OEM, MTU Detroit Diesel, offers factory refurbished parts that meet the specification of new parts at reduced cost on some items that cannot be repaired. There are also further cost reductions available if the existing damaged parts are determined to be in a repairable state by the OEM. If they are able to be factory refurbished, a core refund will also be applied. For example, core credit was received for the cylinder heads and pistons that were returned to the OEM. The refurbished parts were available immediately, saving both time and labour cost.

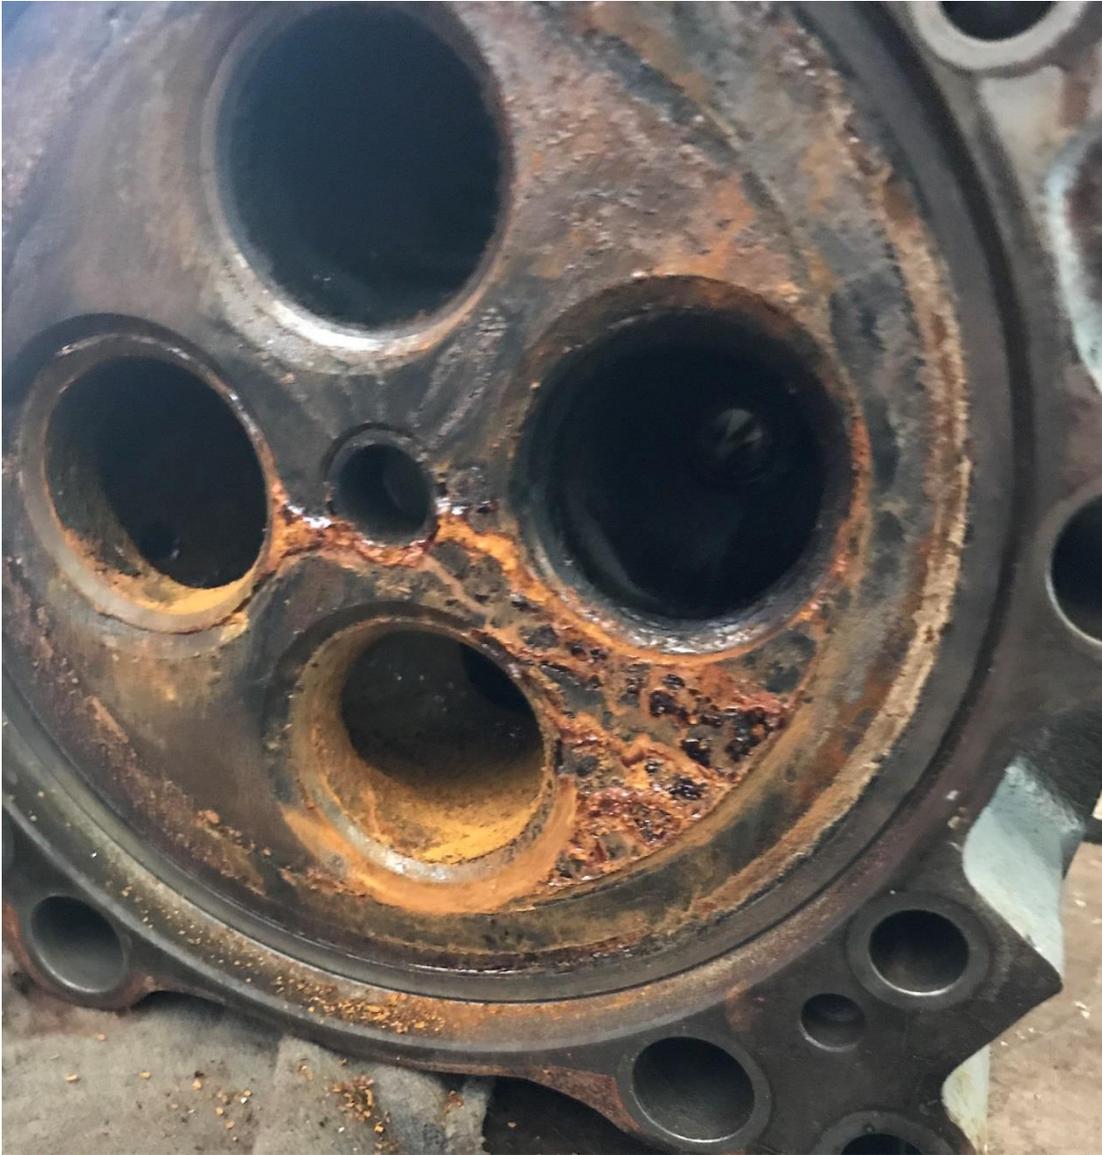
Figure 8 – Typical Cylinder Head Intake and Exhaust Valve Ports. Heavy Corrosion on Valve Seats

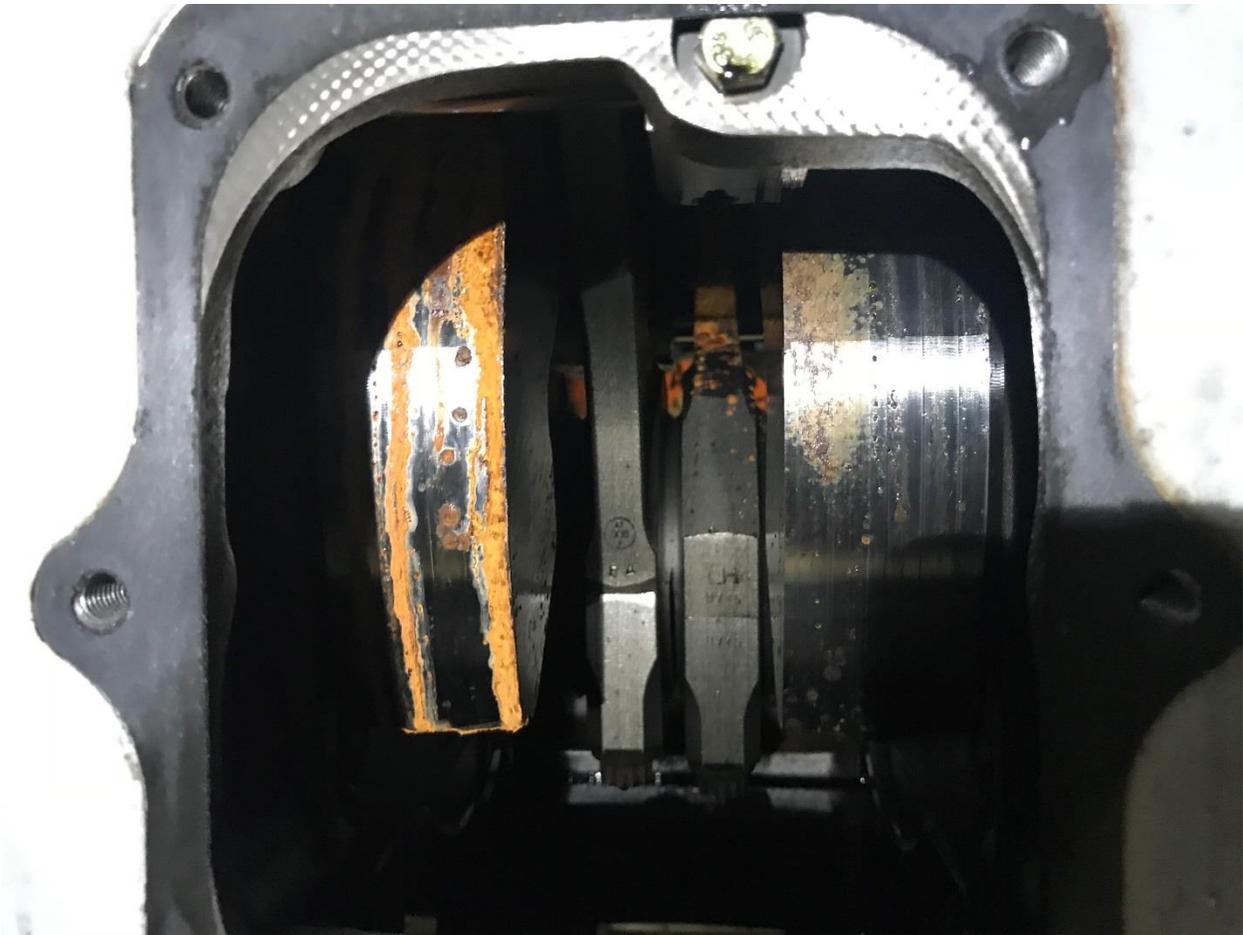
¹³ Water damage to the crank shaft can be seen in Figure 9 of Appendix A

Figure 9 - Typical Surface Corrosion Observed on Crank Shaft.

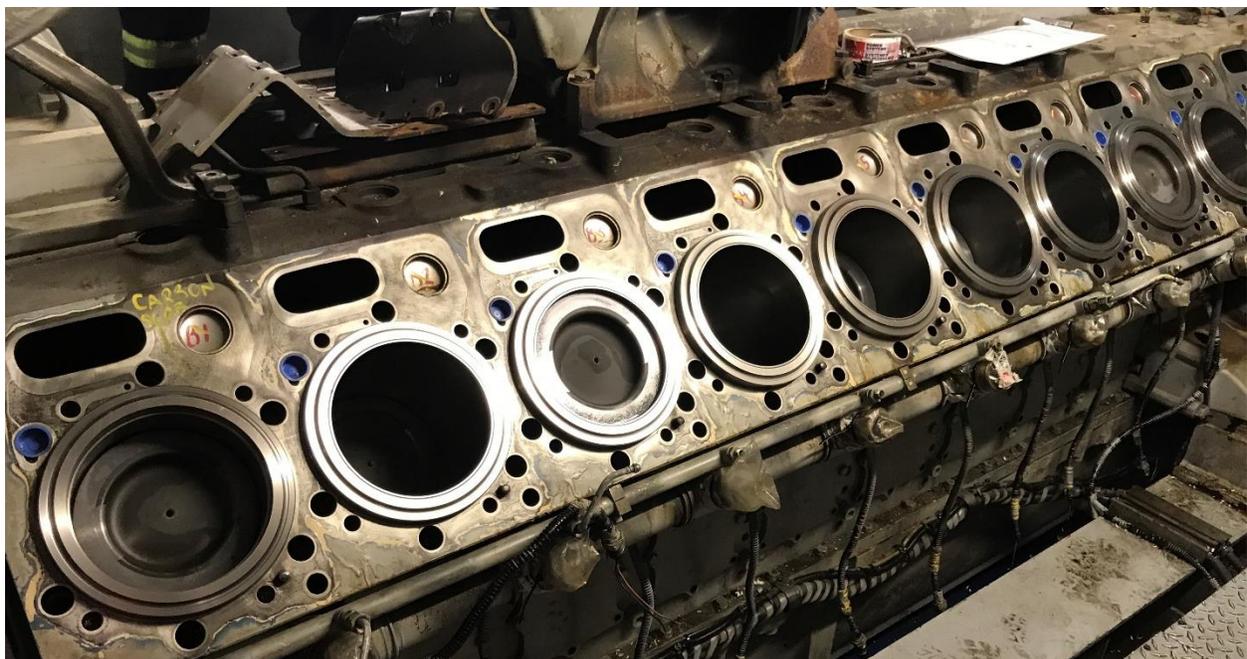
Figure 10 - New Cylinder Liners and OEM Refurbished Pistons

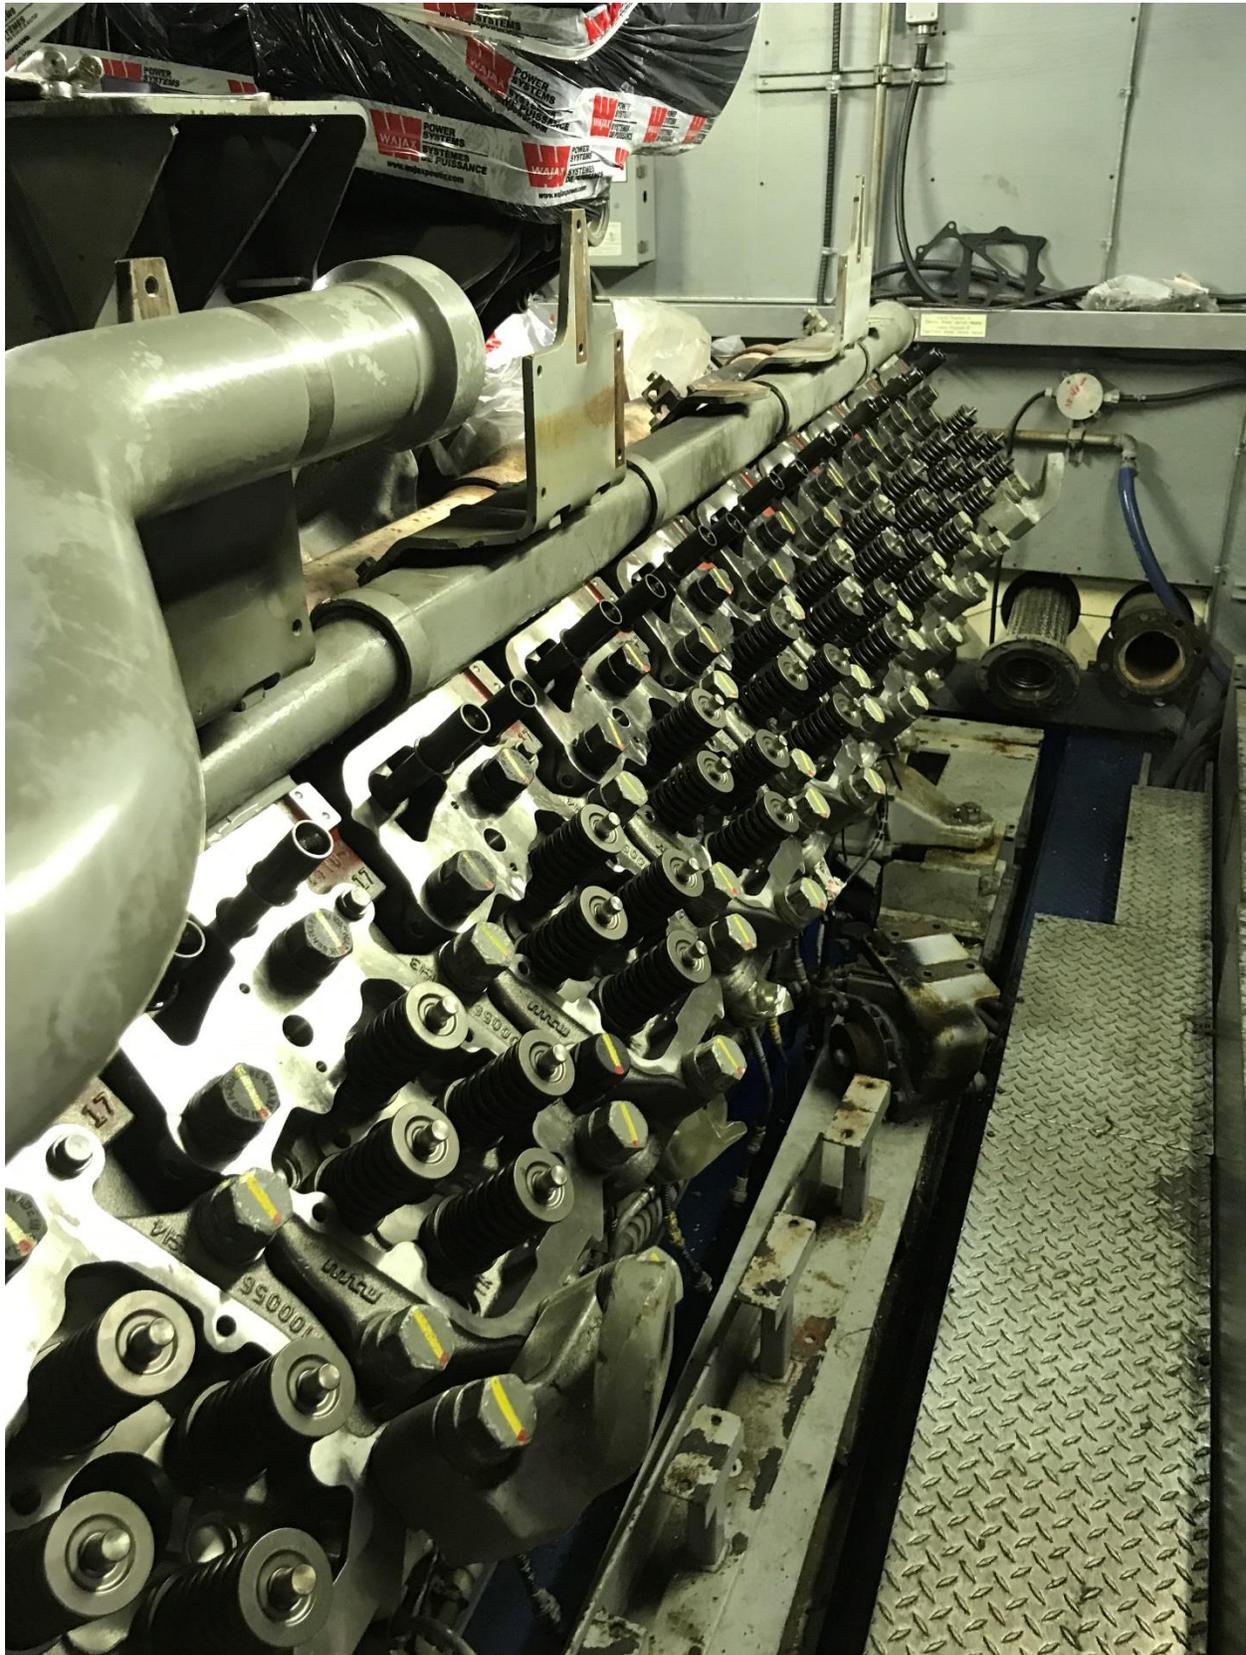
Figure 11 - OEM Refurbished Cylinder Heads Installed

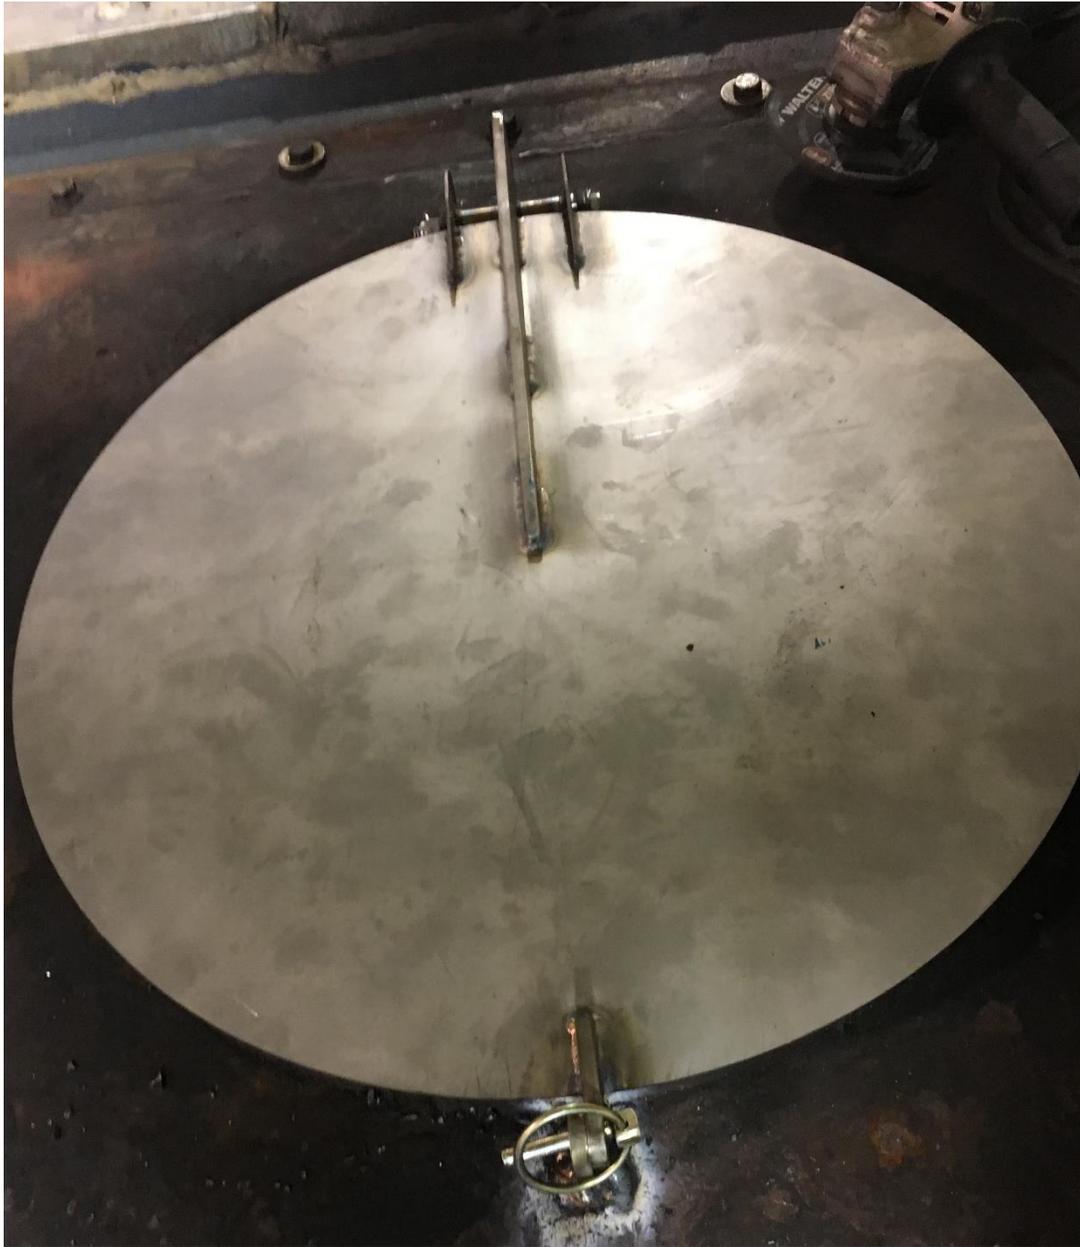
Figure 12 – Exhaust Flap Modified With Securing Latch

¹⁵ The replacement exhaust flap can be seen in Figure 12 of Appendix A
