**Re: Allowance for Unforeseen Items Account – Holyrood Thermal Generating Station Transformer T2 Failure – Final Report**

# **Holyrood Thermal Generating Station Transformer T2 Failure Final Report**

**February 8, 2022**

**A report to the Board of Commissioners of Public Utilities**

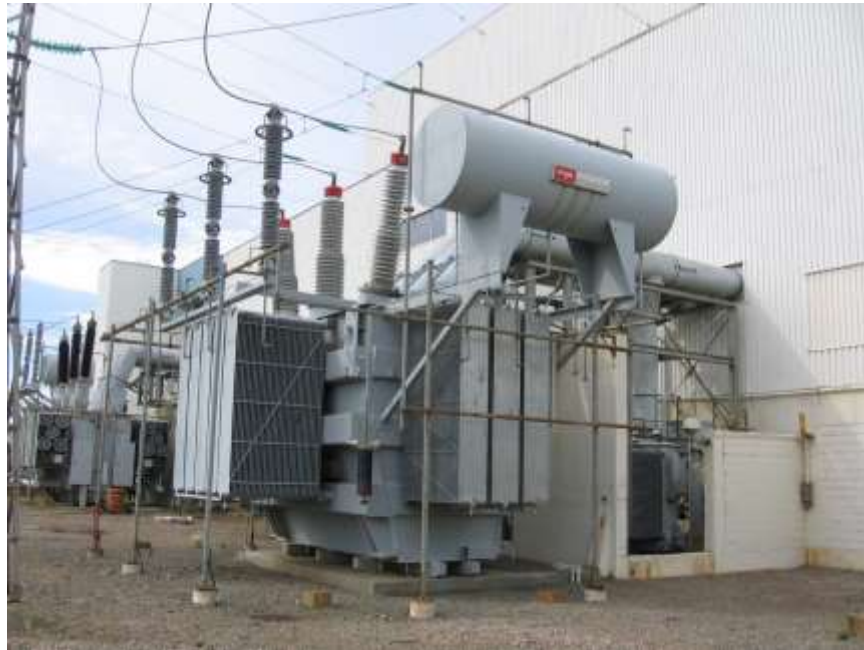
2 On November 12, 2021, during normal operation of Holyrood TGS Unit 2, the T2 transformer  
3 experienced an internal fault. At the time of the event, Holyrood TGS Unit 2 was generating at 130 MW.  
4 Transformer protection operated as designed to remove the T2 transformer and Holyrood TGS Unit 2  
5 from service.

**Figure 1: Holyrood T2 Transformer**

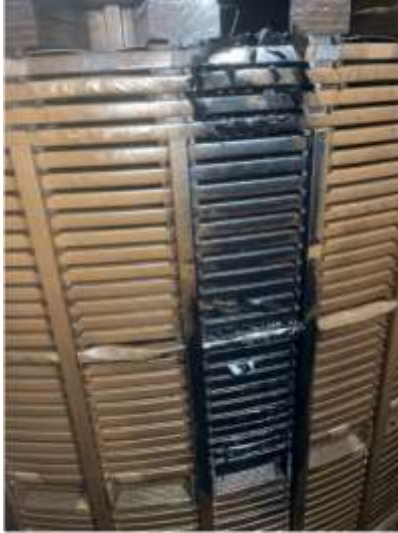
15 The internal inspection confirmed that the transformer had experienced a significant failure on its high  
16 voltage winding (Figure 2). The OEM representative also advised that the issues with the transformer  
17 could not be repaired on site and the winding would need to be rewound. On November 18, 2021,  
18 immediately following the internal inspection and upon receipt of additional information from the OEM,

**Figure 2: Holyrood Transformer T2 Failed High Voltage Winding**

22      As of February 7, 2022, no direct cause has been identified for the Holyrood TGS T2 failure and the  
23      investigation is ongoing.

- 1 Hydro made the decision to replace the failed transformer with the spare transformer located at the
- 2 Holyrood site. This was the only option available to return the T2 transformer and Holyrood TGS Unit 2
- 3 to service and ensure a reliable supply to customers for winter 2021–2022.

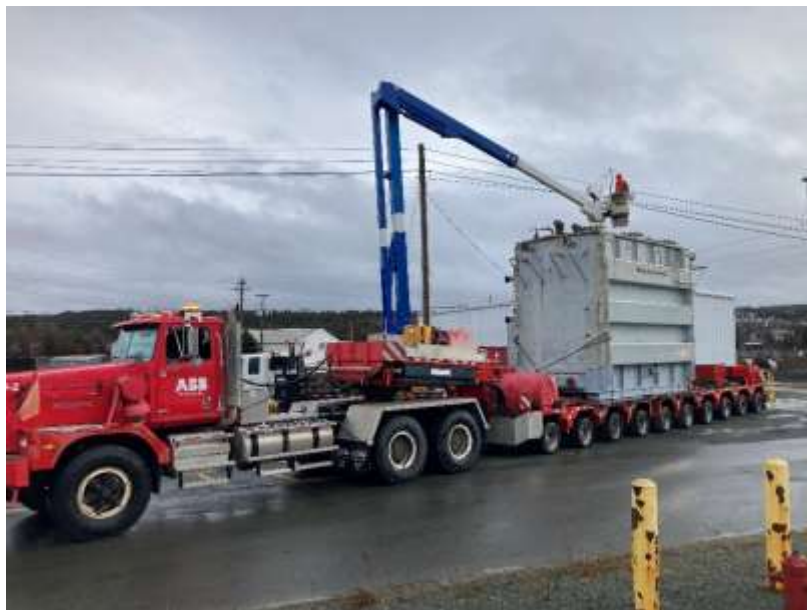
**Figure 3: Spare Transformer Being Relocated**

5 The transformer oil within the spare transformer was drained and an internal inspection was completed  
6 to confirm that there were no issues to prevent it from being placed into service. The spare transformer  
7 was then moved to the transformer pad previously occupied by the failed transformer by the heavy  
8 hauler (Figure 3).
