Root Cause Analysis Report

Bay d'Espoir Penstock No. 1 Refurbishment

H352666-00000-220-066-0002 Rev. F March 17, 2017

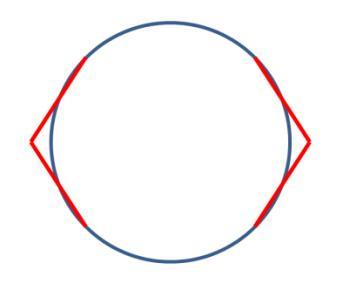
Figure 3-1: Peaking (Red) As Welded (Blue)

During the era in which Penstock No. 1 was constructed, plate rolling was generally completed utilizing a three roll single pinch point roll. When rolling plates with this type of roll, the start and end of each plate will be flat. Figure 3-1 shows an exaggerated peaking (in red) compared to the desired tubular structure (in blue).

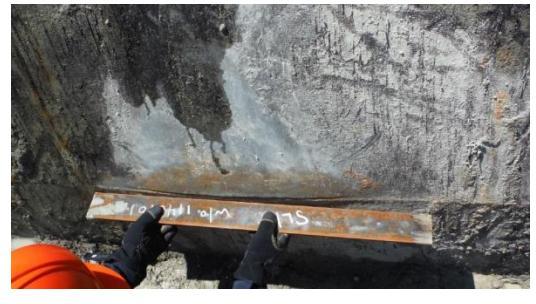
Figure 3-2: Longitudinal Weld Failure Showing Peaking

Difficulties with lining up the longitudinal seams at the time of construction in the 1960s are evident when examining the internals of the penstock and seeing evidence of extensive dogging<sup>1</sup> of the joints to bring the longitudinal seams together. The flat spots and induced stress from fitting the straight ends increase the residual stress at the joints. Below is an image of the longitudinal seam that failed in September. Large amounts of peaking were observed at the initial crack location, see Figure 3-2, and this would mean the weld was resisting significant residual stresses to maintain a round shape at the seam. The increased stress also makes the longitudinal joints more susceptible to material loss as they become sensitized to corrosion.

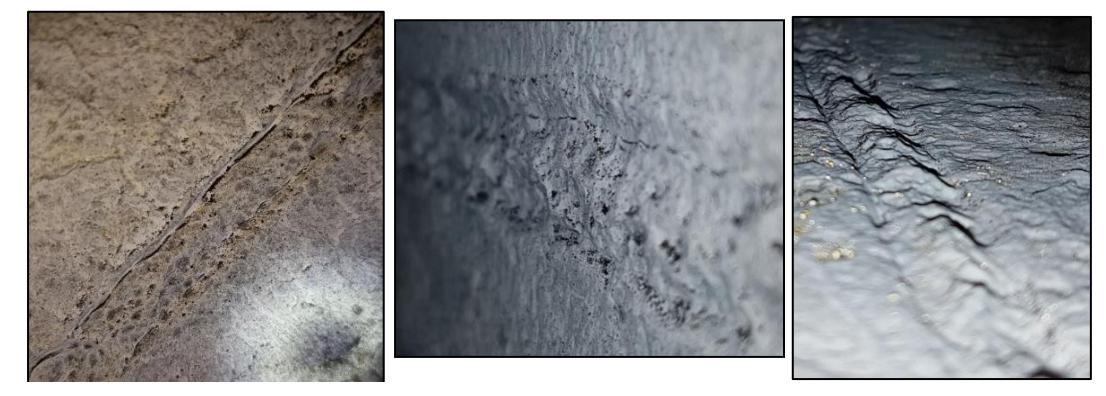
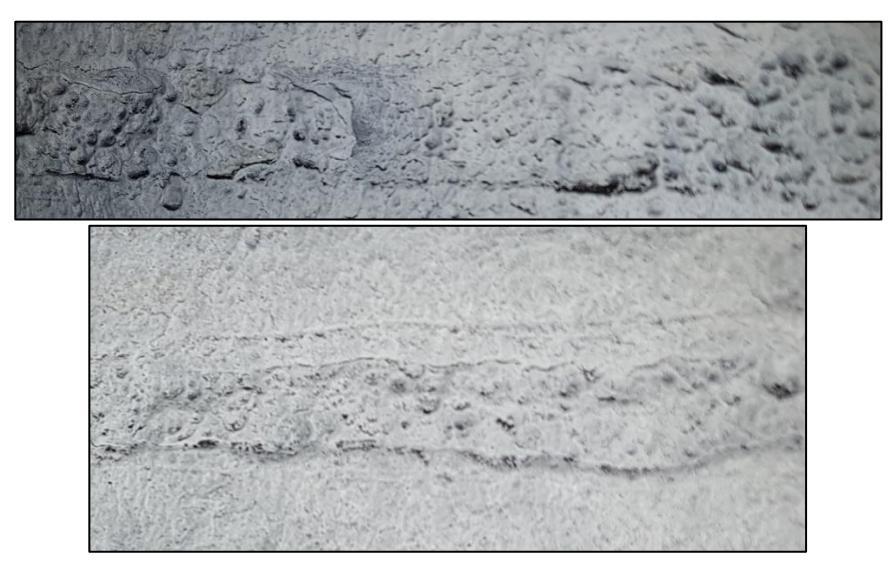
Throughout the upper section of the penstock it was noted that longitudinal seams were experiencing extensive pitting corrosion, material loss and well defined notches along the heat affected zone of the welds. This excess material loss and notching contributes to high stresses, crack initiation and propagation. Refer to Figure 3-3 and Figure 3-4 for images of the notching, excessive pitting corrosion, and material loss.

Figure 3-3: Longitudinal Seams in Penstock No.1 Section 16

Figure 3-4: Longitudinal Seams in Penstock No.1 Section 16

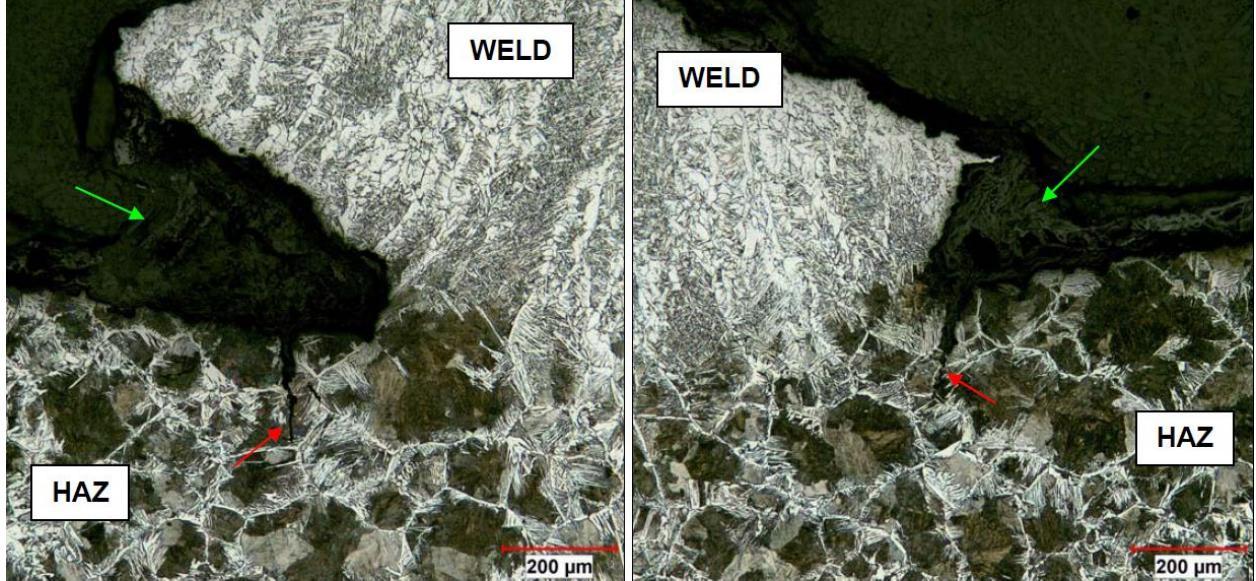
#### Figure 3-5: Coupon #1 Micro of Heat Affected Zone Transgranular Cracks

The macroetch and microetch of coupon #1 (longitudinal) show surface pitting corrosion and advanced stages of preferential pitting corrosion with cracks initiated from the cavities and are progressing through the heat affected zone.

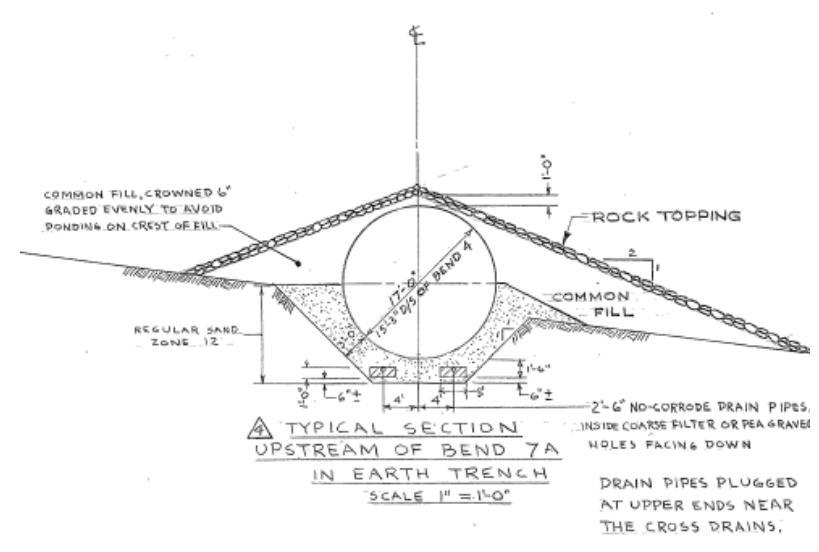
Figure 3-8: Drawing Half Trench as per "As Built" Drawing

The "As Built" drawing shows a detail that has cover thicknesses in multiple locations below 1 ft.

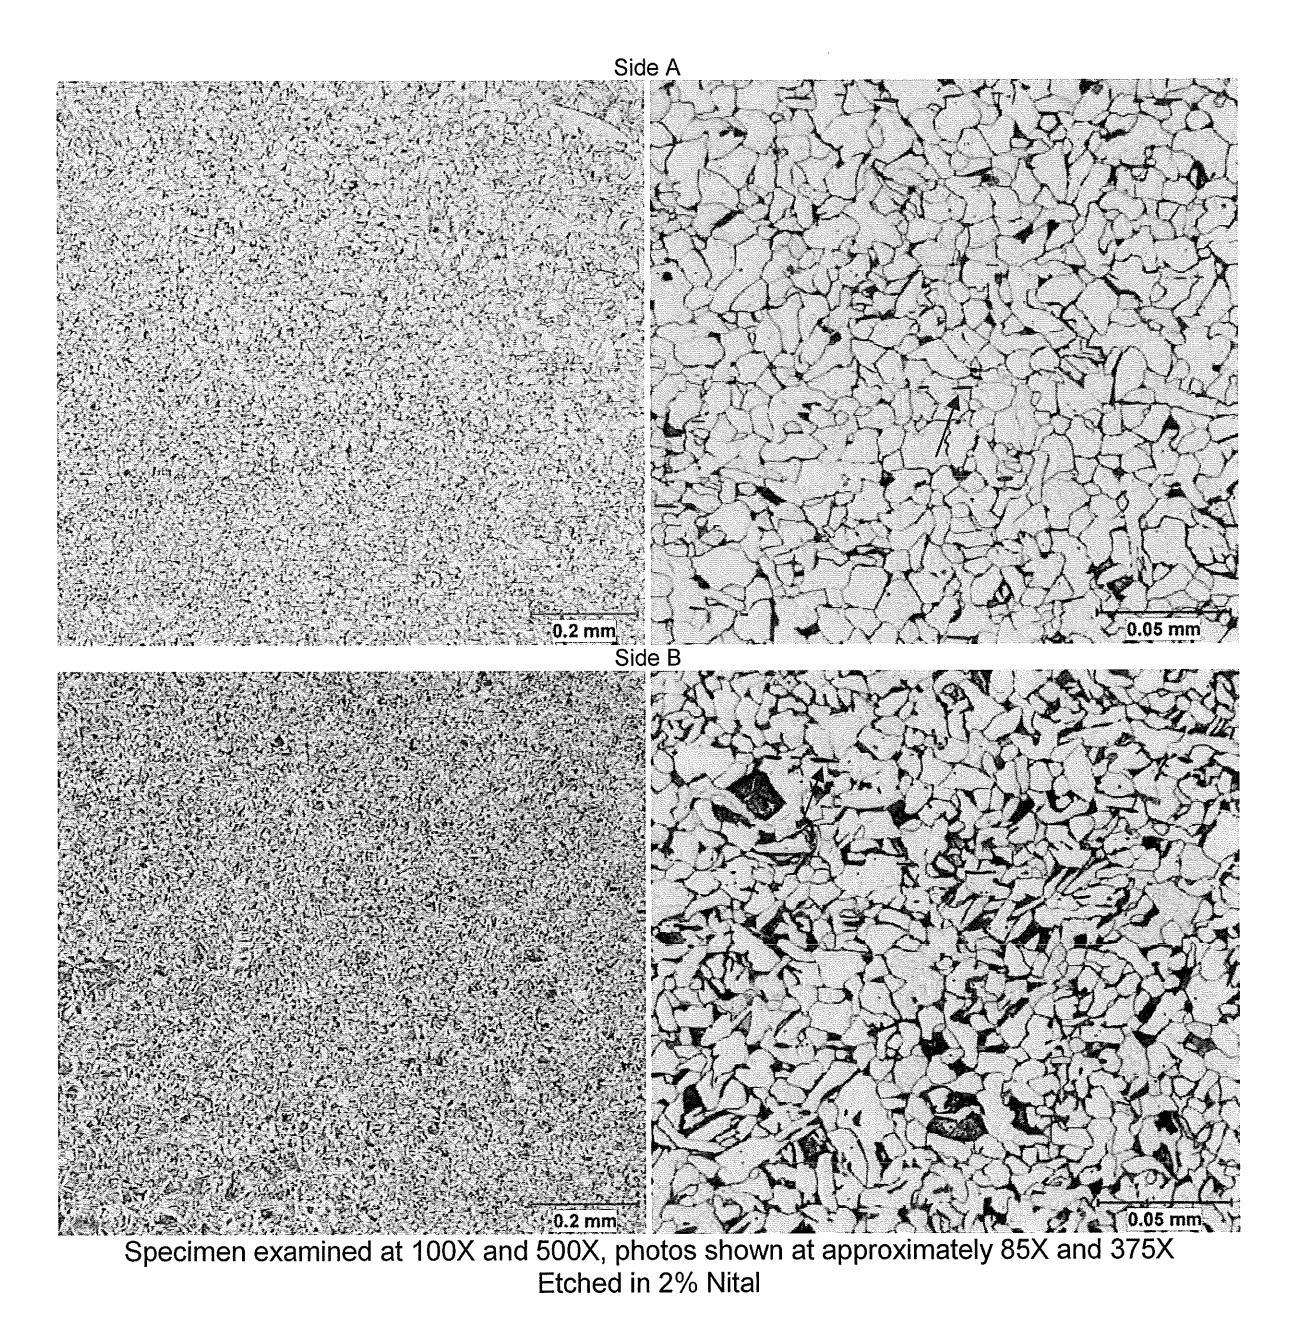
Figure 6: Photomicrographs of the Section 1 "Side A" and "Side B" weld coupon at the "FL +1" locations; where the HAZ microstructure showed a fairly uniform mixture of ferrite and pearlite, with a more refined grain size. At a higher magnification some sulphide inclusions were observed (refer to red arrows).

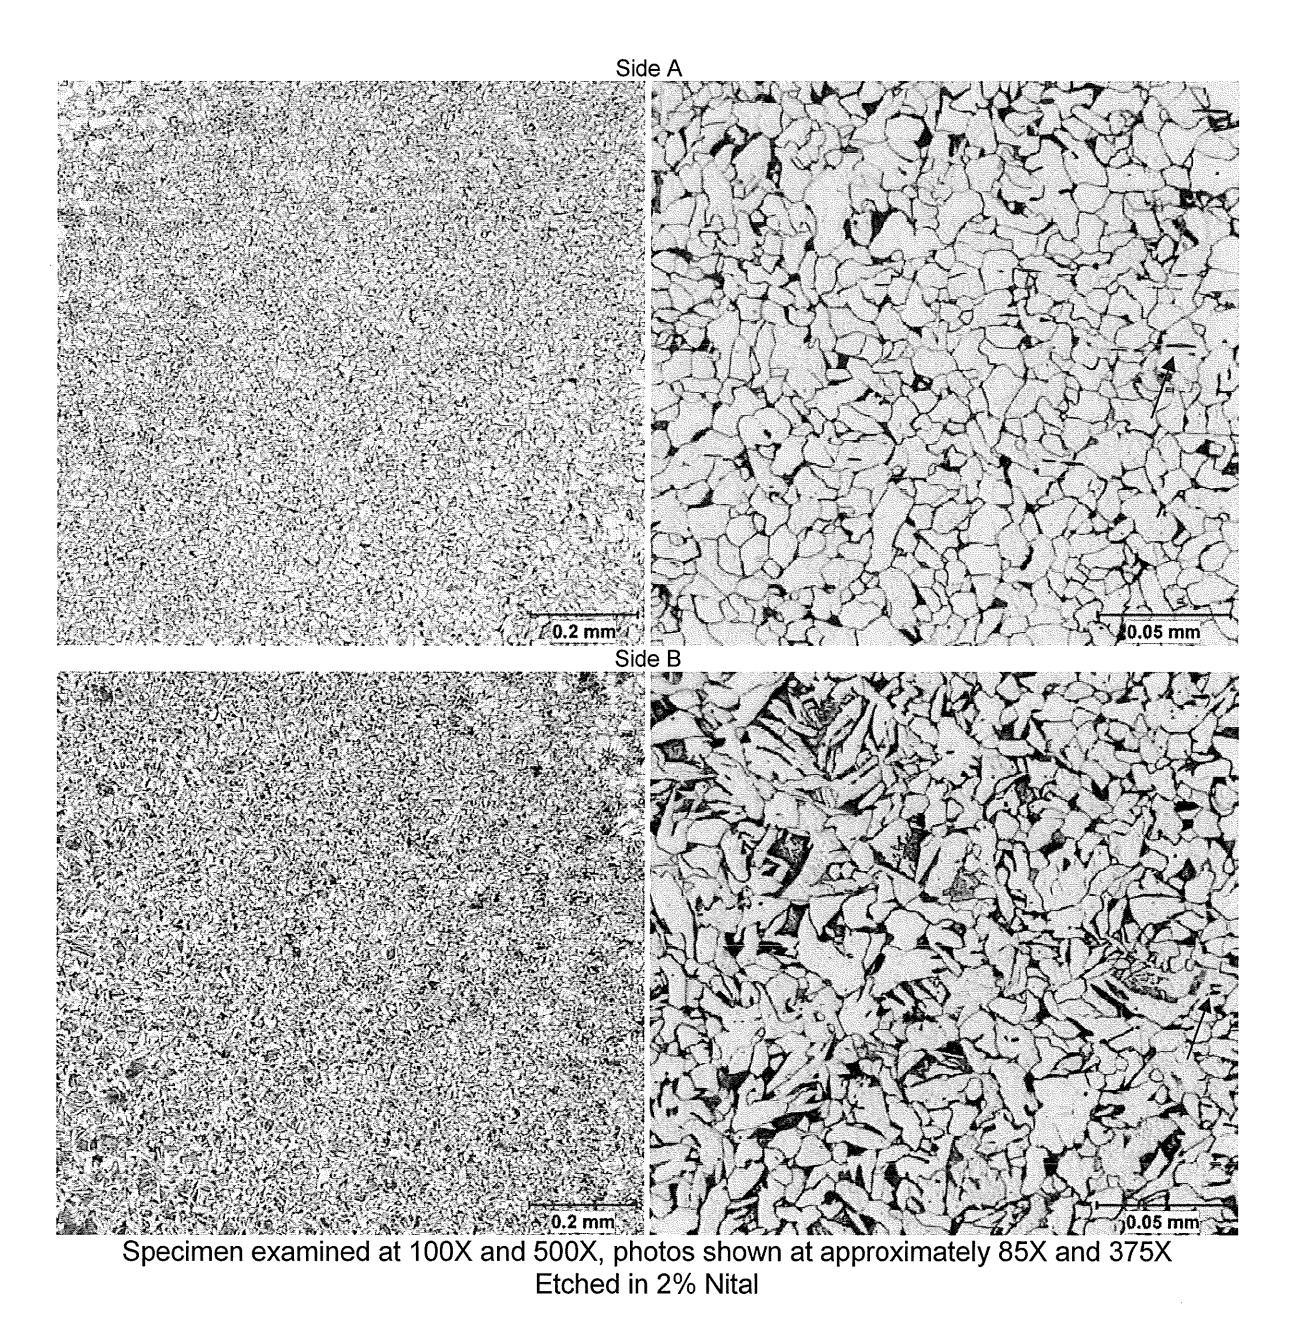
Figure 9: Photomicrographs of the Section 2 "Side A" and "Side B" weld coupon at the "FL +1" locations; where the HAZ microstructure showed a fairly uniform mixture of ferrite and pearlite, with a more refined grain size. At a higher magnification some sulphide inclusions were observed (refer to red arrows).

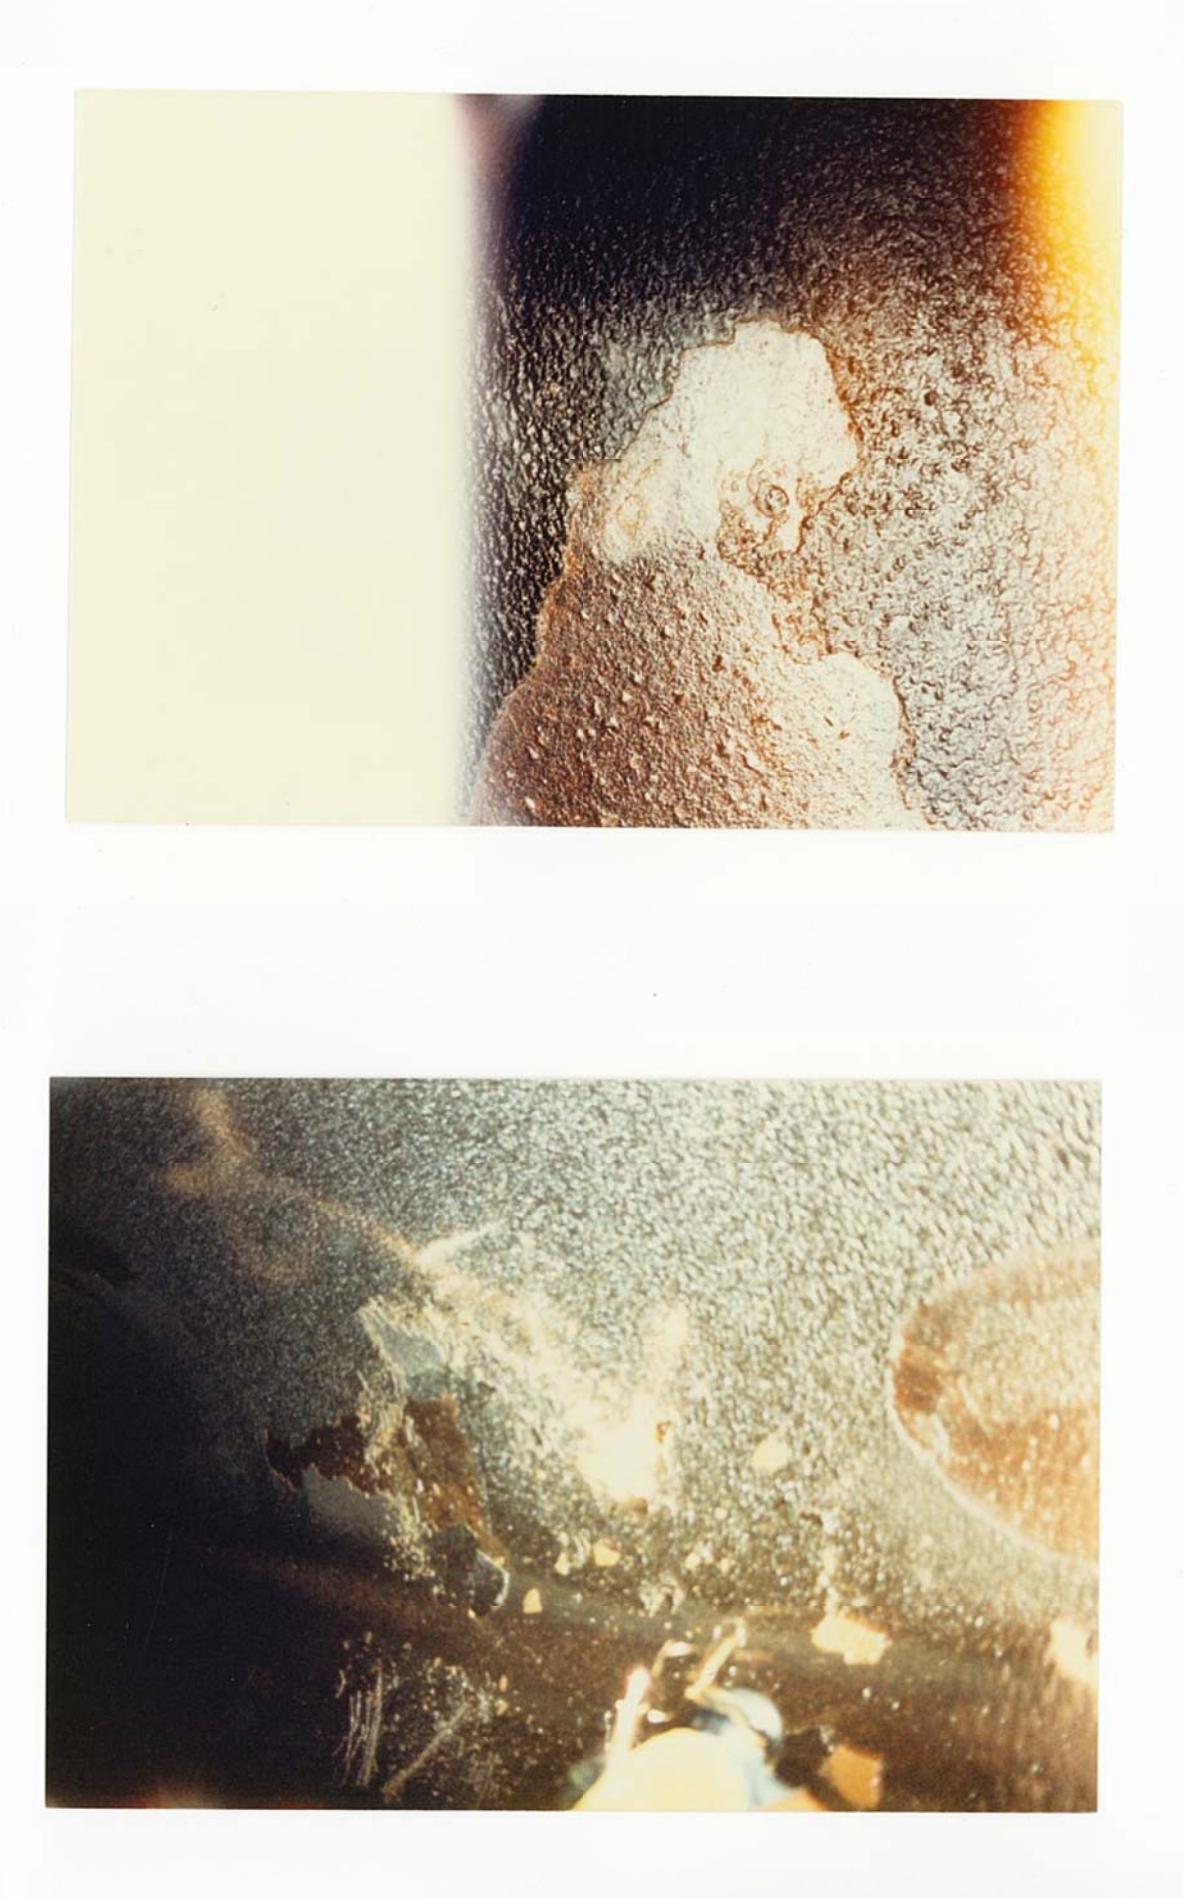
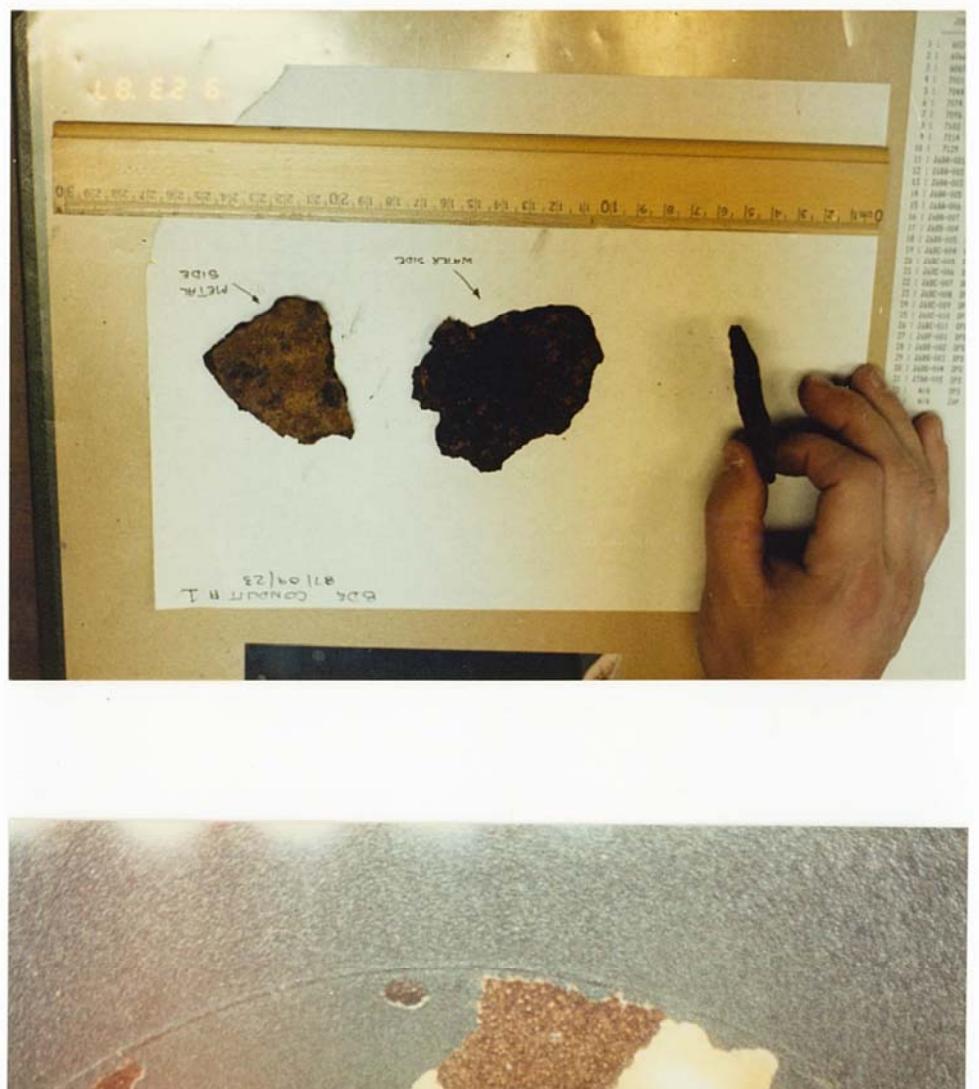
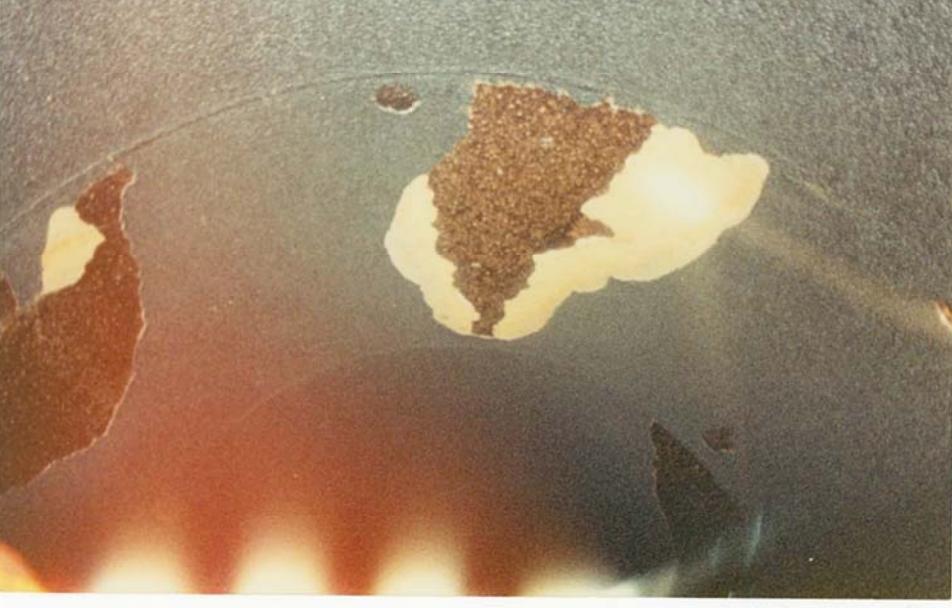
PHOTOGRAPHS OF #1 PRESSORE CONDUIT INTERIOR CONTING.

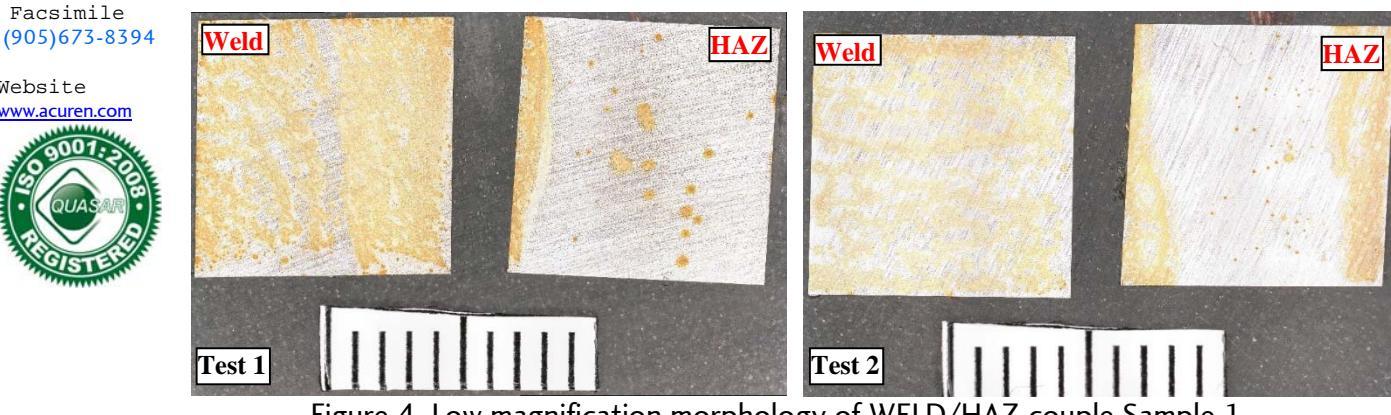
Figure 4. Low magnification morphology of WELD/HAZ couple Sample 1.

shown in Figure 4, HAZ was protected in both tests against the WELD. Based on the observations, it can be suggested that the weld has the least corrosion resistance in the galvanic setup and BM shows the best corrosion resistance.

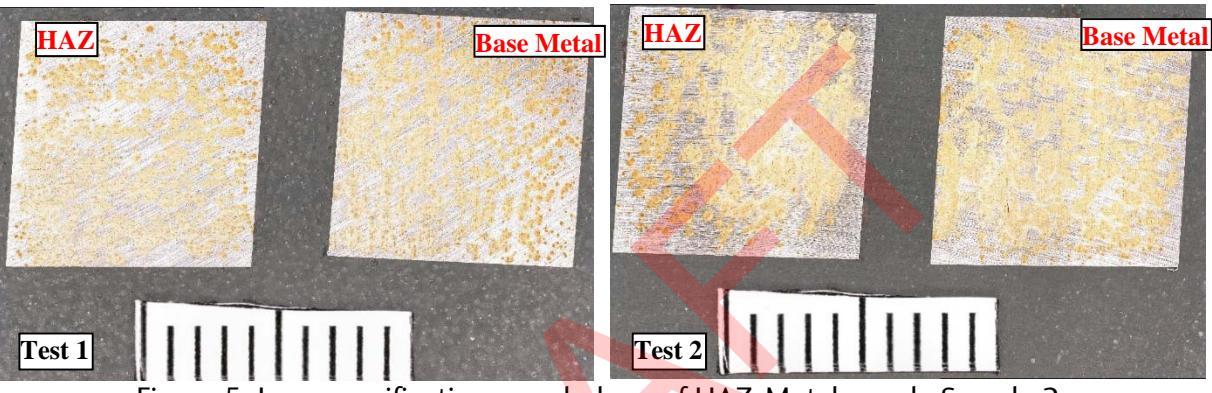
Figure 5. Low magnification morphology of HAZ-Metal couple Sample 2.

Figure 5 suggests that both HAZ and BM were corroded in both tests. For WELD/BM couple, both parts were corroded in both tests as shown in Figure 6. Figure 7 depicts that both WELD and HAZ regions were corroded in both tests. In total, it appears that none of the three regions is protected against one another, and pitting corrosion is a major feature on the surfaces of all samples.

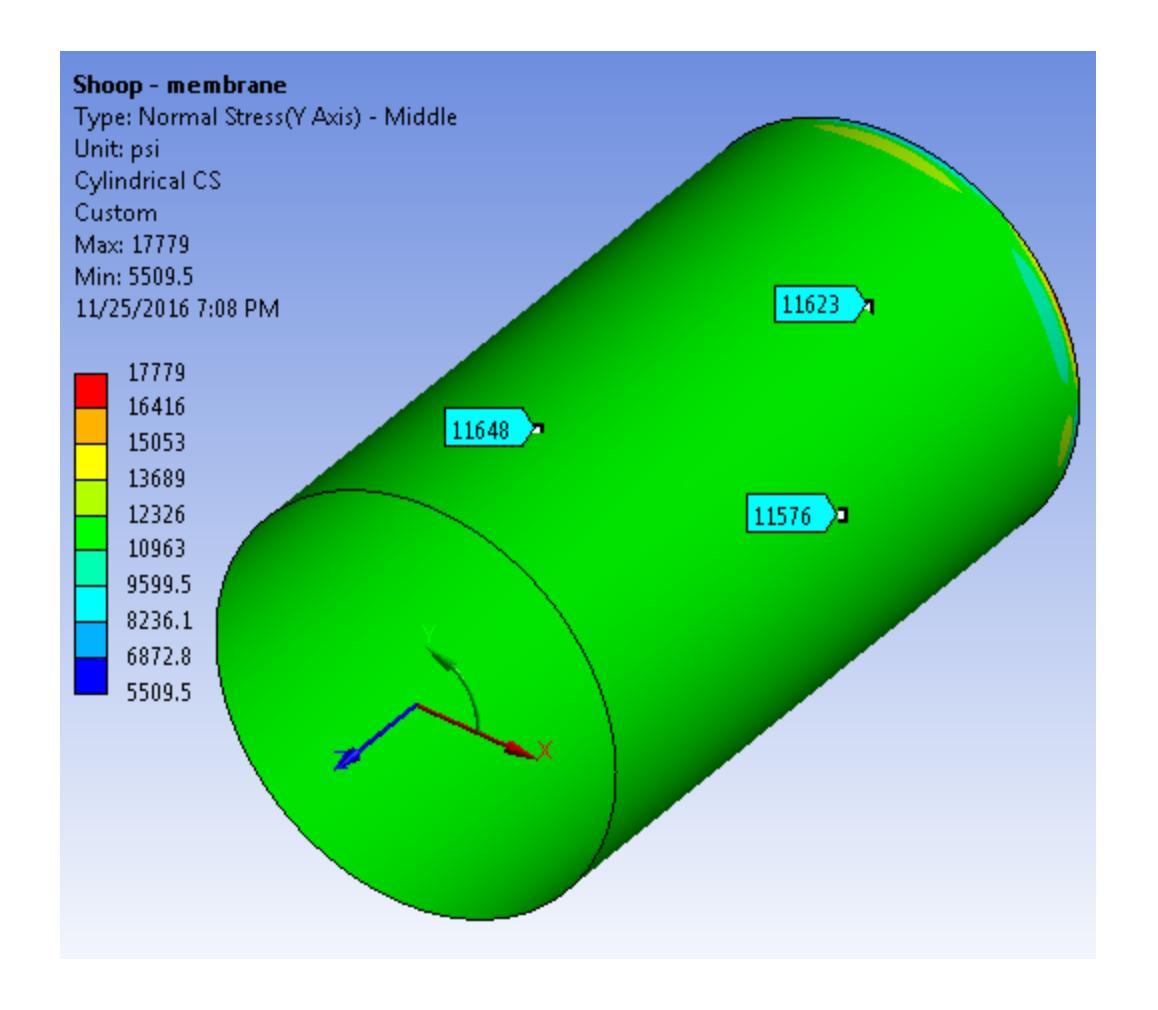
**Figure 16**: LS1 - Membrane hoop stress. Allowable for continuous plate  $Sa_{pA285} = 20000 \cdot psi$ . Ignore minor spikes at the boundary. No overstress.

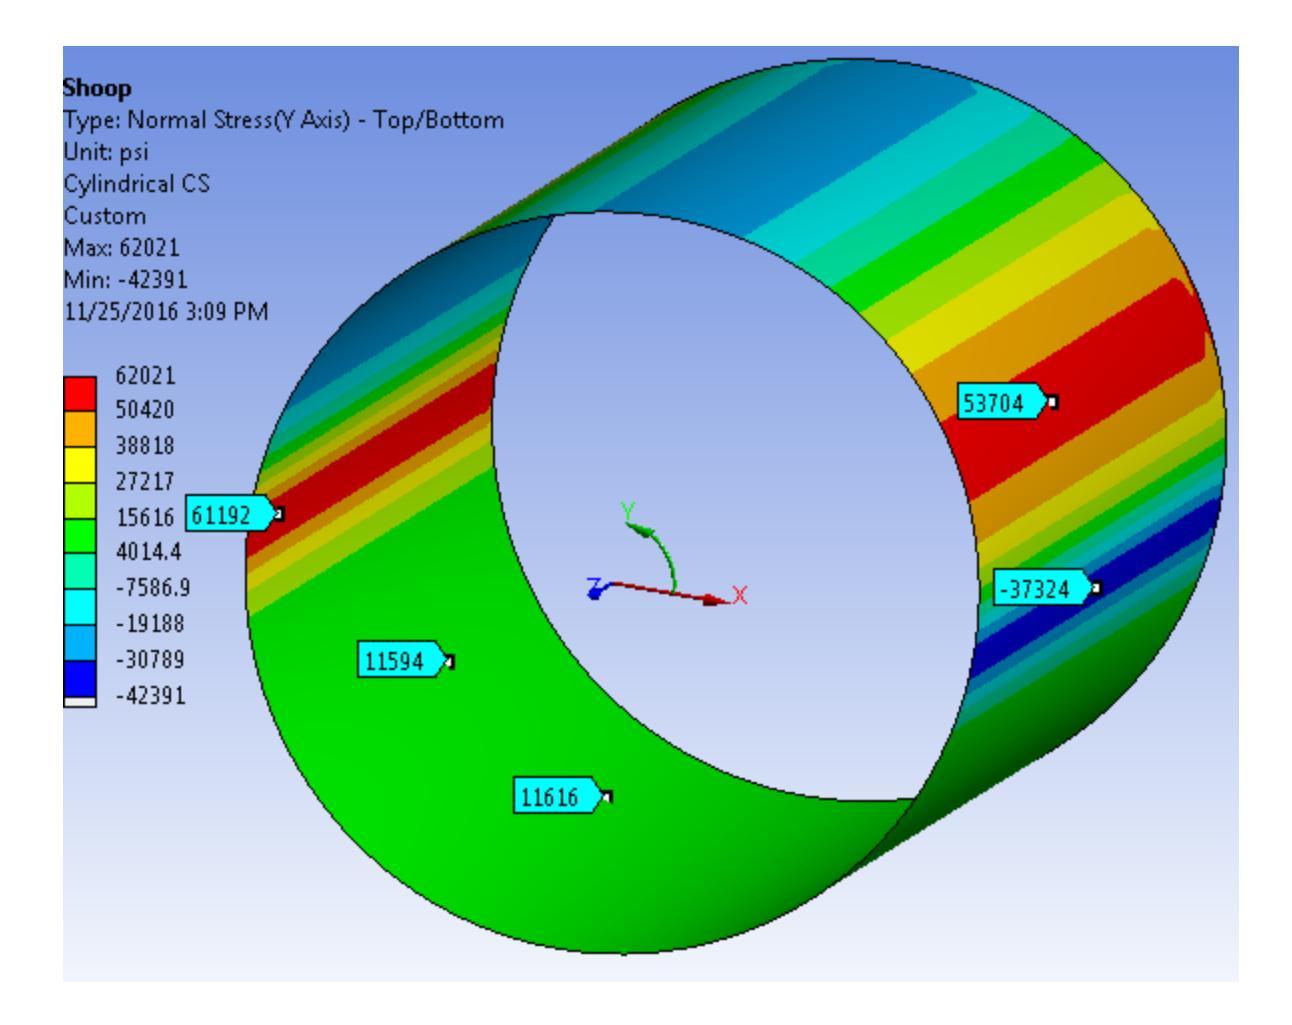
**Figure 17**: LS1 - Total hoop stress. Allowable for continuous plate  $Sa_{A285I} = 30000$  psi. 100% overstress, more if longitudinal welded joint efficiency at 3 and 9 o'clock is taken into account.

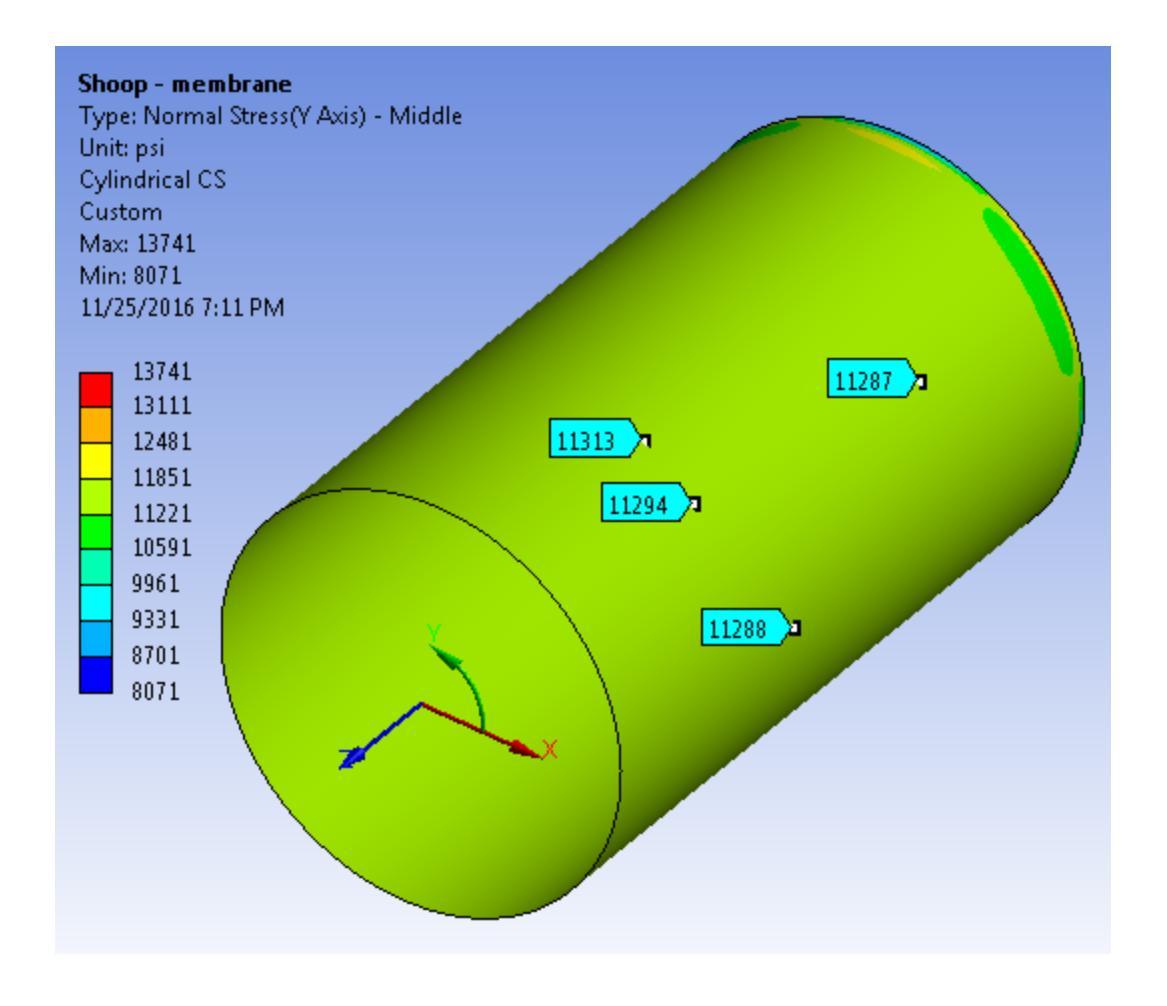
**Figure 18**: LS2 - Membrane hoop stress. Allowable for continuous plate  $Sa_{pA285} = 20000 \cdot psi$ . Ignore minor spikes at the boundary. No overstress.

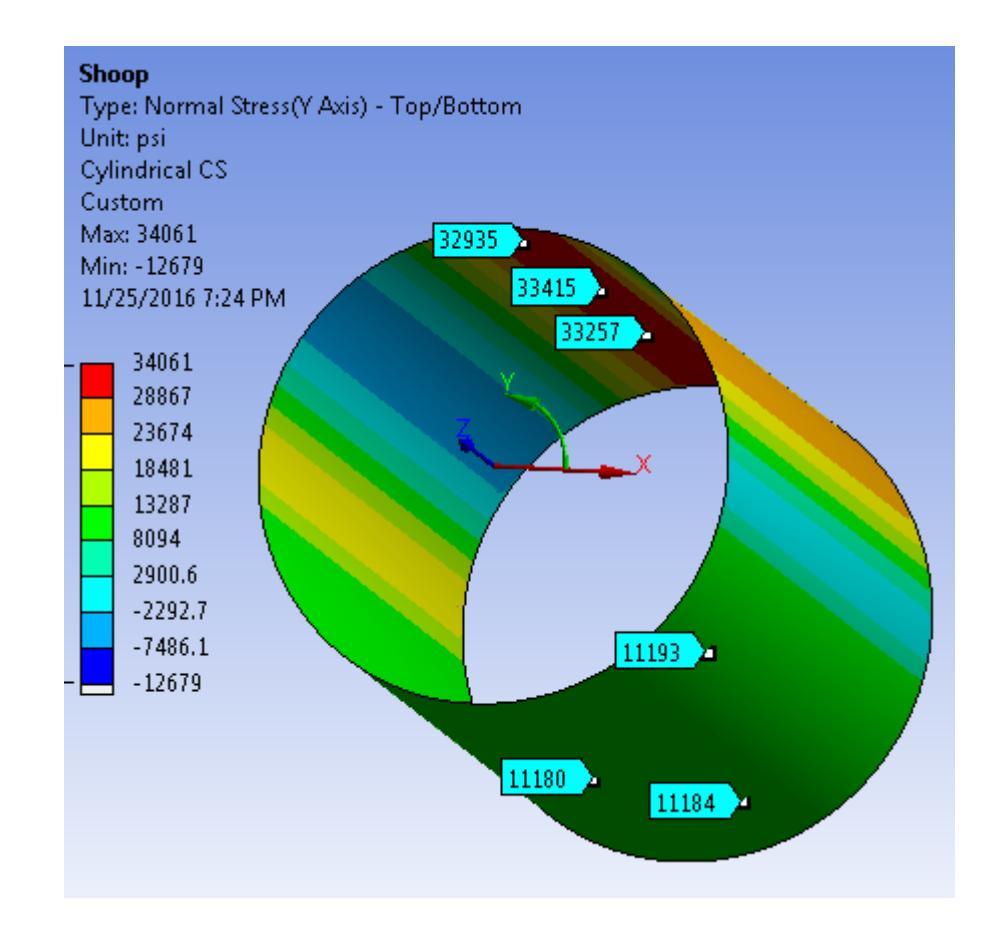
Figure 19: LS2 - Total hoop stress. Allowable for continuous plate  $Sa_{|A285|} = 30000 \cdot psi$ . 12% overstress.

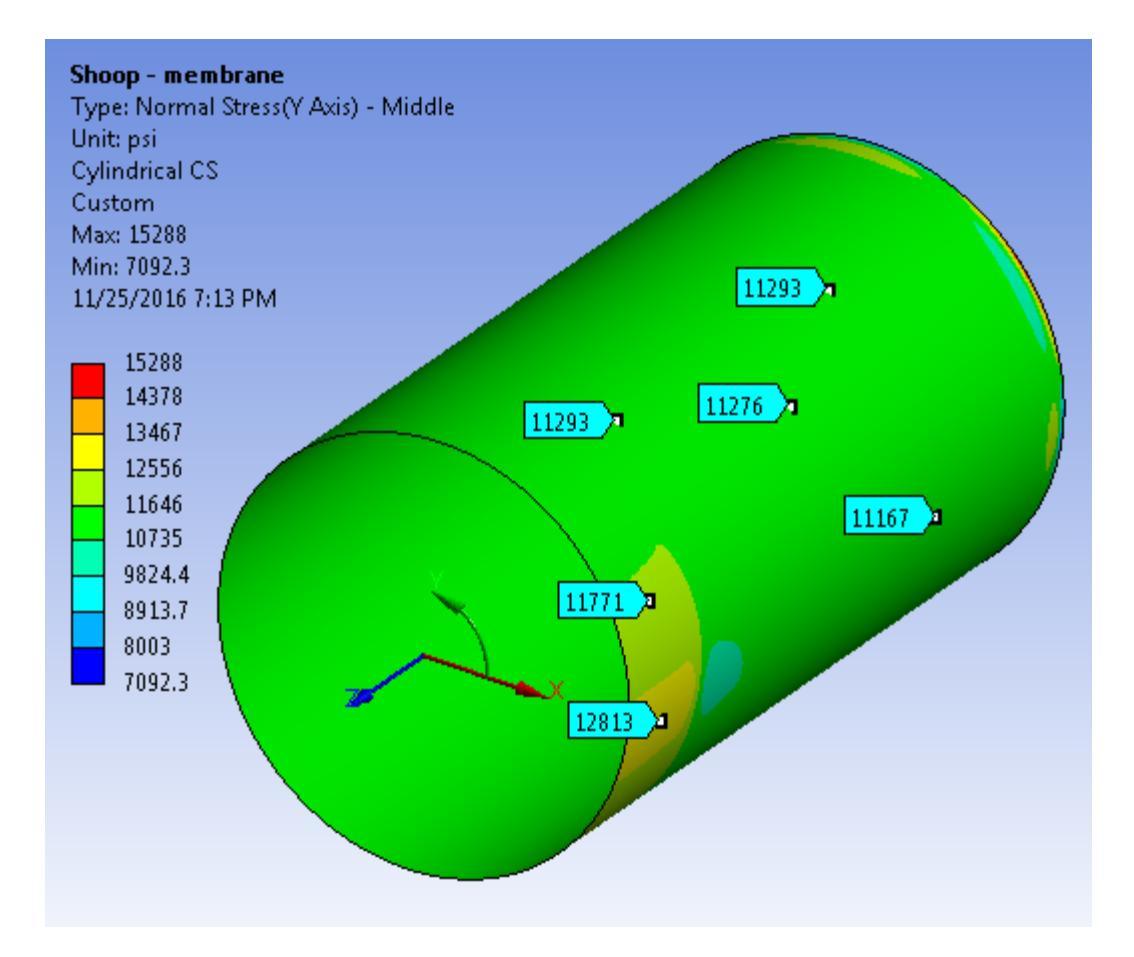
**Figure 20**: LS3 - Membrane hoop stress. Allowable for continuous plate  $Sa_{pA285} = 20000 \cdot psi$ . Ignore minor spikes at the boundary. No overstress.

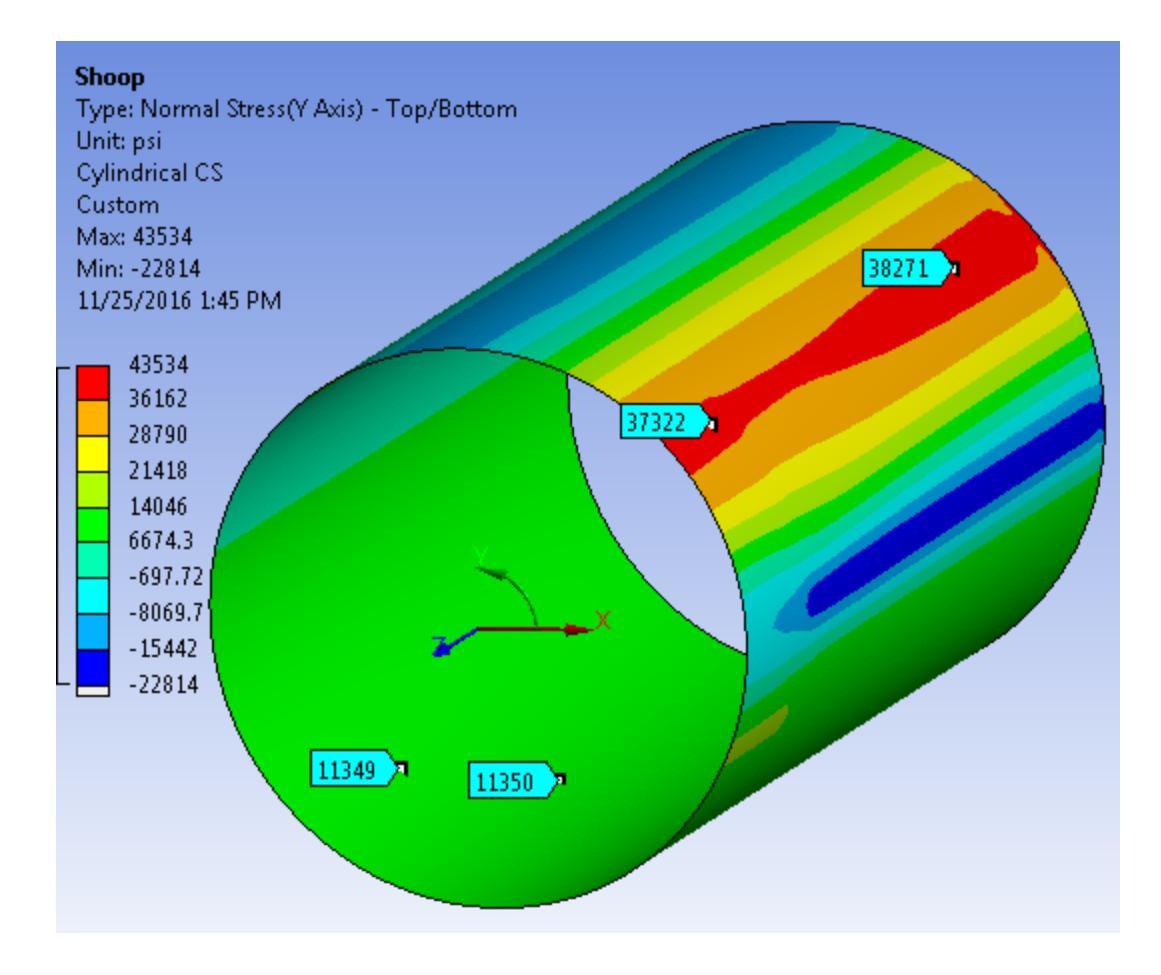
**Figure 21**: LS3 - Total hoop stress. Allowable for continuous plate  $Sa_{A285I} = 30000$  psi. 45% overstress, more if longitudinal welded joint efficiency at 3 o'clock is taken into account.

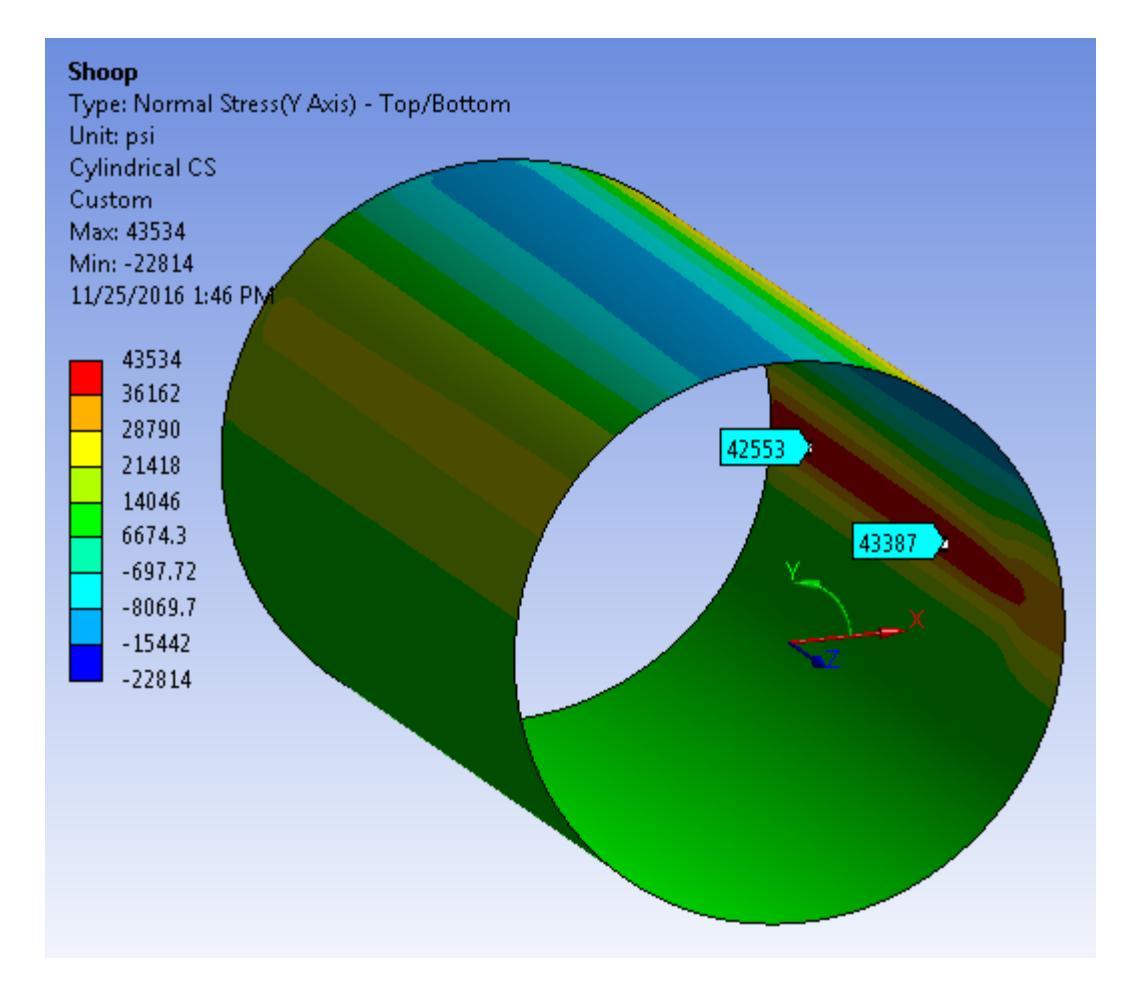
**Figure 22**: LS3 - Total hoop stress. Allowable for continuous plate  $Sa_{A285I} = 30000$  psi. 45% overstress, more if longitudinal welded joint efficiency at 3 o'clock is taken into account.
