**Re: Newfoundland and Labrador Hydro - 2017 General Rate Application
Information Item #16 - The Liberty Consulting Group Report: Analysis of Newfoundland
Island Interconnected System Power Supply Adequacy for the Winter of 2018-19**

**Analysis of
Newfoundland Island Interconnected System
Power Supply Adequacy for the
Winter of 2018-19**

The Liberty Consulting Group

August 30, 2018

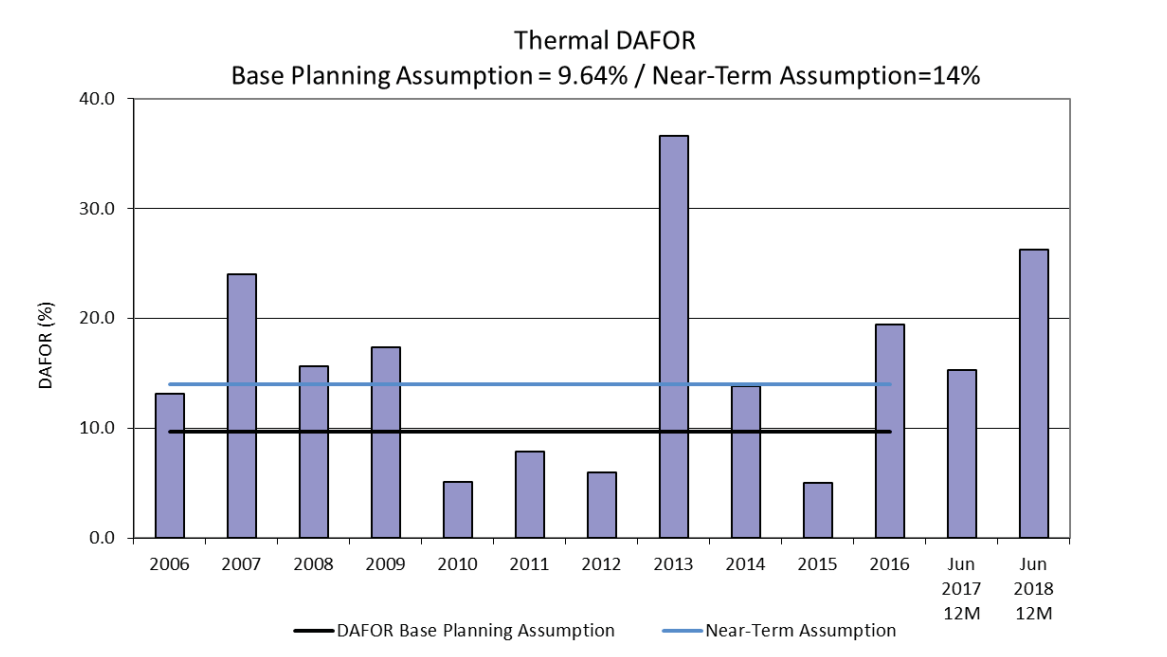
Figure 2: Thermal DAFOR

1 For the 12-month period ending June 31, 2018, the weighted DAFOR of 26.22% for all thermal
 2 units is above the assumed Hydro generation base planning DAFOR value of 9.64%, and the
 3 near-term assumption of 14.00%.⁷ Unit 1 DAFOR was 32.30% and Unit 2 DAFOR was 26.62%.
 4 The performance for both Units 1 and 2 was above the base planning assumption of 9.64% and
 5 the near-term assumption of 15% (Unit 1) and 10% (Unit 2). Unit 3 DAFOR was 16.60%, which
 6 is above the base planning assumption of 9.64% but below the near-term assumption of 18.0%.

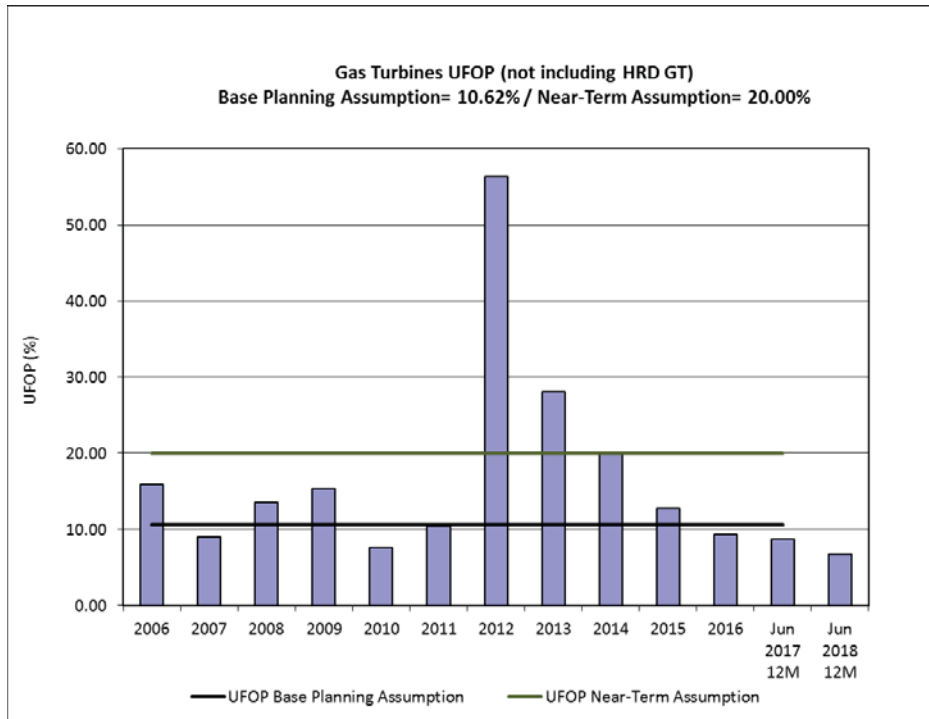
Figure 3: Gas Turbine UFOP – HWD/HVY/SVL Units

1 On September 16, 2017, the Happy Valley gas turbine tripped when attempting a black start of
2 the unit to support an unplanned outage in the Happy Valley area. Hydro's investigation found
3 that the cause of the trip was related to the operation of a voltage protection relay in the
4 terminal station. Upon review of the relevant procedures, drawings and settings it was
5 determined that a setting change was required to the protection relay. The setting was
6 changed and the unit was returned to service on September 21, 2017. During the investigation,
7 it was found that prior to the trip the power turbine had developed higher than normal
8 vibration, though it was not the cause of the trip. Further investigation of the higher than
9 normal vibration found the source to be a high temperature exhaust gas leak from the power
10 turbine. Repairs were made and vibration levels returned to normal on October 7, 2017.

11
12 On October 15, 2017 the Happy Valley gas turbine experienced a trip while operating at near
13 full load. Hydro's investigation determined that the trip was the result of the failure of an
14 emergency fuel shut-off valve solenoid. The failure of the solenoid caused the 3-way valve to
15 divert a portion of fuel away from the engine, as is its design. The reduced fuel flow was not
16 able to sustain the required load and resulted in the unit shutting down. A replacement
17 solenoid was sourced and repairs made with the engine released for service on November 9,
18 2017.

19
20 On May 13, 2018 the Hardwoods gas turbine tripped while operating in synchronous condense
21 mode due to a system under voltage and current phase imbalance. The alternator experienced
22 excessive vibration when attempting to restart the Unit on May 14, 2018. Extensive mechanical
23 and electrical testing was conducted on the alternator to determine its condition, with no
24 damage found prior to returning it to service on June 2, 2018.

25
26 On June 13, 2018 the Hardwoods gas turbine tripped due to excessive alternator vibration
27 while being returned to service after a planned maintenance outage. Inspection of the Unit
28 determined that cause of the vibration was a loss of lube oil due to a faulty check valve in the
29 lube oil supply piping to one of the alternator bearings. The bearing which had the faulty check

1 valve was found to be damaged and required replacement with a spare bearing. The Unit was
2 released for service on June 30, 2018.

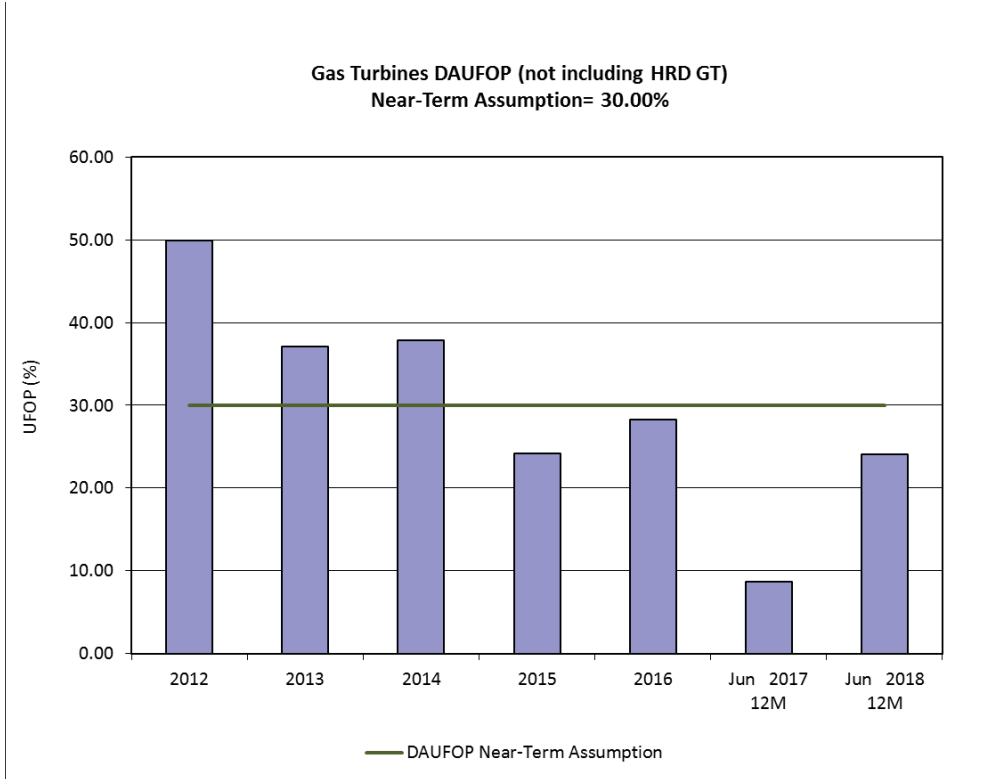
Figure 5: Gas Turbine DAUFOP – HWD/HVY/SVL Units

1 The Stephenville gas turbine DAUFOP for the period was impacted by the unavailability of End A
2 as a result of an exhaust bellows failure at Hardwoods gas turbine End A on December 28, 2017.
3 End A was unavailable at this time due to issues with the power turbine rear bearing which
4 requires the bearing to be replaced. Hydro decided to remove the bellows from End A at
5 Stephenville and install it at Hardwoods End A to return that Unit to full capacity. It is currently
6 expected that the Stephenville gas turbine will be returned to full capacity in August 2018.
7
8 The Hardwoods gas turbine DAUFOP for the period is impacted by the unavailability of End A
9 due to an exhaust bellows failure on May 28, 2018. End A remains unavailable with a planned
10 return to service at the end of July 2018.
