1. Hydraulic Generation Refurbishment and Modernization (2019-2020)

Hydraulic Generation Refurbishment and Modernization

July 2018

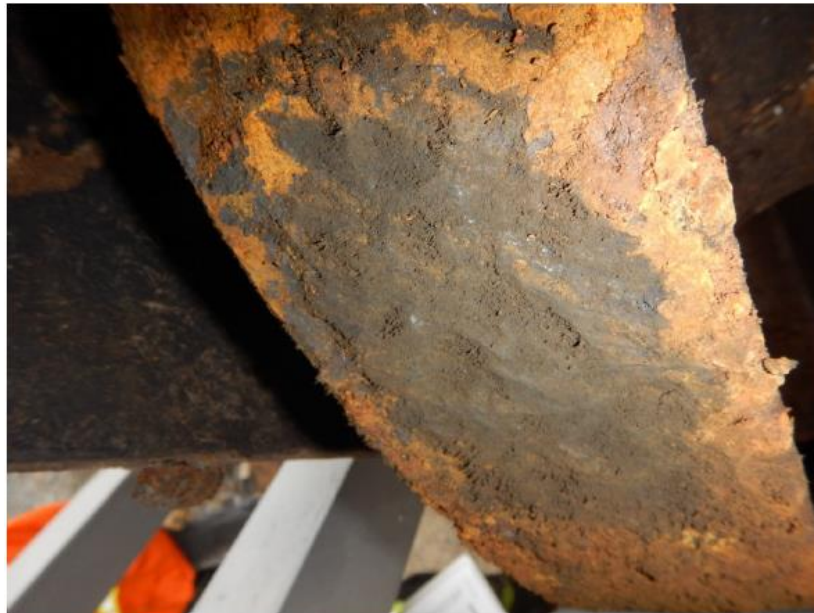
2 A detailed assessment of Bay d'Espoir Intake 1 was completed in 2016 and it was determined
3 that there were varying levels of deterioration, particularly in the submerged/embedded
4 components. Deterioration consists of concrete erosion and corrosion on embedded parts/
5 gate components. Critical components that have shown deterioration include main rollers, roll
6 paths, side-rollers and seals. It was also noted that the deterioration of these components is
7 creating extra stress on the hoist system. As these intakes are the same vintage, with similar
8 operating conditions and in the same environment, Hydro expects that the state of Intakes 2
9 and 3 are similar to the state of Intake 1 identified in 2016. Also, in 2013 Intake gate 2 failed to
10 close due to issues related to those identified for the Intake 1. Figure 5 and Figure 6 are images
11 of the side and main rollers on Intakes 2 and 1.

Figure 6: Pitting Corrosion on Main Rollers – Intake 1 2016

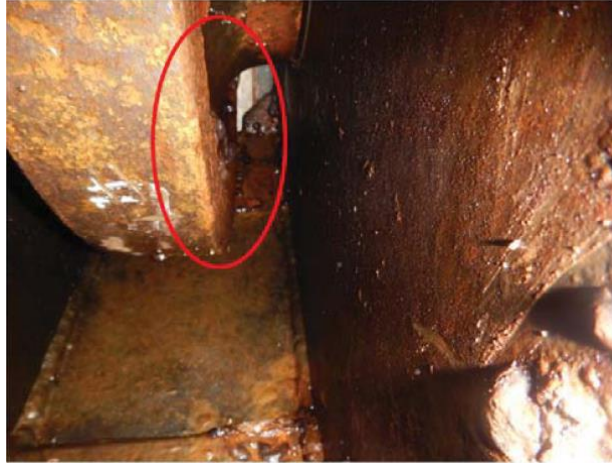
8 In 2017, a detailed condition assessment of the Ebbegunbaeg control structure was completed.
9 The assessment revealed operational issues with the gates, which include damage to the main
10 rollers, embedded parts and lifting systems. The assessment also identified concrete
11 deterioration on the piers, decking, and around the embedded parts. Figure 8, Figure 9, and
12 Figure 10 show some of the deteriorated conditions.

Figure 8: Roller Corrosion - Ebbegunbaeg

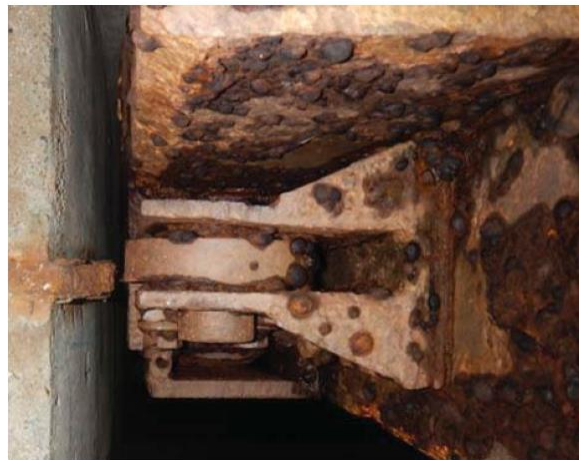
Figure 9: Seized Side Roller - Ebbegunbaeg

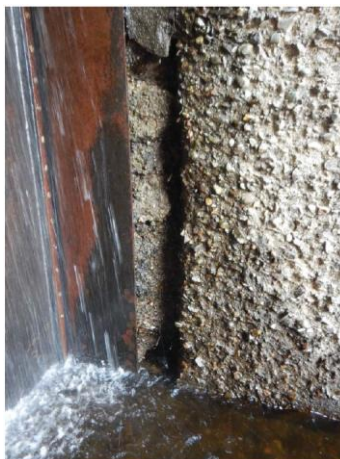
Figure 10: Concrete Deterioration - Ebbegunbaeg

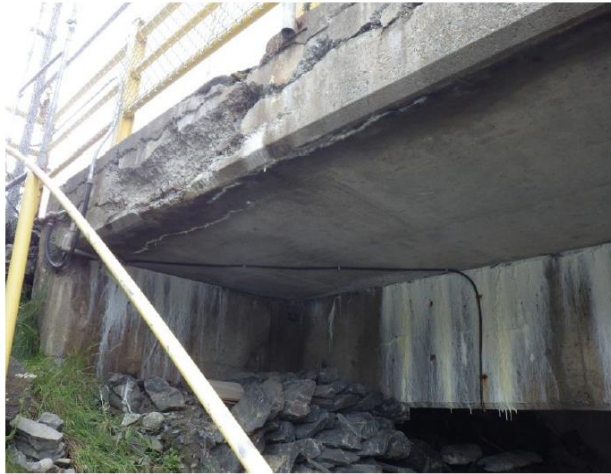
Figure 12: Deterioration on the Draft Tube Deck

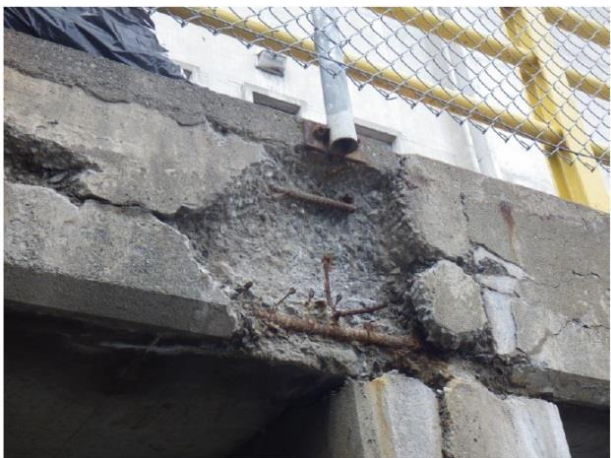
Figure 13: Deterioration on the Draft Tube Deck

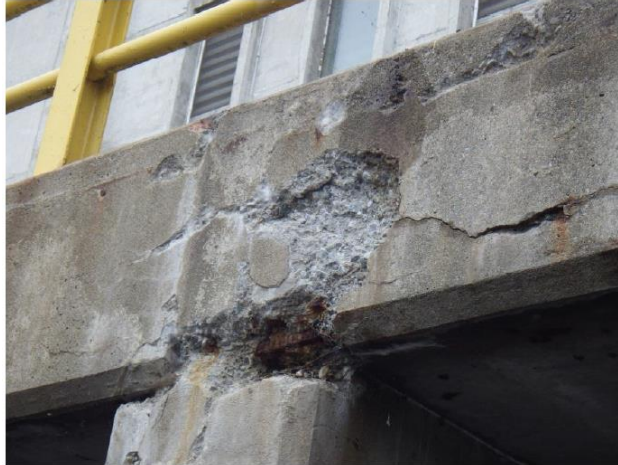
Figure 14: Deterioration on the Draft Tube Deck

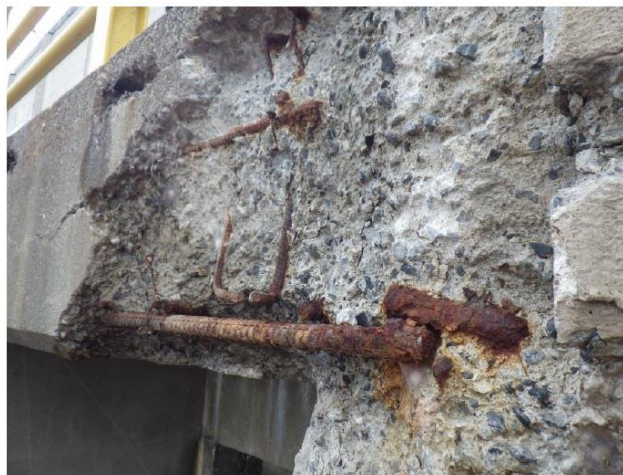
Figure 15: Deterioration on the Draft Tube Deck

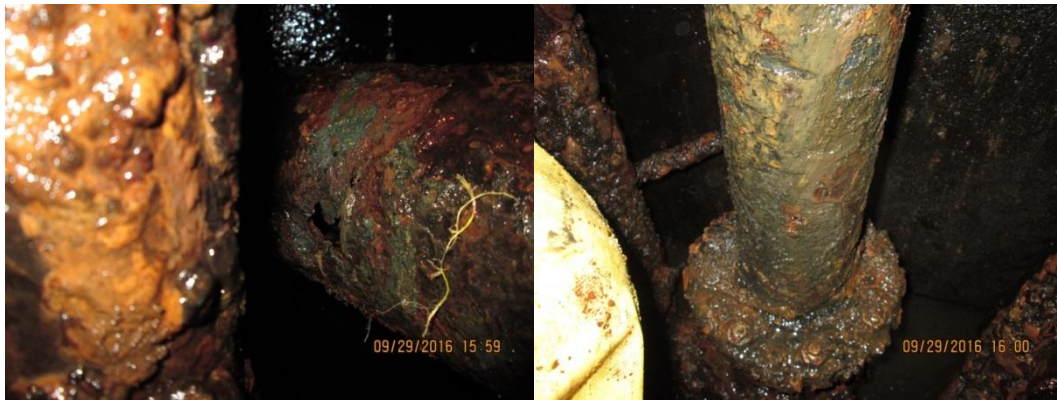
Figure 18: Corroded Component in the Paradise Sump

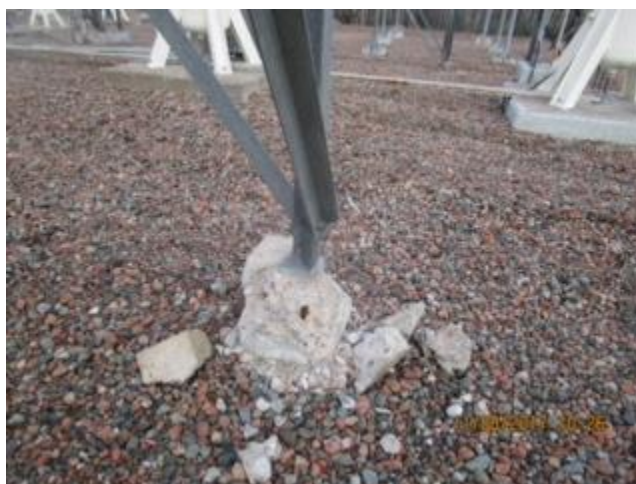
Figure 1: Compromised Foundation at Buchan's Terminal Station

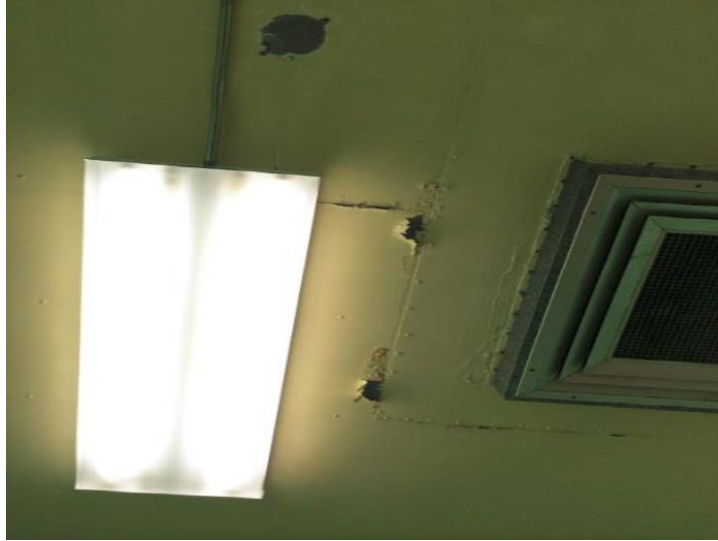
- 16 • Replace Roof System (Figure 2): Roof has reached end of expected service life, and is
17 displaying significant surface cracking. Evidence of leaking present.
- 18 • Exterior Doors (Figure 3): Exterior doors are heavily rusted and deteriorated.
- 19 • Other Upgrades: Hydro will address other issues such as failed HVAC equipment, battery
20 room ventilation, obsolete low voltage distribution equipment, and corroded water
21 service entry.

Figure 2: Leaking Roof at Holyrood

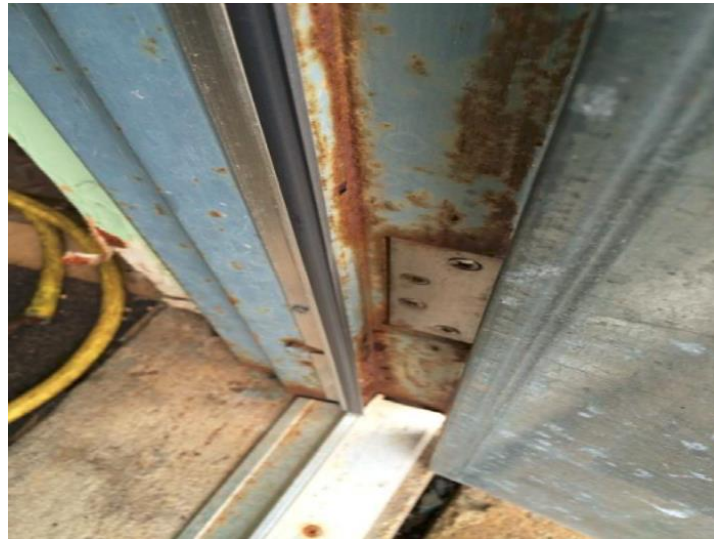
Figure 3: Rusted Doors at Holyrood

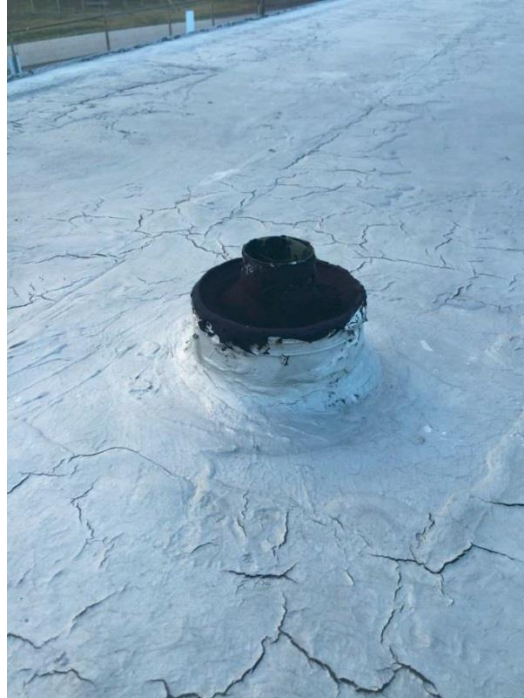
Figure 4: Roof Surface Cracking at Come By Chance

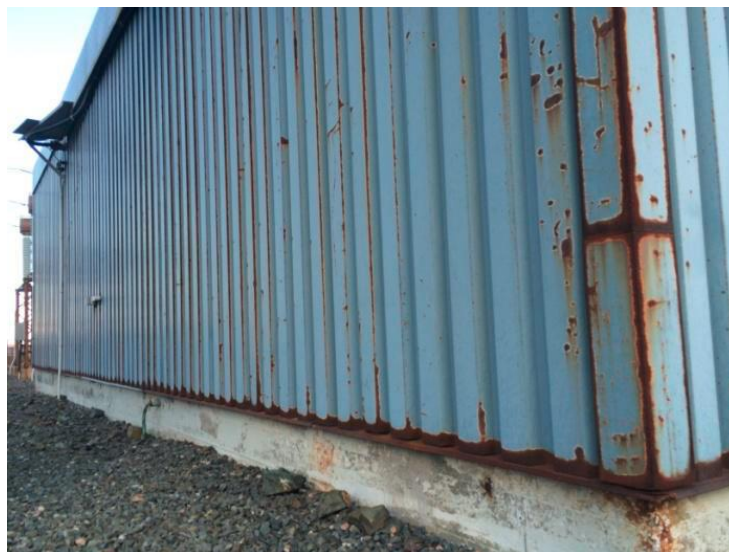
Figure 5: Rusting Exterior Cladding at Come By Chance

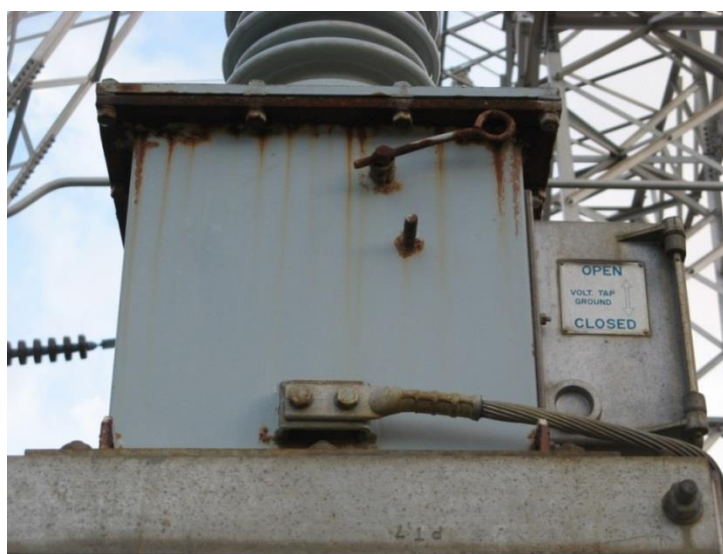
16
17 Physical deterioration involves conditions such as oil leaks, rusting, or small chips and cracks in
18 the insulation. Figure 2 shows an example of rusting on a PT tank.

Figure 2: Rusting on Potential Transformer

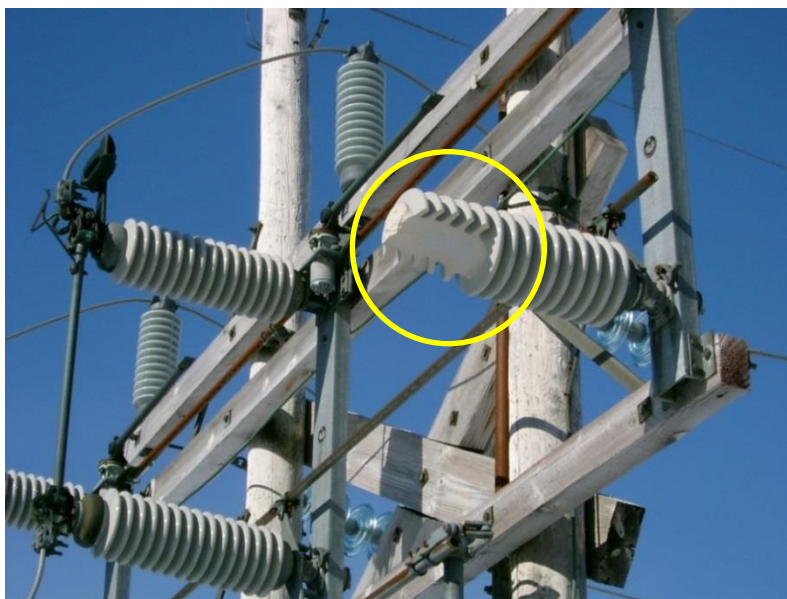
11
12 Figure 4 shows an example of a badly damaged disconnect switch.

Figure 4: Broken Insulator on 69 kV Disconnect Switch

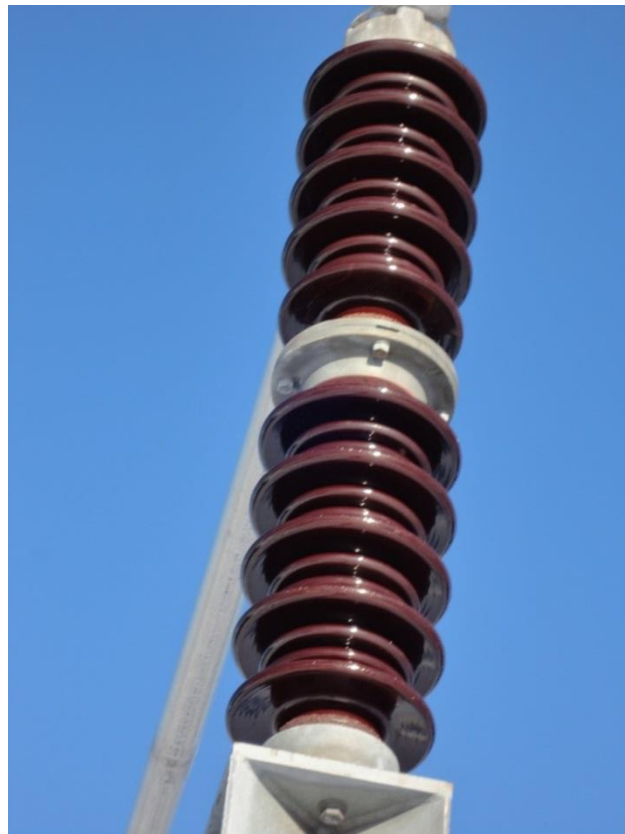
Figure 6: A Multi-cone type insulator prone to failure due to cement growth

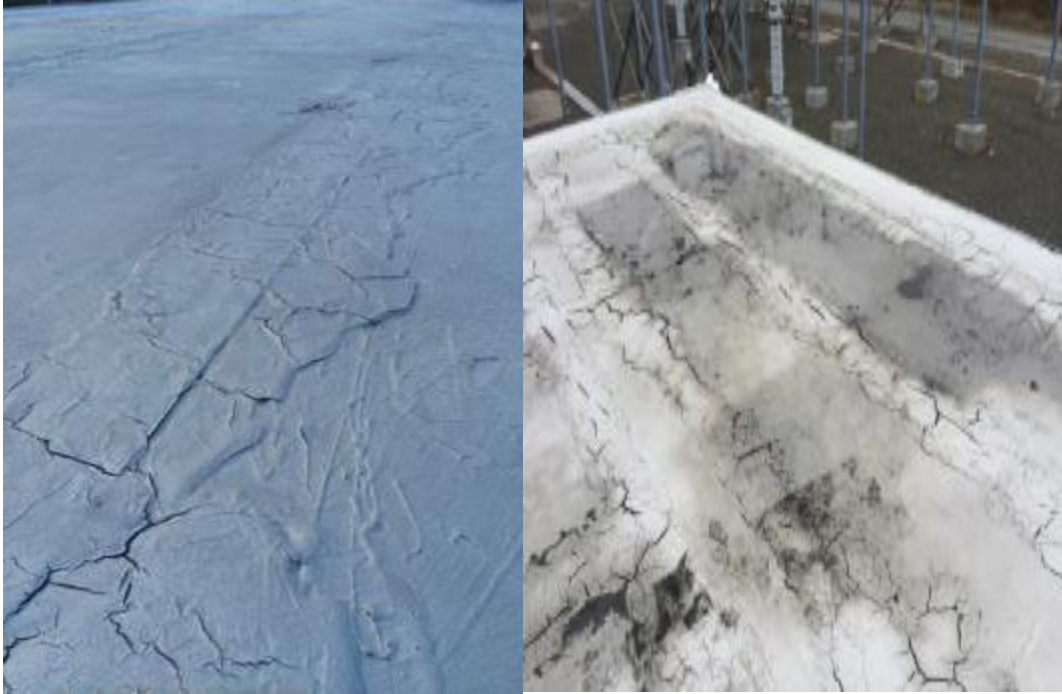
Figure 15: Terminal Station Control Buildings (Come By Chance and Sunnyside) showing cracking and deterioration of the roof membrane systems.

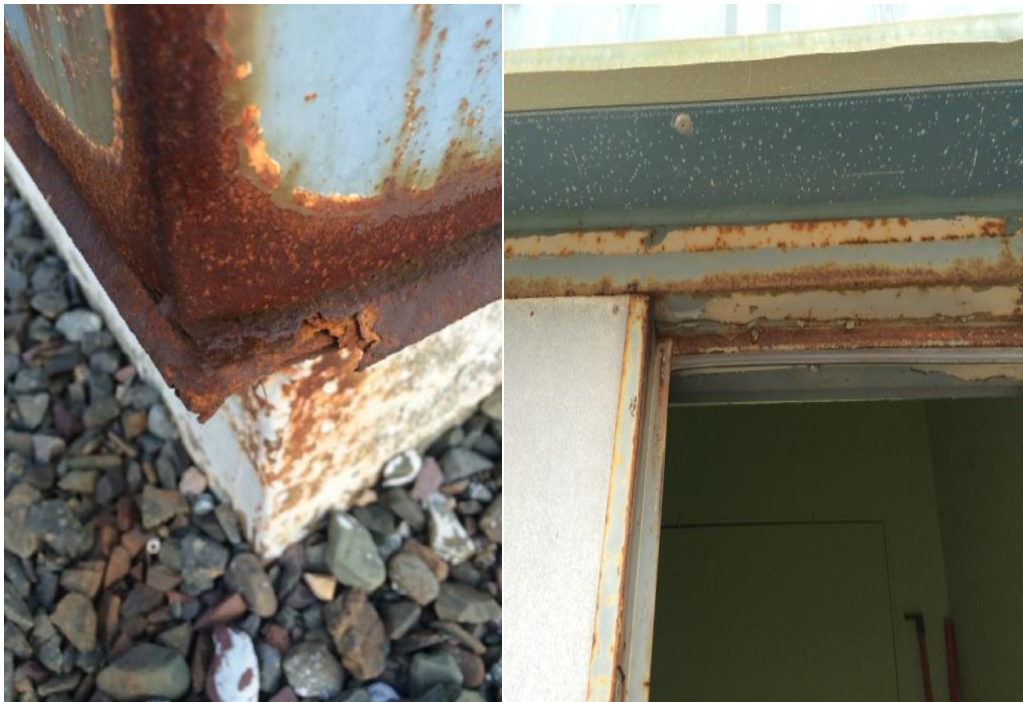
Figure 16: Building exterior cladding and doorways displaying severe rusting and deterioration

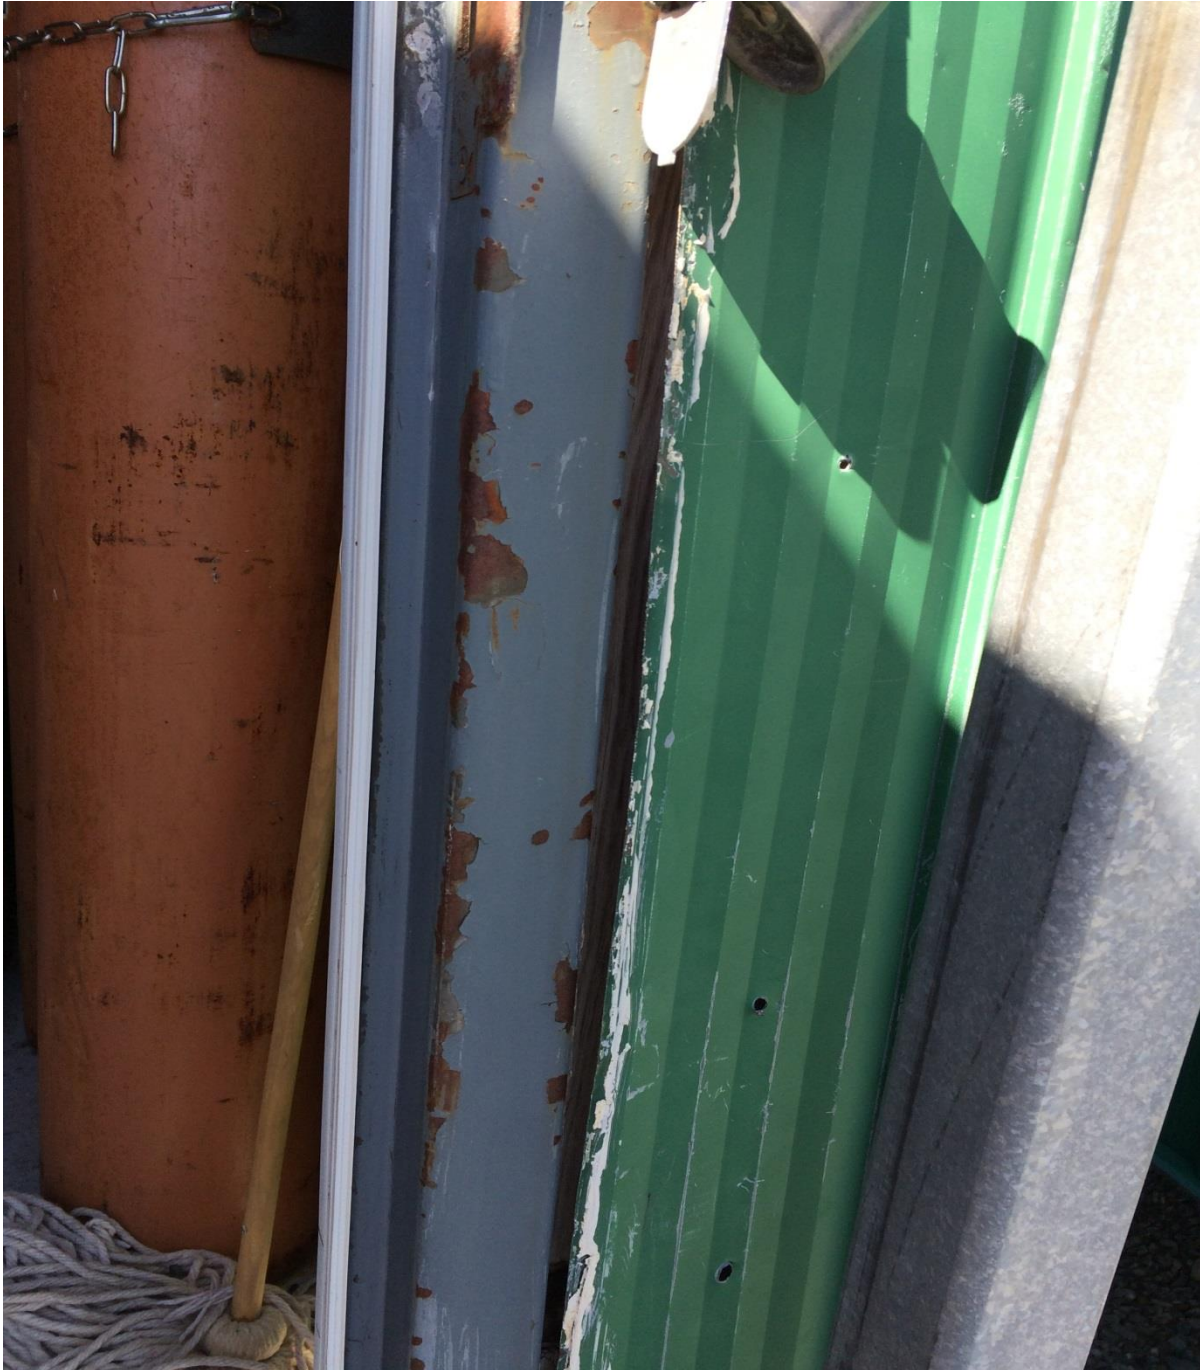
Figure 4: Gull Pond Hill – exterior metal siding – weathered, damaged, and separating from building

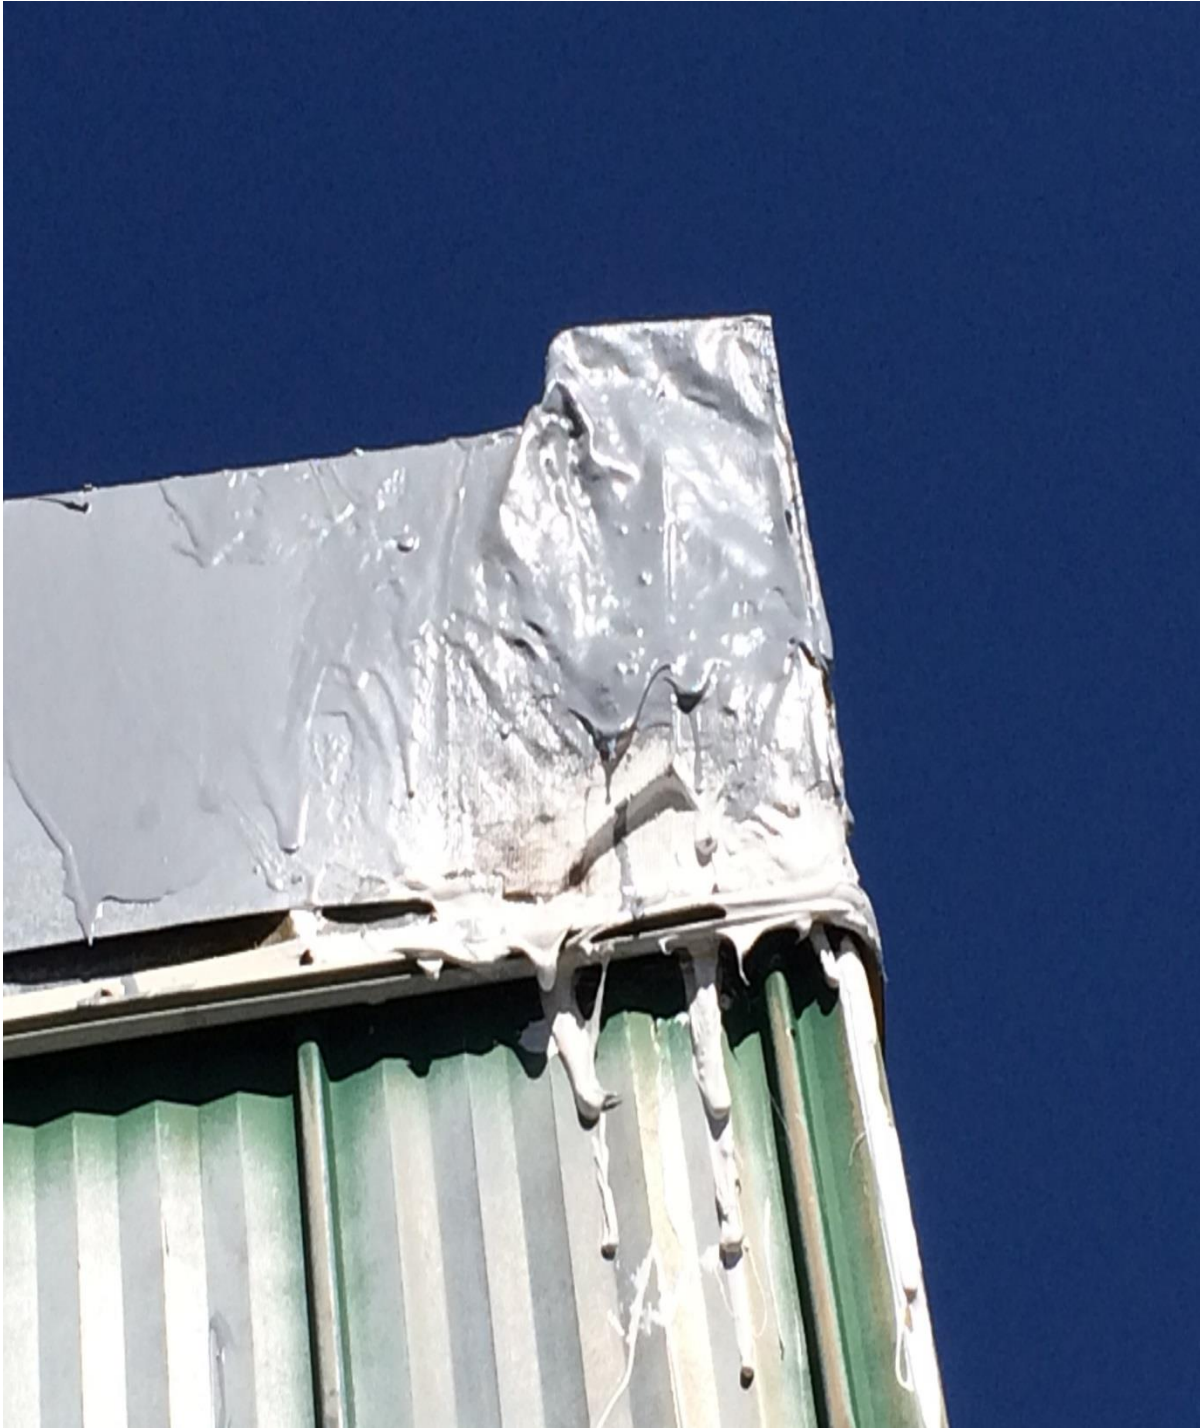
Figure 5: Gull Pond Hill – Temporary patching of metal roof to help prevent water entry

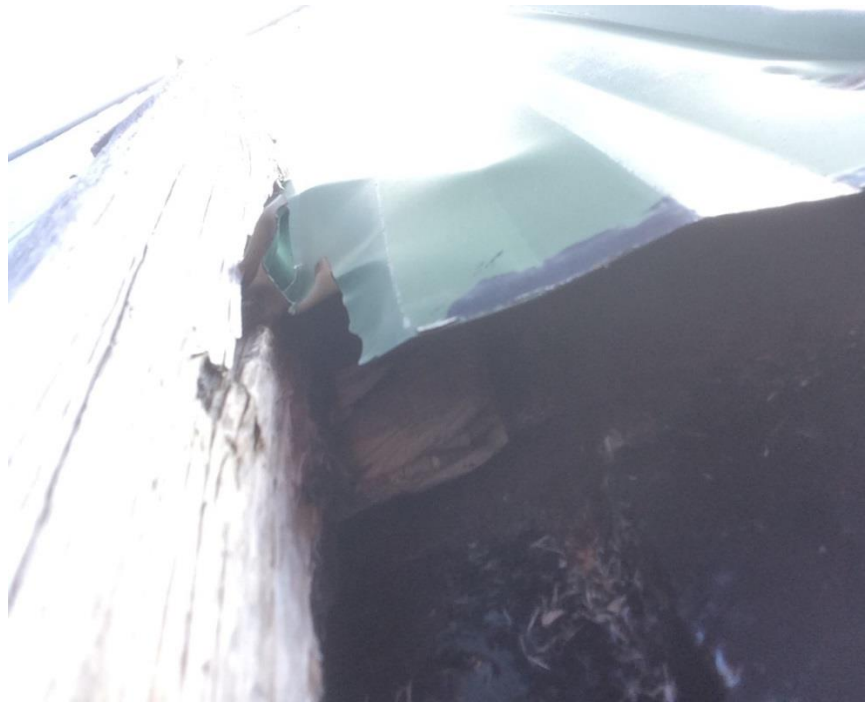
Figure 6: Gull Pond Hill – Damaged siding and exposed sheathing

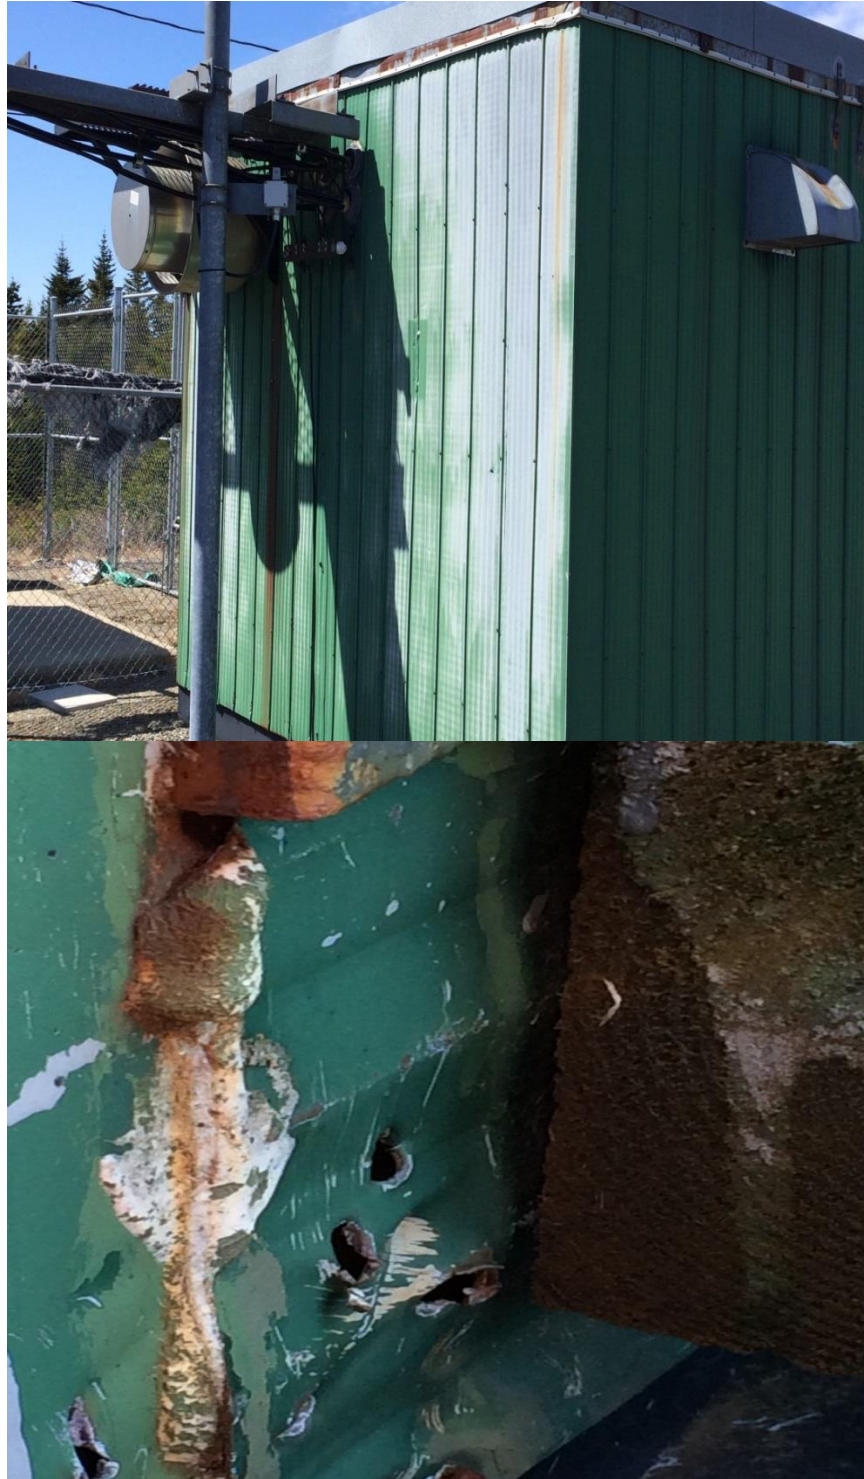
Figure 8A and 8B: Bay d’Espoir Hill – Deteriorated siding and rusted metal roof

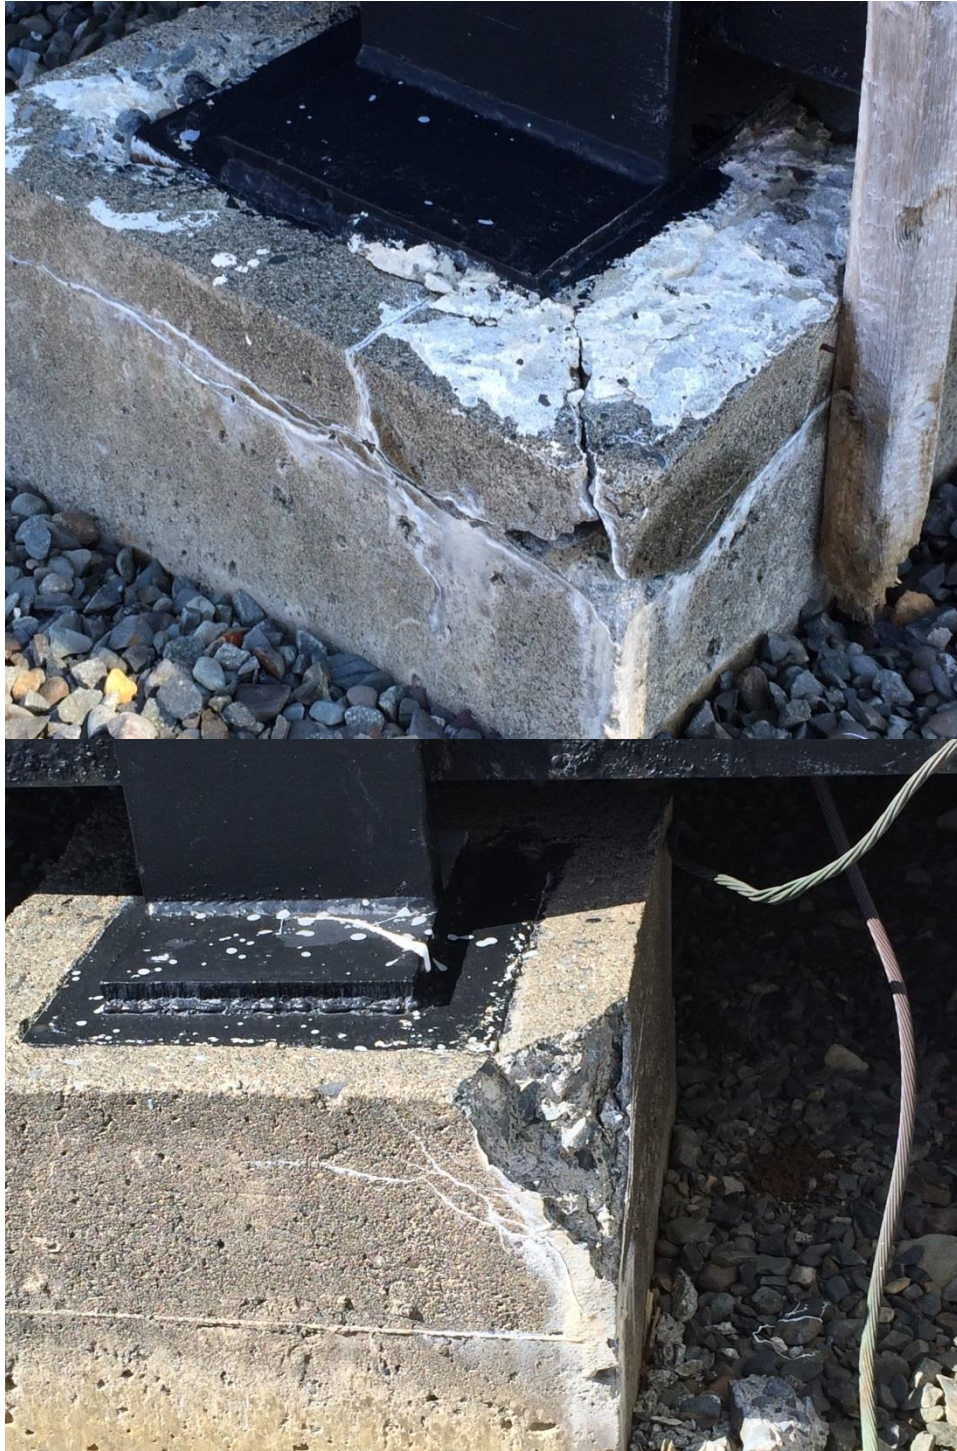
Figure 9A and 9B: Gull Pond Hill: Cracked and deteriorated building foundations

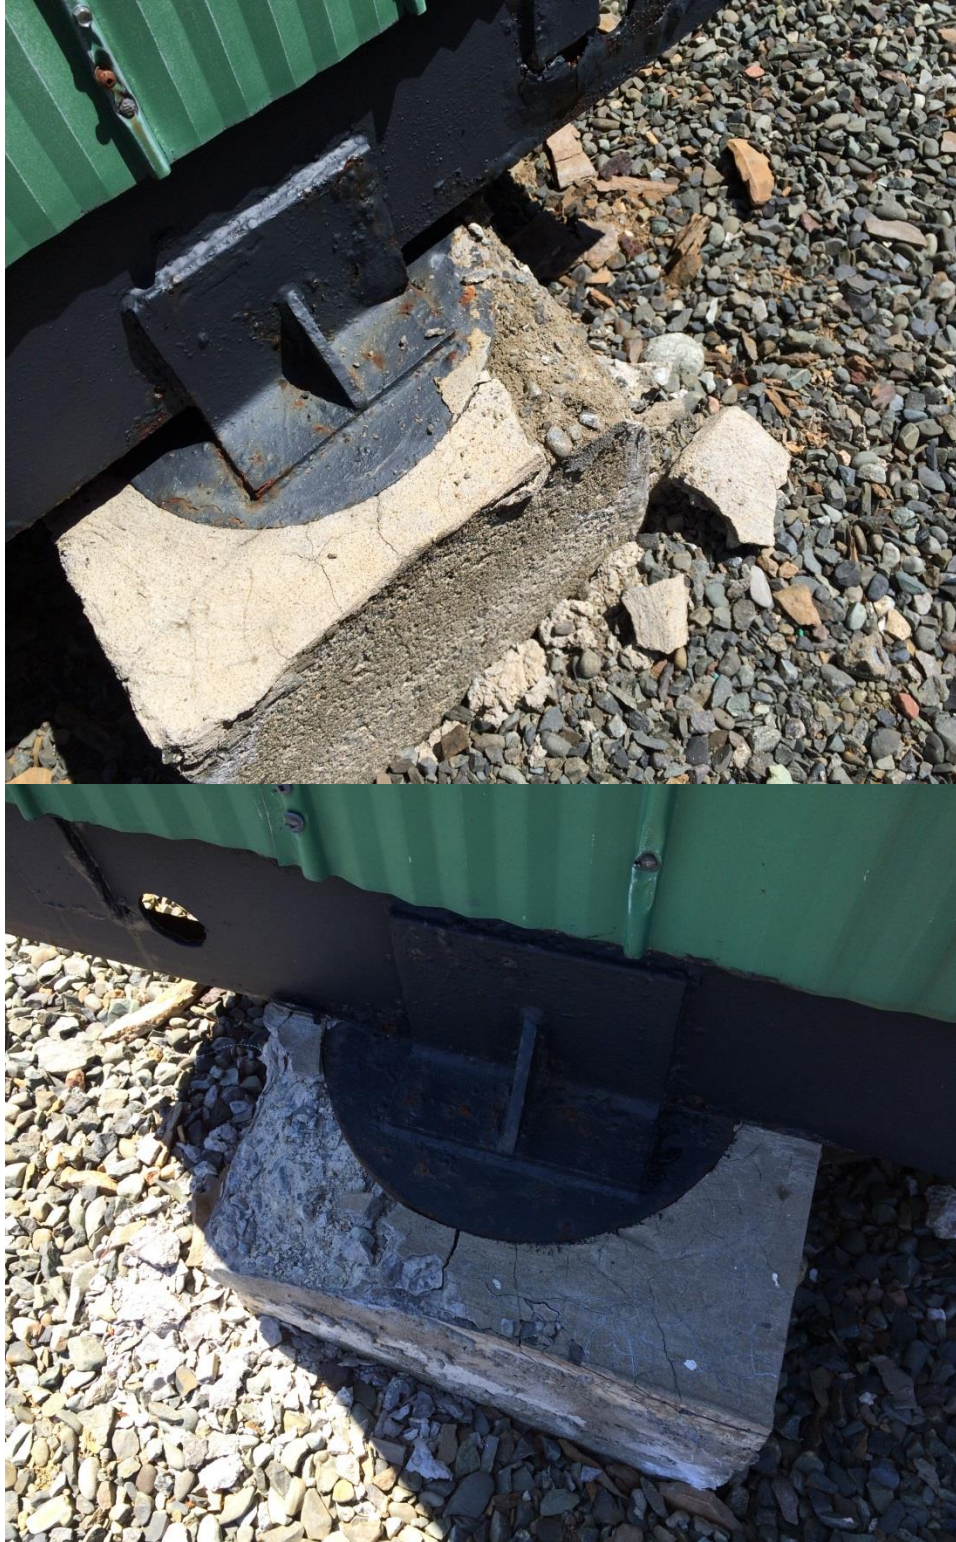
Figure 10A and 10B: Bay d’Espoir Hill – cracked and deteriorated building foundations

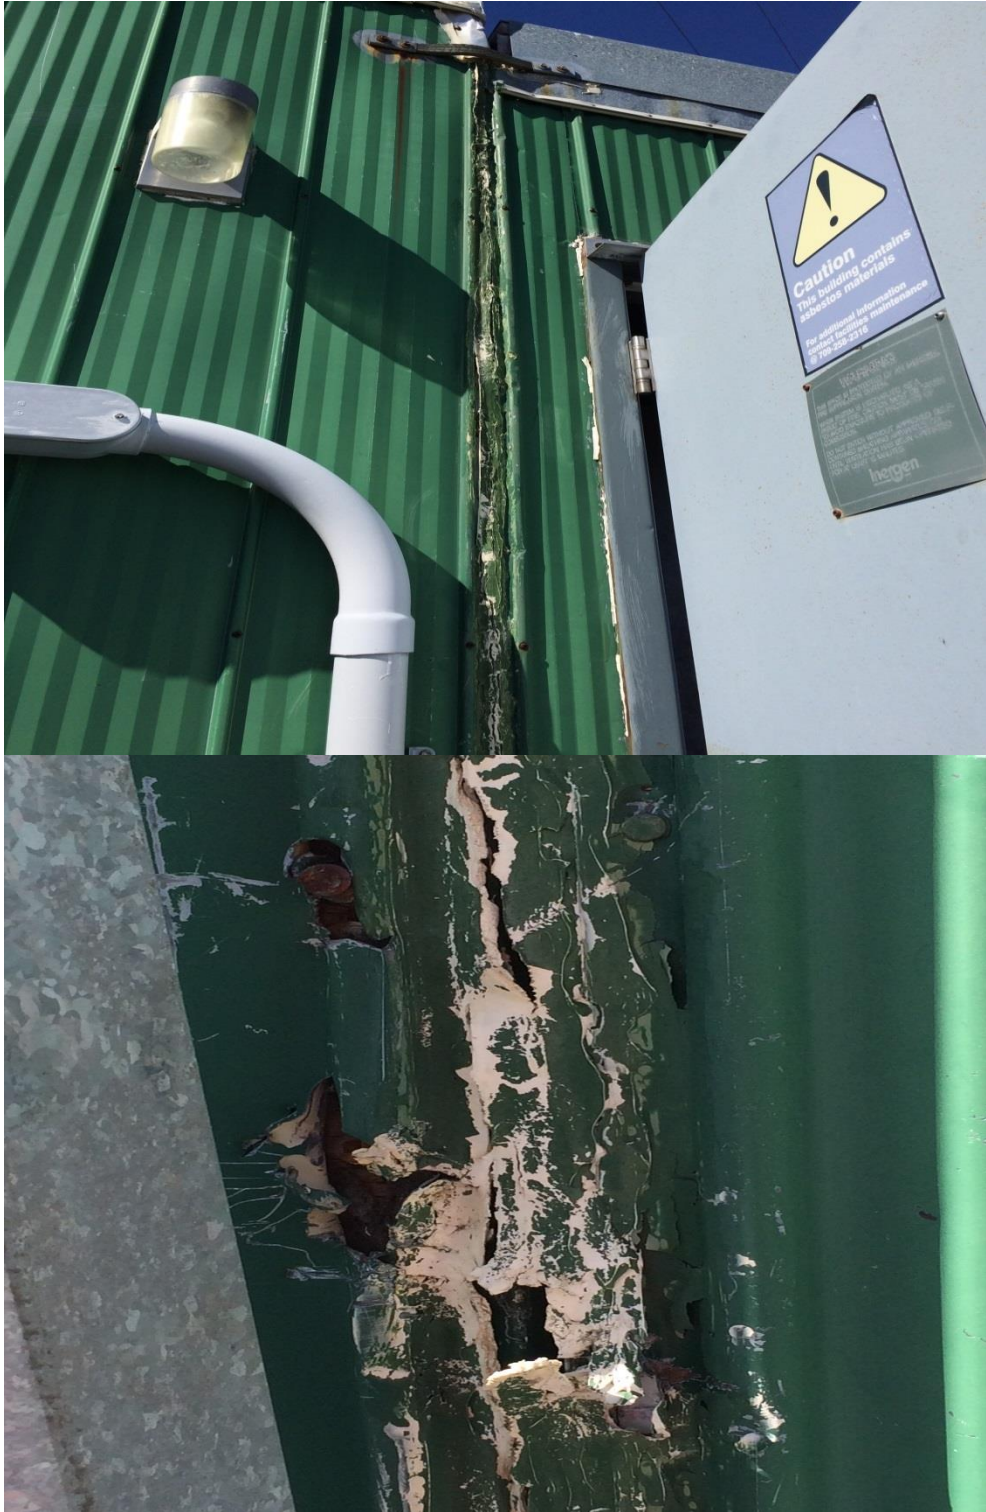
Figure 11A and 11B: Gull Pond Hill – porch separating from main shelter

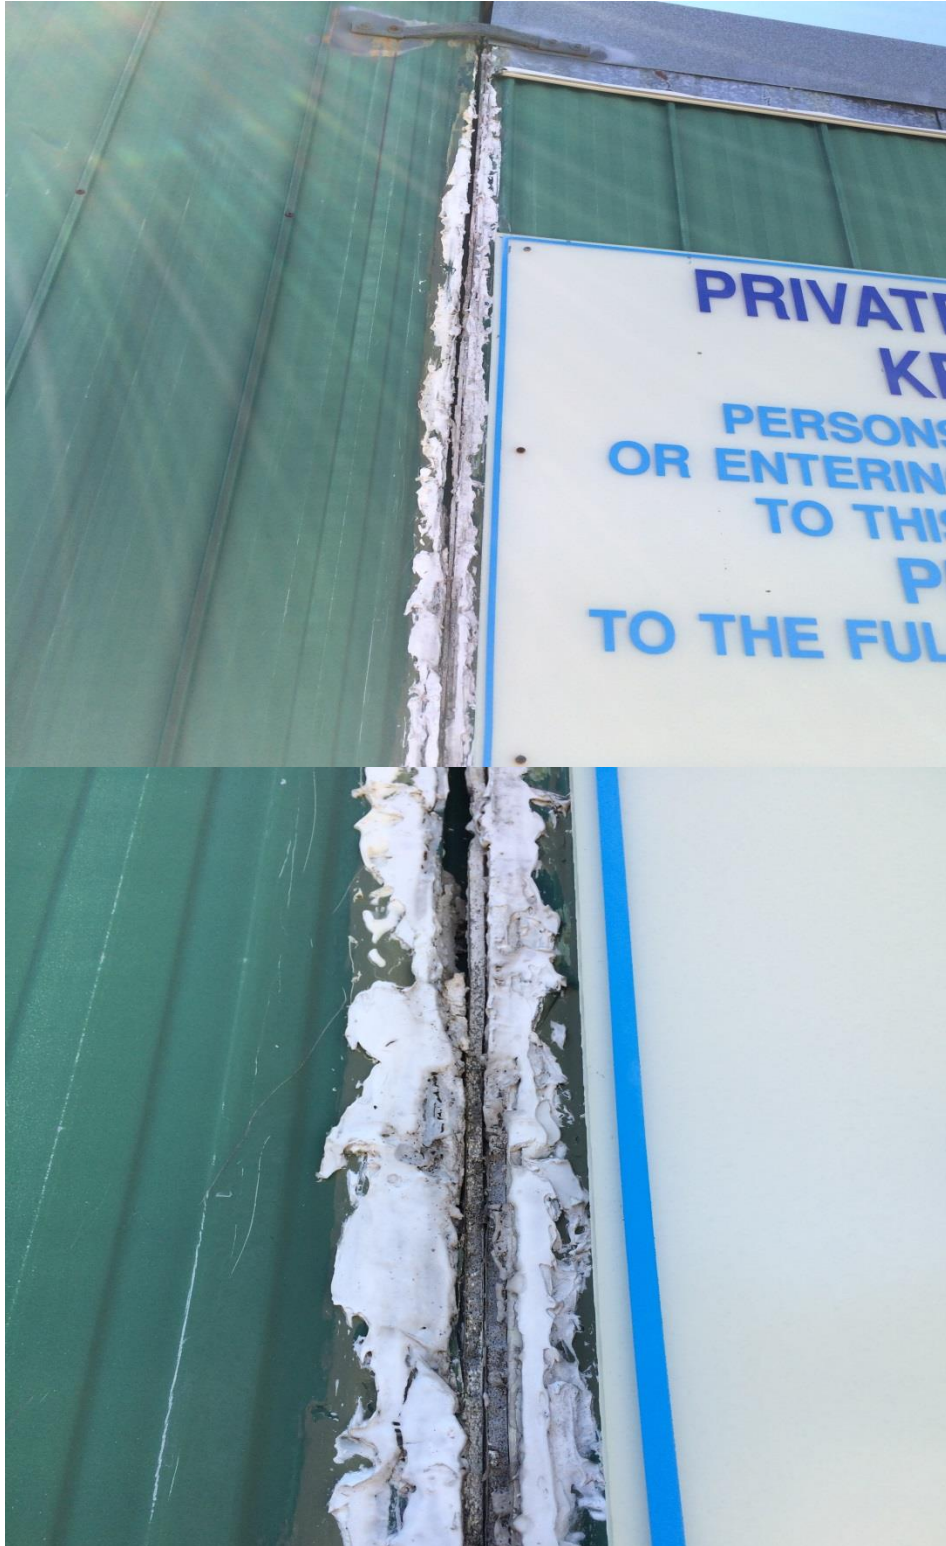
Figure 12A and 12B: Bay d’Espoir Hill – porch separating from main building

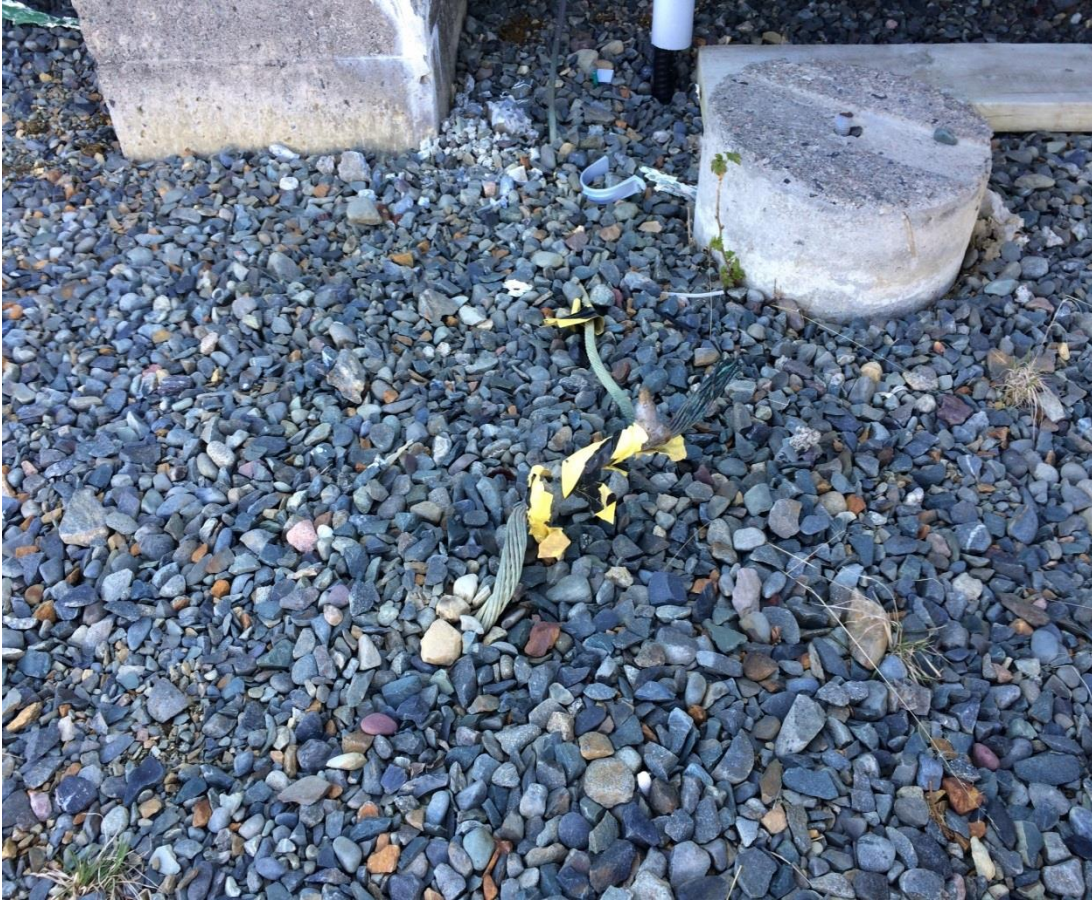
Figure 13: Gull Pond Hill – ground rod and wire above surface

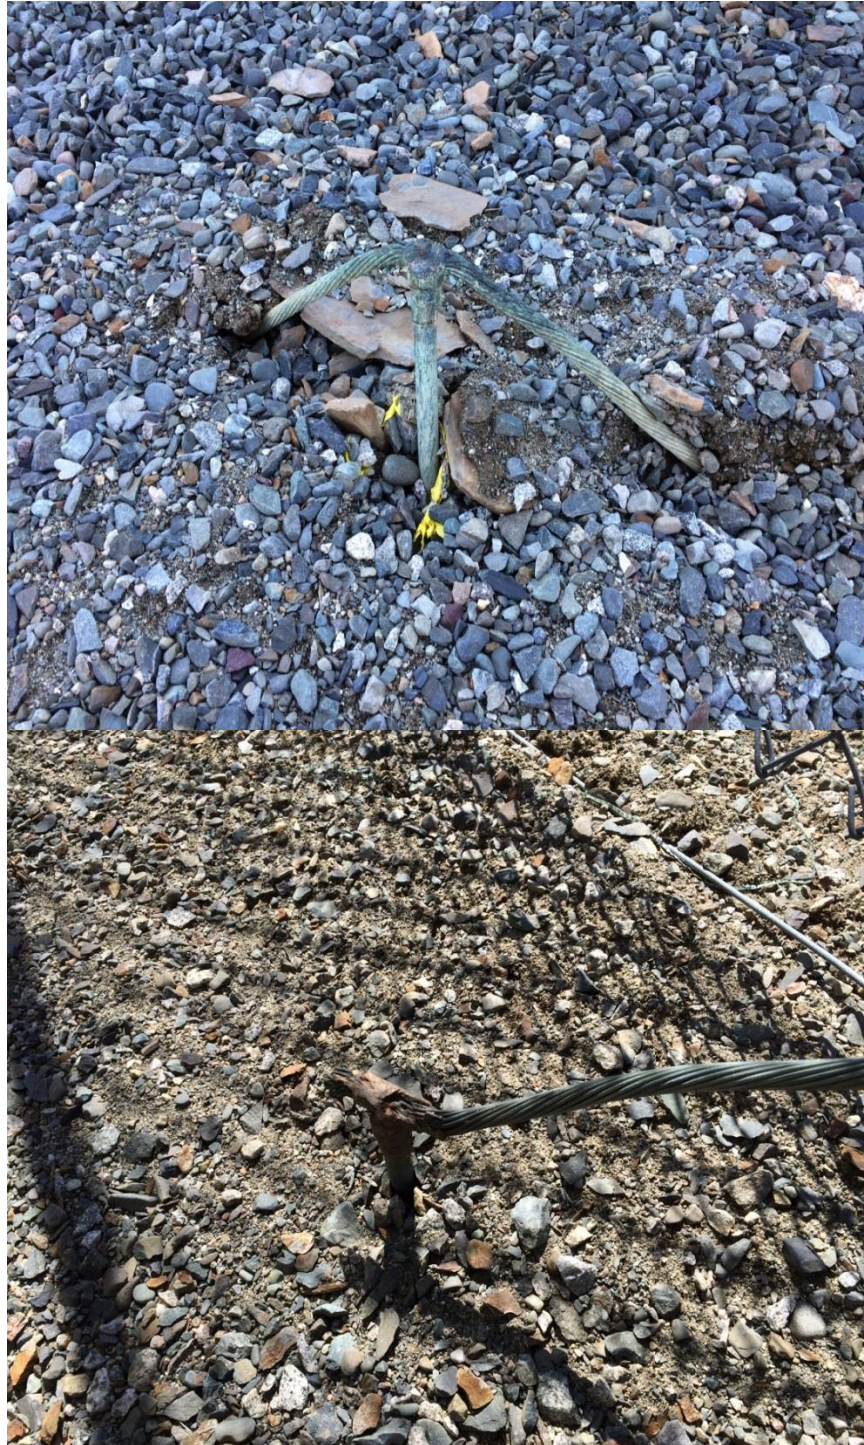
Figure 14A and 14B: Bay d’Espoir Hill – ground rods and wire migrating above the surface
