1. Hydraulic Generation Refurbishment and Modernization (2019-2020)

Hydraulic Generation Refurbishment and Modernization

July 2018

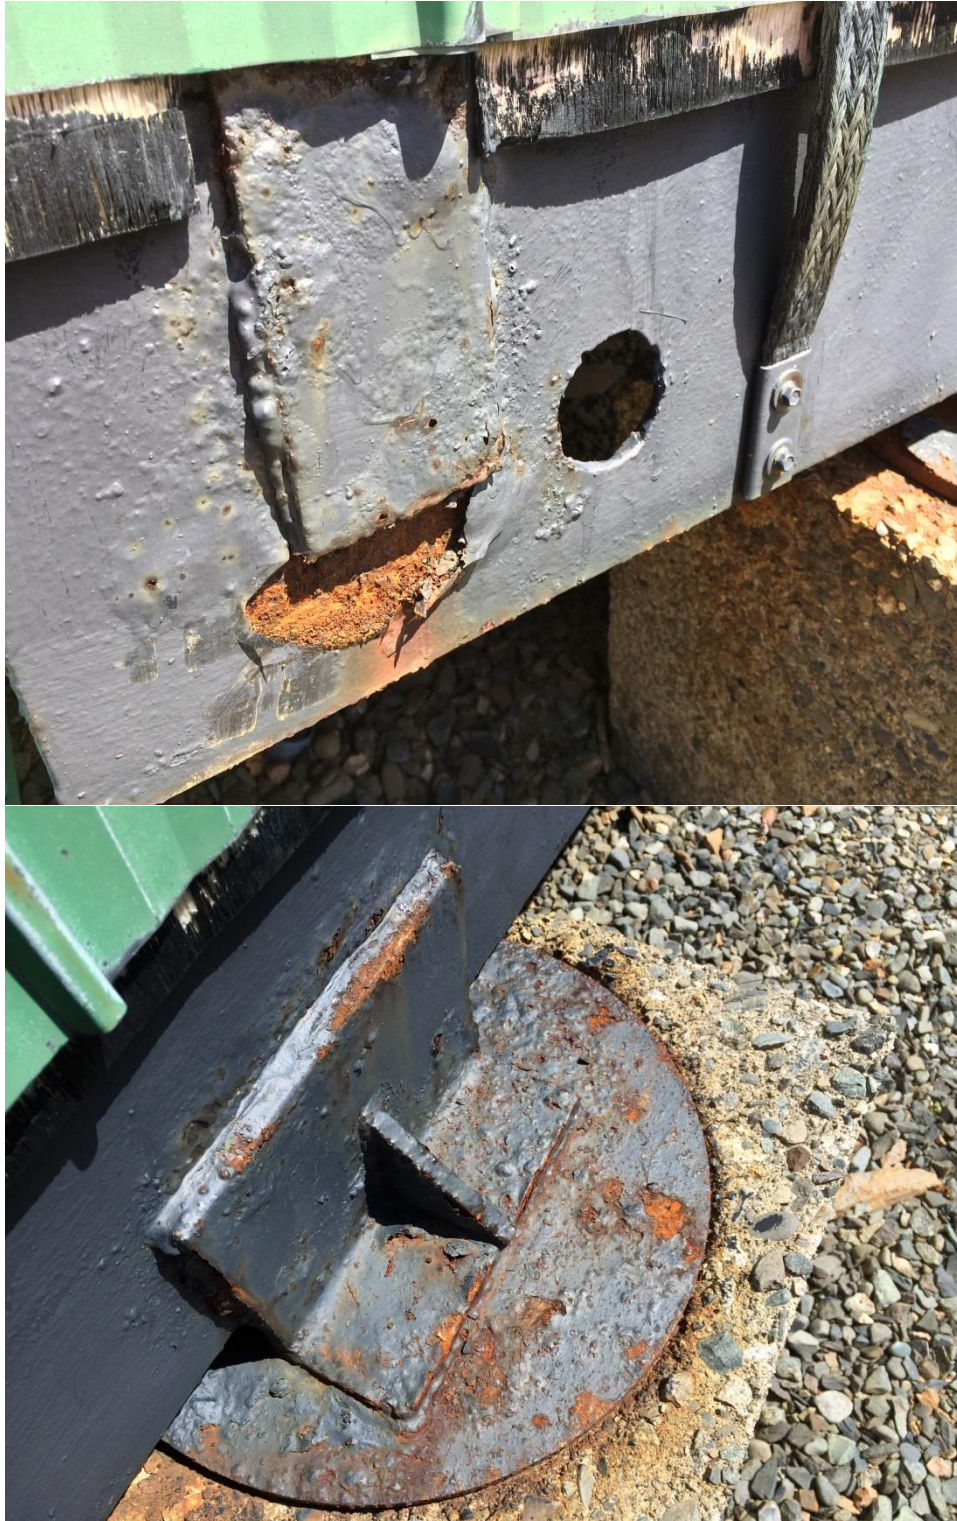
Figure 15A and 15B: Bay d’Espoir Hill – building metal floor frame rusting
