Install Infrared Scanning Ports – Happy Valley Gas Turbine

Category: Generation – Gas Turbines

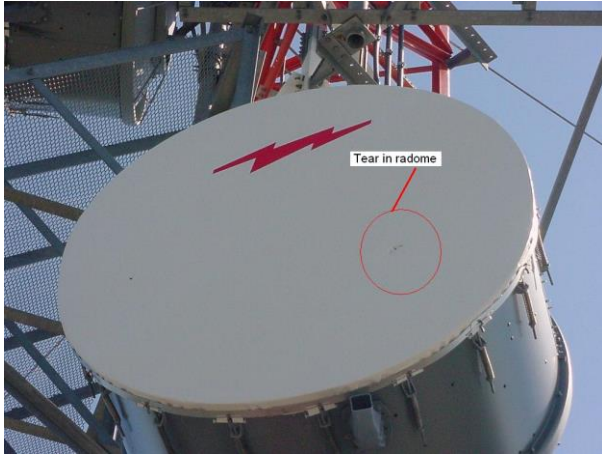
10 Damage to radomes can occur in several ways. Exposure to wind, sun, rain, and ice causes the radomes
11 to deteriorate over time. When the radome weakens, tears form in the fabric, as shown in Figure 2. Left
12 unchecked, the tears quickly grow in size (Figure 3) and the material can be torn free by wind. Such tears
13 may result in severe damage to the delicate antenna components.

Figure 2: Tear in Radome

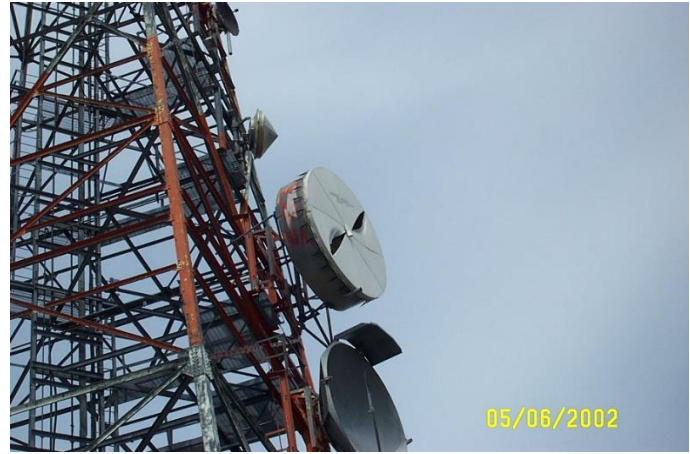
Figure 3: Heavily Damaged Radome

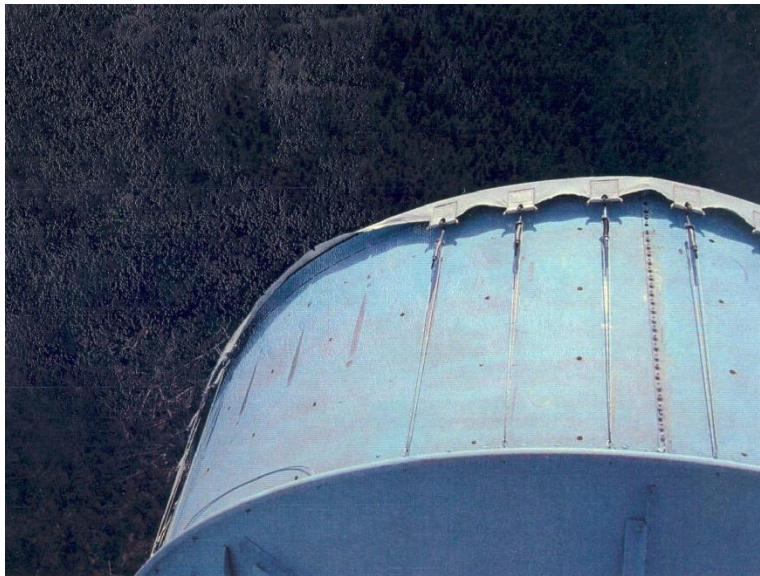
Figure 4: Missing Radome Mounts

- 1 Other modes of failure are less common. Ice falling from the tower can damage radome components,
- 2 such as the hardware that hold the radome in place, as shown in Figure 4. Vandalism by the use of
- 3 shotguns, rocks, or other projectiles has also occurred at sites that are accessible by road. Each of these
- 4 occurrences has the potential to damage the radome and make it prone to complete failure.
- 5 There are 77 radomes throughout Hydro's system. They are installed on towers from St. John's west to
- 6 Deer Lake and south to Bay d'Espoir. Figure 5 shows Hydro's Telecommunication Network.

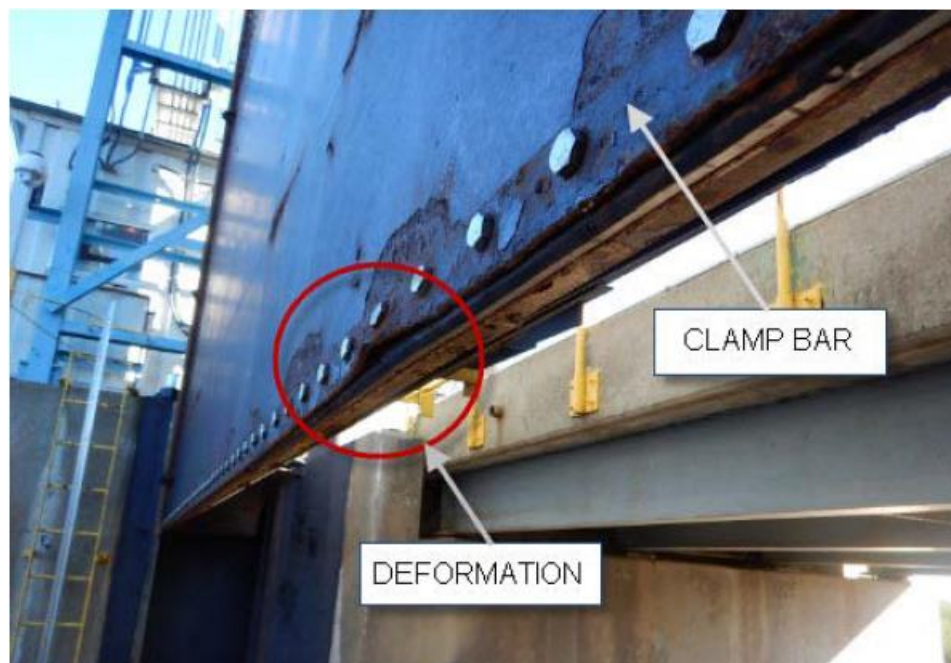
In October 2017, a condition assessment was completed of the gates/embedded parts at the Burnt Dam Spillway. This inspection revealed deterioration with the gate hardware such as rollers, seals, screw stems, transfer cases. The inspection also revealed deterioration in the embedded parts such as concrete and roll paths. Figure 15 to Figure 17 highlight the deterioration in Burnt Dam.

Figure 15: Deformed Gate Knife – Burnt Dam

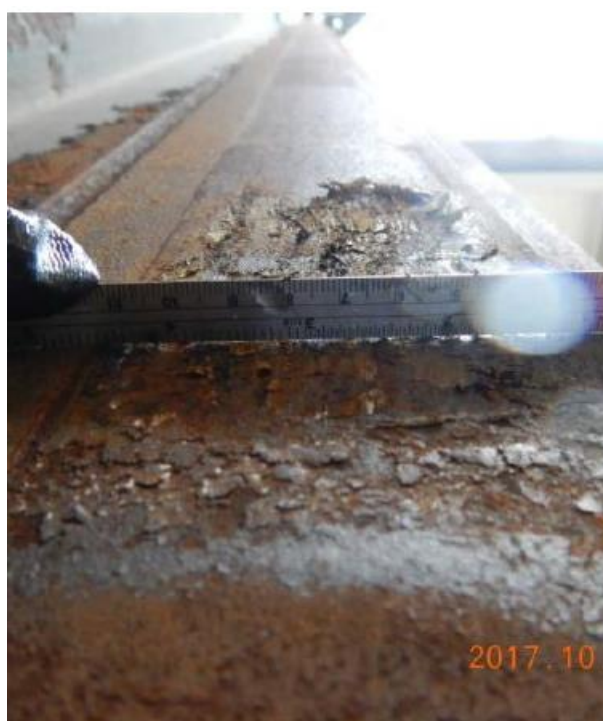
Figure 16: Rubbing Marks on Embedded Parts – Burnt Dam

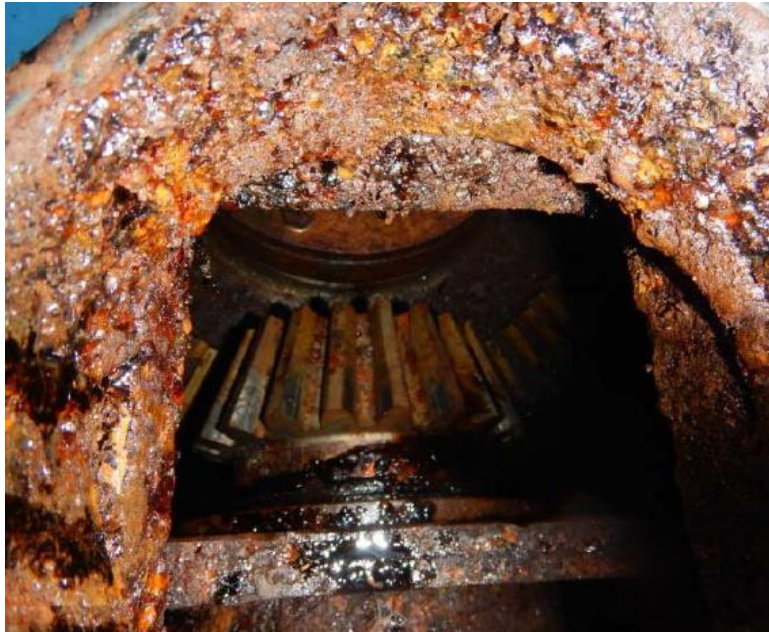
Figure 17: Transfer Case Corrosion – Burnt Dam

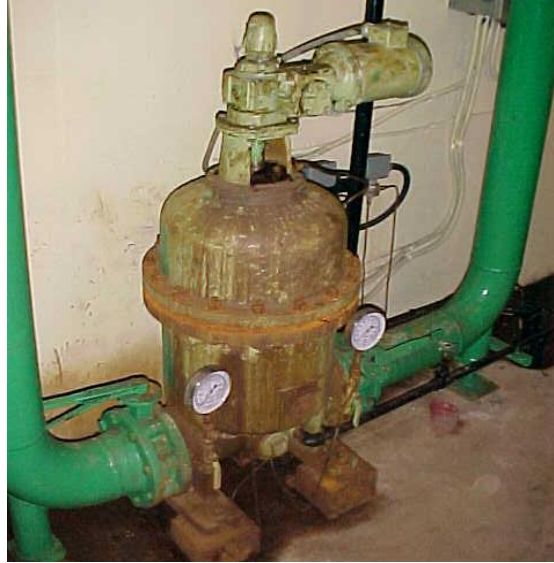
The rotary strainer is original to Upper Salmon and is over 38 years old. The strainer is subjected to raw water with heavy organic material that can cause premature wear and organic buildup. In recent years, Hydro has undertaken work to change out cooling water lines downstream of the rotary strainer with stainless steel piping to reduce the impact of organic buildup in piping. The strainer is subjected to this organic buildup and all foreign debris that may be flowing through the inlet line from the penstock. The strainer is also showing signs of visible external corrosion with work completed in recent years due to blockages, alarm malfunctions and strainer flooding. Figure 19 illustrates this external corrosion on the body of the strainer.

Figure 19: Upper Salmon Rotary Strainer

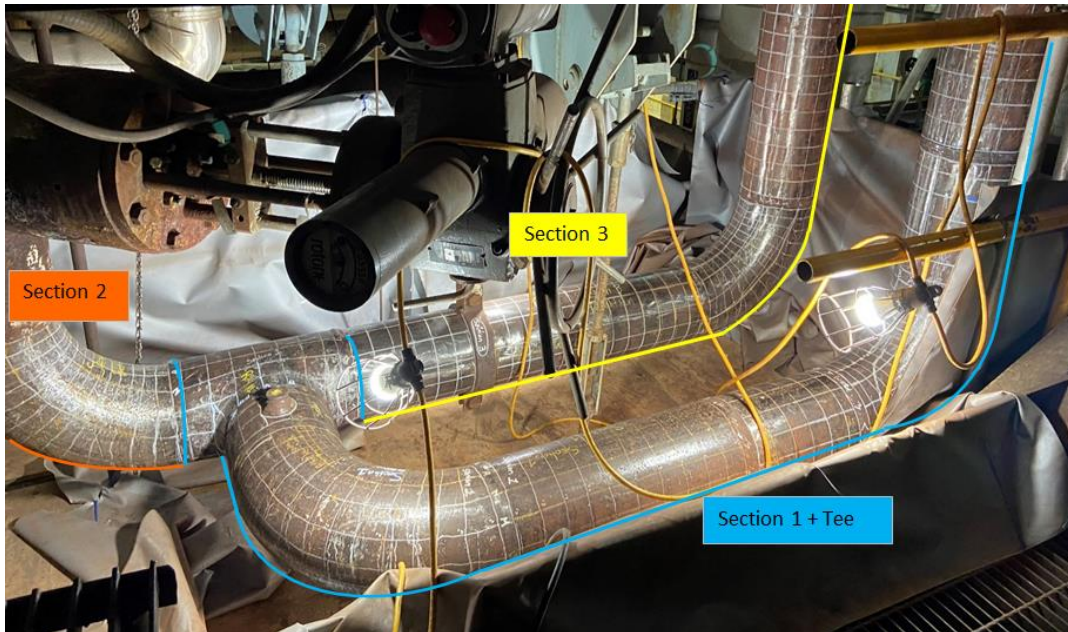
- 1 • Flow accelerated corrosion (“FAC”) of a section of eight inch diameter feedwater piping in Unit 3
- 2 was detected that had degraded the pipe to the point where replacement of one elbow section
- 3 was required. This replacement has been completed (see Figures 1 and 2 below).

Figure 1: Unit 3 Feedwater Piping Prepared for FAC Assessment.
Assessment determined that the horizontal elbow in the foreground required replacement.

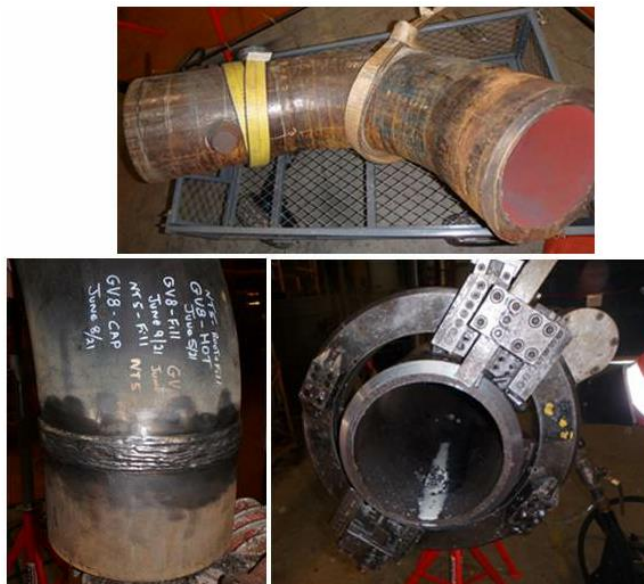
Figure 2: Unit 3 Feedwater Piping Replacement in Progress

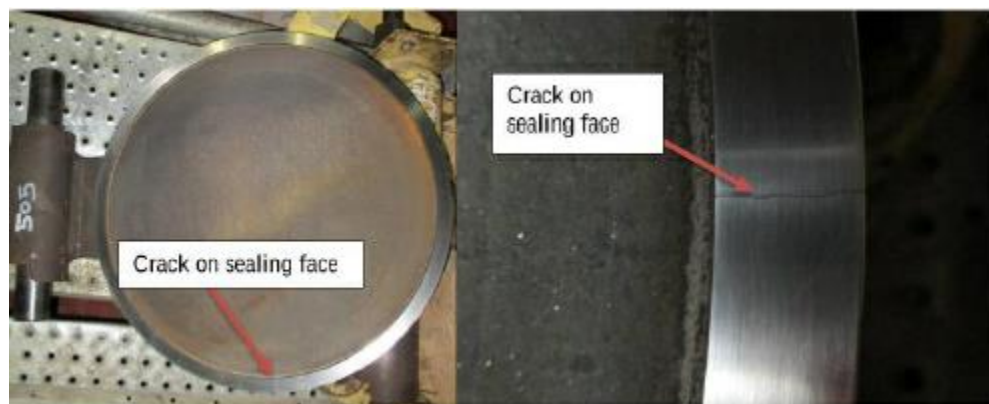
Figure A-1: Crack Found on Sealing Surface of a Non-Return Valve Disc

After the seat face was machine off and new seat re-established and machined, the seats were lapped flat and smooth and free of any indications.

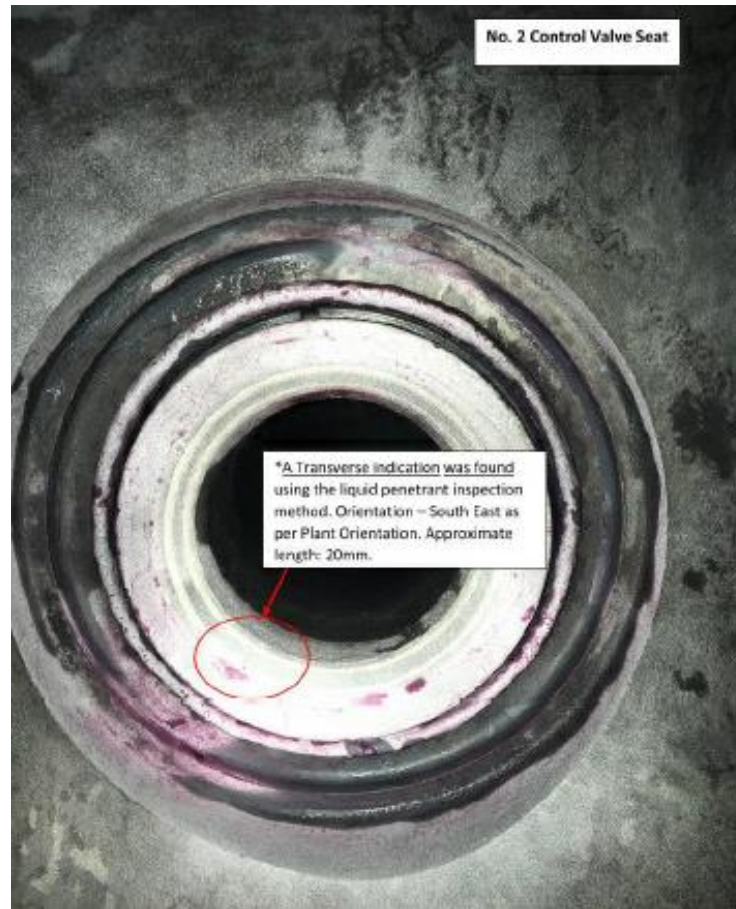
Figure A-3: Crack Found in Control Valve Seat

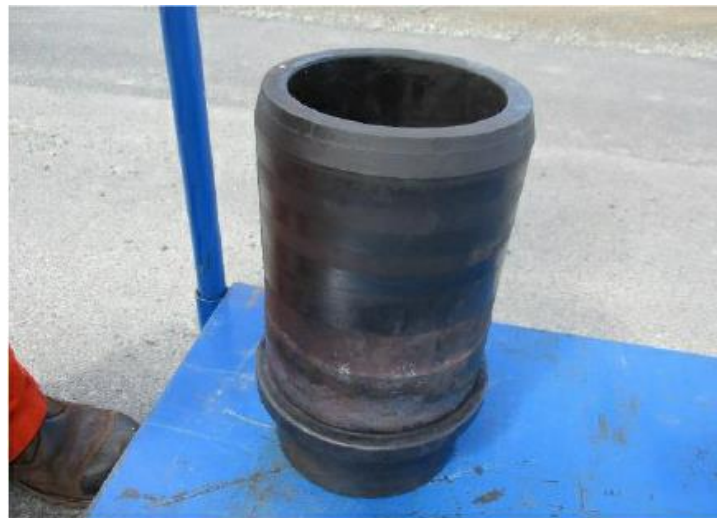
Figure A-4: Failed Control Valve Seat Removed for Replacement

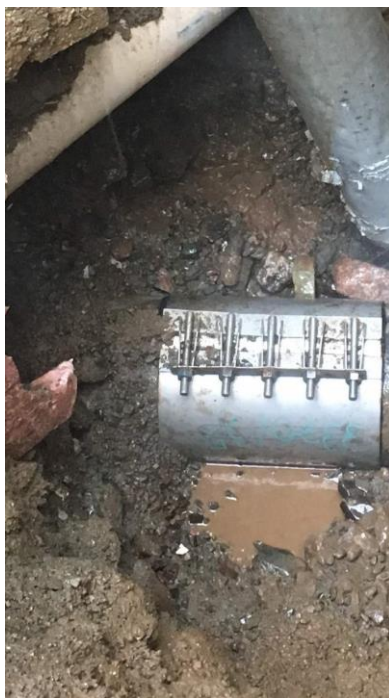
5 Figure 1 shows a fire distribution line break identified in 2019, located behind the stack of Unit 2. A
6 clamp was temporarily placed on the pipe to stop the water leakage until a replacement section of pipe
7 was installed.

Figure 1: Fire Distribution Line Break behind the Stack of Unit 2

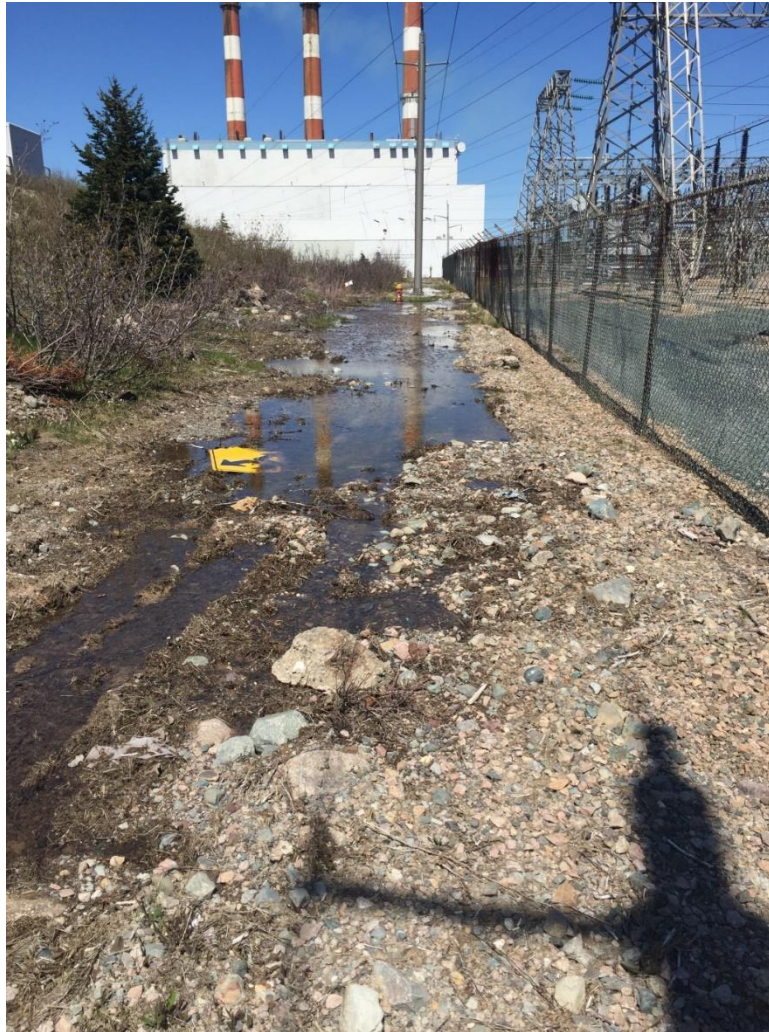
- 1 Figure 2 shows water leakage due to a fire distribution line break in 2019 near the terminal station. The
- 2 leakage presented a hazard as it could extend to the terminal station. A section of pipe was replaced. A
- 3 valve downstream of this break also required replacement as it failed to isolate the line to complete the
- 4 pipe section replacement.

Figure 2: Fire Distribution Line Leakage near the Terminal Station.

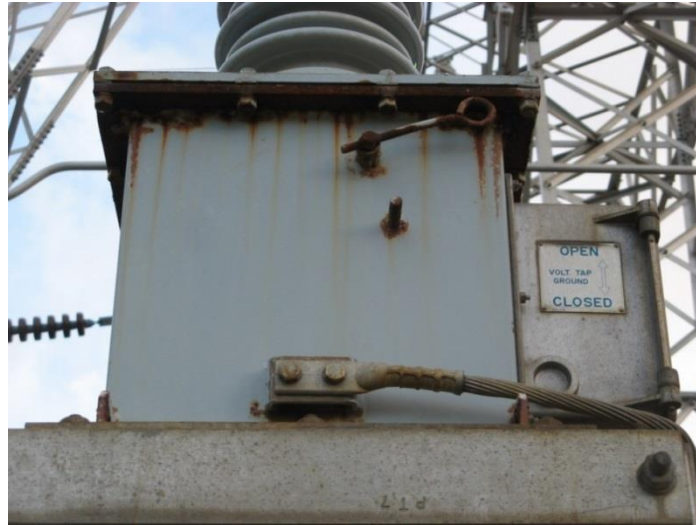
Figure 2: Rusting Potential Transformer

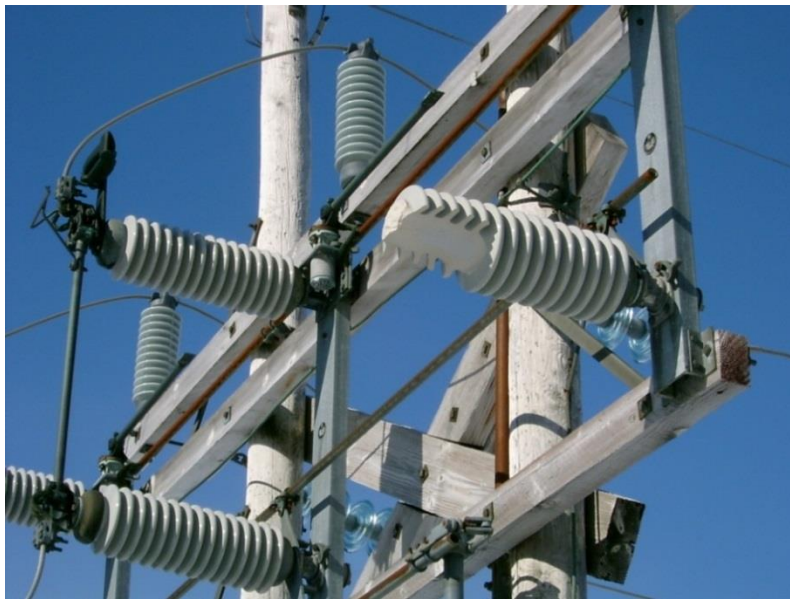
Figure 4 shows an example of a badly damaged disconnect switch.

Figure 4: Broken Insulator on 69 kV Disconnect Switch

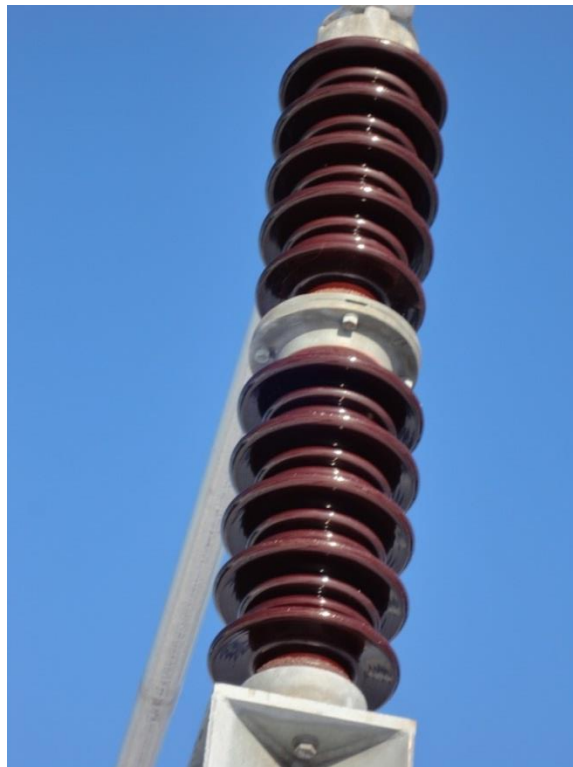
Figure 6: Multi-Cone Type Insulator Prone to Failure due to Cement Growth

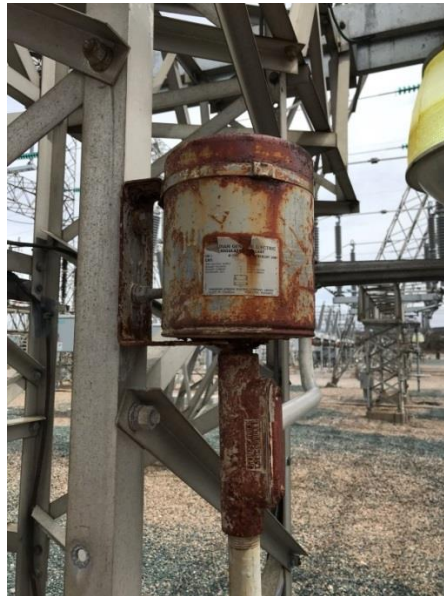
Figure 12: Corroded Ballast Requiring Replacement

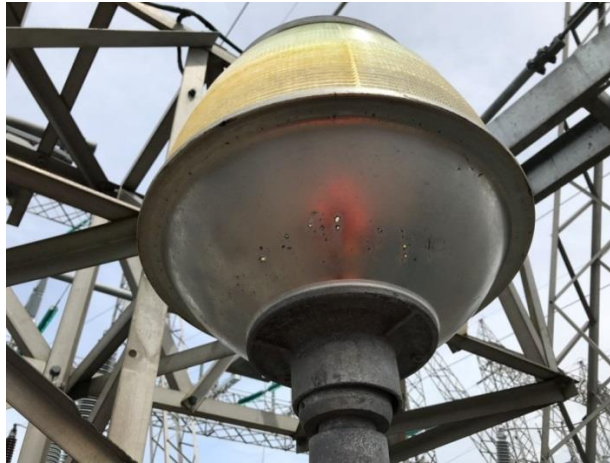
Figure 13: Light Fixture Showing Perforations due to Corrosion, Enabling Moisture Ingress

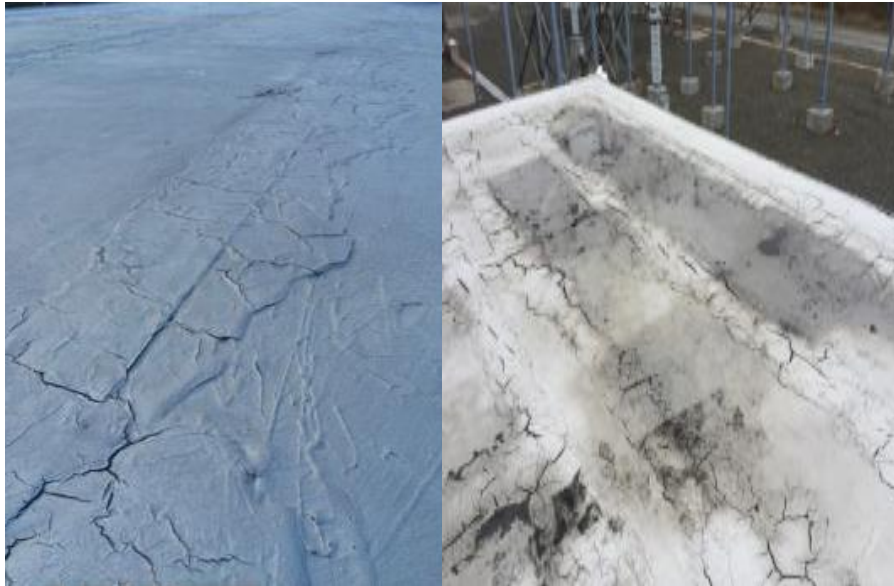
Figure 16: Terminal Station Control Buildings (Come by Chance and Sunnyside) Showing Cracking and Deterioration of the Roof Membrane System

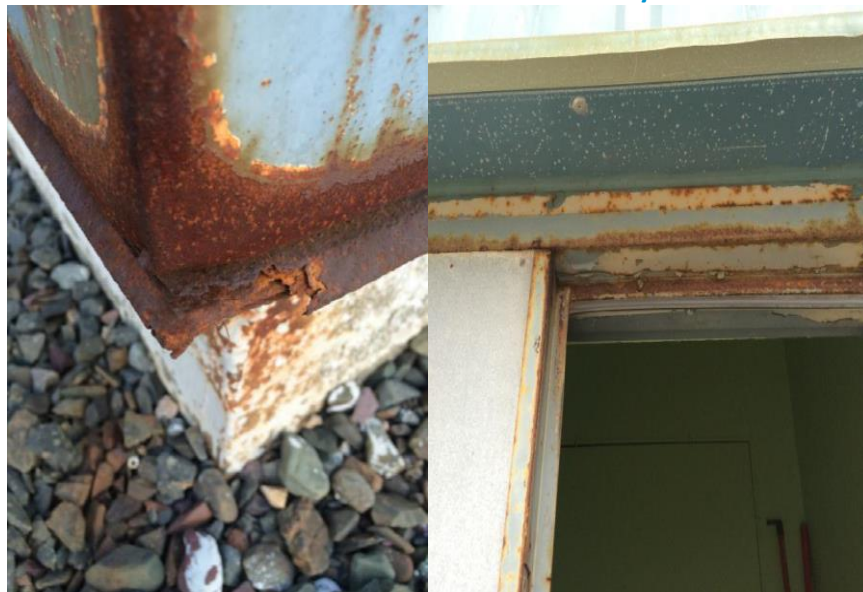
Figure 17: Building Exterior Cladding and Exterior Doorways Displaying Severe Rusting and Deterioration

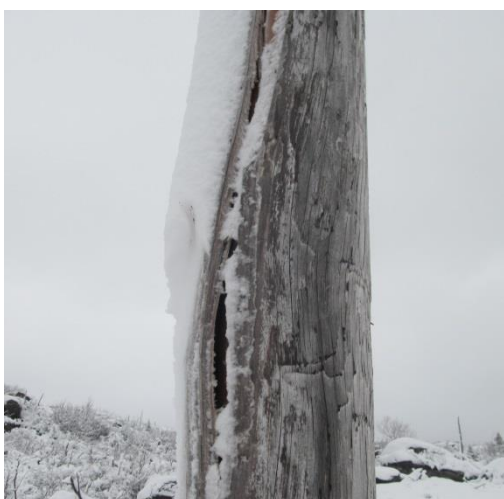
Figure 3: Deteriorated Pole

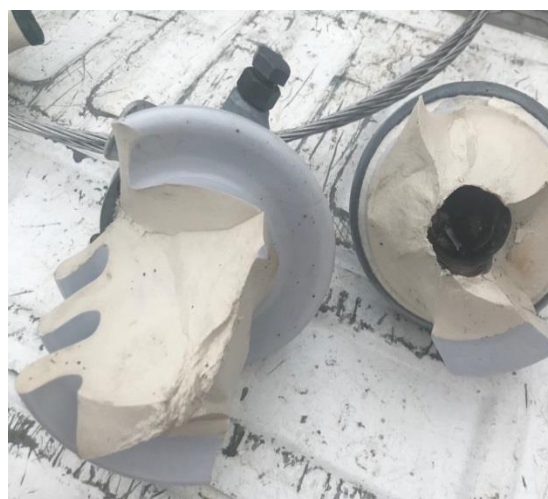
Figure 4: Damaged Insulator

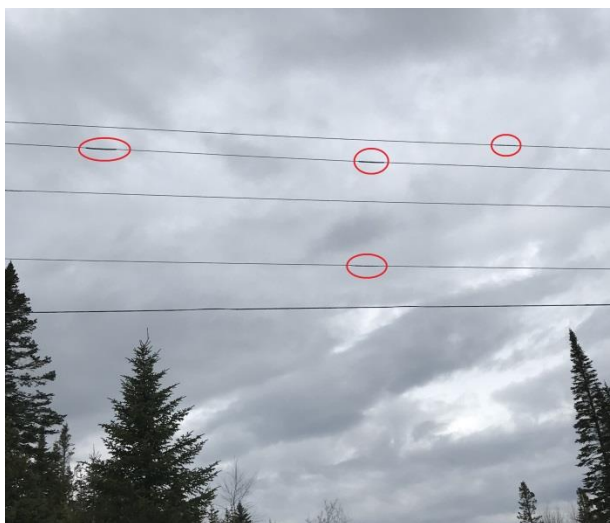
Figure 5: Deteriorated Conductor with Multiple Sleeves
