1 Q. **Project C-5: Replace Interior Coating of Surge Tank 3**

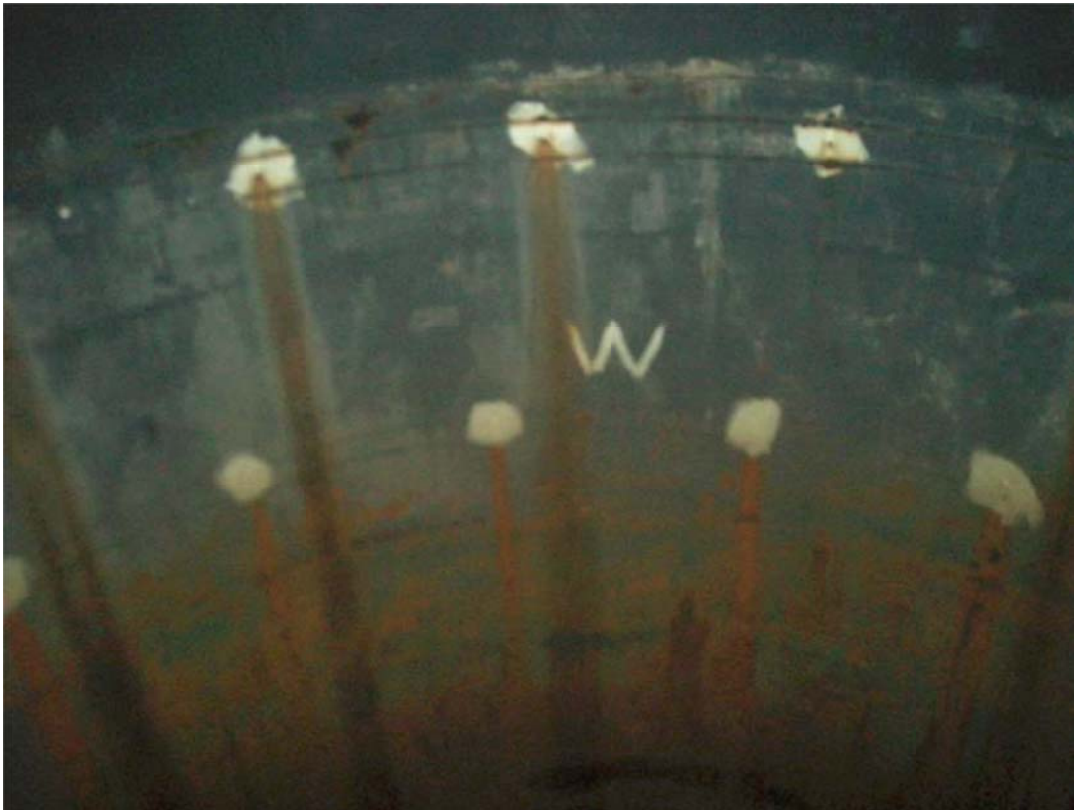
A review of the Hatch condition assessment report, in conjunction with the RAT inspection report suggests the coating is in need of repair. The photo below is indicative of the corrosion evident on the interior of the surge tank.

To address the corrosion observed inside the tank as well as the observed pitting of the coating in the riser, two considerations for repairs were made in consultation with a vendor experienced in coating application in wet environments: spot coating and full coating. The vendor indicated that both a spot coat application and a full coating application would require the same surface preparation of the entire tank surface as well as the same spot priming treatment. As a result, the two options would require the following steps:

b) **Full Repair** - water blast the entire surface, spot prime and apply a full coating.

1 Given that the construction costs and outage time for spot coat and full coat are
2 similar, and there are increased outages and costs required for more frequent spot
3 coating inspections, the decision was made to opt for the longer term solution that
4 requires less outage time for surge tank three as well as a lower probability of
5 recoating in the near future. Hydro has determined that the better long term
6 solution for the refurbishment of the tank interior is to water blast the surface, spot
7 prime areas where the coating is weak or has failed and apply a full surface coating.
