**Re: Newfoundland and Labrador Hydro – 2014 Capital Budget Application**

**An Application to the  
Board of Commissioners of Public Utilities**

# **2014 CAPITAL BUDGET**

### **VOLUME I**

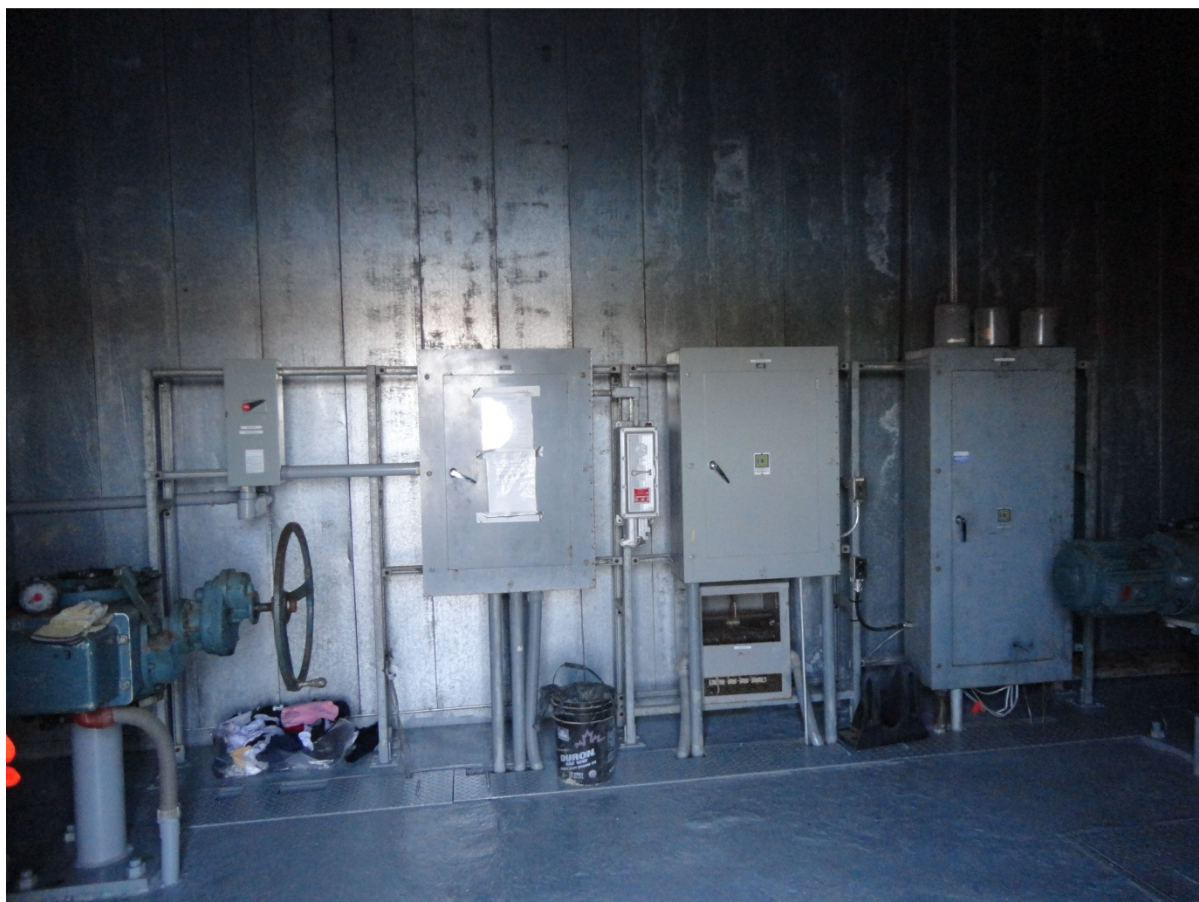
- Replacement and upgrading of all deteriorated electrical panels (see Figure 3) and transformers;
- Replacement of power cables between the electrical panels and the four gate actuators;
- Refurbishment and/or replacement of gate screws, stems, wedges, guides and limits;
- Detailed inspection of gate actuators (motors and drives) (see Figure 4), gates and embedded parts by the original manufacturer ( Flowserve Limitorque) and an engineering consultant ( RD Energy) to determine upgrade requirements for a future year;
- Detailed inspection and evaluation of the concrete structure and water passages by an Engineering consultant; and
- Refurbishment of the balancing valve.

**Figure 3: Victoria Control Structure - Electrical Panels and Power Cables**

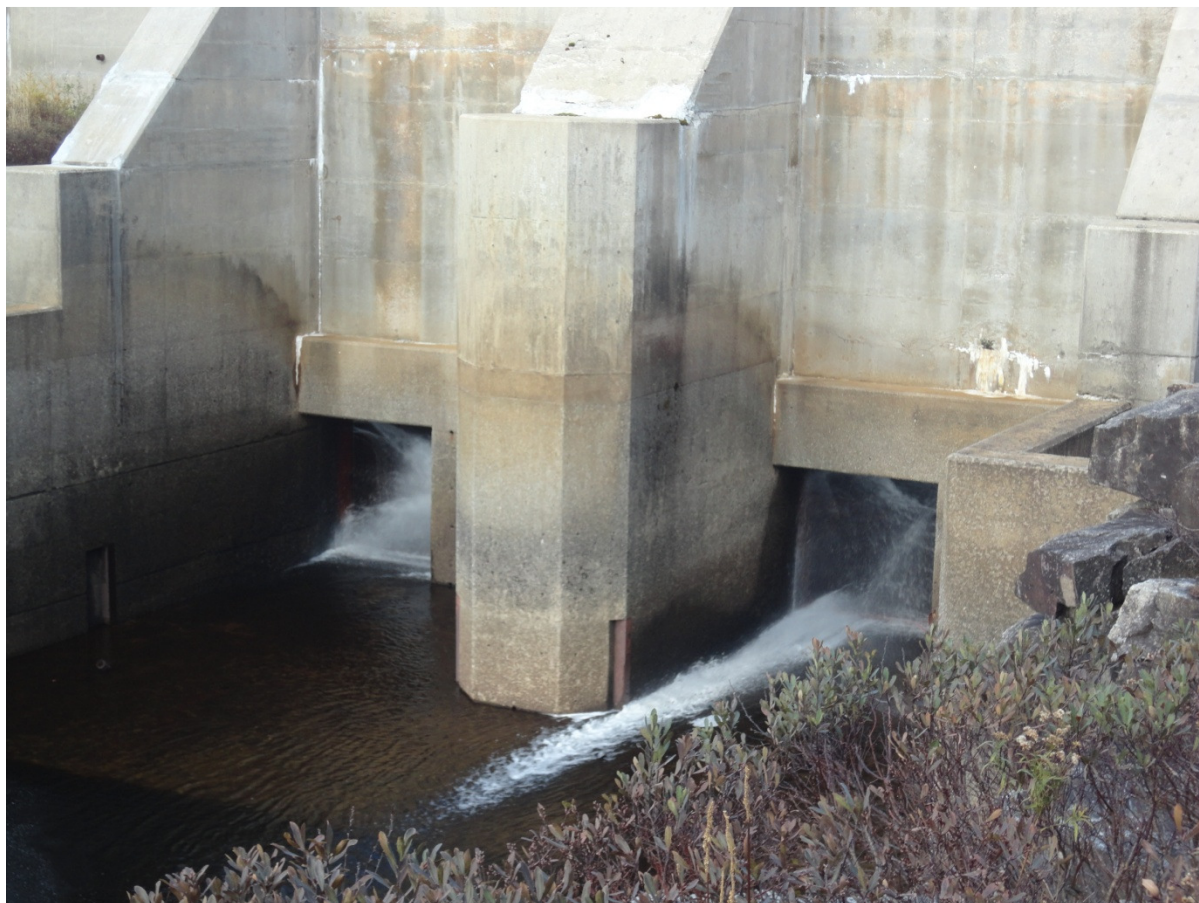
continue to deteriorate the gate and concrete, accelerating the deterioration of the asset.

**Figure 5: Victoria Control Structure – Gate Leakage**

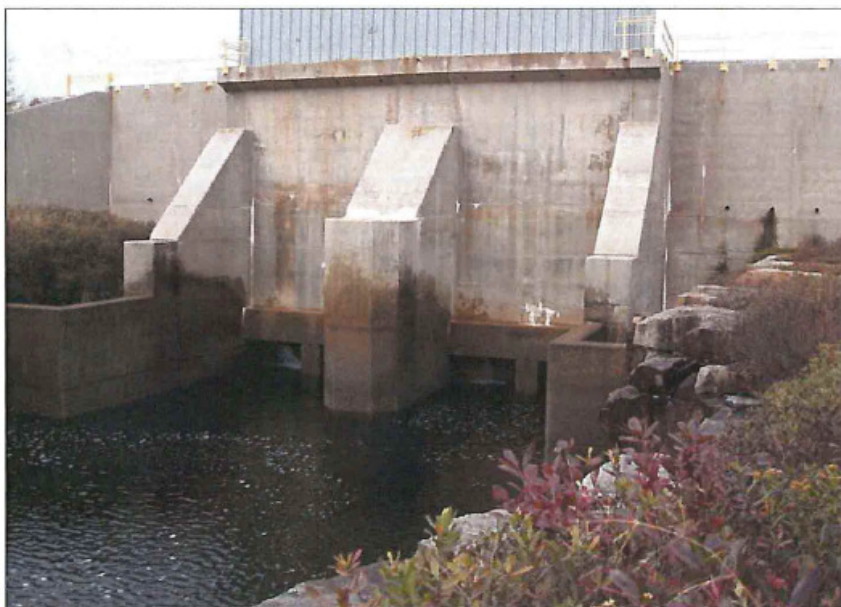
**Photo 98: Victoria - Downstream View of Victoria Control Structure - Notice Leakage from Gates**

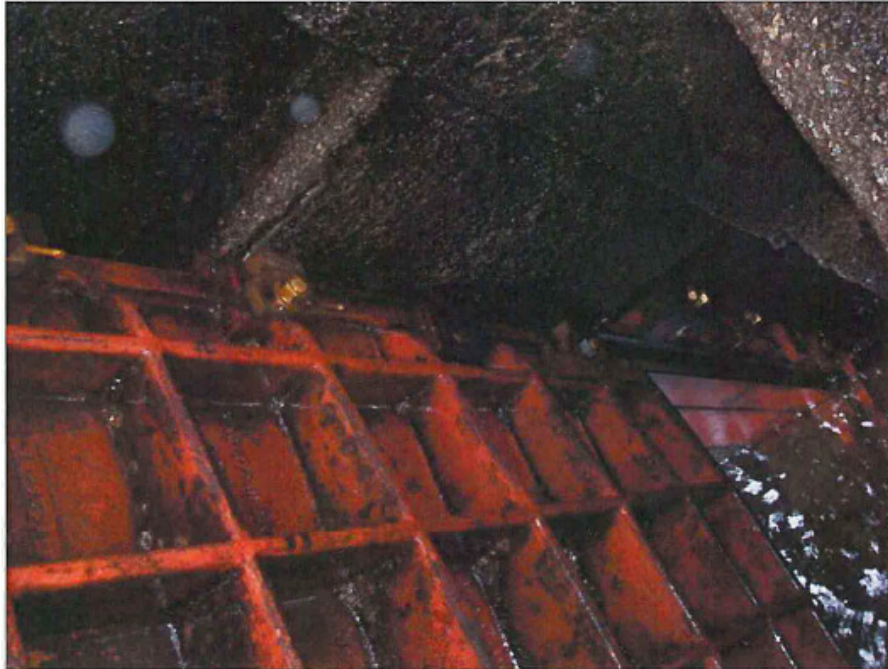
**Photo 102: Victoria Control Gate 1 - Notice Missing Wedge Block in Centre of Photograph**

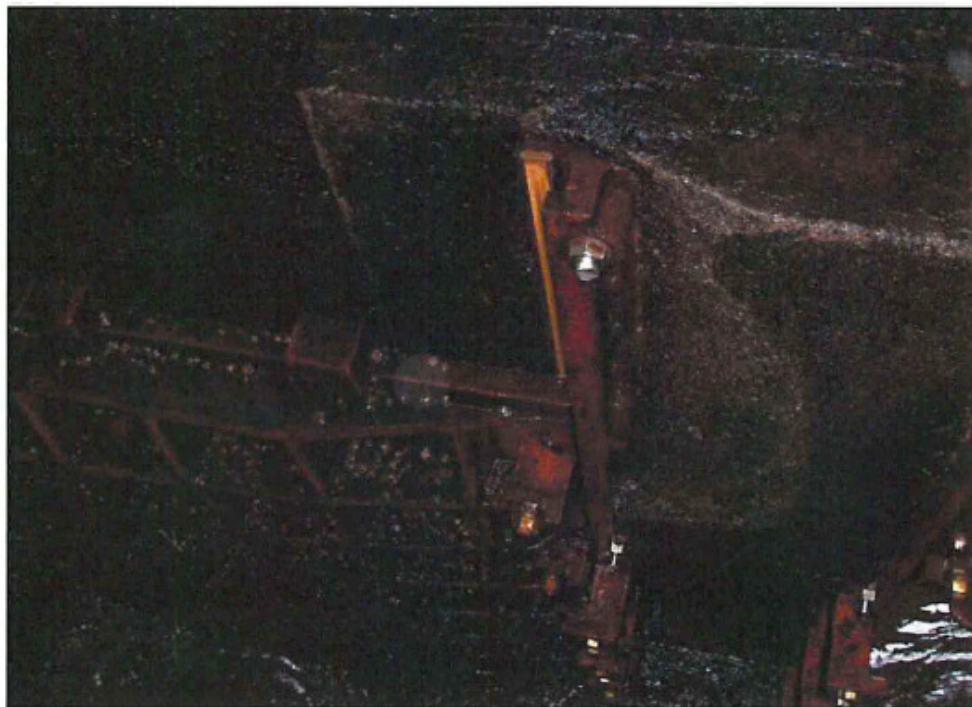
**Photo 104: Corrosion on Victoria Control Gate 4**

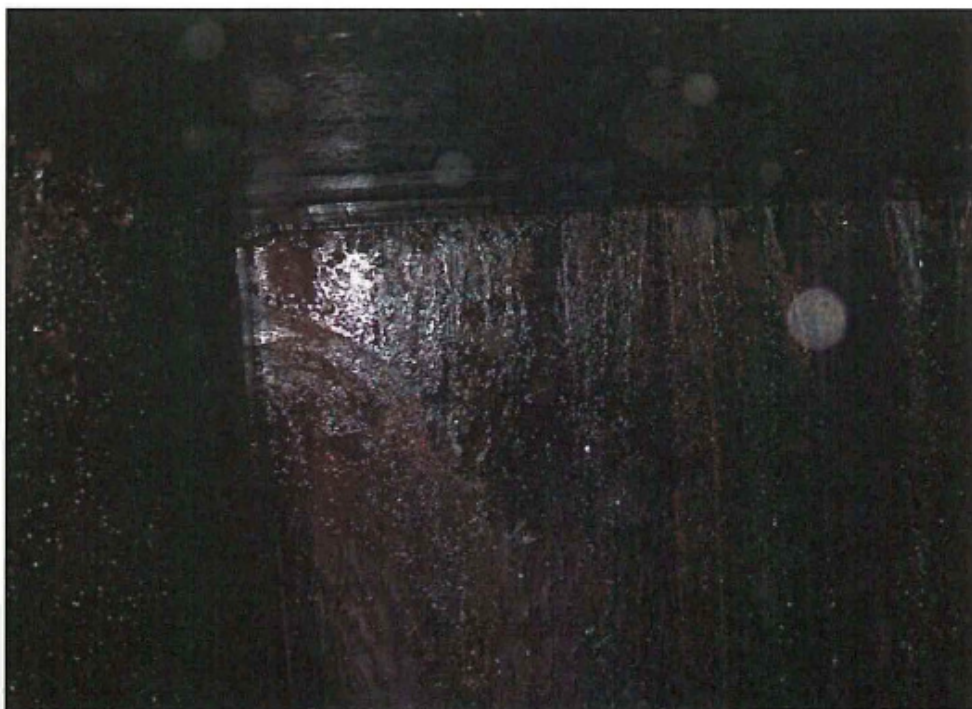
**Photo 105: Leakage Past Bulkhead Gates Upstream of Victoria Control Gates 3 and 4**

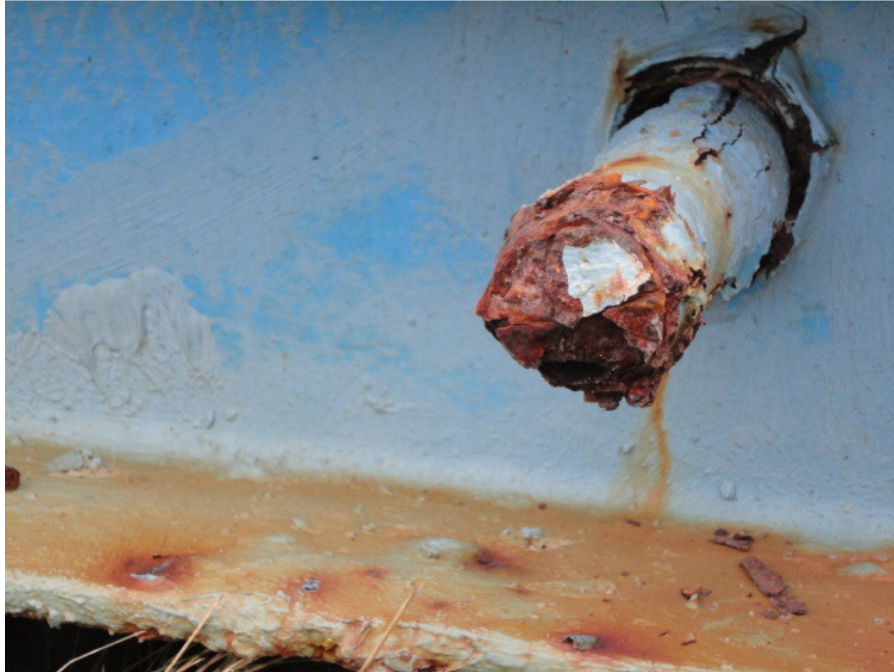
The existing fuel storage tank was installed in 1994. The tank has deteriorated with age due, in large part, to its proximity to a corrosive marine environment. During the completion of a daily tank inspection on October 28, 2011, it was noted that the tank's dyke drain and drain valve had completely rusted through (see Figures 1 and 2).

**Figure 1: Corroded Dyke Drain Valve**

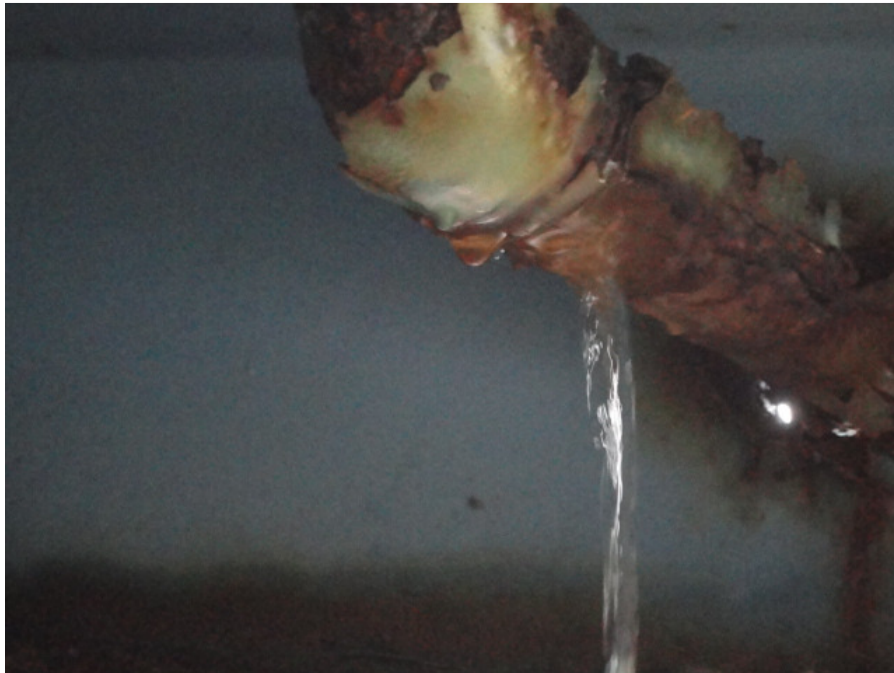
**Figure 2: Water Leaking from Dyke Drain Valve Piping During Leak Test**

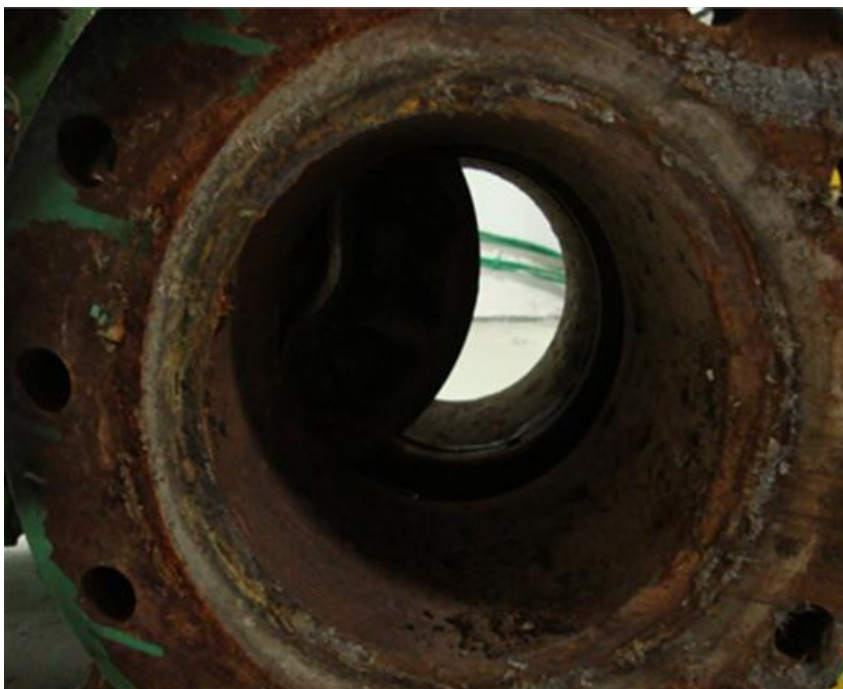
**Figure 2: By-Pass Valve with Disk Jammed in Half Open Position**

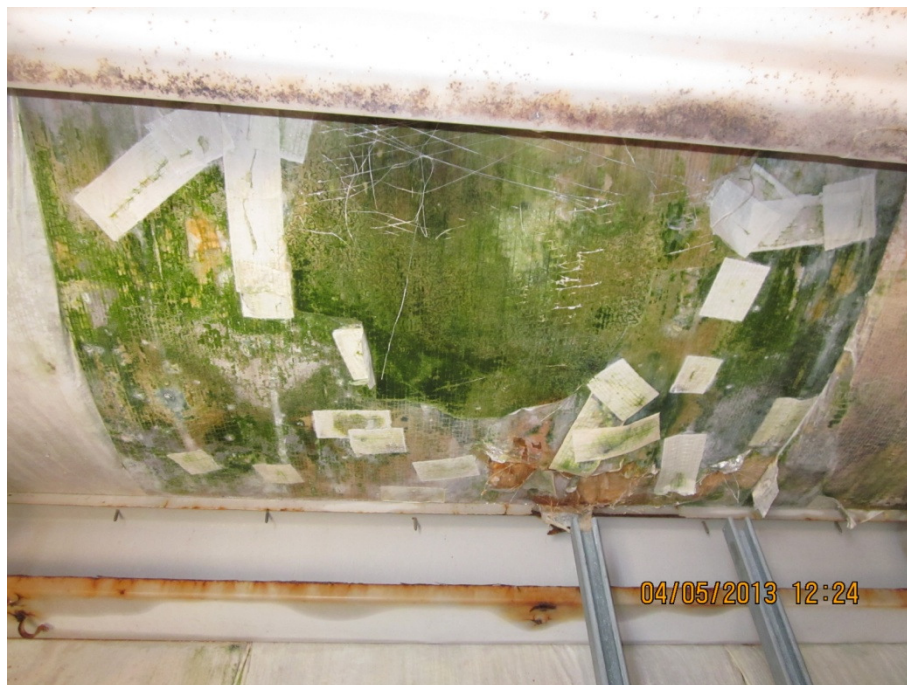
The waste water basin building (WWBB) provides the essential housing for the Holyrood Thermal Generating Station's (Holyrood) continuous and periodic equalization basins<sup>1</sup>. The building's structural steel is corroded and mold growth is present throughout (see Figures 1 and 2).

**Figure 1: Mold Growth on Interior Face of Roof Insulation**

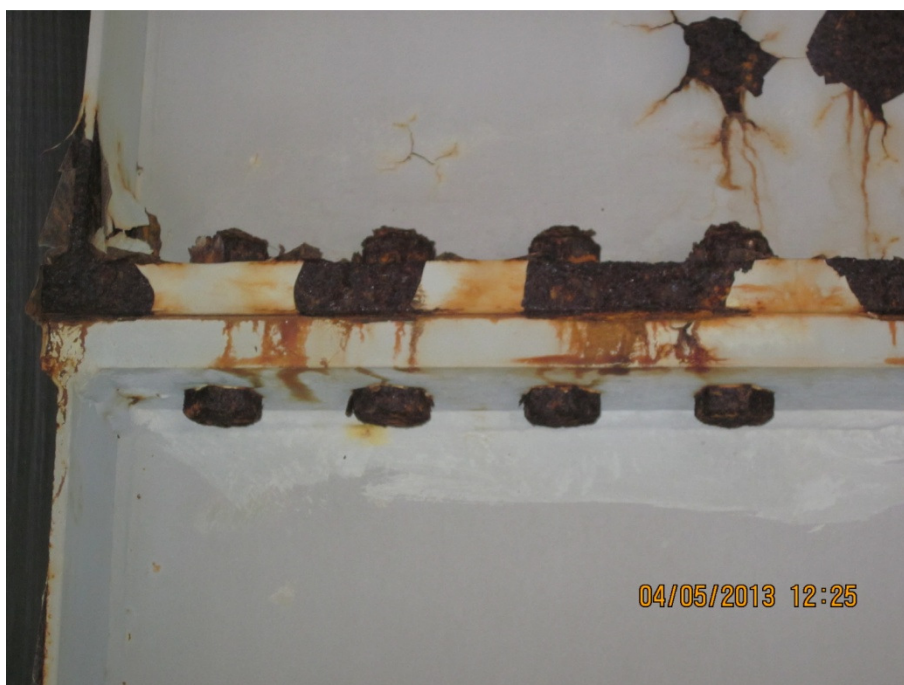
**Figure 2: Corrosion on Bolted Connection**

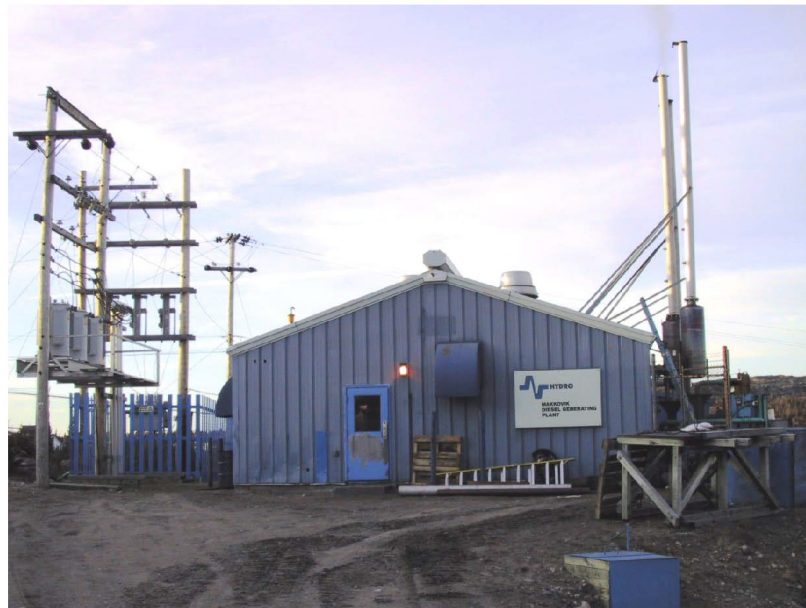
The building is constructed with metal siding and roofing. Over the years, the siding has become damaged and weathered. Also, there are many patches around the perimeter due to repairing the damaged areas and covering unused equipment penetrations. Figure 4-1 shows an example of the damaged metal siding on the north side of the building.

Figure 4-1: Makkovik Generator Plant North End

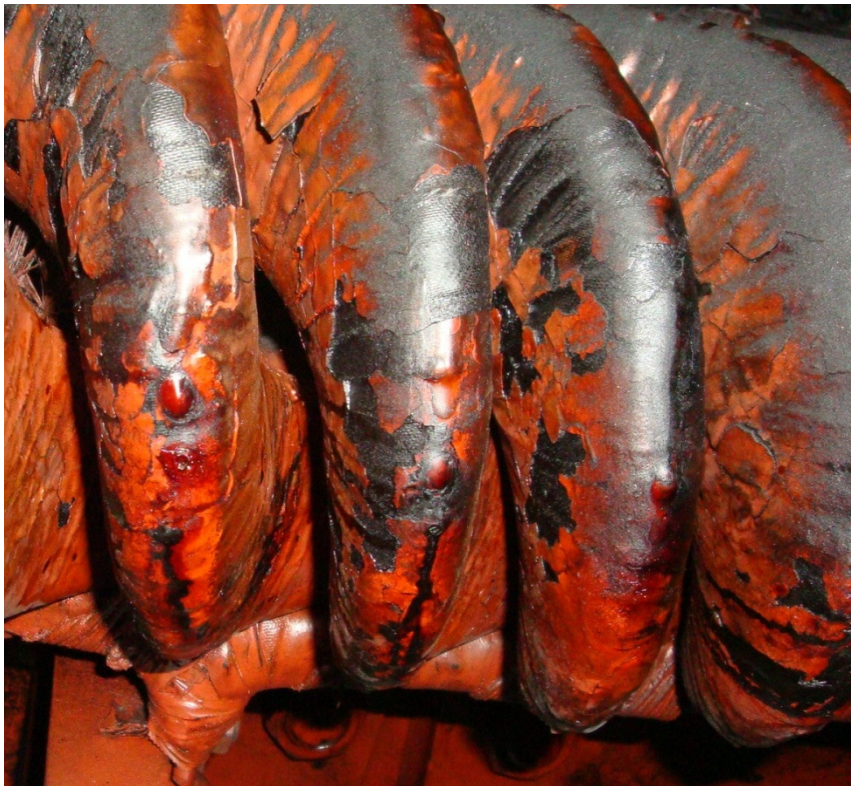
The replacement of Unit 3 is the final winding replacement of the stage 1 units, all of which were beyond their useful service life of 40 years and have deteriorated to a level of possible failure during operation. During regular preventative work on Unit 3, as with the previous units of stage 1, Unit 3 has shown signs of deterioration that include brittle insulation as shown in Figure 5 below, along with seeping asphalt from many locations of the winding, both being indicators of increased wear, insulation breakdown and the end of serviceable life for the winding. Unit 3 electrical testing for partial discharge (PD) produced poor results showing the winding is within the 90<sup>th</sup> percentile, indicating future problems. See Appendix A, section 4.3, page 13. This level of partial discharge indicates Unit 3 has poor insulation levels and has a high risk of failure.

**Figure 5: Existing Stator Winding**

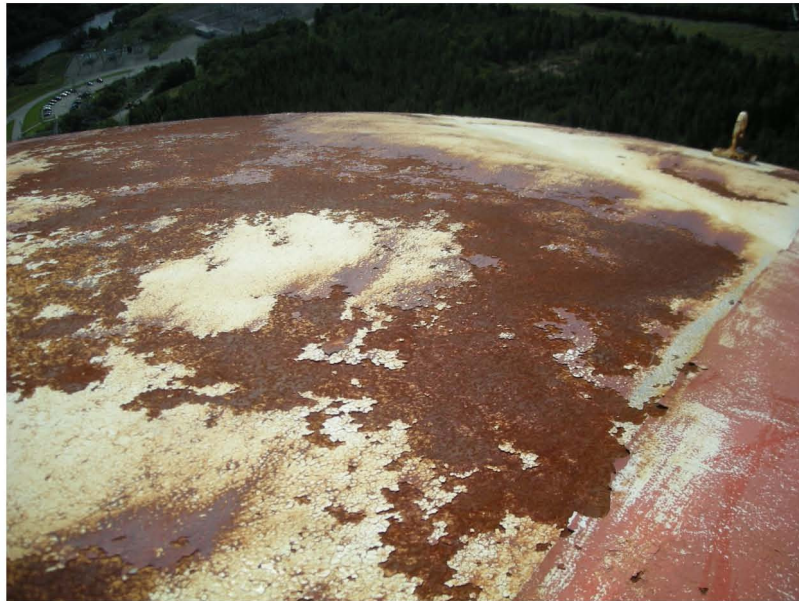
Figure 4-1: Tank Top Showing Significant Coating Breakdown

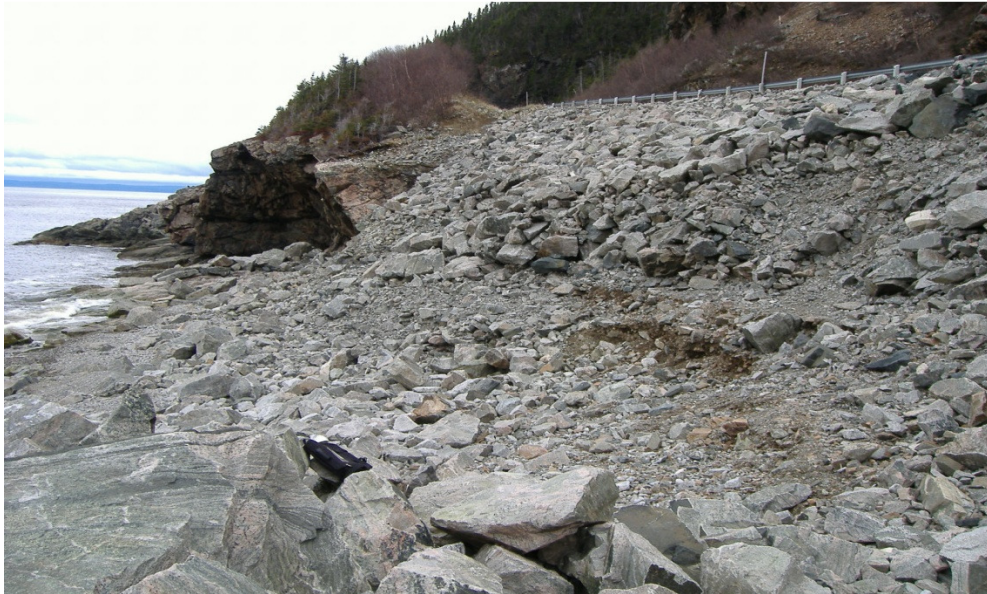
**Figure 2: Eroded Section of Road Embankment**

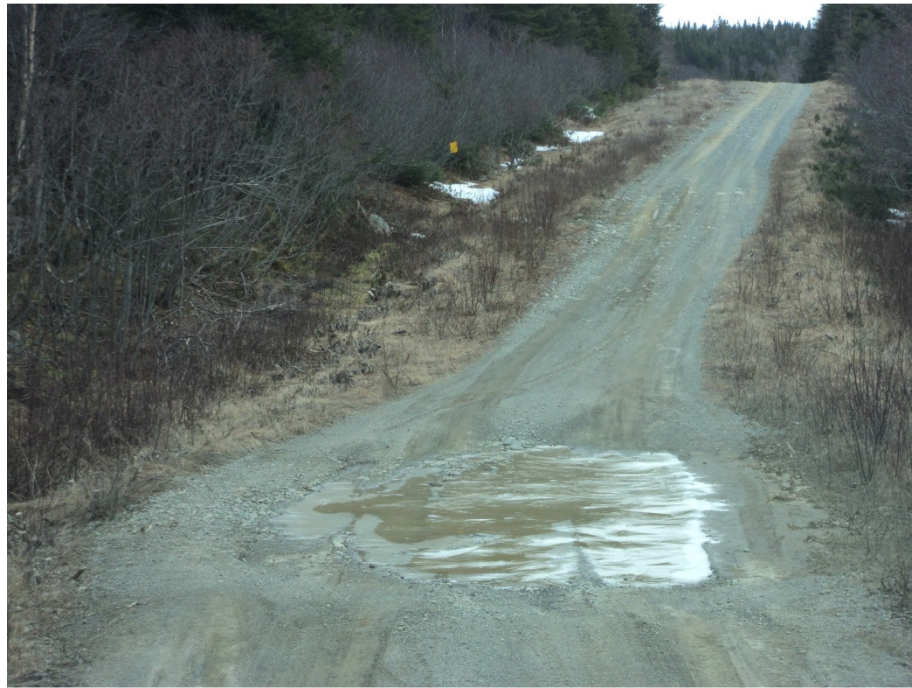
**Figure 3: Inadequate Drainage**
