1 **Q. Please describe how distribution substation equipment repairs are prioritized and**  
2 **state the repair-by time limits for each prioritization.**

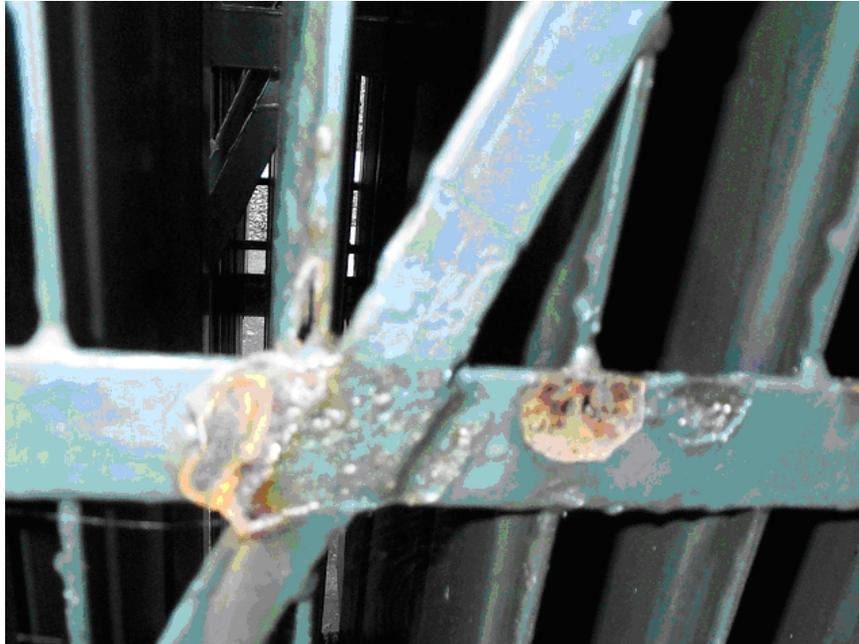
T3 transformer is in good condition. T2 transformer has cooling radiator fin edges that are perforated due to rusting. The perforated fin edges have been patched as a temporary measure to prevent leaking but require replacement. The lightning arrestors on T2 and T3 transformers are silicon carbide and require replacement with metal oxide arrestors. The air break switch on T2 transformer is 30 years old and requires replacement. Protection against small animals should be installed on the 25 kV equipment and bus. A maintenance overhaul is required for the T2 and T3 power transformers in 2007 which will be completed at the same time as the required capital work.

Deteriorated radiator fin edges – Blaketown Substation

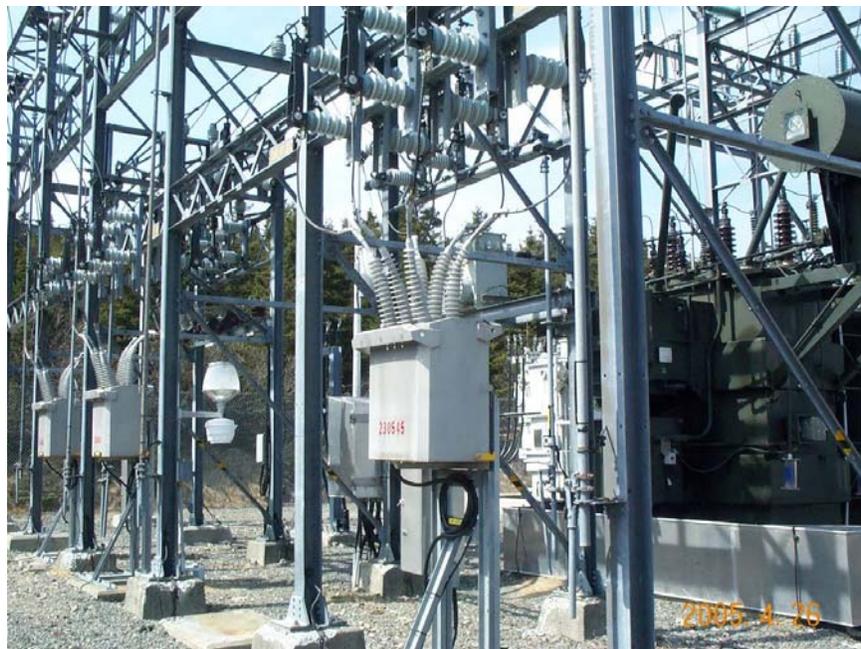
**Foundation damage at Clarkes Pond Substation**

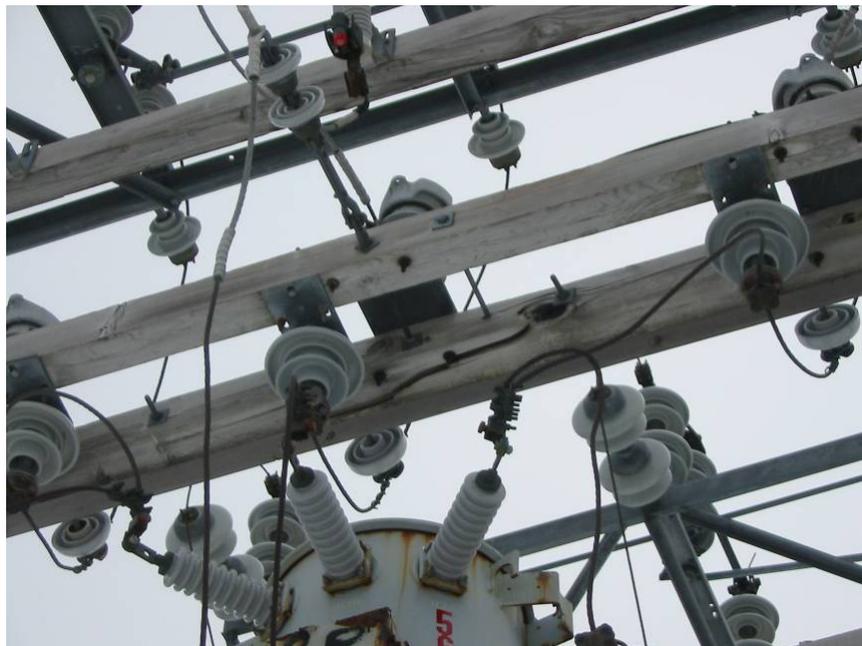
**Cracked crossarm Garnish Substation**

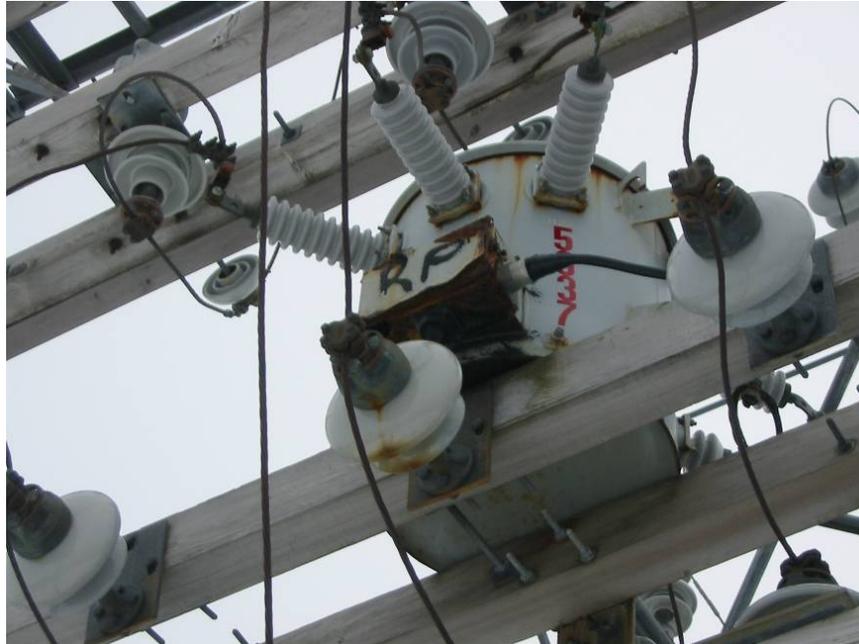
**Corrosion damage Garnish Substation**

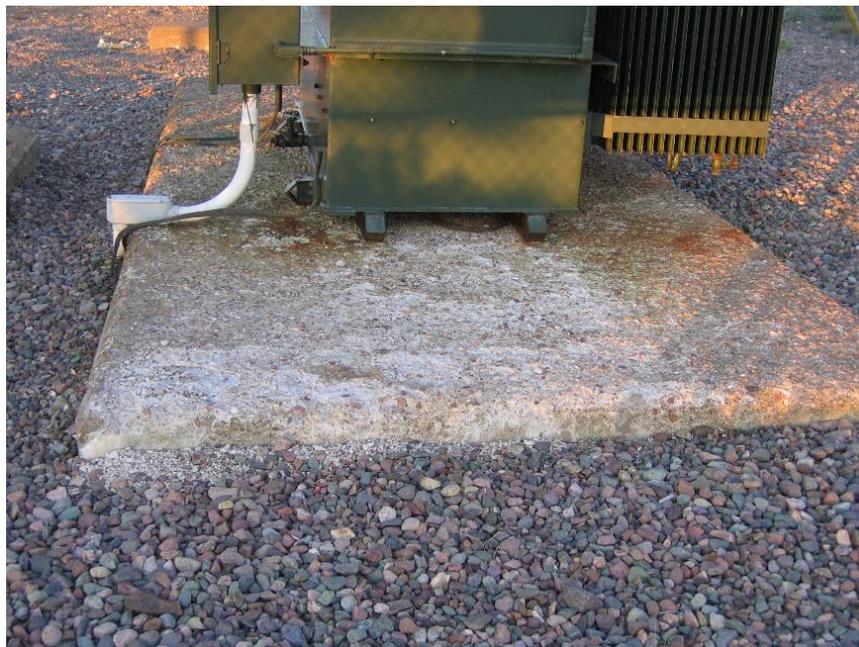
**Foundation damage Garnish Substation**

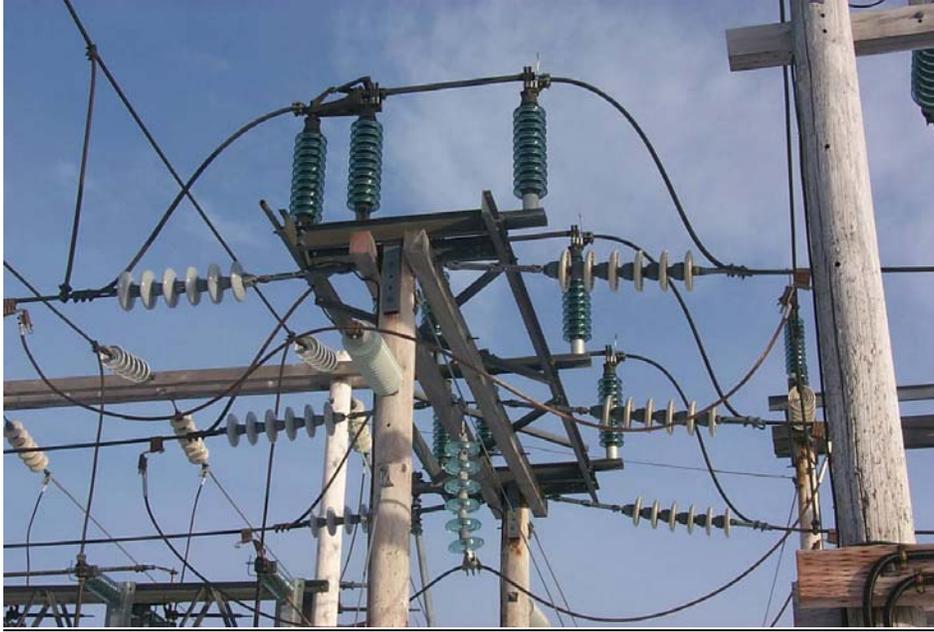
The radial line 17L to Big Pond substation requires a bypass switch to facilitate maintenance on the breaker. The 66 kV potential transformers are over 40 years old and showing signs of deterioration. These potential transformers are essential for providing protection for the transmission lines and equipment at Goulds substation and must be replaced to maintain reliability. A maintenance overhaul is required to be completed on the three power transformers in 2007 which will be completed at the same time as the required capital work.

**Bus Tie Switch Bypassed Goulds Substation**

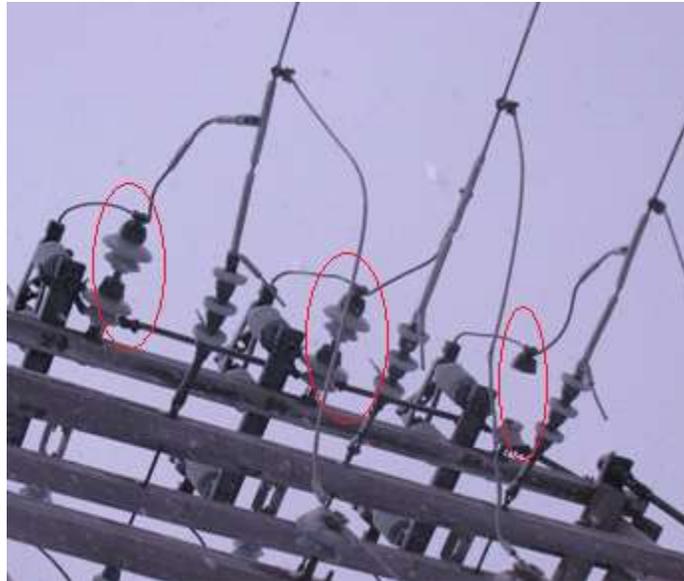
**Low Voltage Structure Insulator Missing**

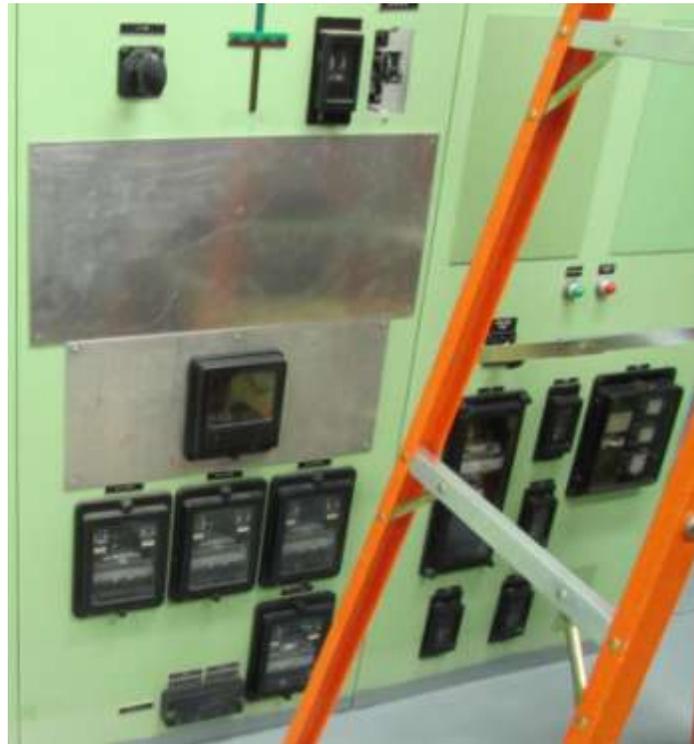
The existing transformer protection relays are electromechanical types that are original to the 1965 substation construction.<sup>7</sup> The 48 year old transformer protection will be replaced with new microprocessor based digital relays. In addition, a complete communications package including a gateway will be installed, to facilitate remote monitoring and control of the various protection elements within the substation. The monitored protection elements will include the T1 transformer protection and 4 intelligent reclosers.

**Transformer Protection Panel (Electromechanical Relays)**

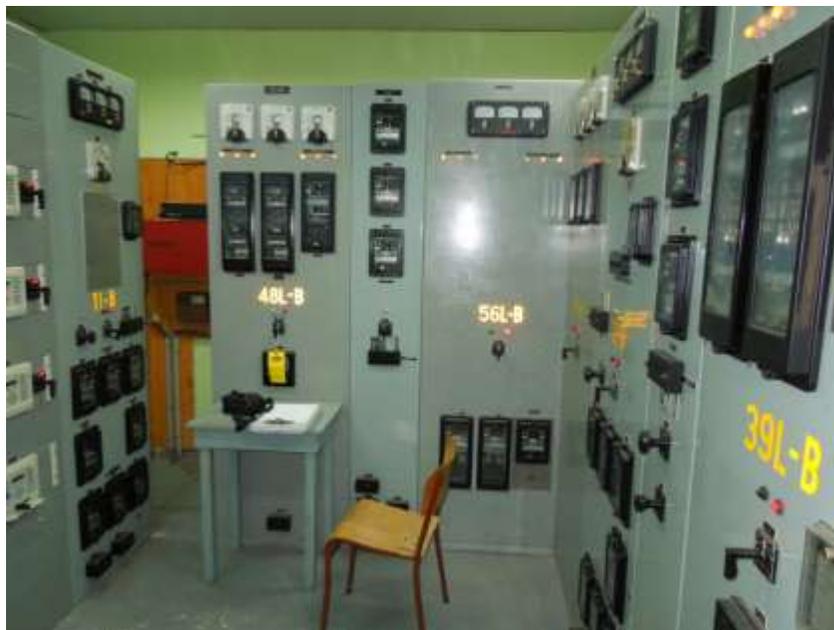
At present, there are 42 electromechanical relays installed in 9 individual protection panels inside the substation control building. These relays, used for the protection of 4 transmission lines, 3 transformers and 2 bus structures are vintage electromechanical type, ranging in age from 35 to 45 years old. Electro-mechanical relays contain moving parts and are prone to failure as they age, wear, and accumulate dirt and dust. The age of these relays dictate they are to be replaced.

**Electromechanical Relay Panels**

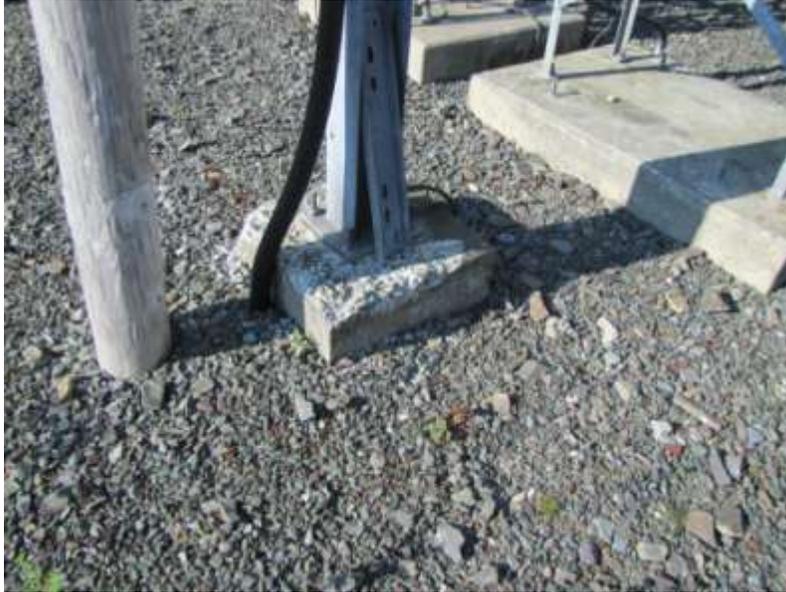
**Deteriorated 15kV Pothead Structure Column Foundation**

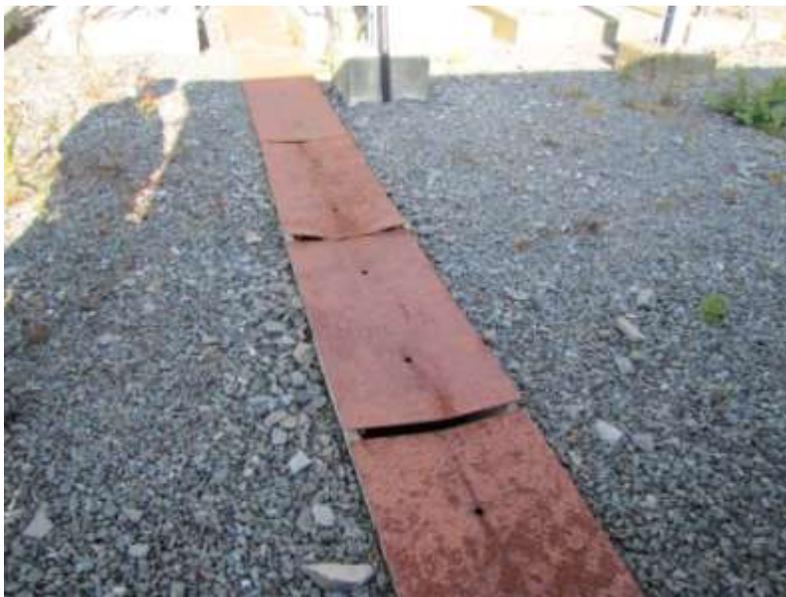
A large section of cable trench and 26 trench covers will be replaced with rust-resistant trench covers.<sup>33</sup> A large section of substation fencing is in need of replacement due to frost heaving. The root cause of the frost heaving issue is poor drainage in that area of the substation, and to correct this issue, a continuous ditch will be created around the perimeter of the substation.

**Deteriorated Cable Trench Covers**

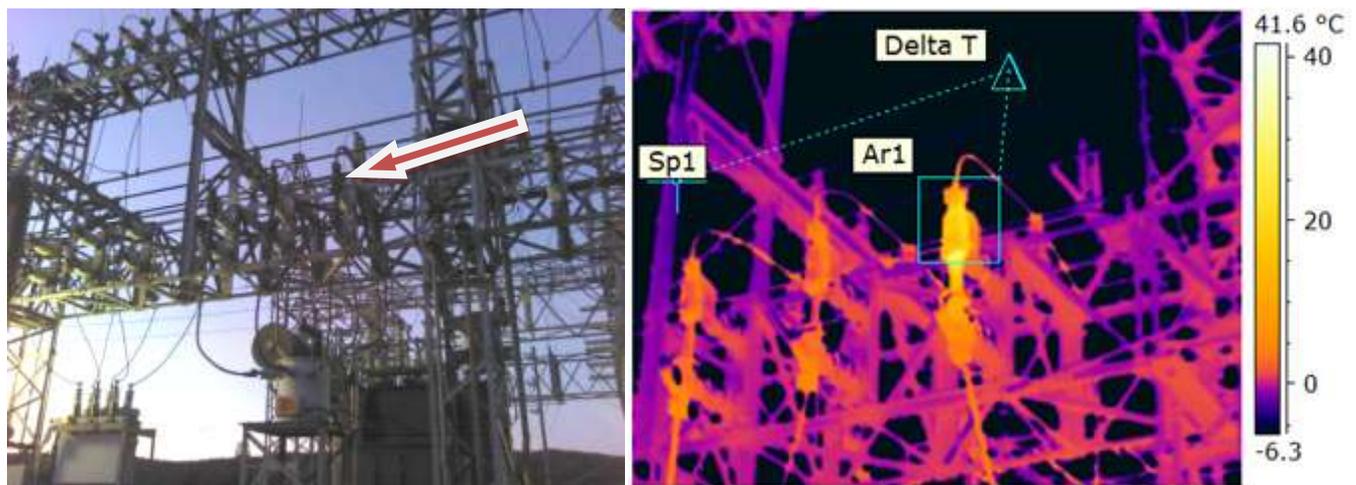
In addition, all 1974 vintage high voltage and low voltage switches will be replaced due to their age and the presence of multiple hot spots in the current carrying path.<sup>35</sup>

CAR-T1-D Switch Replacement (Hot spots visible with infrared camera)

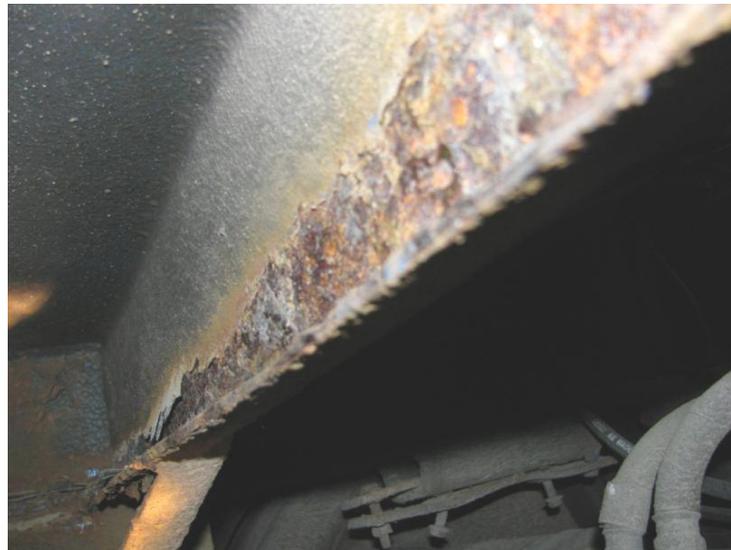
**Deterioration on Chassis above Axle**

The trailer will undergo an overhaul addressing rust damage and applying a rust inhibiting coating to the chassis. A fall arrest system and work platforms will be installed in areas where employees have to work aloft. External lighting will be provided at locations around the trailer.

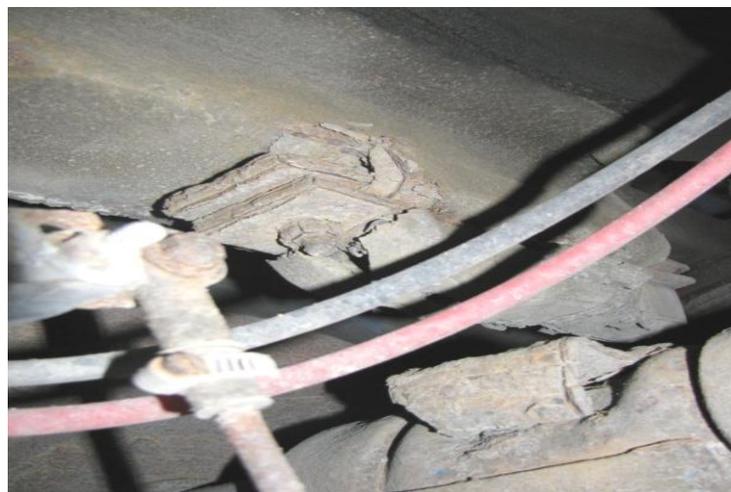
**Deterioration on Axle**

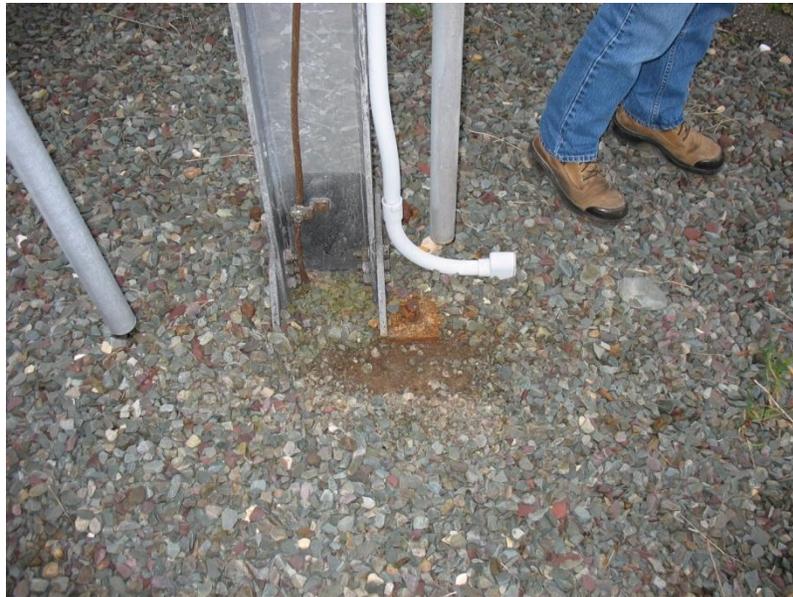
**Severe Rusting On Anchor Bolt**

The fence is showing significant deterioration and sections will be refurbished or replaced. There have been issues with flooding in the station and drainage improvements will be made to prevent re-occurrence. The ground grid for the substation will be extended to improve safety for personnel inside the substation

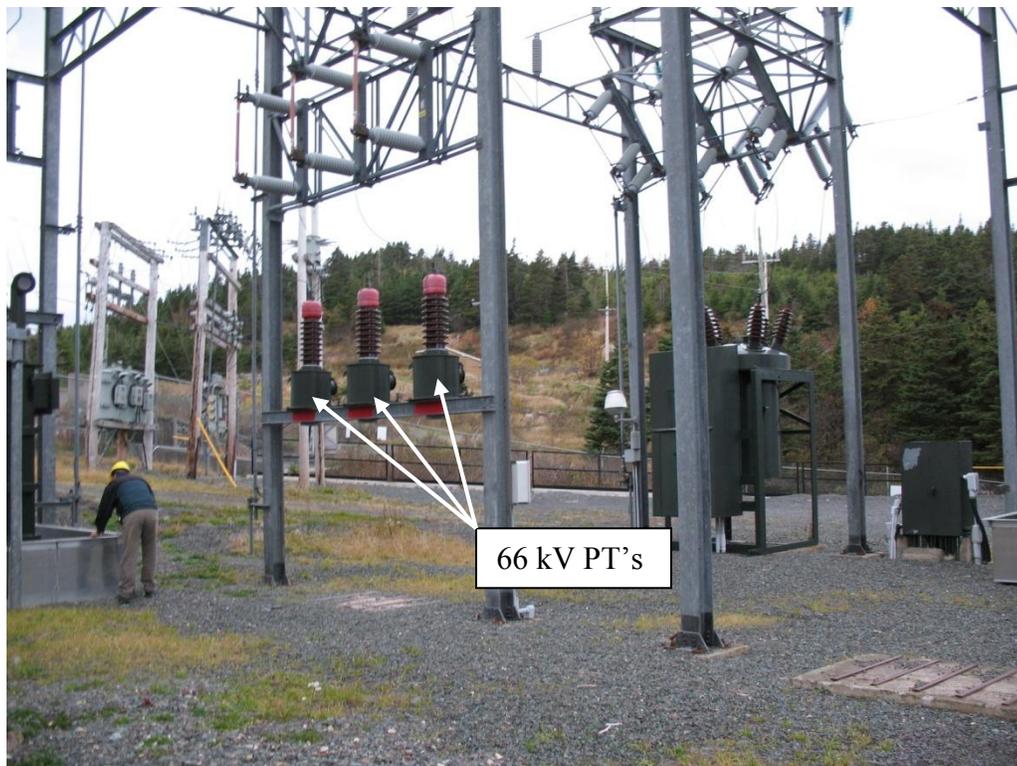
**39 Year Old Potential Transformers**

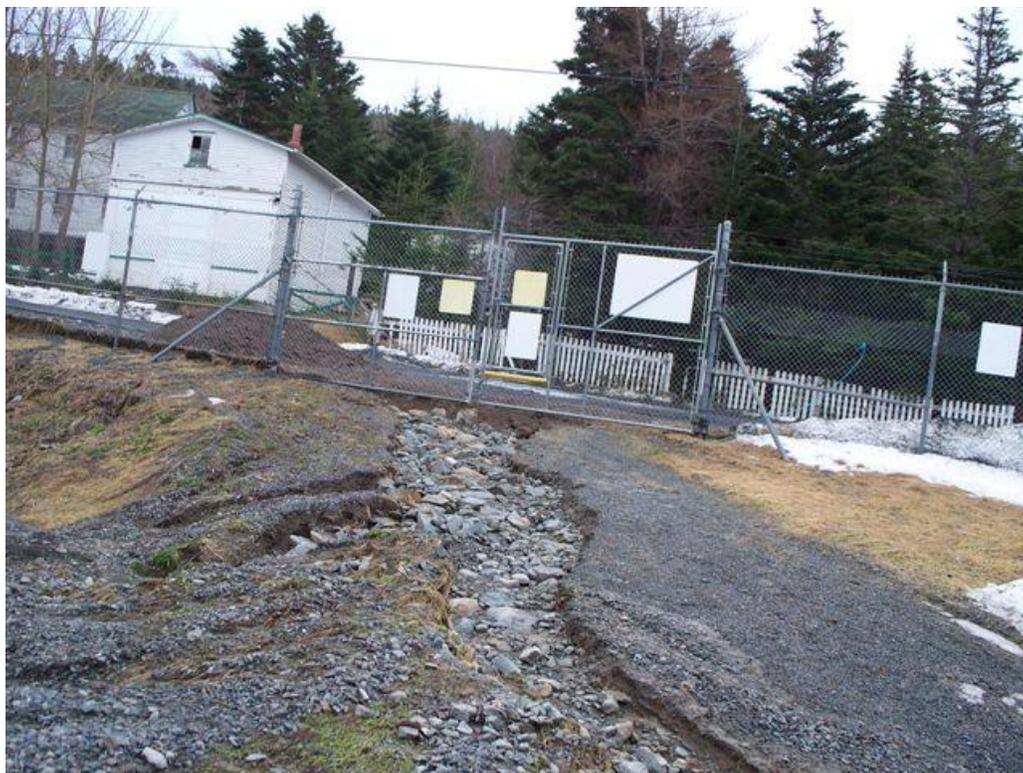
Damage Due To Flooding

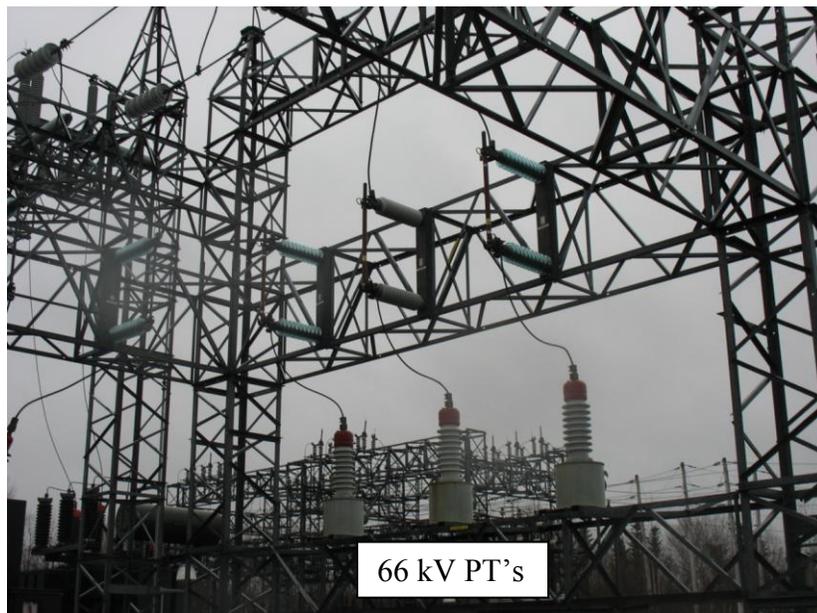
The 25 kV potential transformers and 66 kV potential transformers on 101L show significant deterioration and will be replaced. A new set of 25 kV potential transformers will be installed on the 25 kV bus of transformer T3 for protection and monitoring when T2 & T3 transformers are not operating in parallel.

66 kV potential Transformers

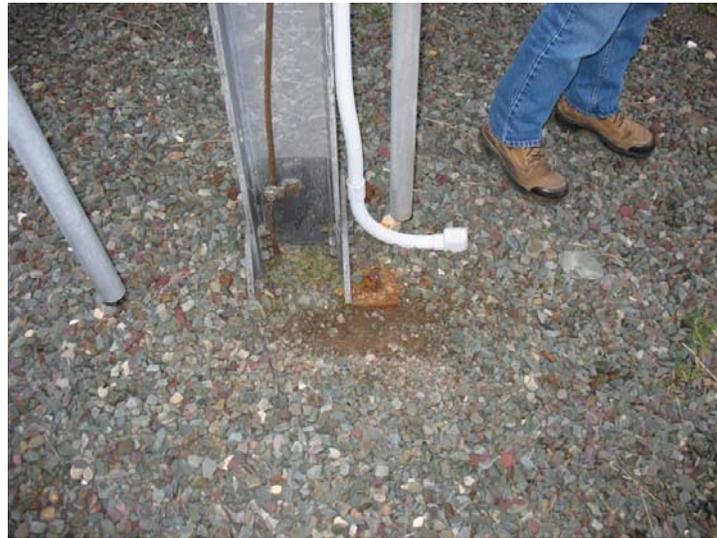
Maintenance records and on-site engineering assessments show that the 66 kV steel structures and bus are in good condition. Some of the structure foundations are in poor condition as anchor bolts have rusted off. These foundations will be replaced.

**Severe Rusting On Anchor Bolt**

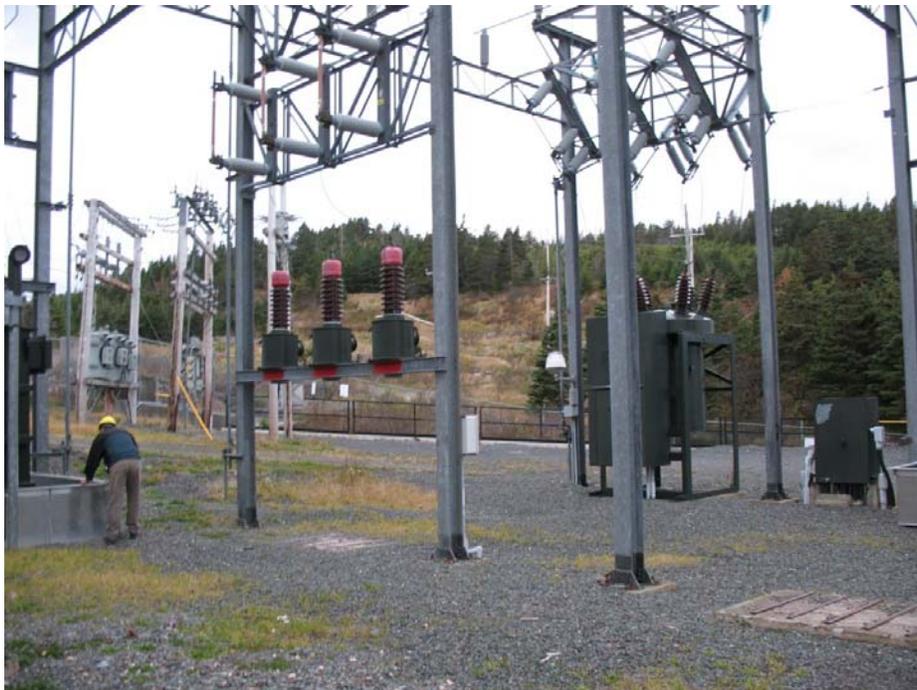
**39 Year Old Potential Transformers**

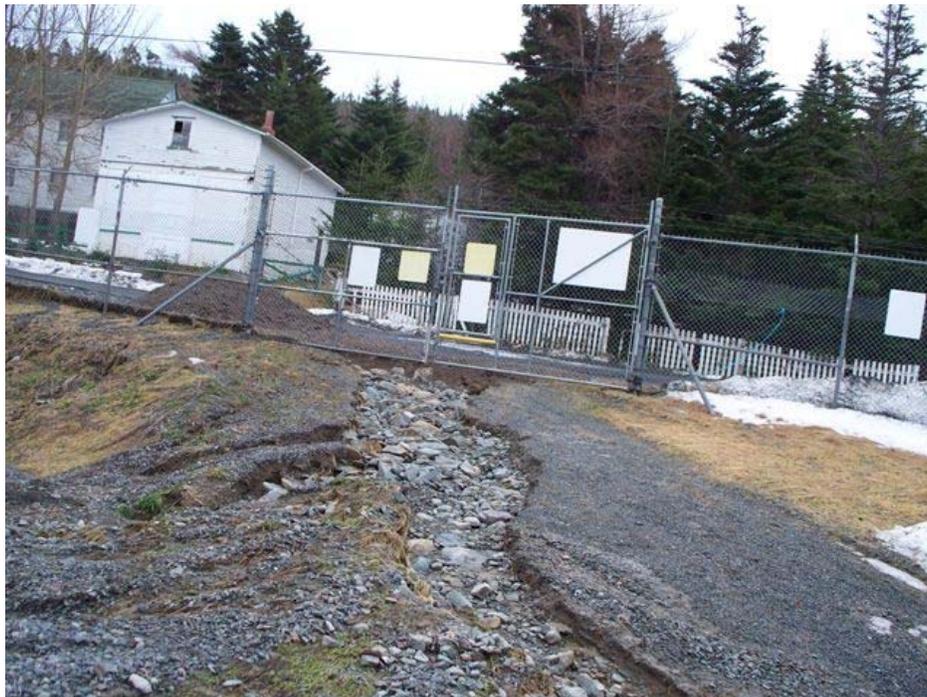
Damage Due To Flooding

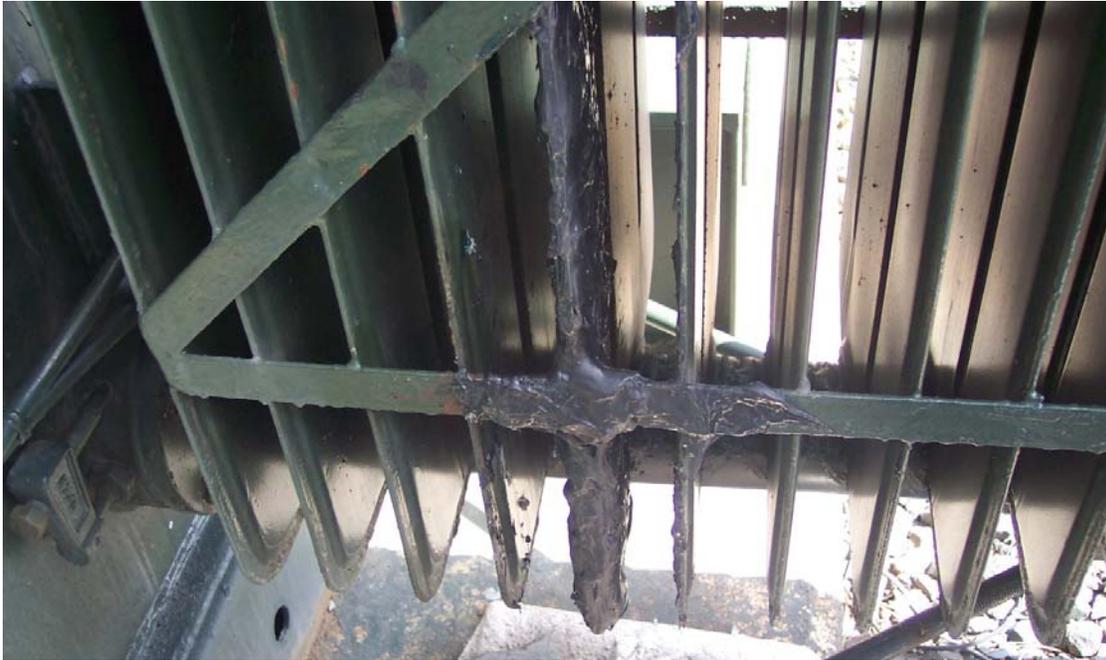
Patched Radiator on SLA-T2

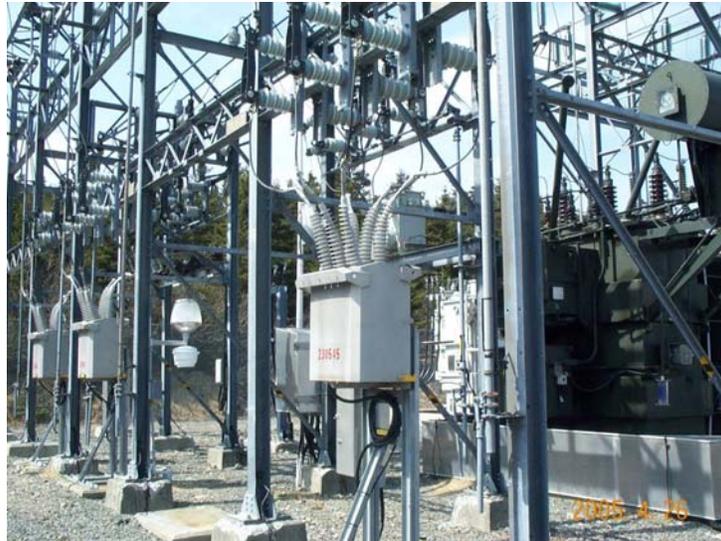
Foundation damage at Clarkes Pond Substation

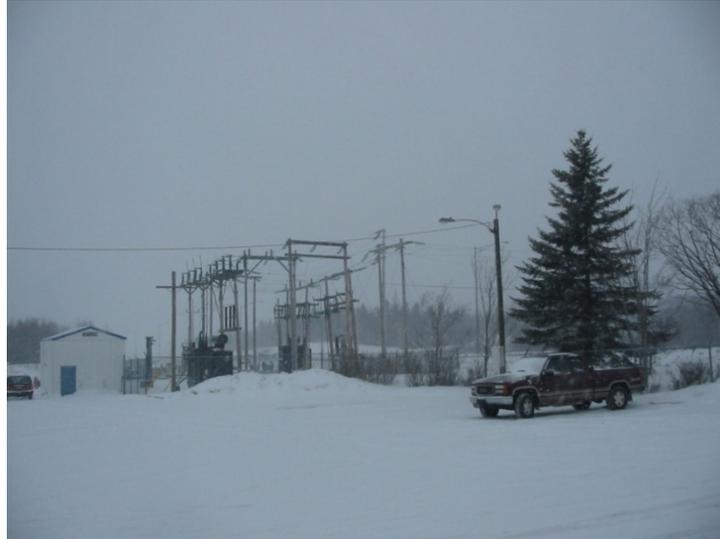
**Grand Falls Substation 66 kV Wood Pole Structures (Leaning)**

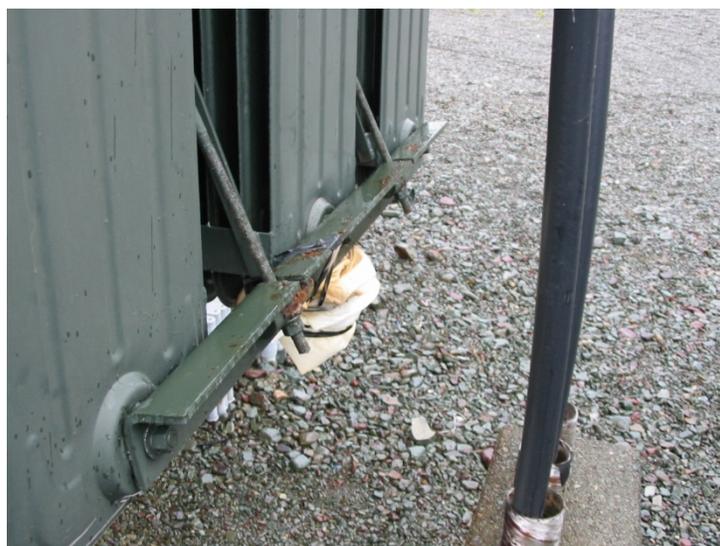
Leaking Radiator

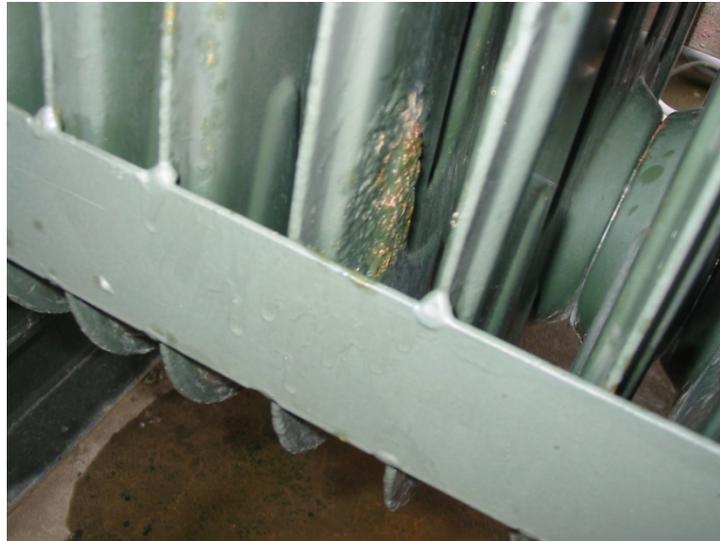
**Deteriorated Radiator**

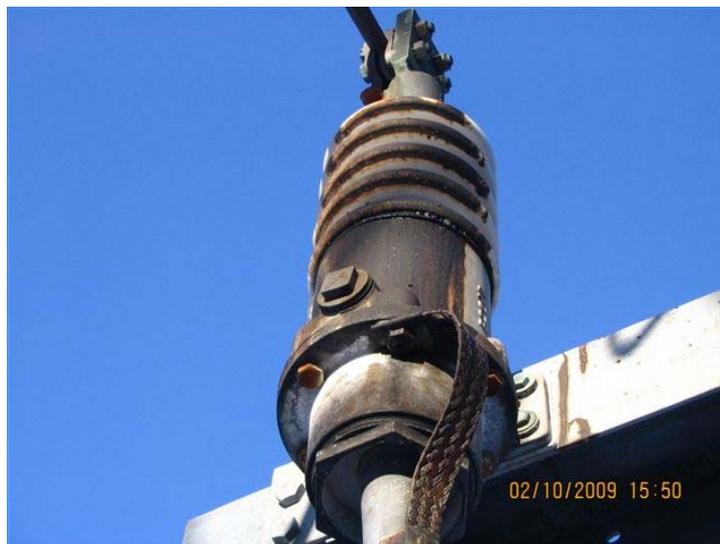
**Leaking 12.5 kV Potheads**
