1 **Q. Please describe how overhead and underground feeder distribution mainline and**
 2 **URD feeder equipment repairs are prioritized and state the repair-by time limits for**
 3 **each prioritization.**
 4

5 **A. 1. Distribution Maintenance in Context**
 6

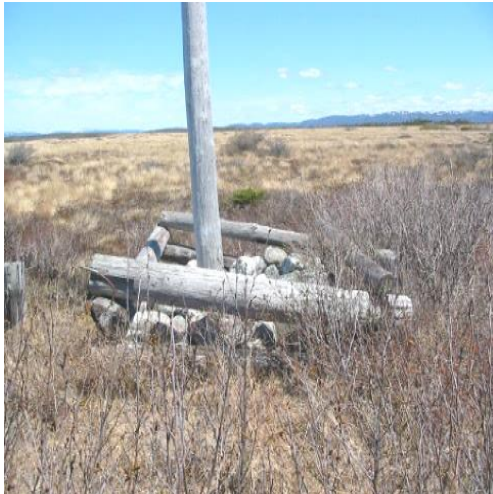
Figure 3: Pole Crib Requiring Repairs

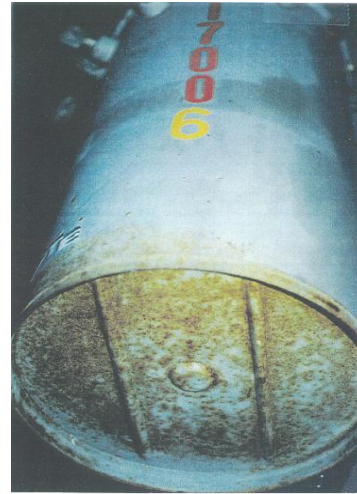
Figure 4: Rusted Transformer

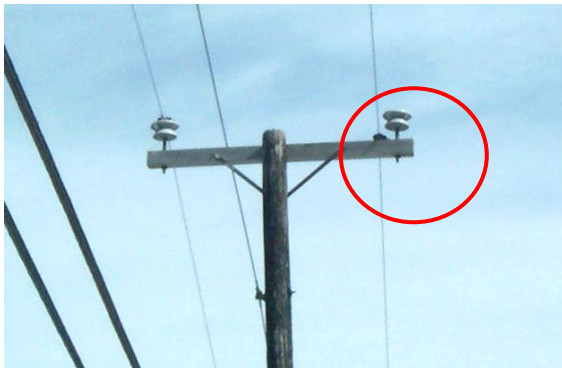
Premature failure of porcelain insulators due to “cement growth” is a known problem through the utility industry.¹² Newfoundland Power began to experience abnormal failures of porcelain insulation in the early 1980s.¹³ Since that time, the Company has replaced a significant number of defective CP8080 suspension insulators and 2-Piece pin-type insulators.¹⁴

Figure 6: Broken Insulator In Service

¹⁴ CP8080 suspension insulators fail by radial cracks, which are sometimes contained inside the metal cap and are not visible. The crack causes a current path between the metal cap and pin and shorts out the insulator. Pin type and pin cap type (2-Piece) insulators fail by circumferential cracks. Failure is usually mechanical; the top shears off the insulator causing the conductor to float clear of the structure.

- *Locations where CP8080 and 2-Piece insulators remain in service.* In the year following the inspection, insulators identified for replacement are included as part of the *Rebuild Distribution Lines* project.

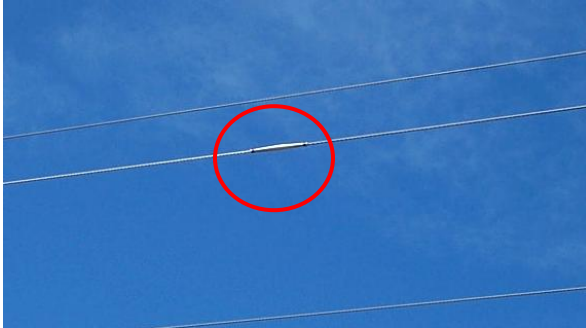
nine years in service these automatic sleeves began showing signs of premature deterioration, in large part due to our severe environmental conditions.¹⁹

Figure 9: Automatic Sleeve In Service

- *Locations where automatic sleeves remain in service.* In the year following the inspection, automatic sleeves identified for replacement are removed as part of the *Rebuild Distribution Lines* project.

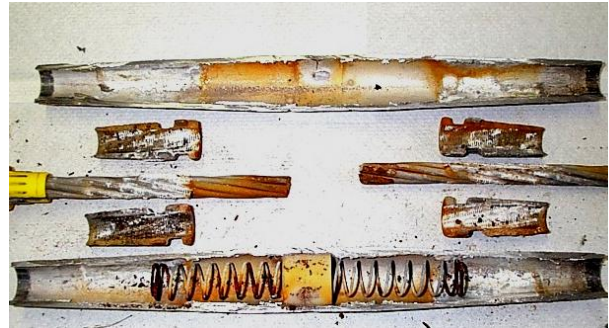
Figure 10: Disassembled Automatic Sleeve Showing Corrosion

First indications of a problem surfaced in early 2002 when an automatic sleeve failed. An investigation followed which showed a high percentage of sleeves were experiencing signs of water ingress and internal corrosion.²⁰ The potential risks to public and employee safety, as well as system reliability prompted the Company to discontinue the use of automatic sleeves by the fall of 2002.²¹

²⁰ In the Fall of 2002, a total of 35 sleeves were removed from various areas throughout the Company and inspected. The results indicated widespread internal deterioration of automatic sleeves. 71% of the sleeves removed showed at least some corrosion with 37% being severely corroded.

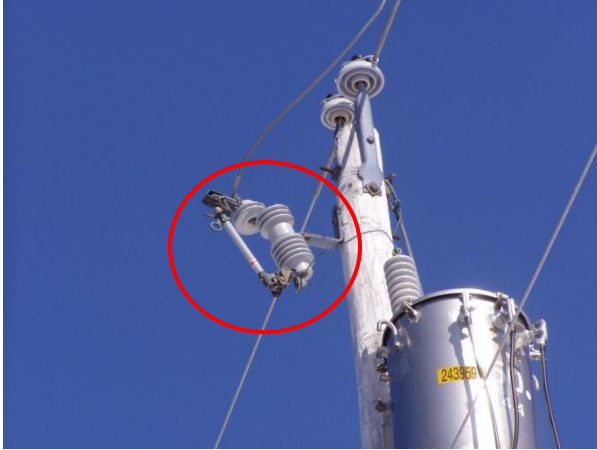
Porcelain insulated cutouts have been in use in the electrical industry for many decades.²² Throughout that time, design and manufacturing processes have changed somewhat, but porcelain remained as the basic insulating material. In 2000 and 2001, the Company began to experience incidents of failed porcelain cutouts. Through 2002 and into 2003, hundreds of cutout failures were reported, and line personnel became increasingly concerned with the safety hazards associated with cutout failures.²³

Figure 11: Broken Porcelain Cutout In Service

- *Locations where porcelain cutouts remain in service on the main trunk of distribution feeders, as well as lateral taps and large customers.* In the following year porcelain cutouts identified for replacement are removed as part of the *Rebuild Distribution Lines* project.

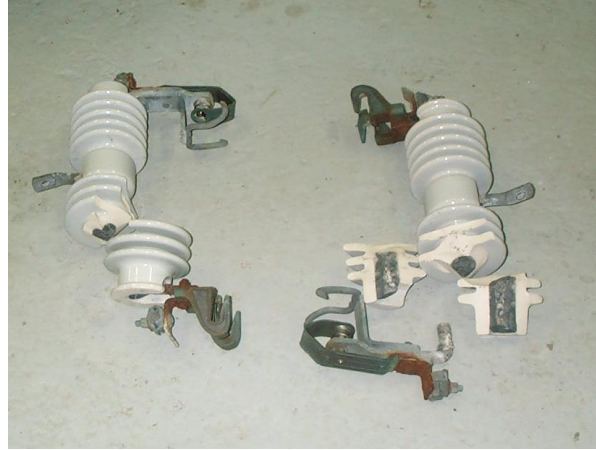
Figure 12: Two Broken Porcelain Cutouts Removed From Service

In 2003, as a result of the increasing rate of failures, the Company decided to discontinue the use of porcelain insulated cutouts and adopt the polymer insulated cutout as its new standard.²⁴

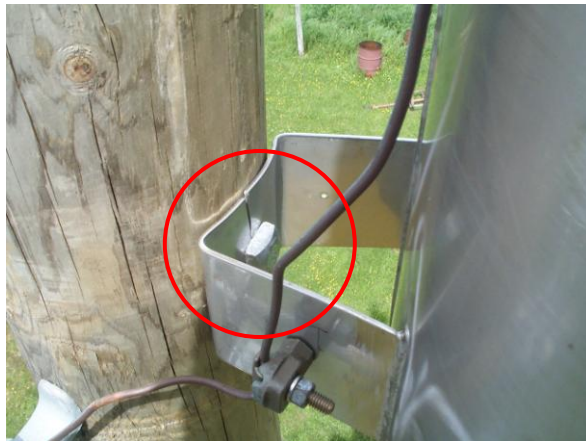
The Company began purchasing pole mounted transformers manufactured with 316L stainless steel in 2001. This was done as a result of numerous failures due to rusting transformer tanks, largely due to higher levels of salt contamination in Newfoundland. After several years of using the new stainless steel tank design, the issue of broken hanging brackets began to surface on 25 kVA and 50 kVA transformers.²⁶

Following discussions with the manufacturer it was determined that the hanging brackets were not sufficient for the mechanical forces exerted by higher wind conditions in the Newfoundland environment. To address this issue, the Company changed its specification for stainless steel transformers in 2007, requiring a hanging bracket made of a thicker gauge stainless steel.

Figure 14: Broken Stainless Steel Transformer Hanging Bracket

In total there have been 27 transformer bracket failures reported on stainless steel transformers manufactured from 2001 to 2006, inclusive.²⁷ As a result, the Company has worked with the manufacturer to develop a reinforcing bracket that can be installed on in-service transformers. Beginning in 2013, 25 kVA and 50 kVA transformers manufactured between 2001 and 2006 will be identified and retrofitted with a reinforcing bracket as part of the *Rebuild Distribution Lines* project.

- *Locations of stainless steel transformers manufactured from 2001 to 2006.* In the year following the inspection, transformers identified to be retrofitted with a reinforcing bracket will be included as part of the *Rebuild Distribution Lines* project.
