# Re: *Reliability and Resource Adequacy Study Review* – Labrador-Island Link Failure Investigation Reports

# Failure Investigation Report – L3501/2 Tower and Conductor Damage

Failure Investigation Report – L3501/2 Tower	R	evision R1		
Icing Event January 2021 in Labrador	Date:	Revision R1     :   28-May-2021     :   ii		
Nalcor Doc. No. ILK-EG-ED-6200-TL-RP-0001-01	Page:	ii

# FAILURE ANALYSIS OF ELECTRODE CROSS ARM IN LABRADOR ISLAND TRANSMISSION LINK (LITL)

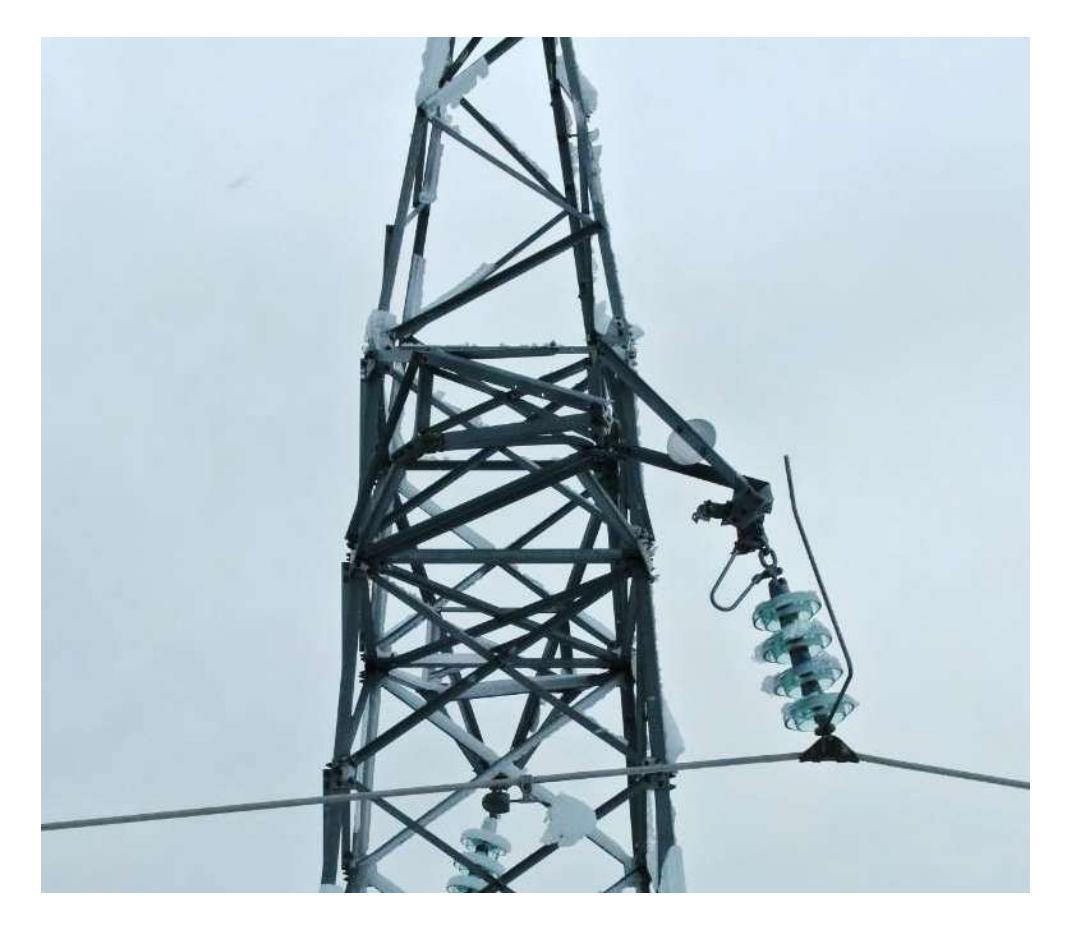
Photo 1 – Str. 364 Broken EL1 Cross arm

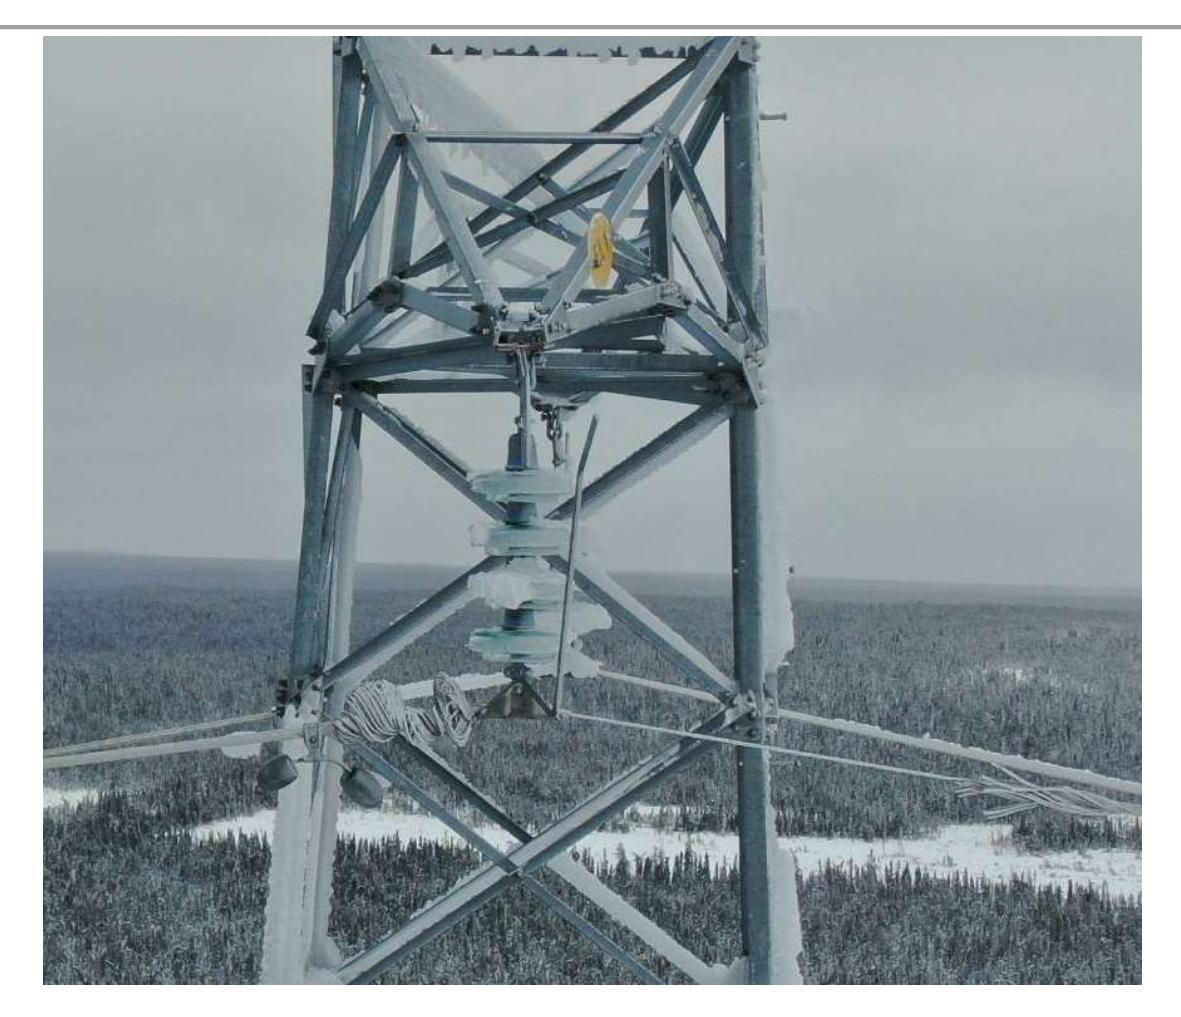
Photo 2 – Str. 365 Severe E1 Conductor Damage

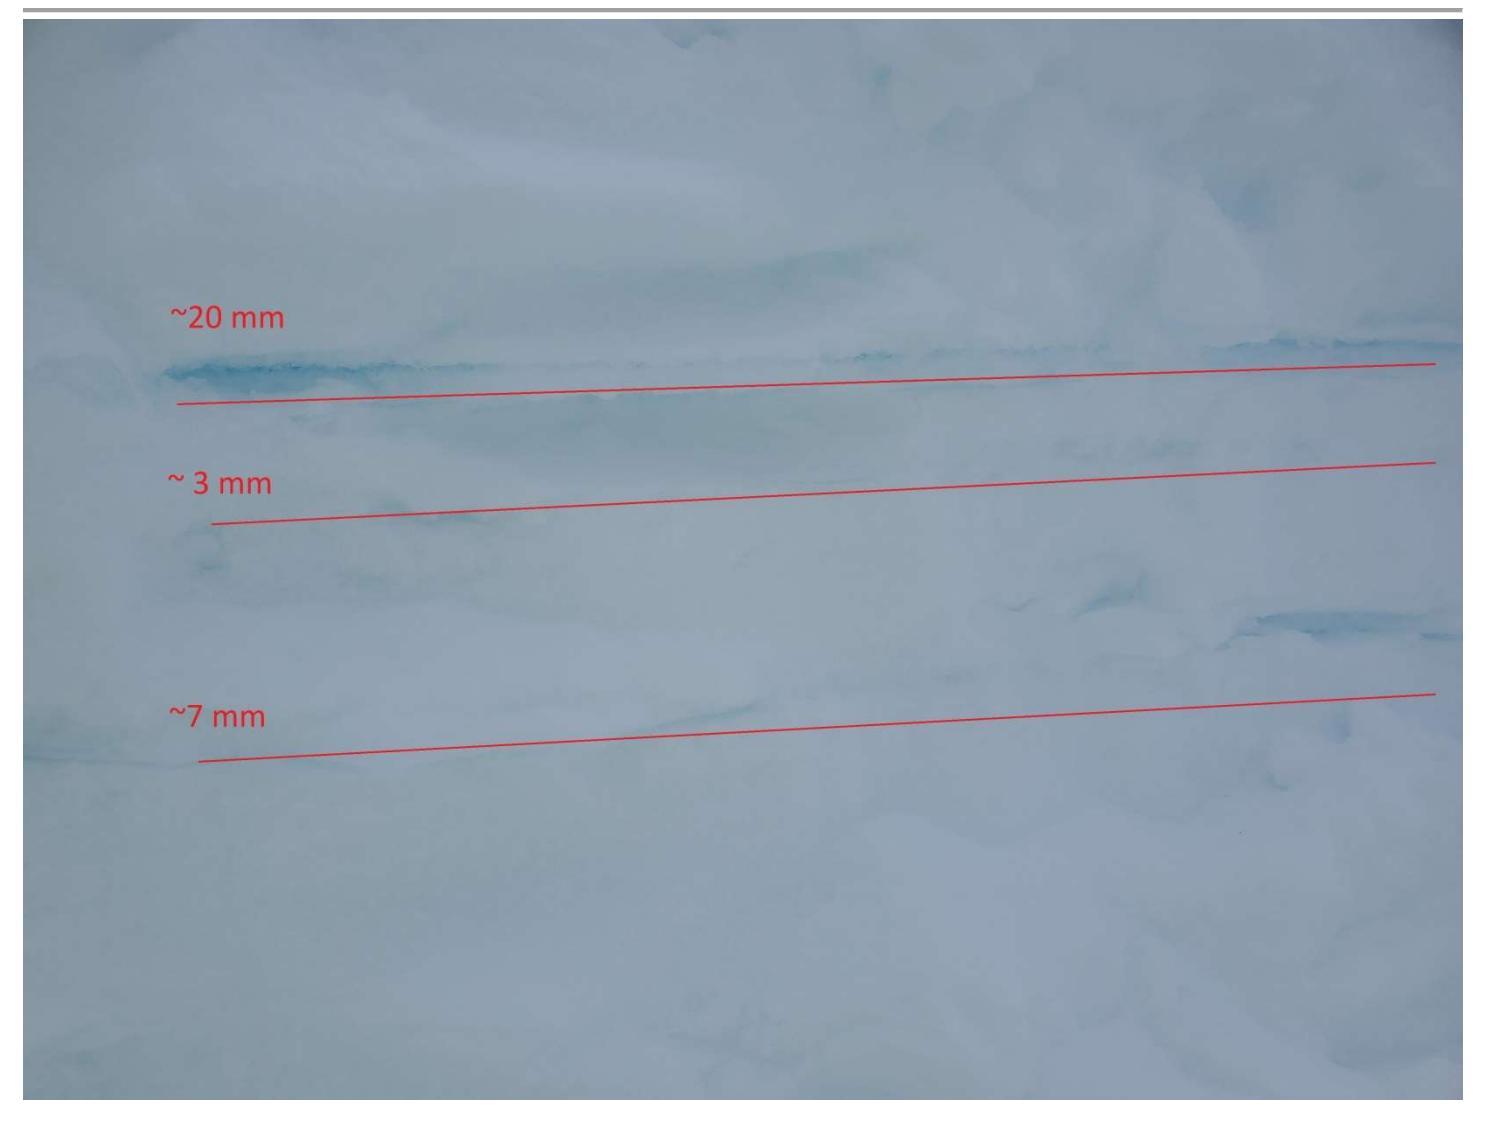
Figure 13 – Evidence of 3 Ice Events (2021.01.27)

Figure 13 shows a cross section of the ground snow located in the area of the damage. Three separate icing events were clearly identified within this cross section, indicating that in addition to the original ice storm, several smaller icing events occurred following adding to the overall accumulation on the line in certain segments.

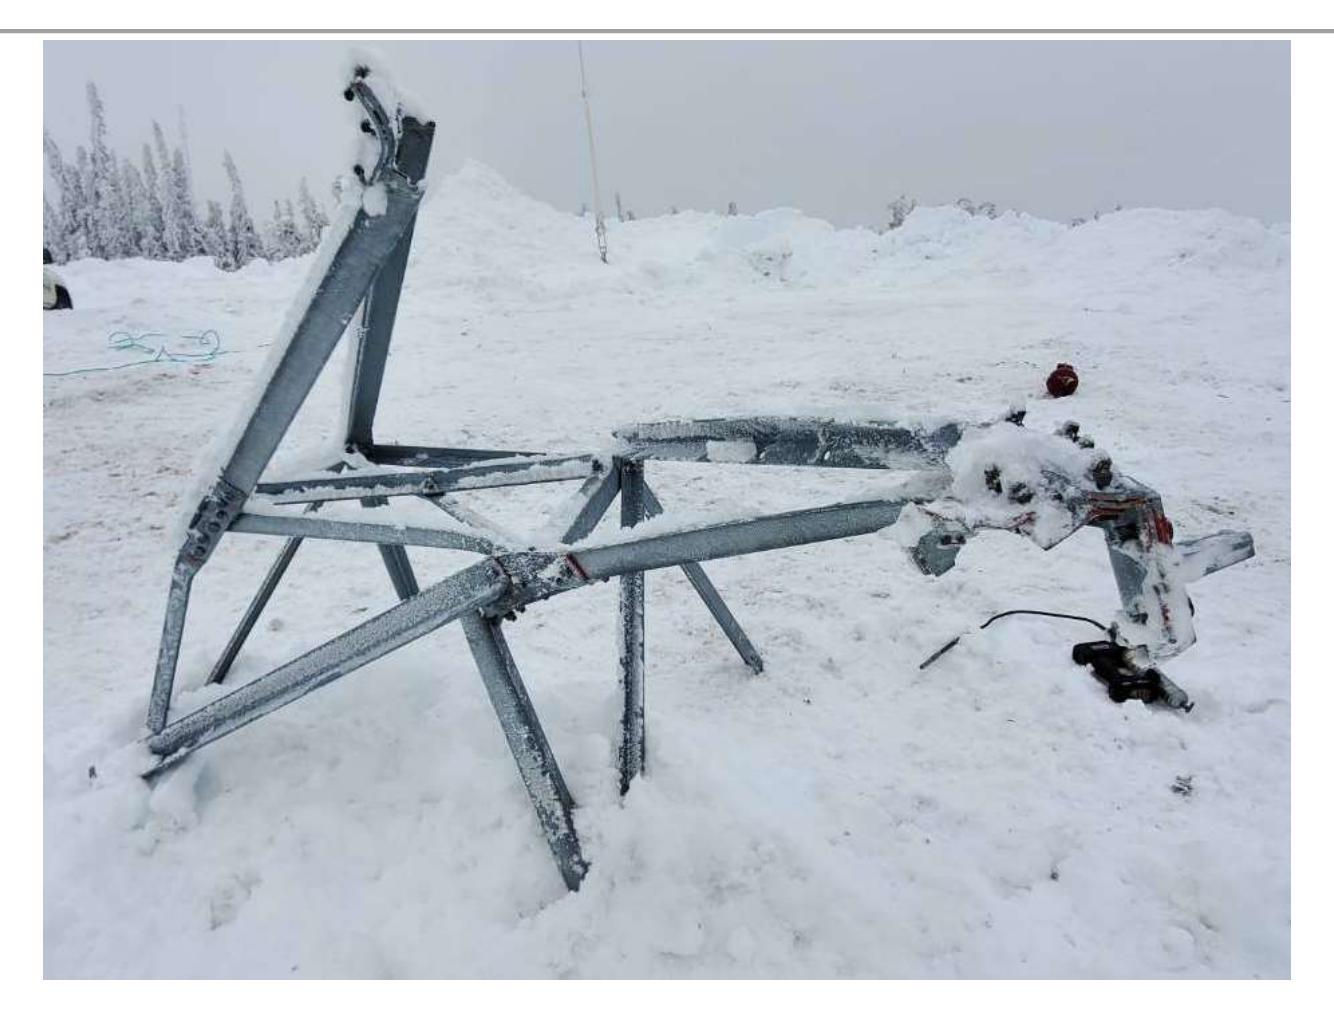
Figure 31 – Damaged Cross Arm from Str. 526

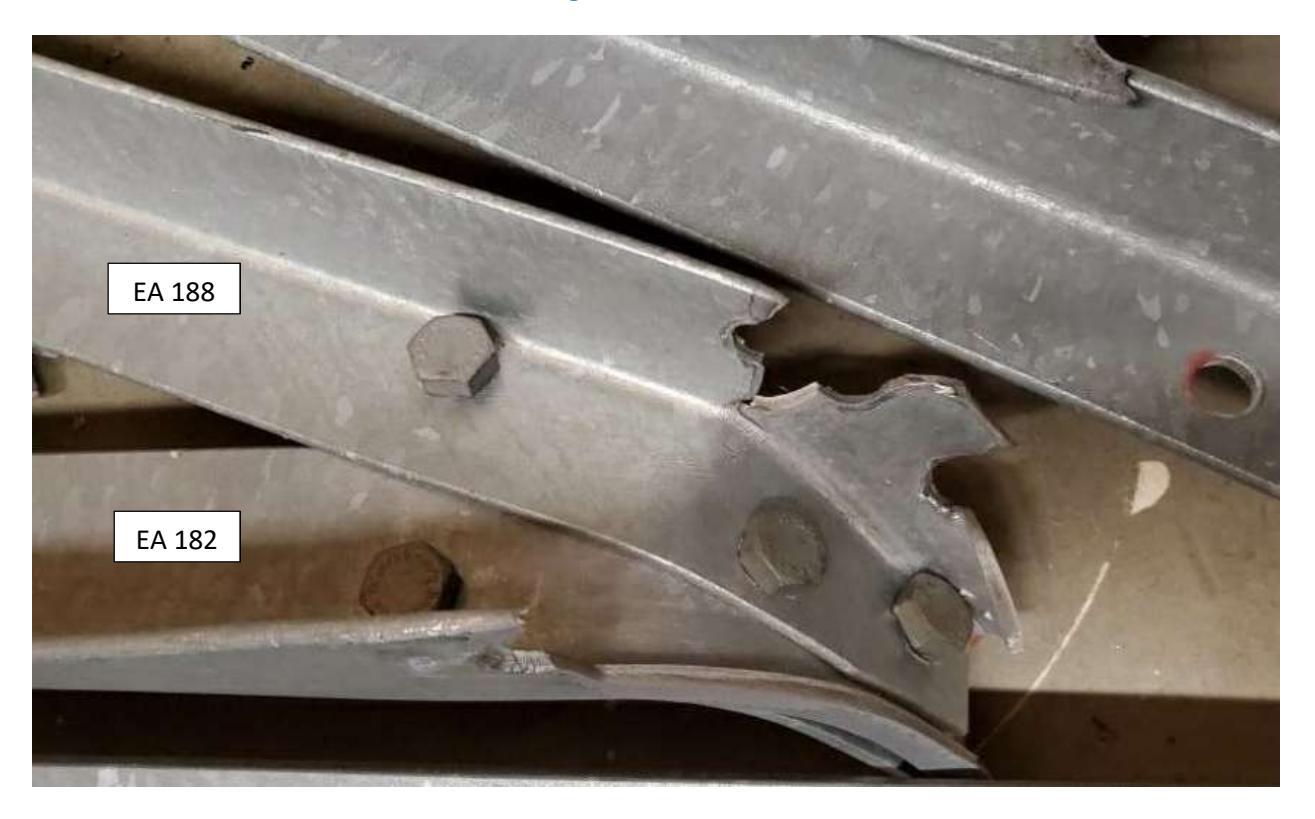
Figure 33 – Str. 340 Close up of Failed Bolt Hole Patterns

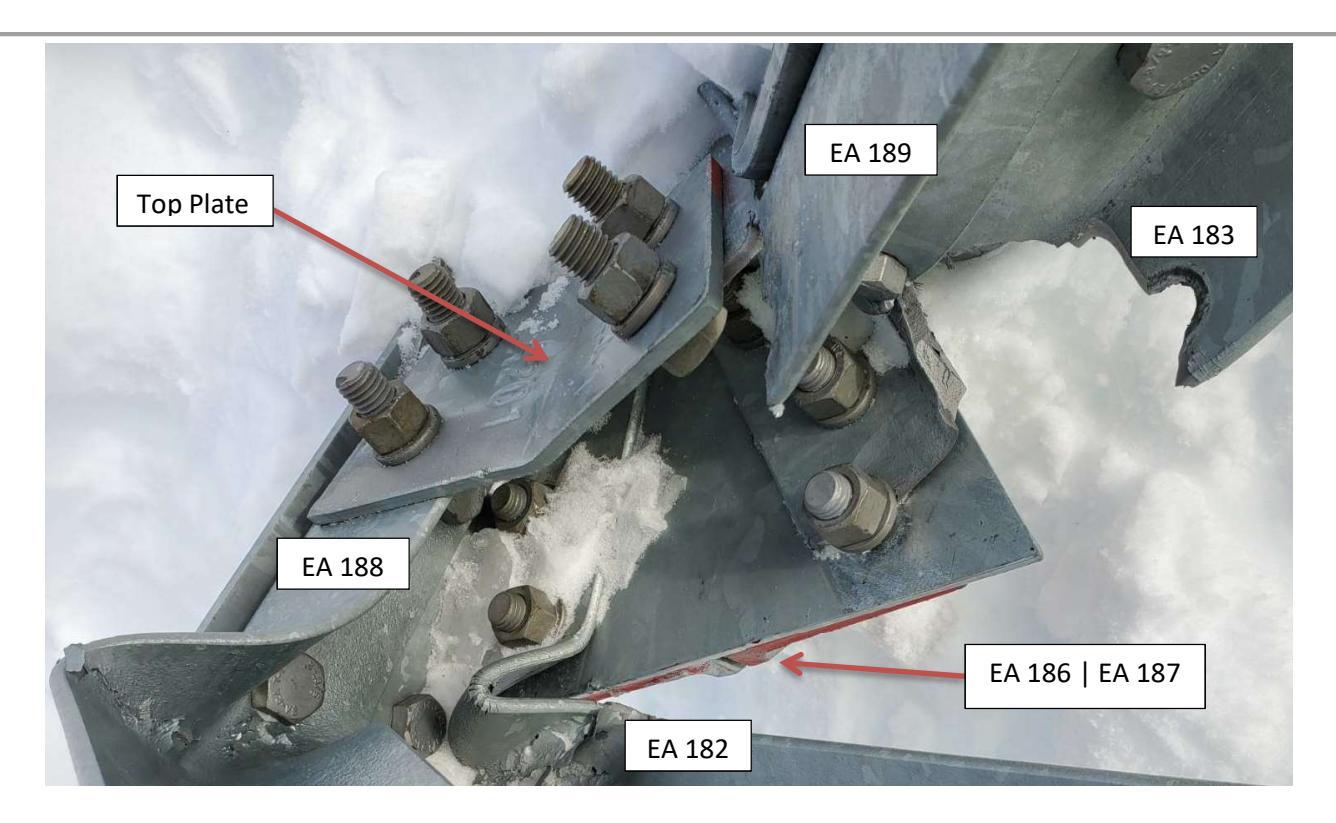
Figure 36 – Str. 343

The failure path of the bolt holes, although not identical, it is quite similar and is caused by similar loadings.

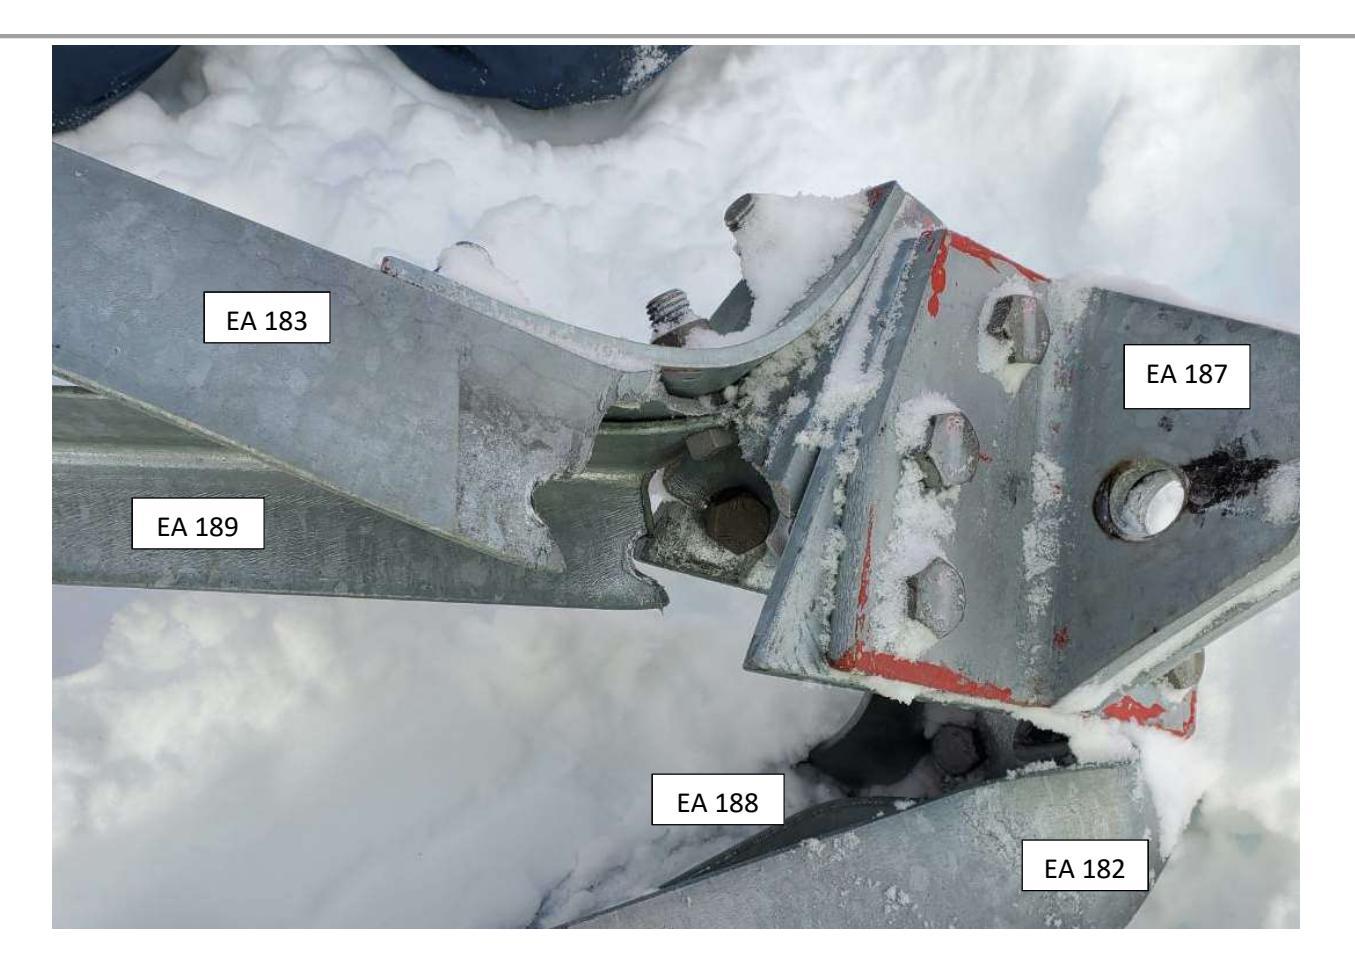
Figure 37 – Str. 343 Alternate View

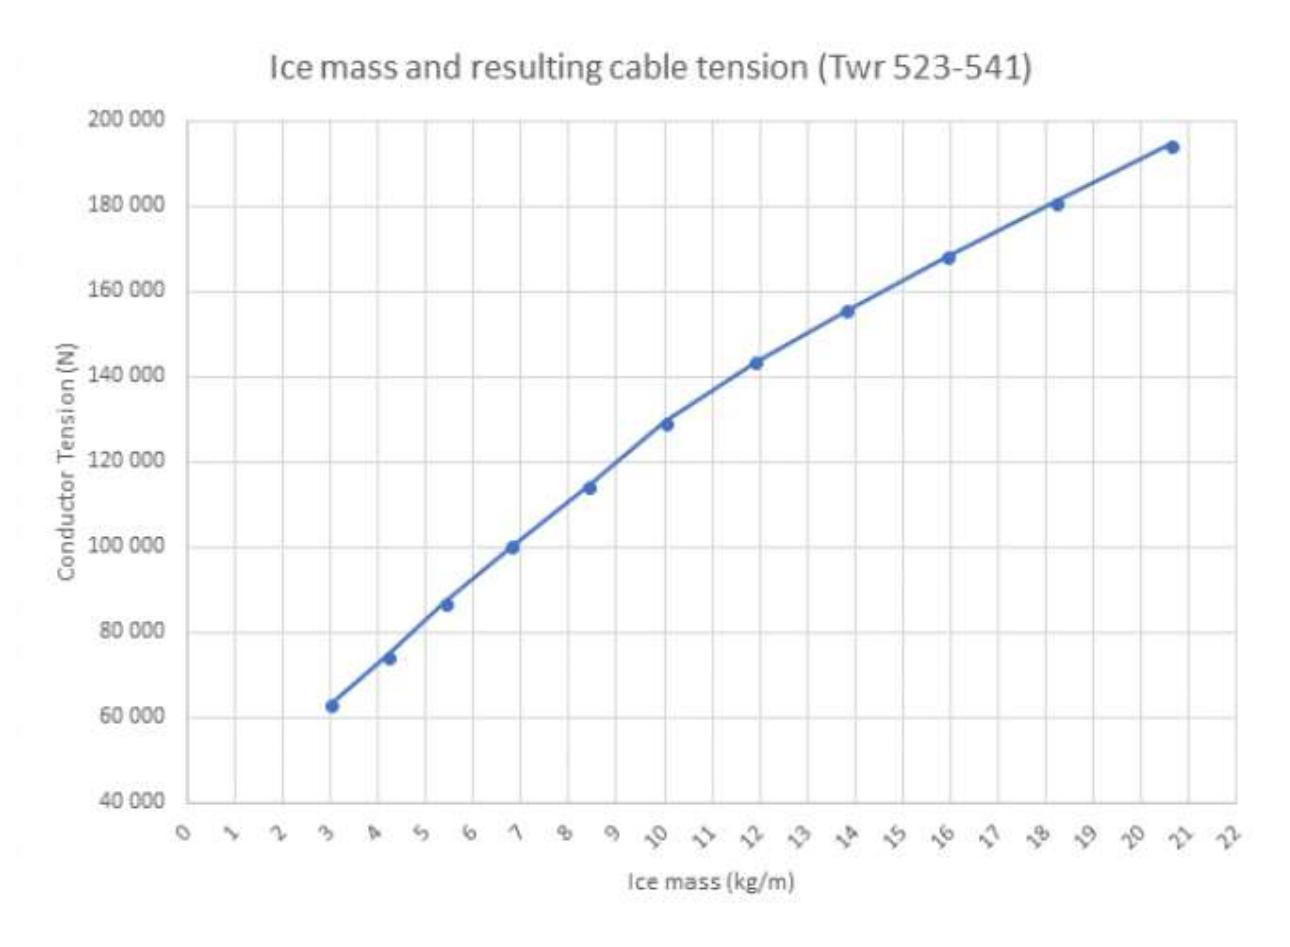
The conductor would require approximately 16 kg/m of ice load to get to fail under a tensile force of 173kN. See Figure 40

#### Figure 40 – Conductor Tension vs Ice Mass

Estimated ice loading is described in detail in Section 6.4 above Weather Modeling, however, it can be stated that the estimated ice load is not quite as high as 16 kg/m.

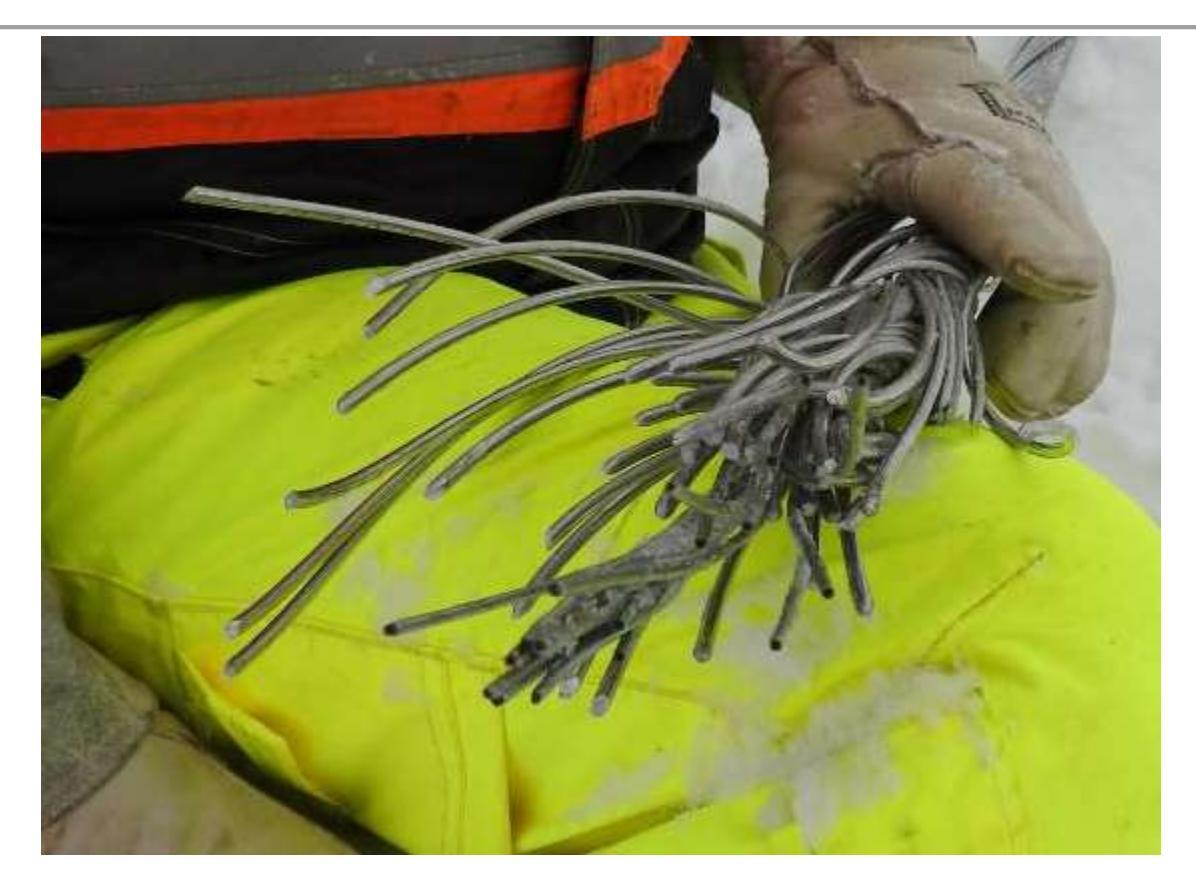
Figure 42 – Failed EL2 Conductor at Str. 526

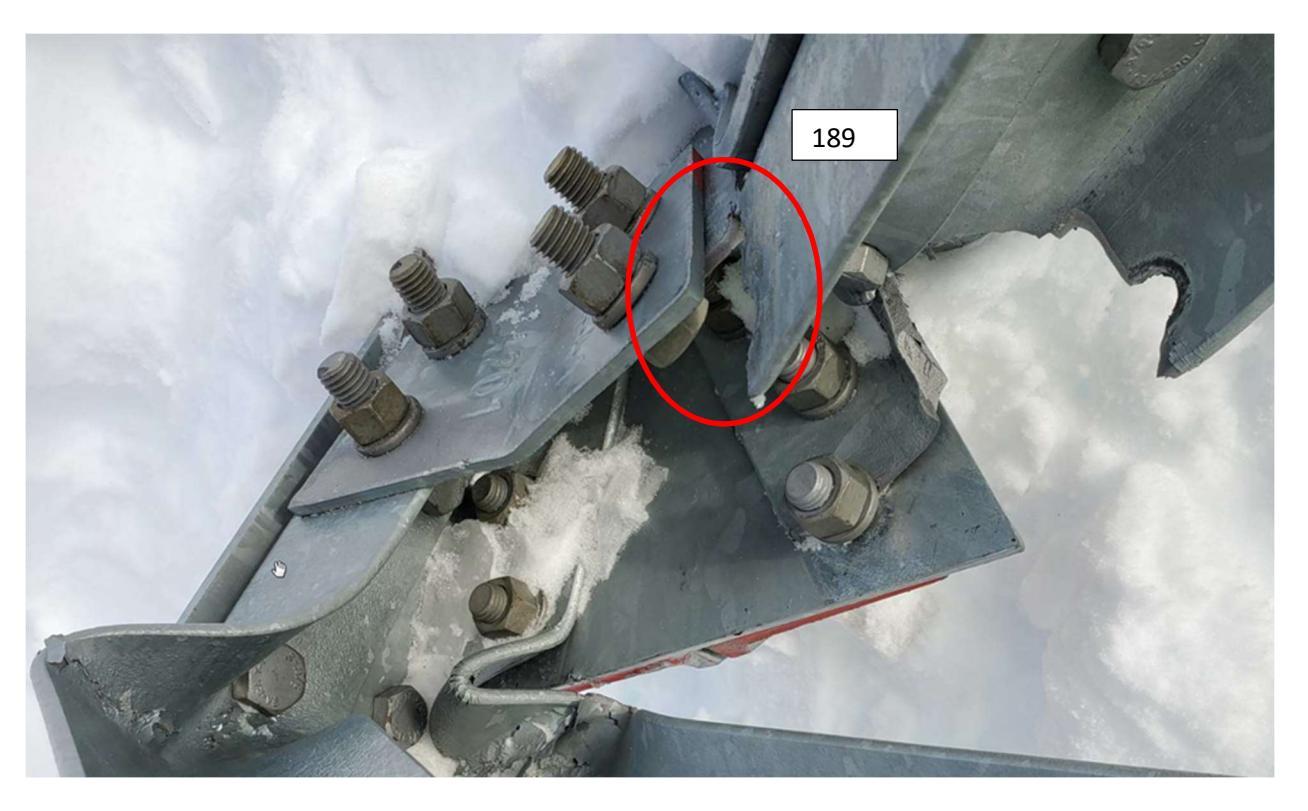
Figure 45 – Block Tear Out on Member 189 from Str. 343

The failure path which occurred above was calculated to happen at roughly 123 kN. This calculation is shown in Mathcad calculation shown below as the Rupture ( $R_n$ ) value. The Design Max load taken from of ILK-JY-SD-6200-TL-H03-0001-01 (350 kV HVdc Line Tower Type A1 Design Calculations) is roughly 100 kN for that specific member. This proves that the applied load during the ice event must have exceeded the design load for the failure path shown above to occur.

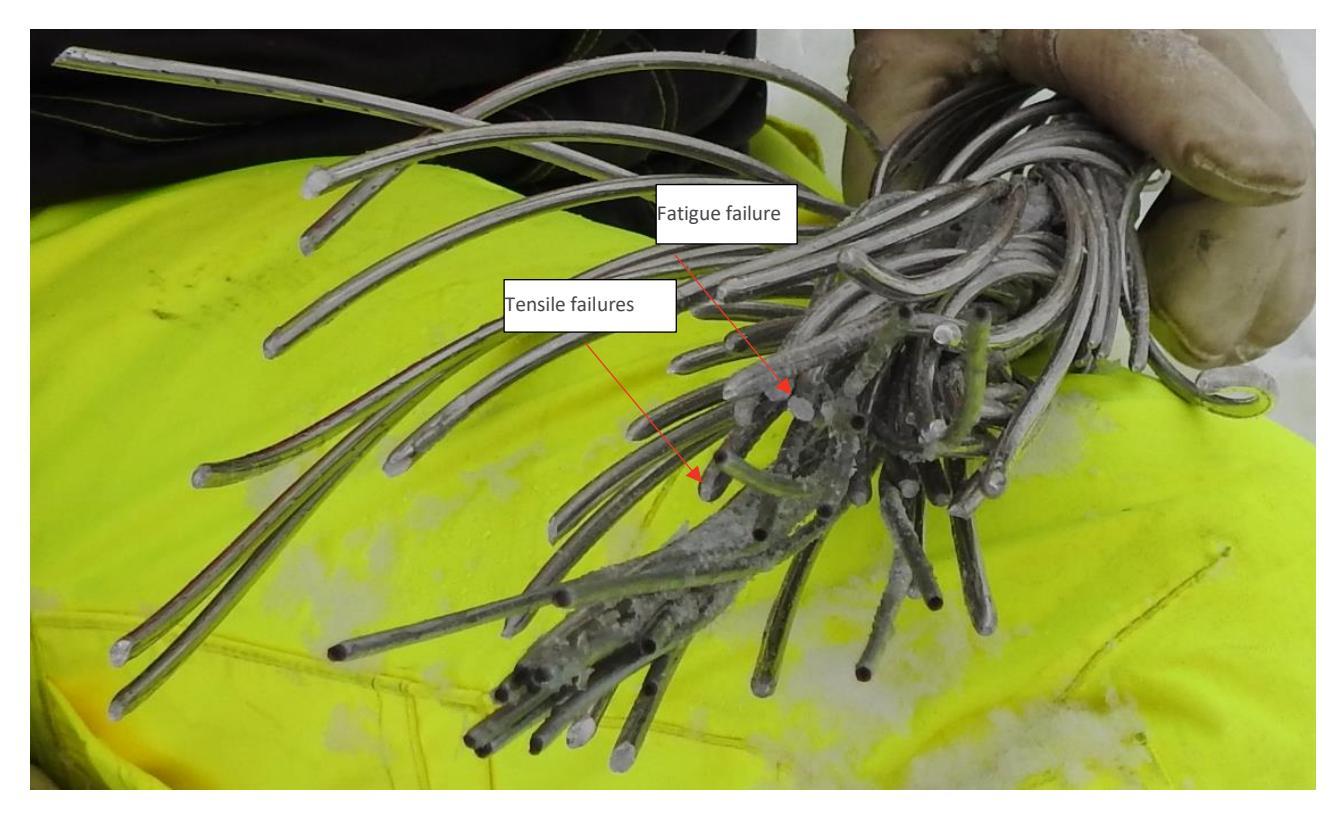
**FIGURE 11** shows 42 of the 54 Aluminium strands of which 19 show signs of fractures due to fatigue loading while the remaining strands have a tensile failure mode. The fractured strands are from the outer (1<sup>st</sup>), 2<sup>nd</sup> and 3<sup>rd</sup> layer of aluminium. Fracture breakages from the 2<sup>nd</sup> and 3<sup>rd</sup> layers are associated with fatigue failure and are likely caused by a combination of galloping, aeolian vibration or large amplitude low frequency movement of iced conductors.

FIGURE 11 Conductor damage from tower 526: Tensile and fatigue failures visible

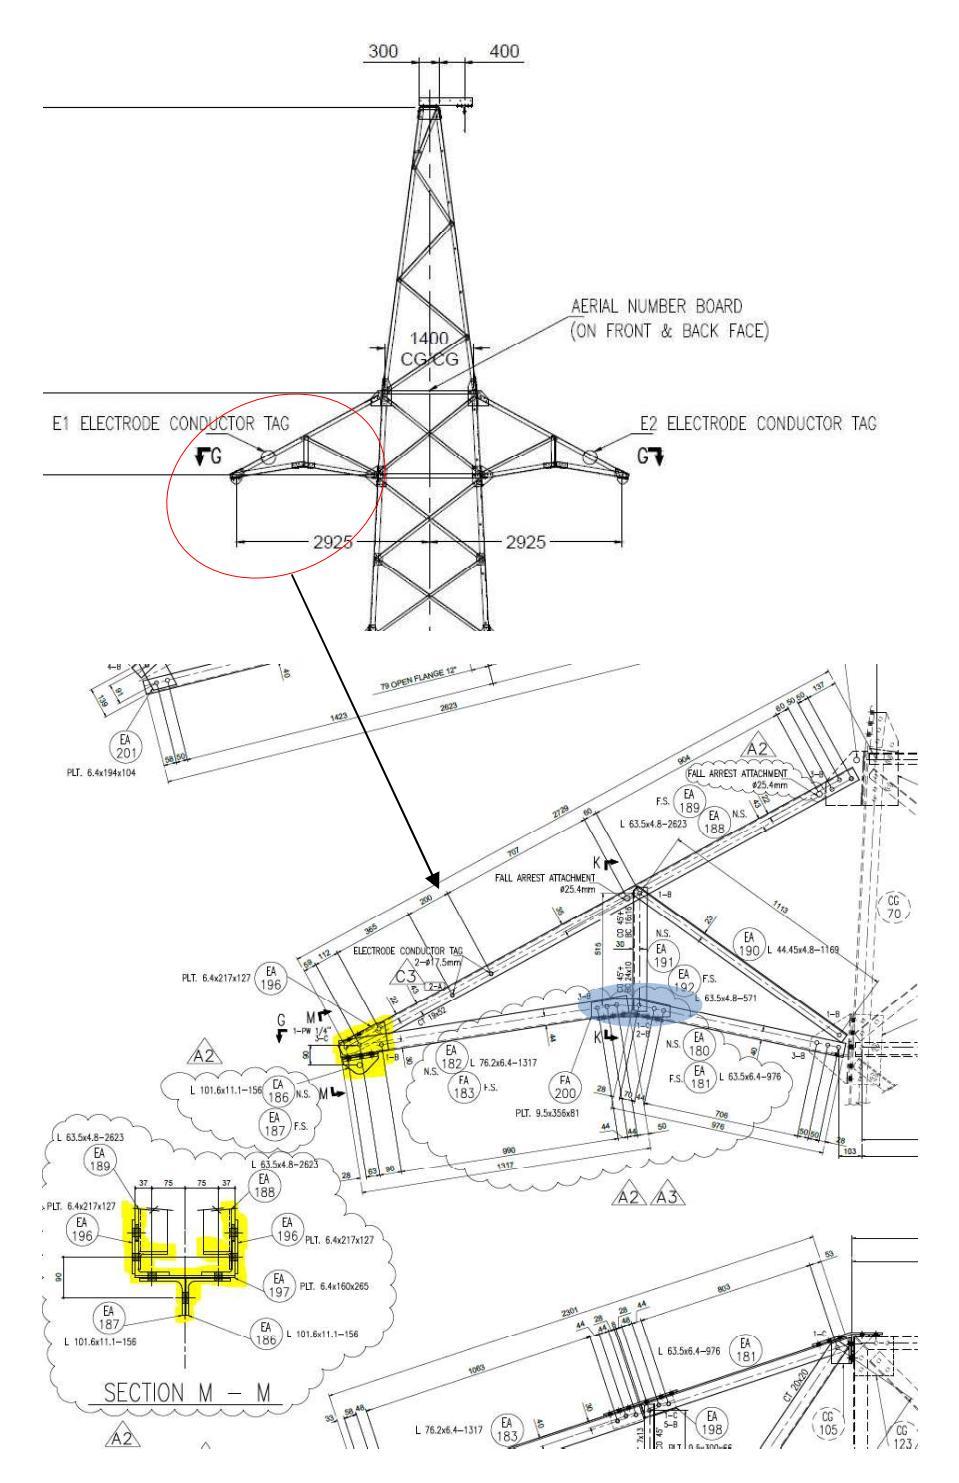
Figure 1: Excerpt from Drawing [1] showing Cross Arm Location on Tower and the Areas of Damage. Damage to Cross Arm 526-EL1 in Yellow and Blue. Damage to Cross Arm 343-EL2 in Yellow.

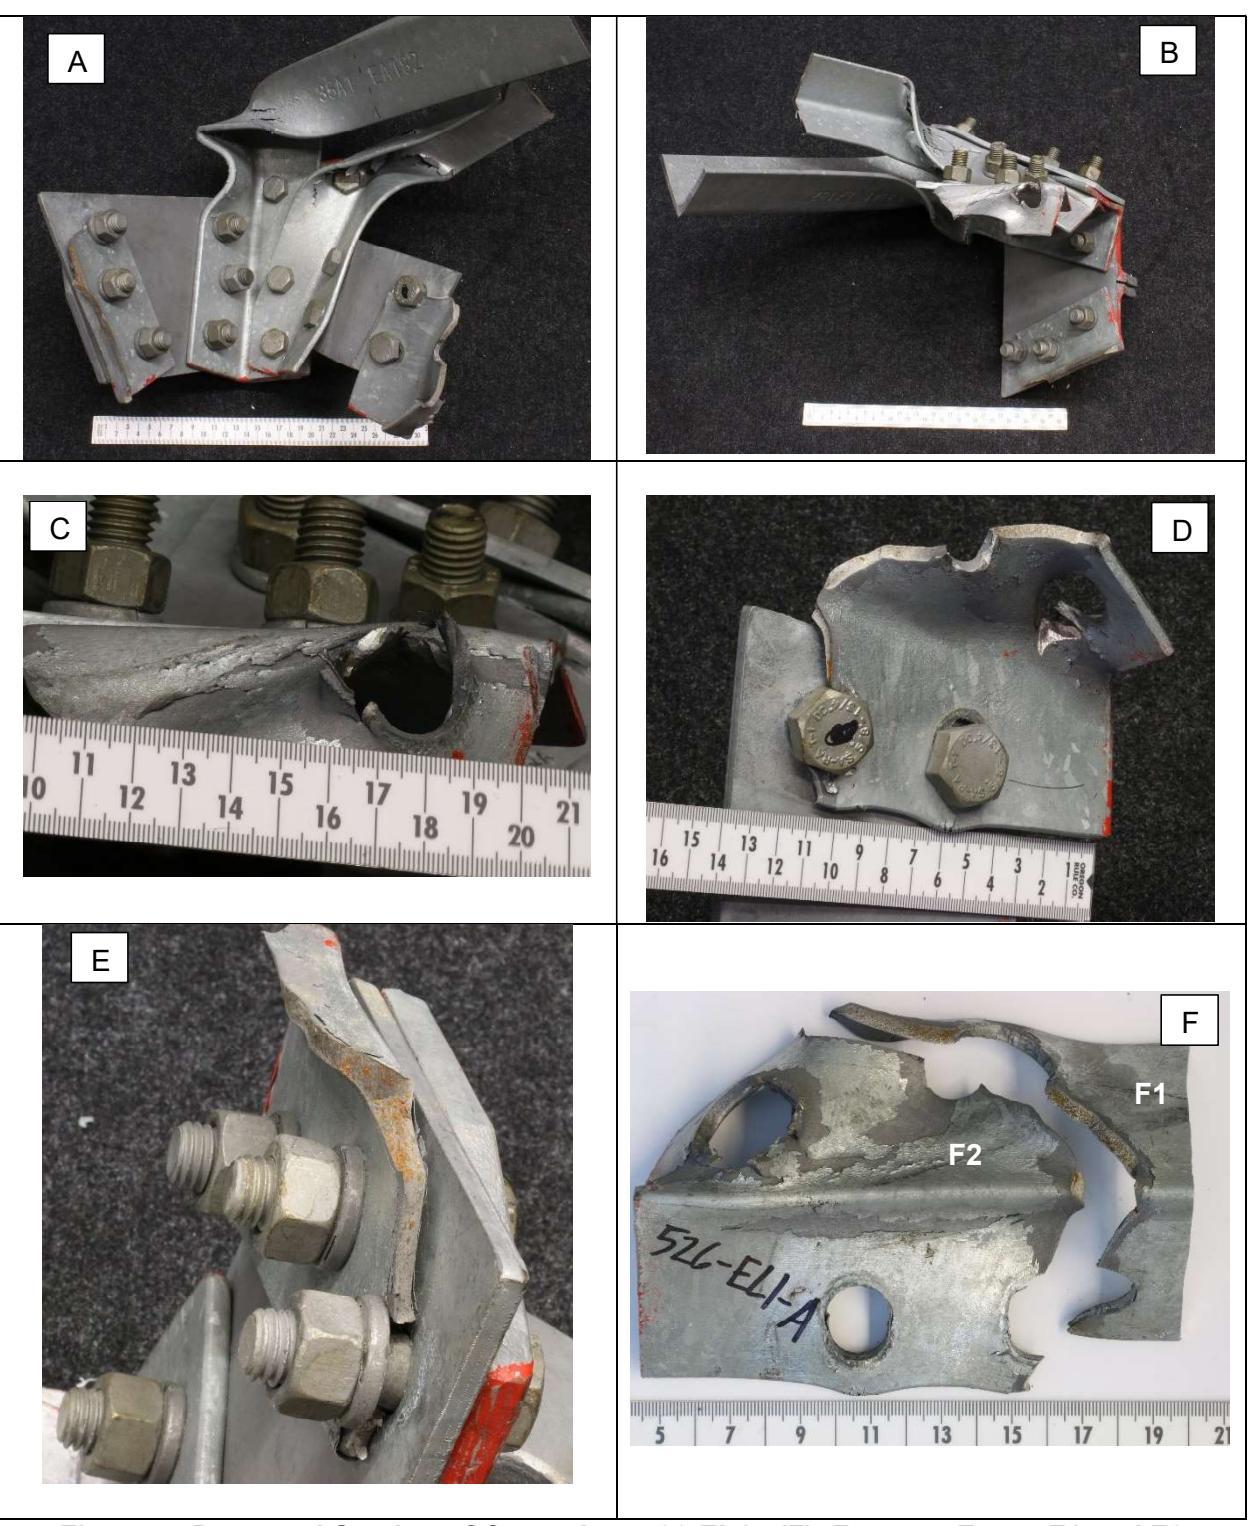
Figure 5: Damaged Section of Cross Arm 526-EL1. (F), Fracture Faces F1 and F2 Retained for Further Examination

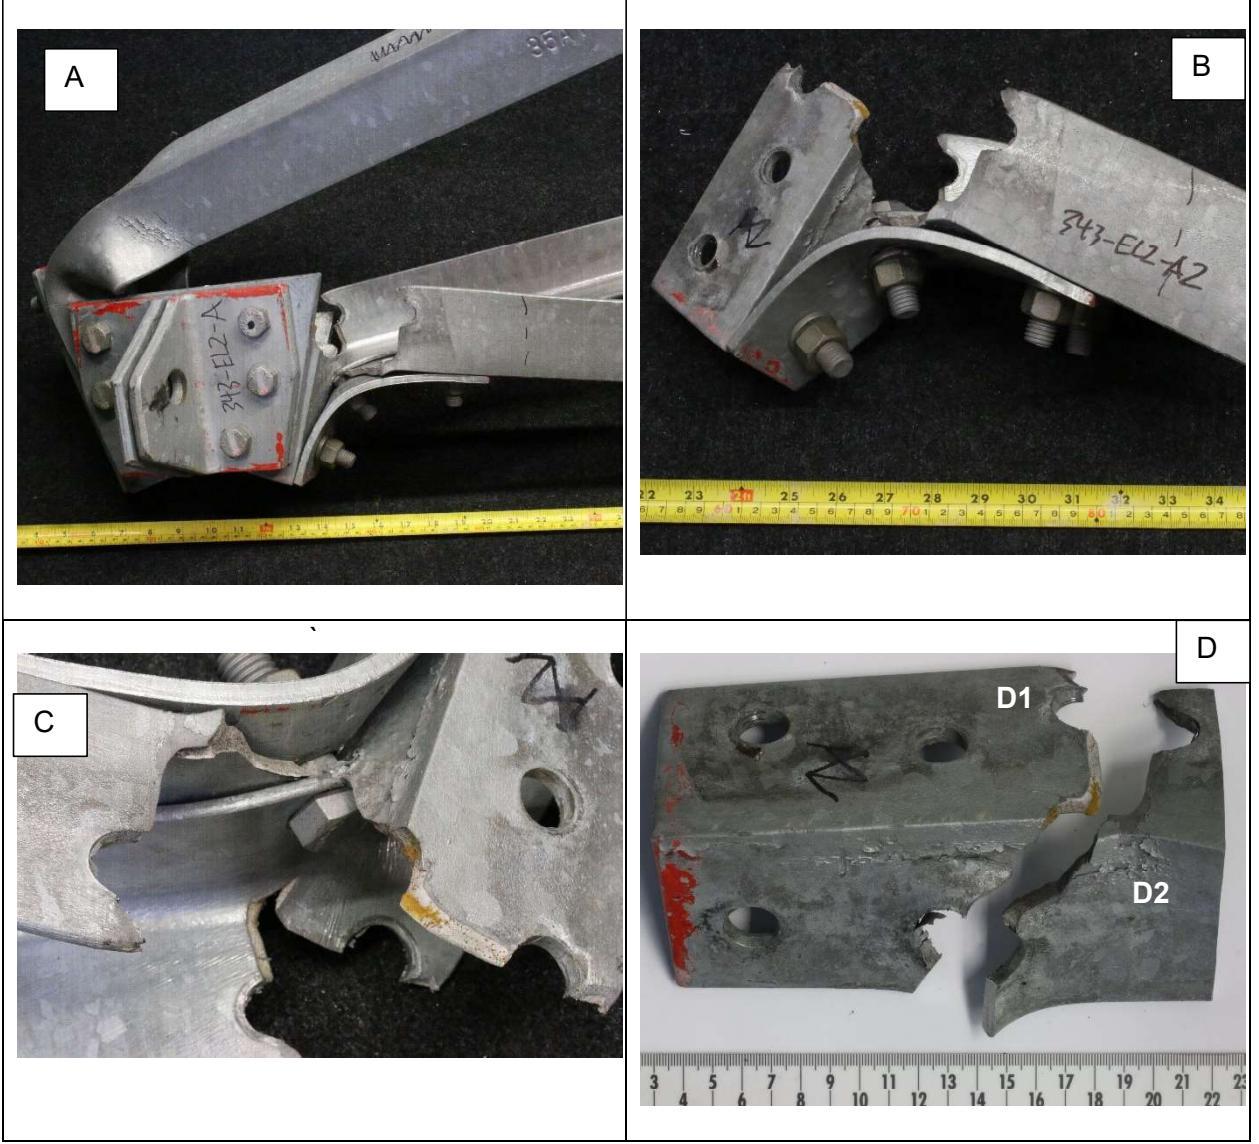
Figure 8: Damaged Section of Cross Arm 343-EL2. (D), Fracture Faces D1 and D2 Retained for Further Examination

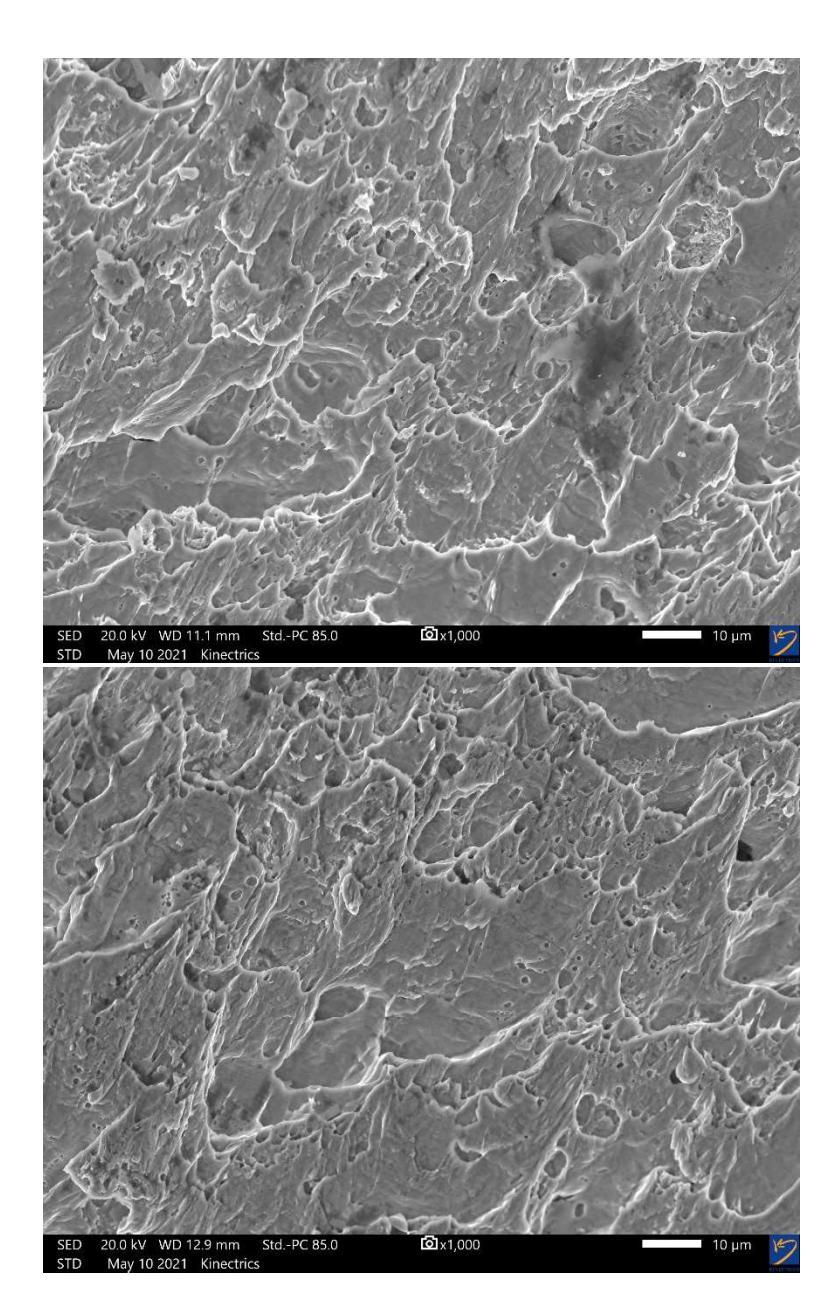
Figure 17: Cross Arm 526-EL1 Fracture Face Segment A SEM Micrograph showing smeared dimple morphology.

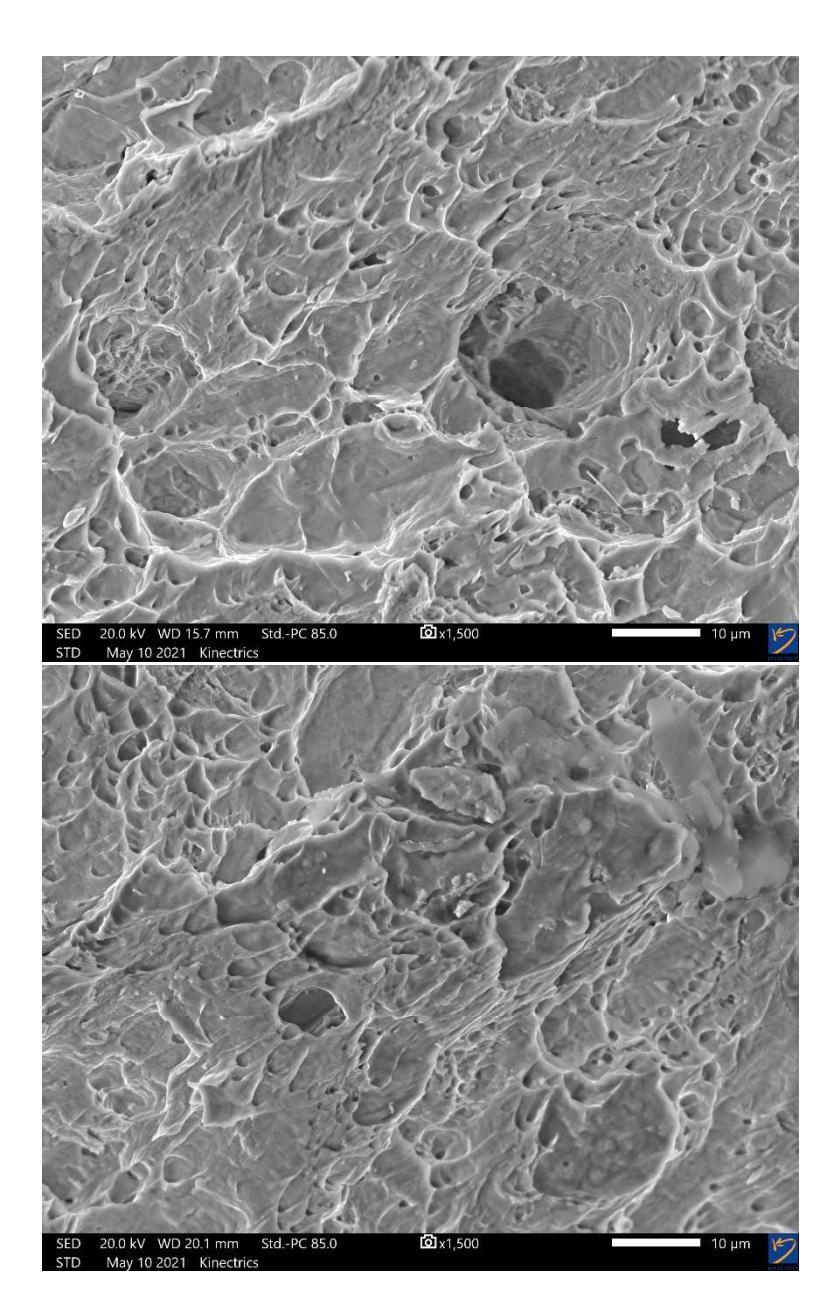
Figure 18: Cross Arm 526-EL1 Fracture Face Segment B SEM Micrograph showing smeared dimple morphology.

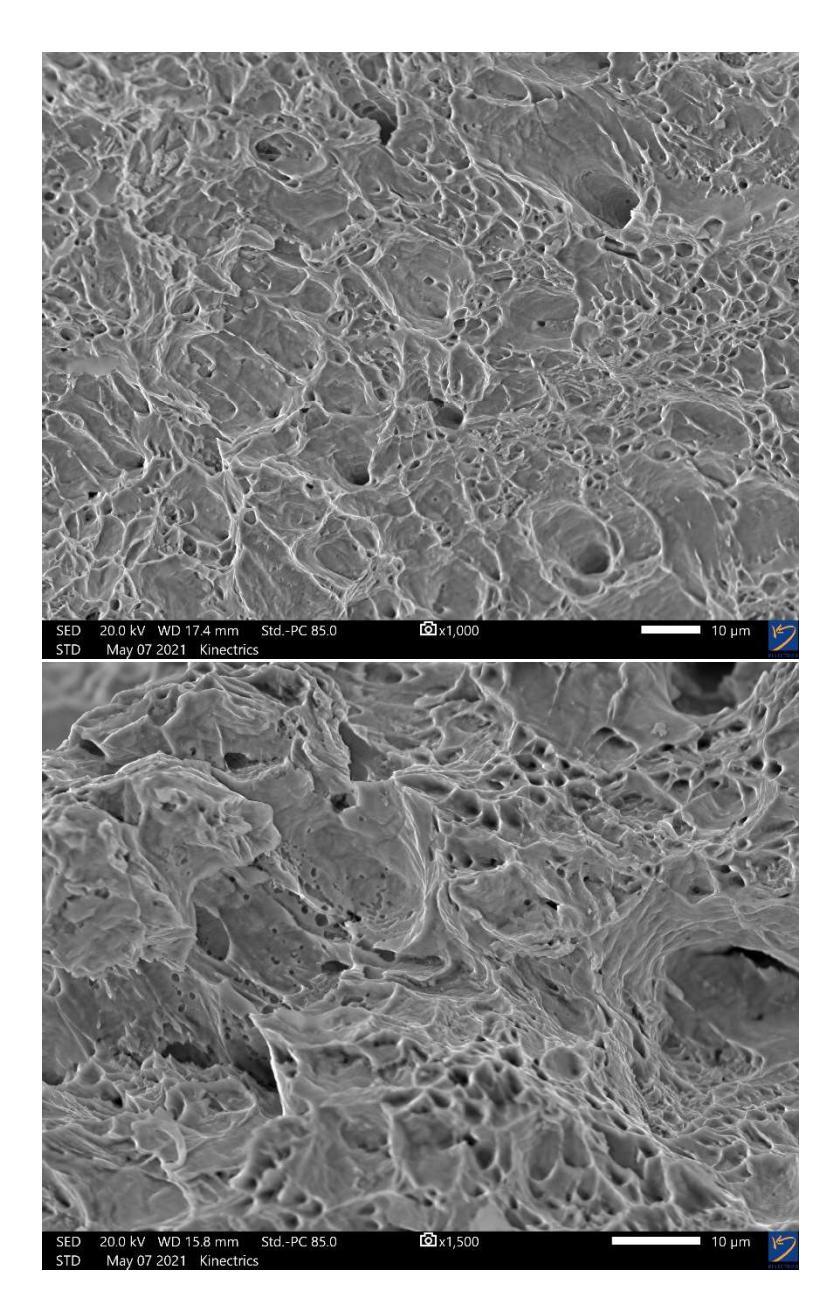
Figure 19: Cross Arm 526-EL1 Fracture Face Segment C SEM Micrograph showing smeared dimple morphology.

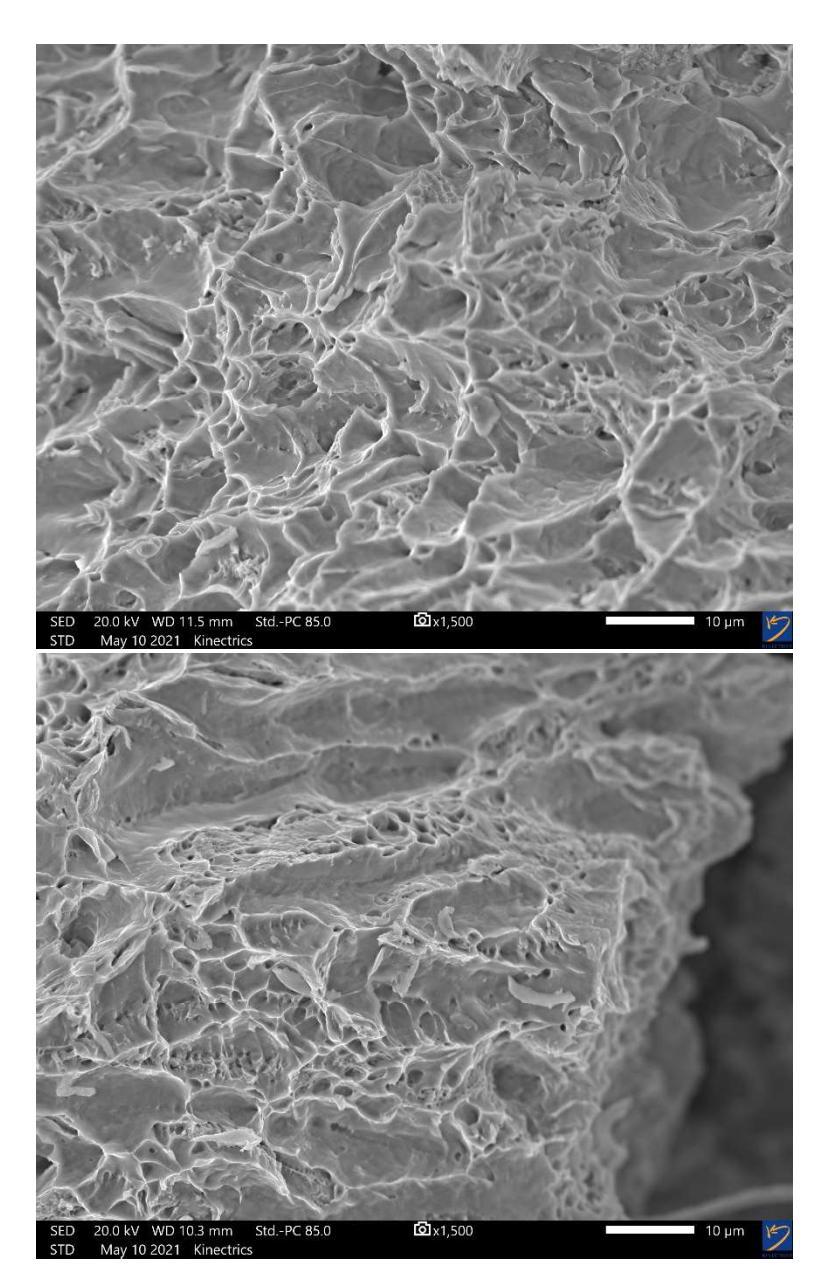
Figure 20: Cross Arm 526-EL1 Fracture Face Segment D SEM Micrograph showing dimple morphology
