# Re: *Reliability and Resource Adequacy Study Review* – Labrador-Island Link Failure Investigation Reports

# Failure Investigation Report – L3501/2 Tower and Conductor Damage

Failure Investigation Report – L3501/2 Tower	R	evision R1		
Icing Event January 2021 in Labrador	Date:	Revision R1     :   28-May-2021     :   ii		
Nalcor Doc. No. ILK-EG-ED-6200-TL-RP-0001-01	Page:	ii

# FAILURE ANALYSIS OF ELECTRODE CROSS ARM IN LABRADOR ISLAND TRANSMISSION LINK (LITL)

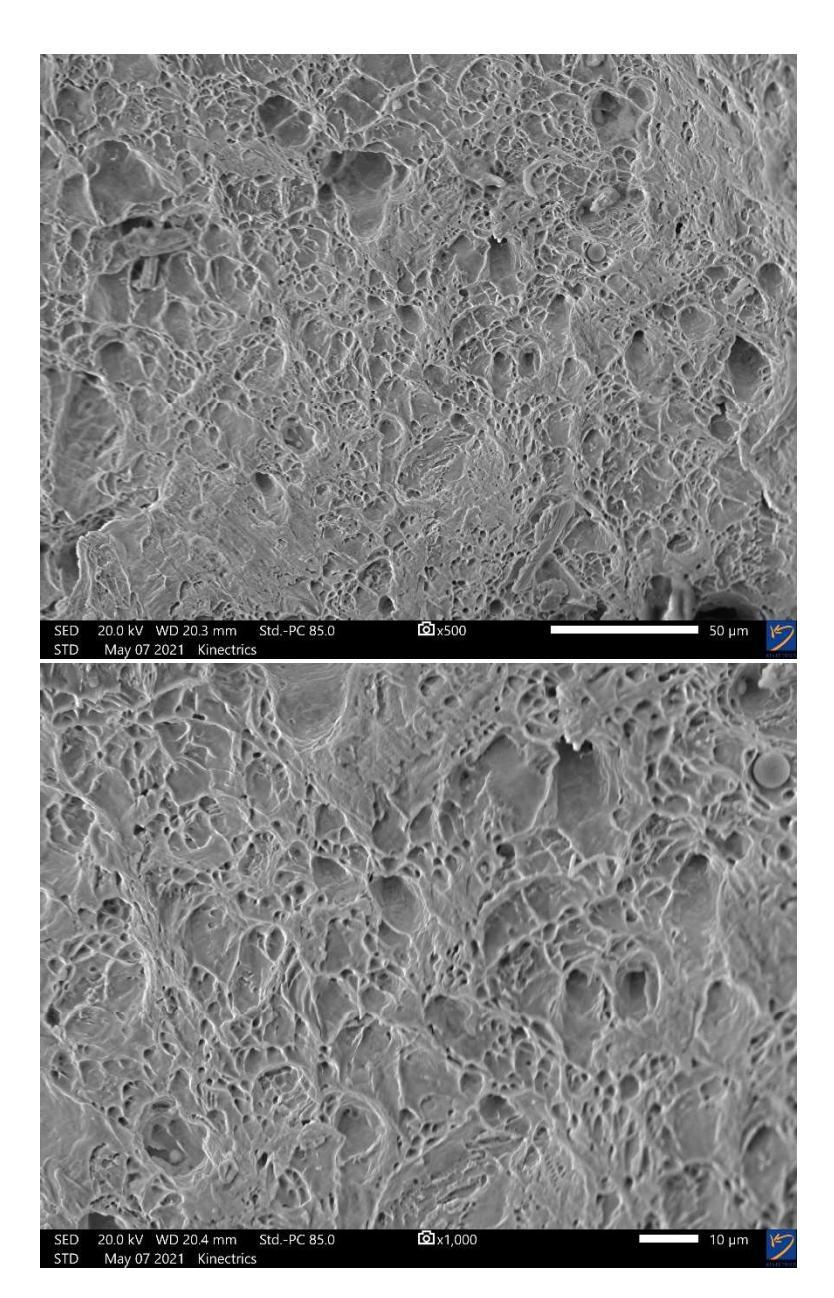
Figure 25: Cross Arm 343-EL2 Fracture Face Segment A SEM Micrograph showing dimple morphology

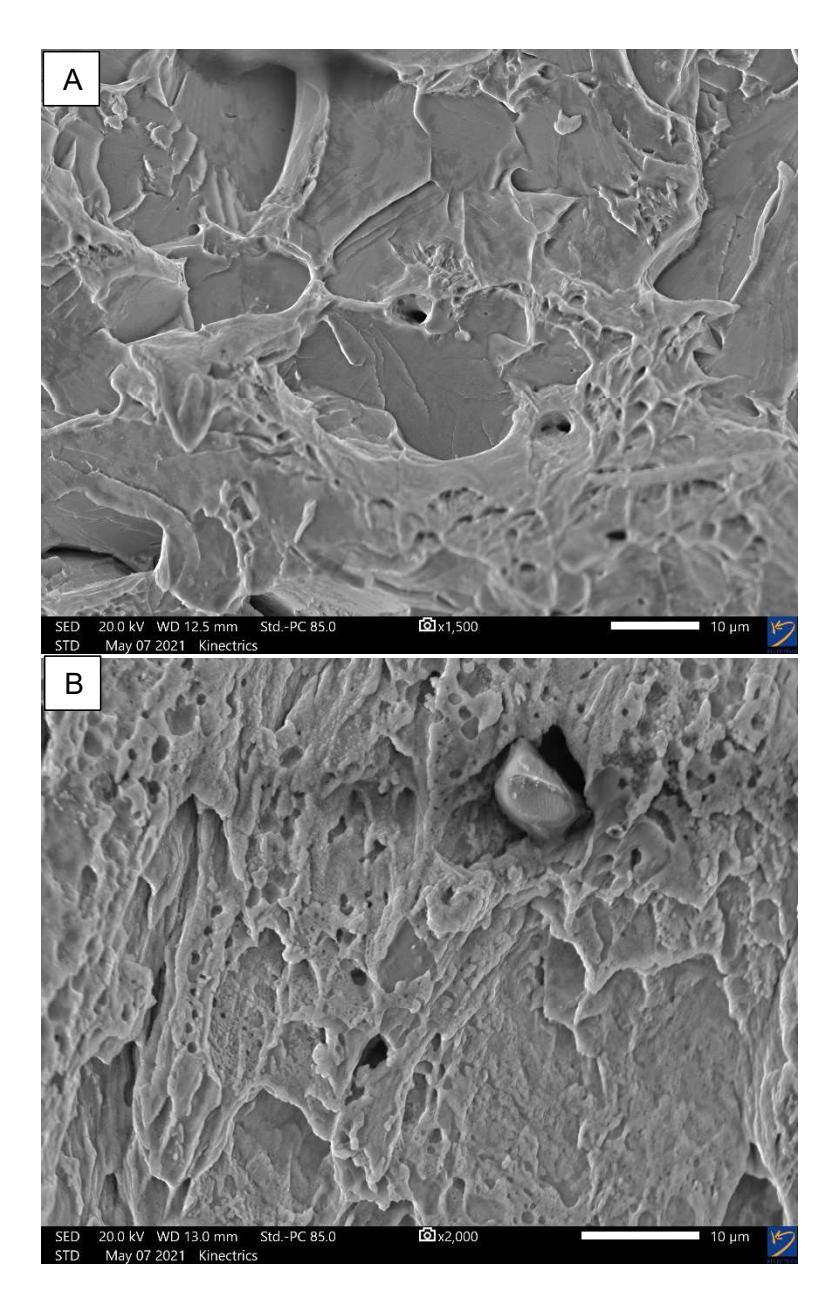
Figure 26: Cross Arm 343-EL2 Fracture Face Segment B SEM Micrograph showing, (A) Quasi-Cleavage and (B) Dimple Morphology

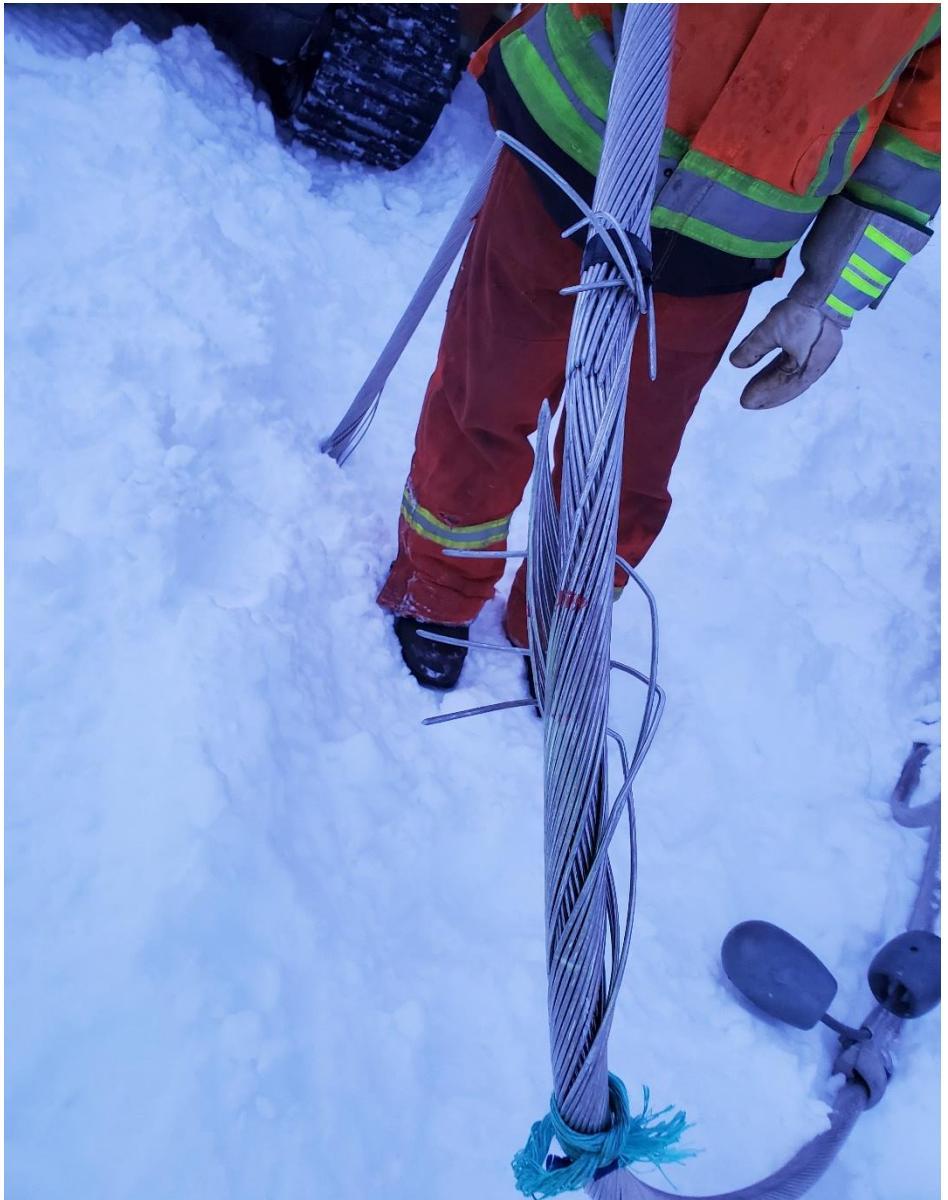
FIGURE 3. PARTIALLY BROKEN CONDUCTOR (PICTURE PROVIDED BY THE CLIENT)

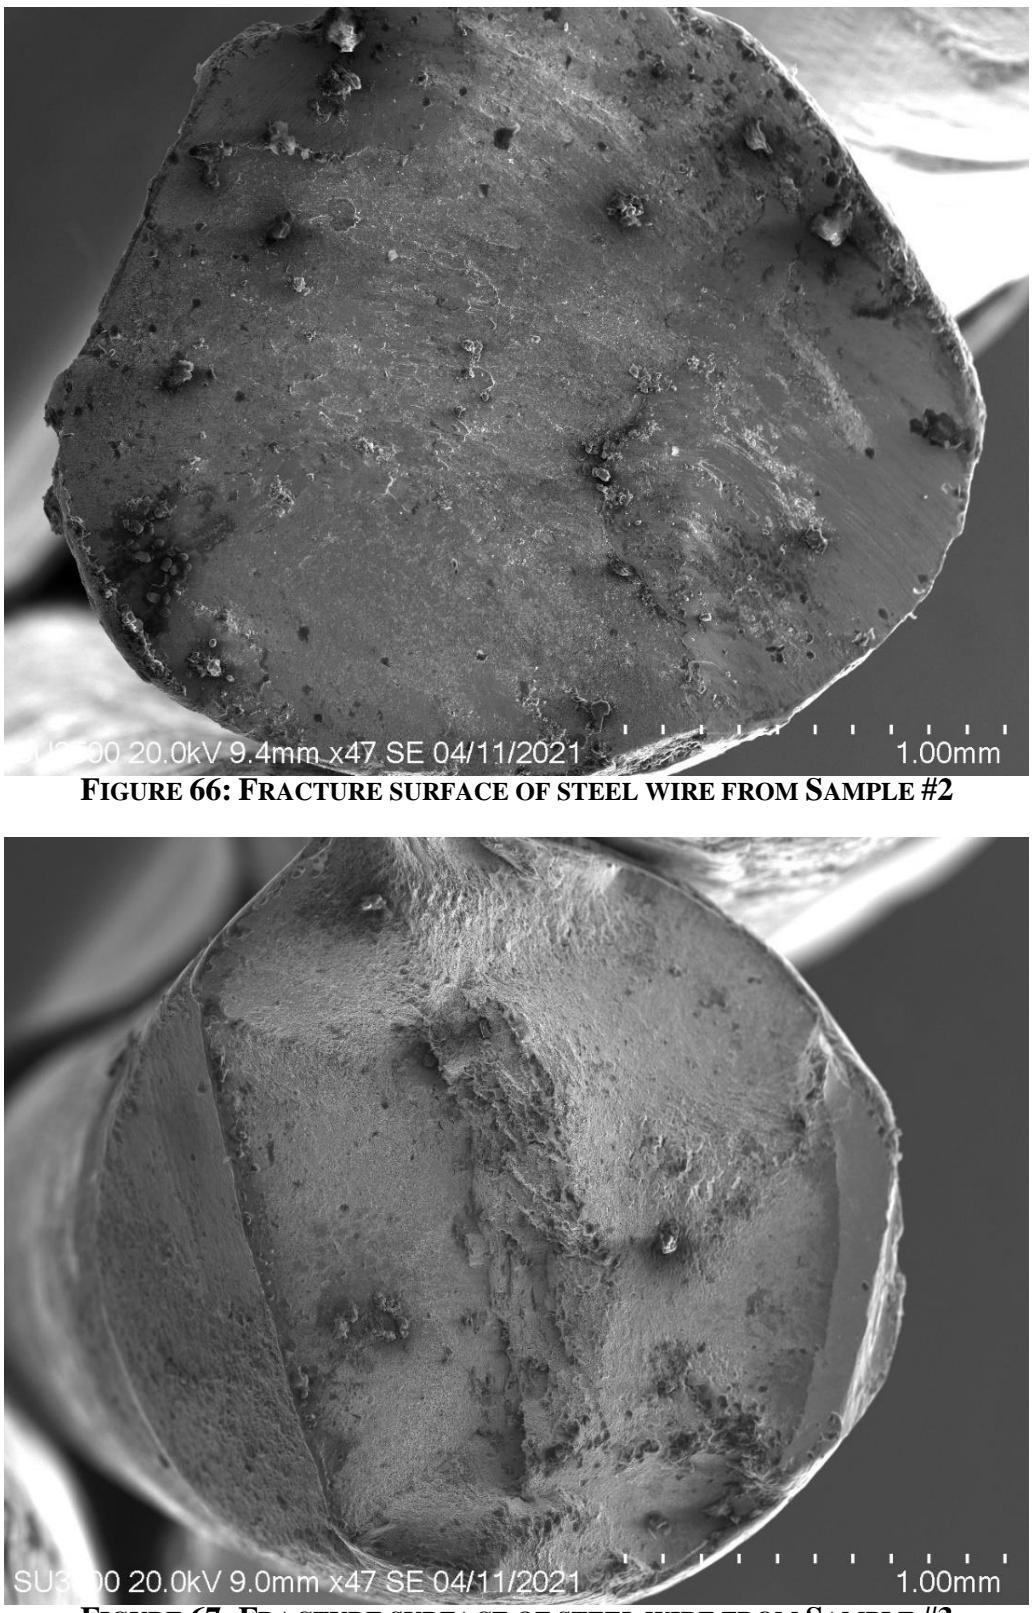
FIGURE 67: FRACTURE SURFACE OF STEEL WIRE FROM SAMPLE #3

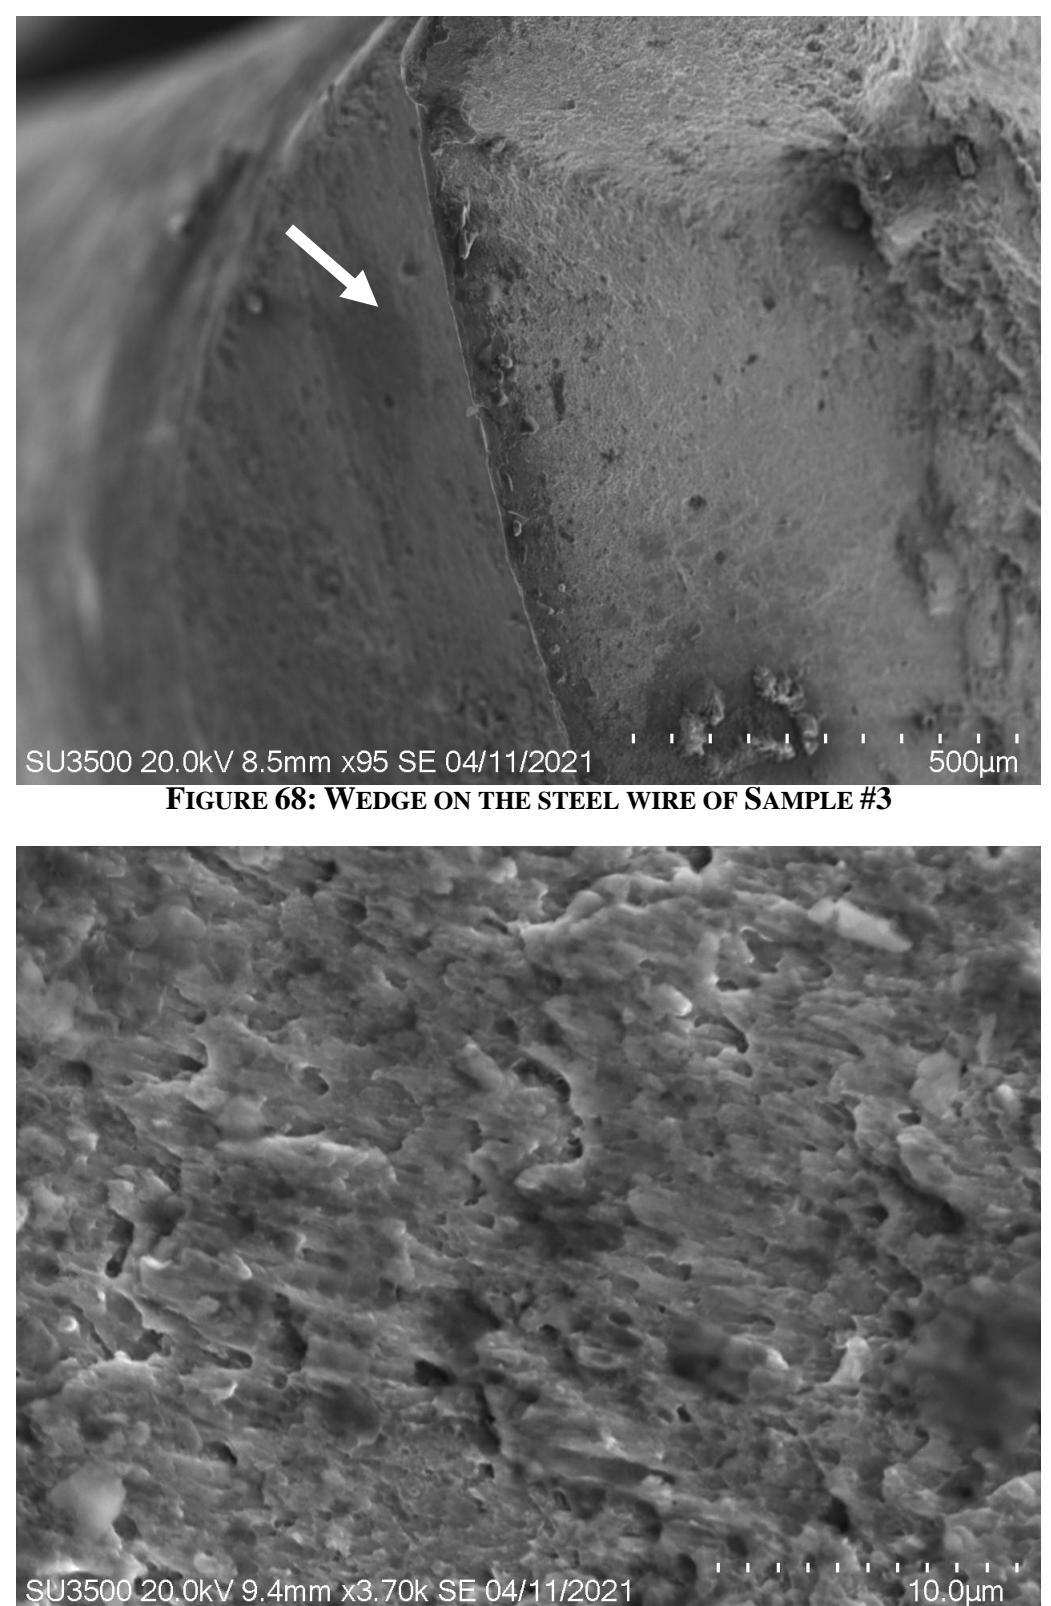
FIGURE 69: SHEAR DIMPLES ON FRACTURE SURFACE OF WIRE FROM SAMPLE #2

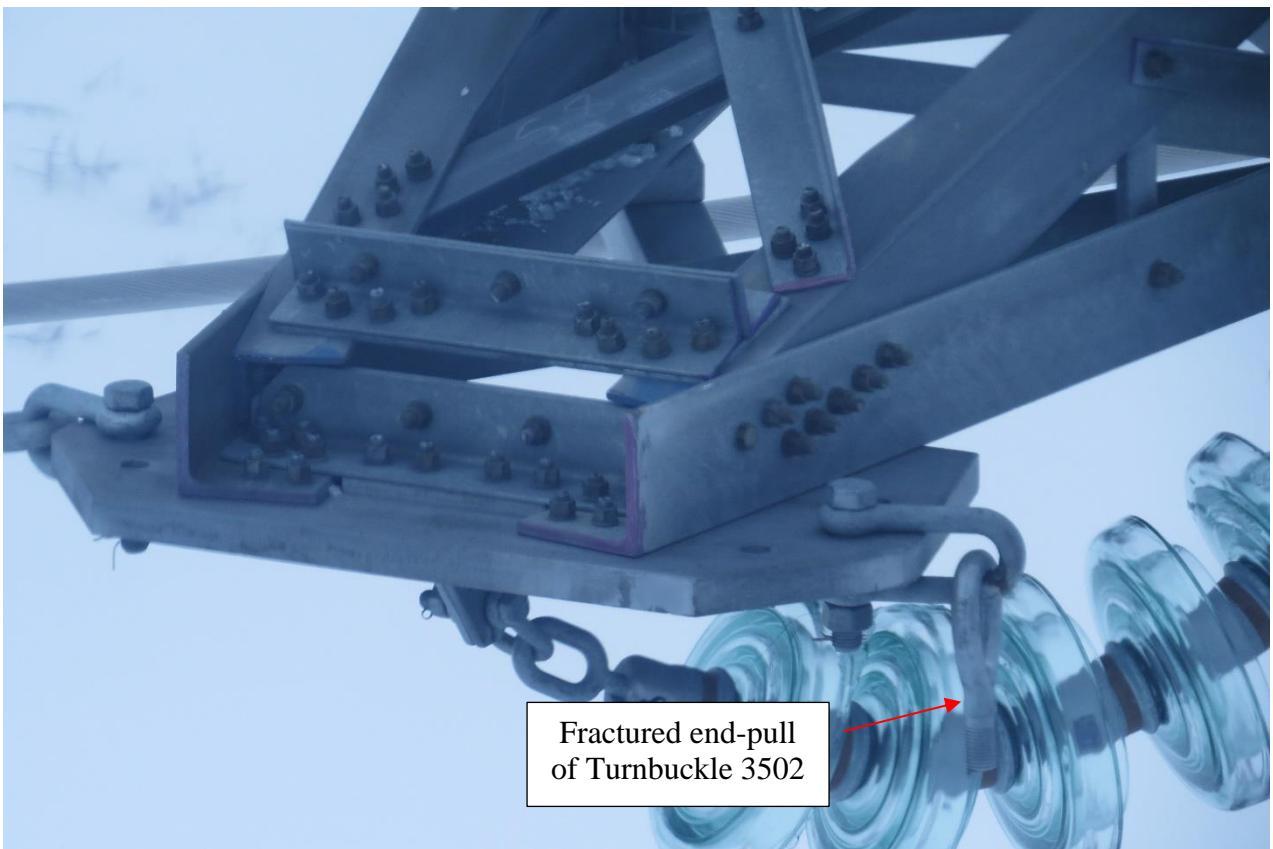
FIGURE 2. FRACTURED TURNBUCKLE, PROVIDED BY THE CLIENT

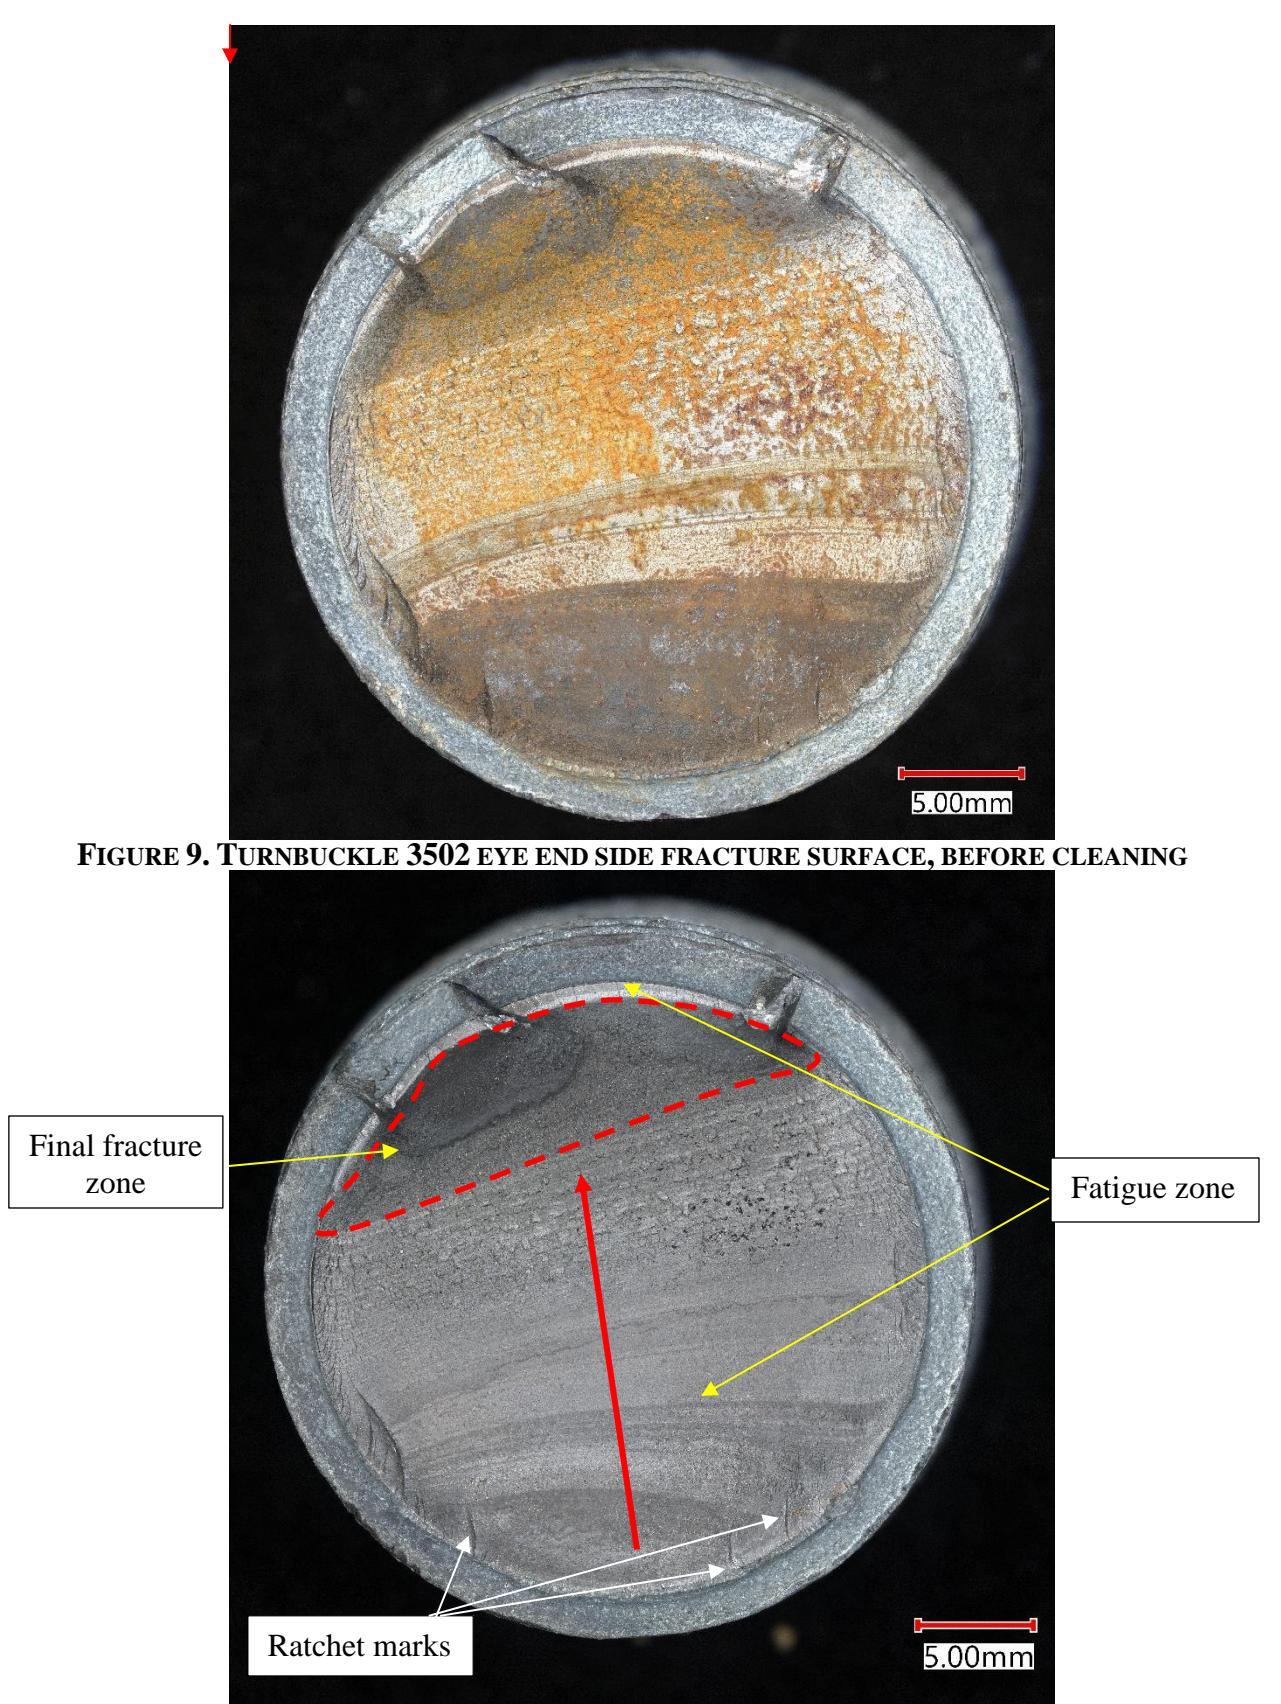
FIGURE 10. TURNBUCKLE 3502 EYE END SIDE FRACTURE SURFACE, AFTER CLEANING

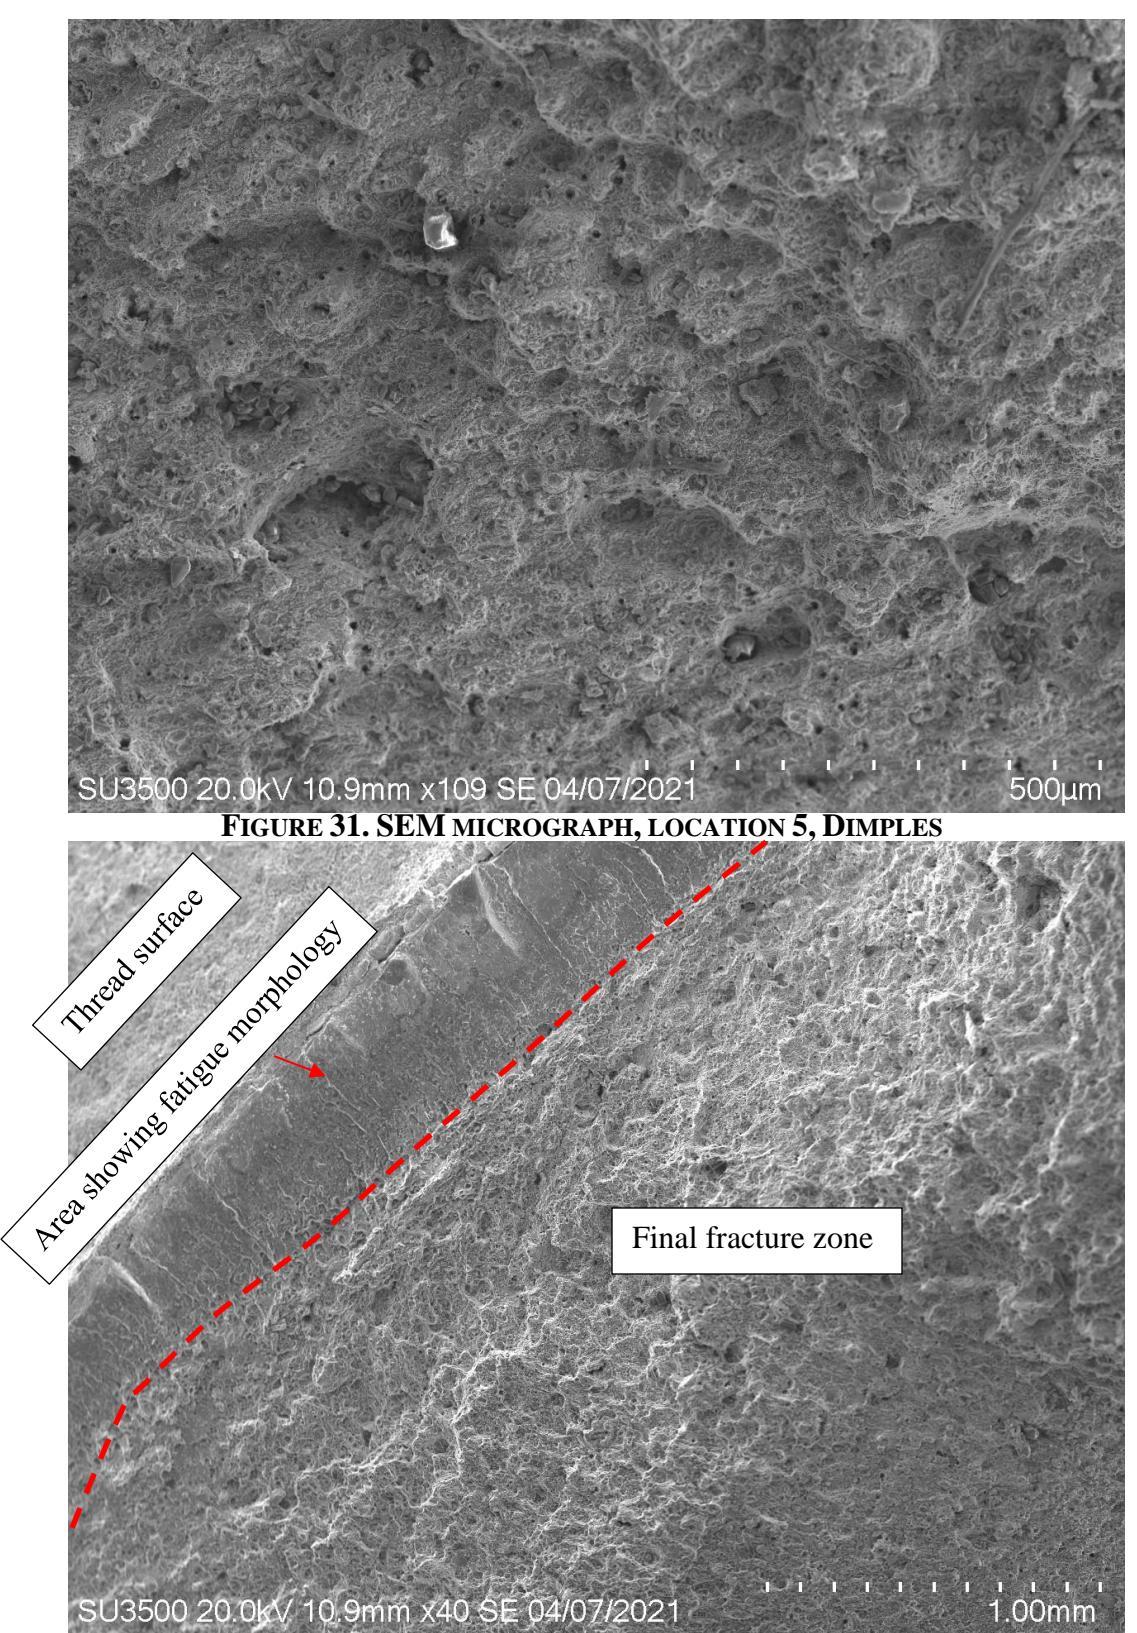
FIGURE 32. SEM MICROGRAPH, LOCATION 6, FATIGUE ZONE ON FINAL FRACTURE SIDE

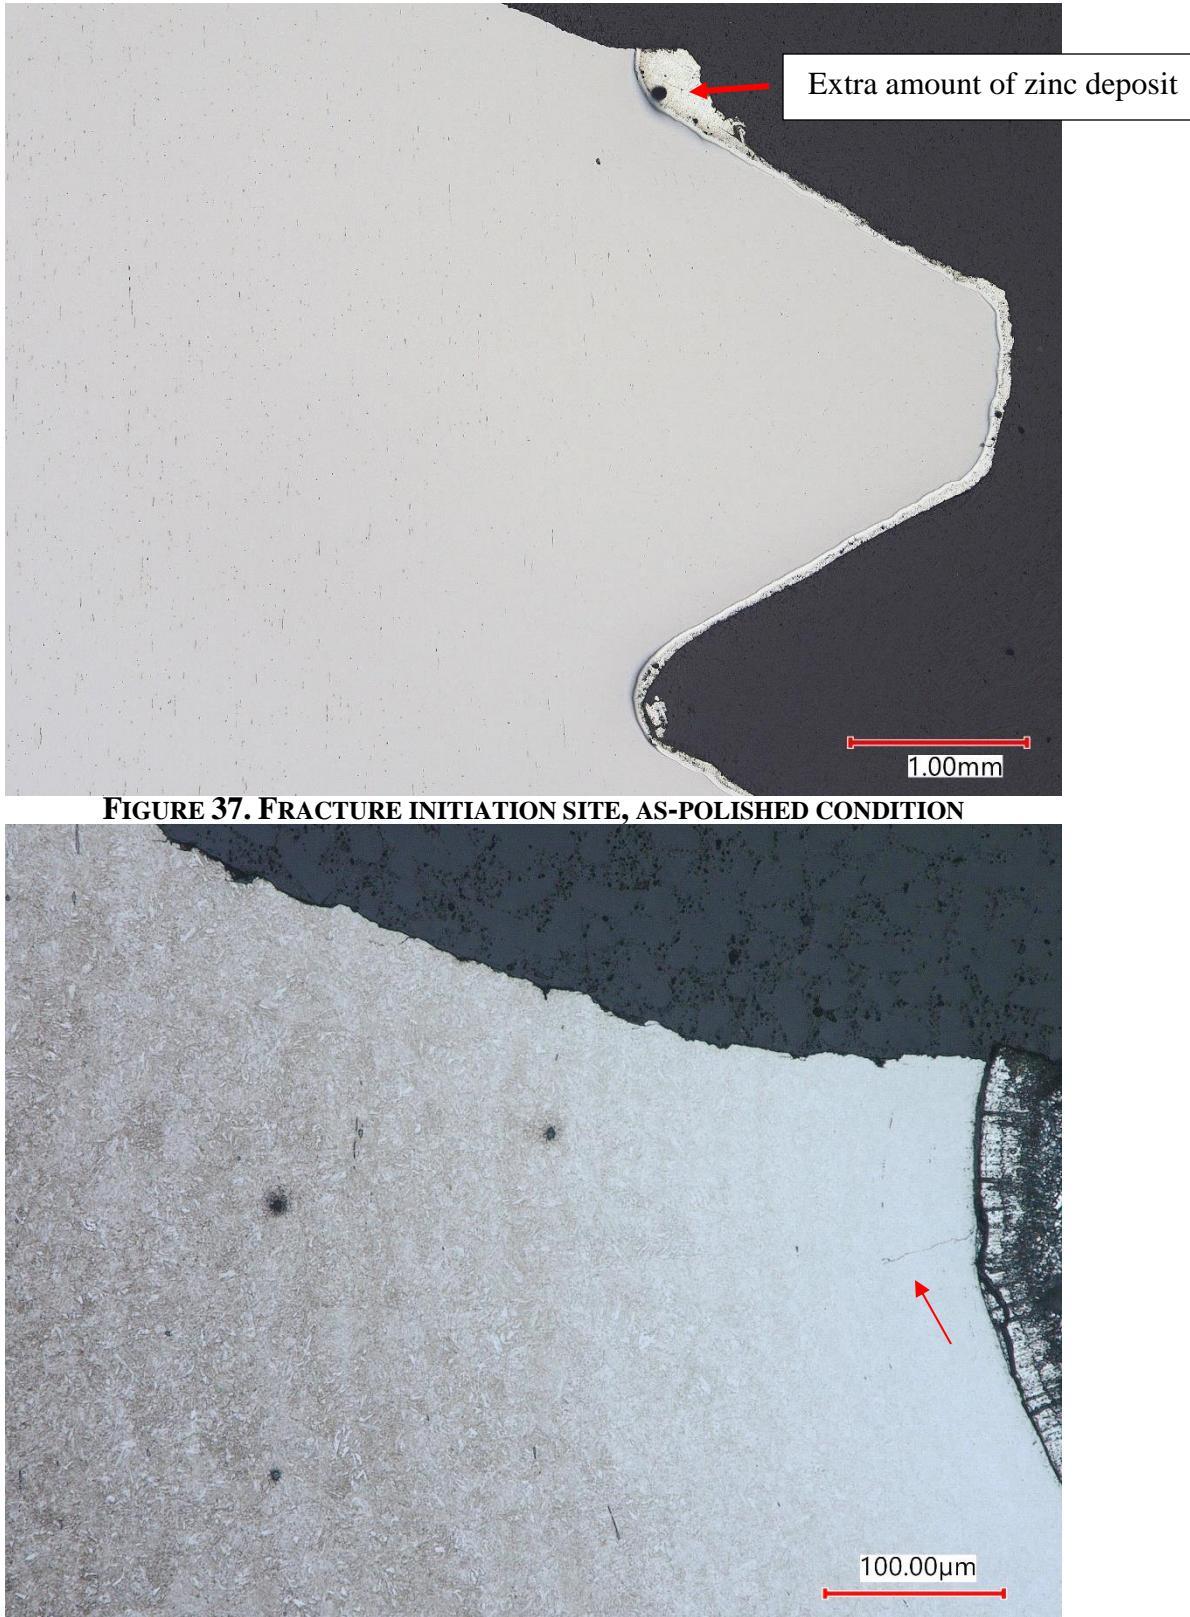
FIGURE 38. FRACTURE INITIATION SITE, ETCHED CONDITION
