Newfoundland and Labrador Hydro

Project Report Volume III

Hardwoods and Stephenville Viability Assessment

> H365408-00000-210-066-0003 Rev. 1 June 27, 2022

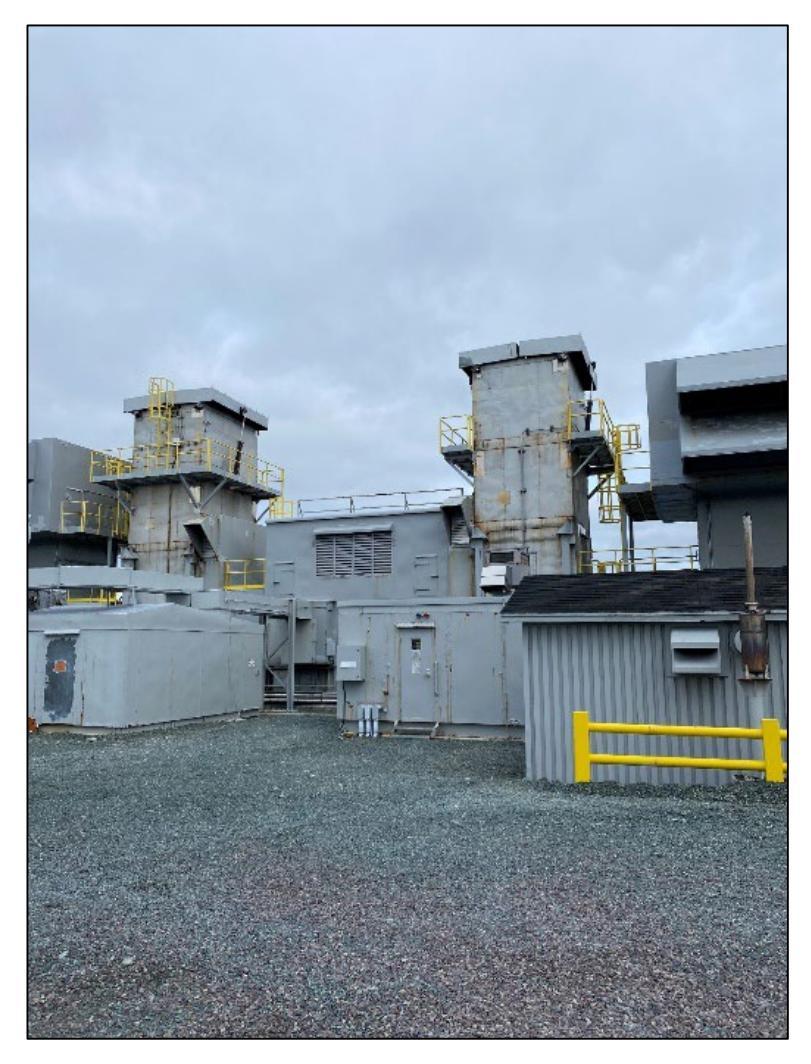
Figure 5-7: Building Envelopes

The Power Station Buildings and Exhaust Stack envelopes show signs of rust and corrosion. Grinding to bare metal and repainting is recommended to stop the advancing corrosion.

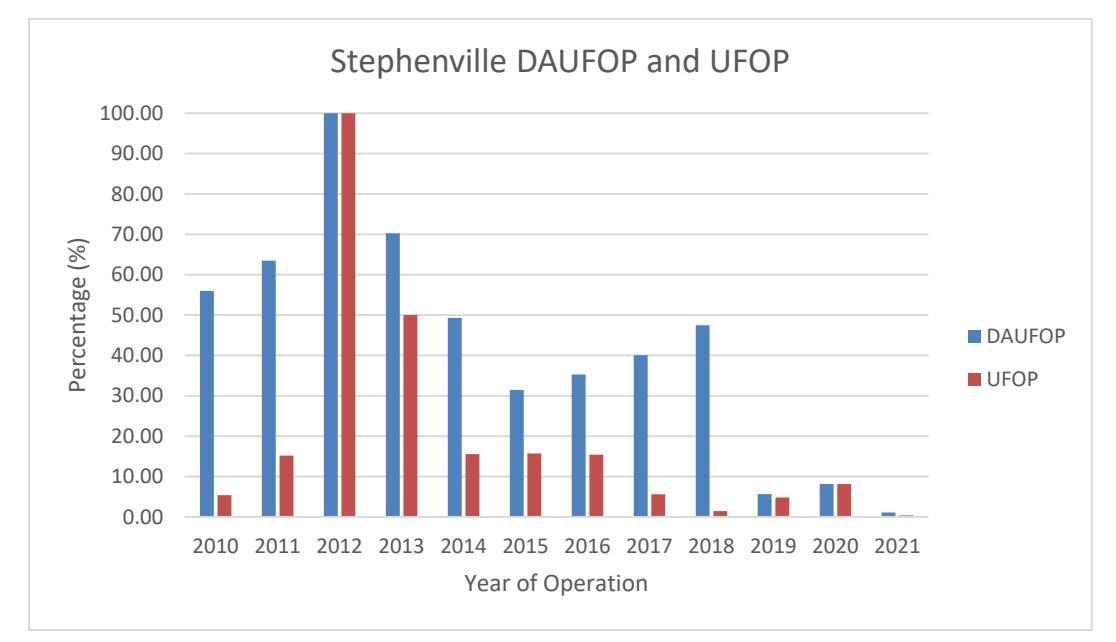
Figure 5-9: SVL DAUFOP and UFOP

The Derated Adjusted Utilization Forced Outage Probability (external conditions excluded) and Utilization Forced Outage Probability (external conditions excluded) from 2010 – 2021 is shown in the chart below:

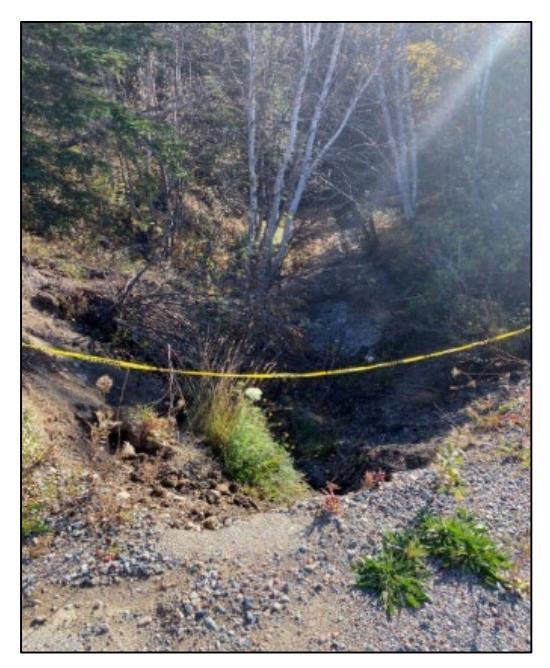
Figure 5-11: Shoulder of Service Road

The side of the road leading to the station has significant material washout creating a ravine. If the dirt road is compromised the station would not be accessible to NLH staff and for fuel oil deliveries. It is recommended that this hazard is corrected. The estimated cost of repair is on the order of \$100K.
