2020 Capital Budget Application Hydraulic Generation Refurbishment and Modernization (2020–2021)

July 2019

A report to the Board of Commissioners of Public Utilities

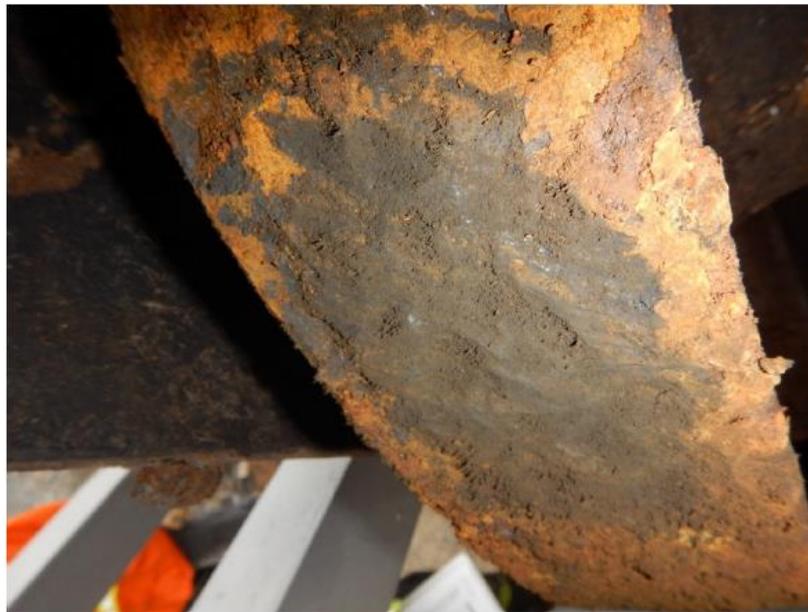
15 In October 2017, a condition assessment was completed of the gates/embedded parts at the Burnt Dam
16 Spillway. This inspection revealed deterioration with the gate hardware such as rollers, seals, screw
17 stems, and transfer cases. The inspection also revealed deterioration in the embedded parts such as
18 concrete and roll paths. Figures 8, 9, and 10 are examples of the deterioration in Burnt Dam.

Figure 7: Pitting Corrosion on Main Rollers – Intake 1 2016

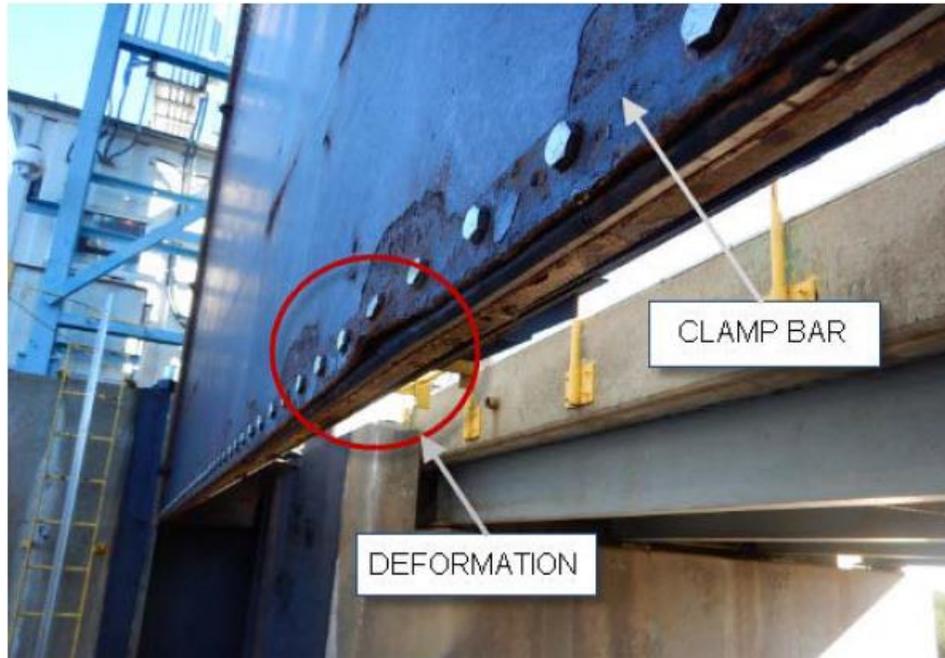
Figure 8: Deformed Gate Knife - Burnt Dam

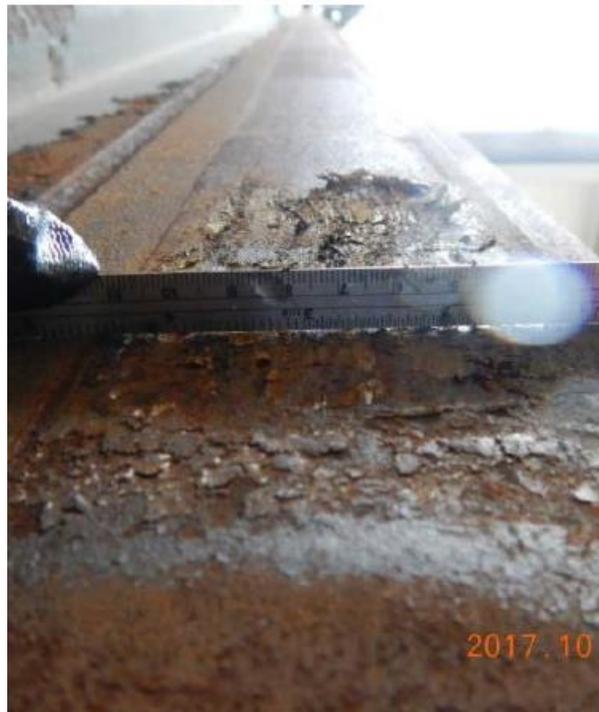
Figure 9: Rubbing Marks on Embedded Parts - Burnt Dam

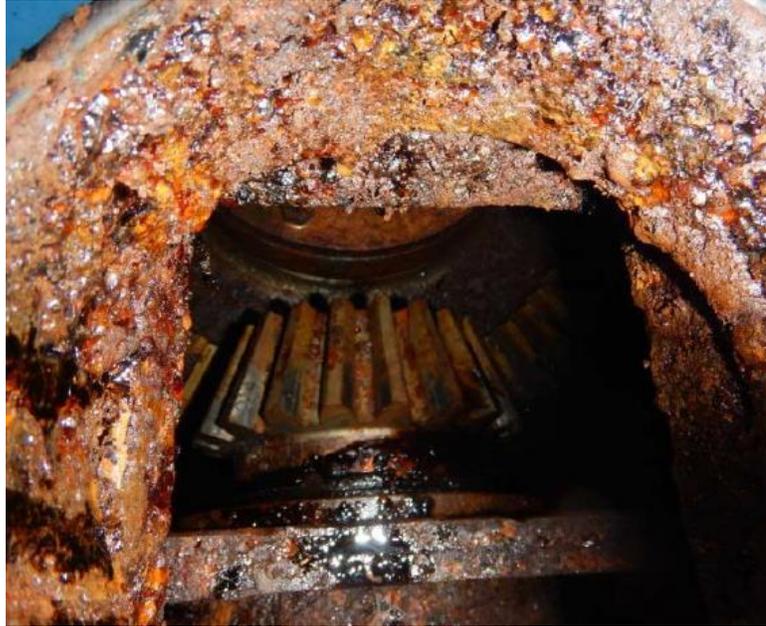
Figure 10: Transfer Case Corrosion - Burnt Dam

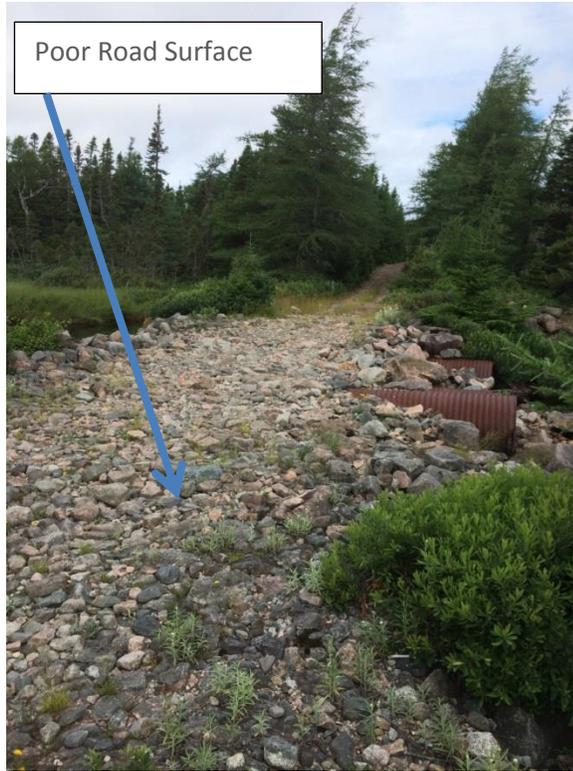
2 The condition of the road is poor with some road sections severely degraded due to weather events,
3 erosion, age, and culvert degradation as shown in Figures 18 to 21. Ditching, an activity that involves
4 clearing accumulated vegetation and sediment from roadside ditches to allow proper water drainage, is
5 required in several areas and there is a lack of suitable road topping.

Figure 18: Ebbegunbaeg Access Road Condition

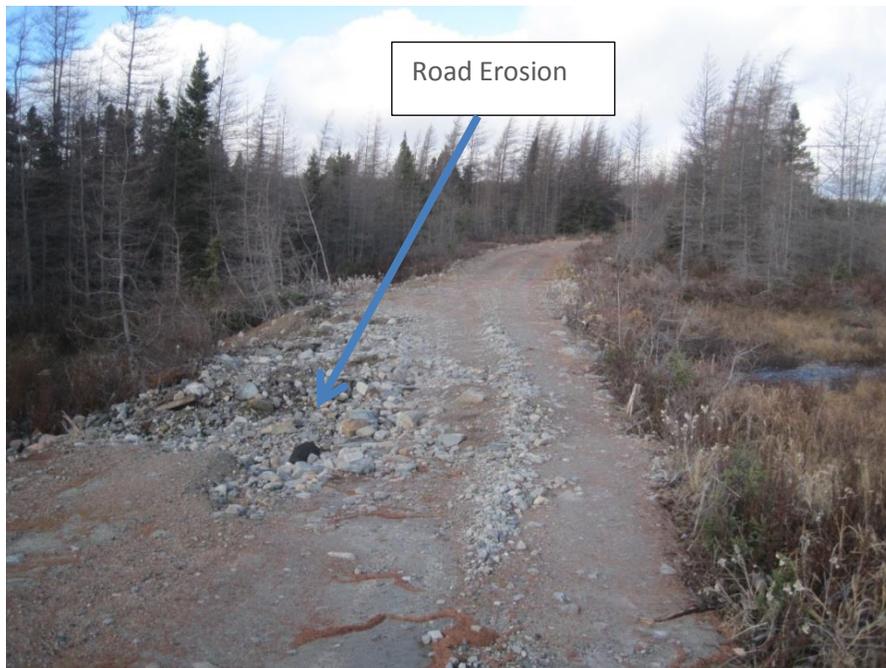
Figure 19: Ebbegunbaeg Access Road Condition

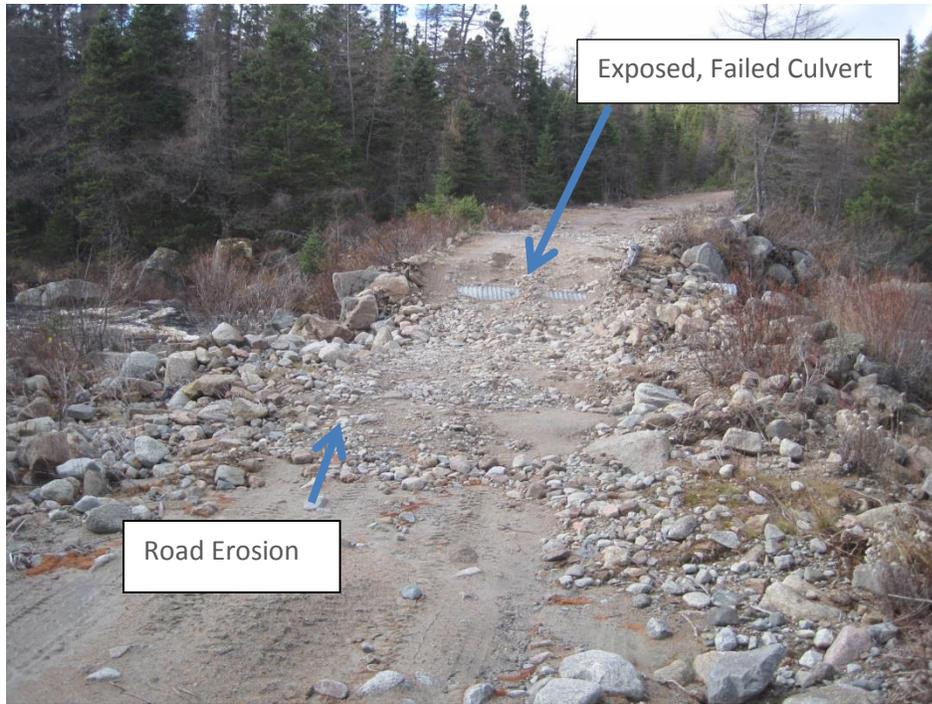
Figure 20: Ebbegunbaeg Access Road Condition

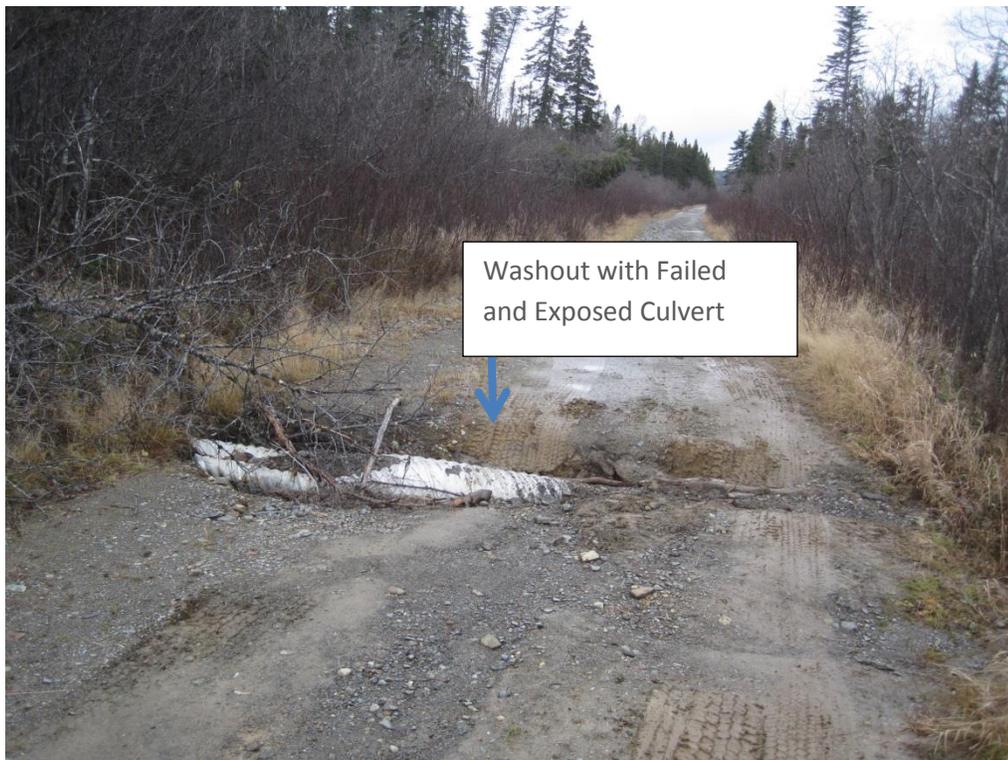
Figure 21: Ebbegunbaeg Access Road Condition

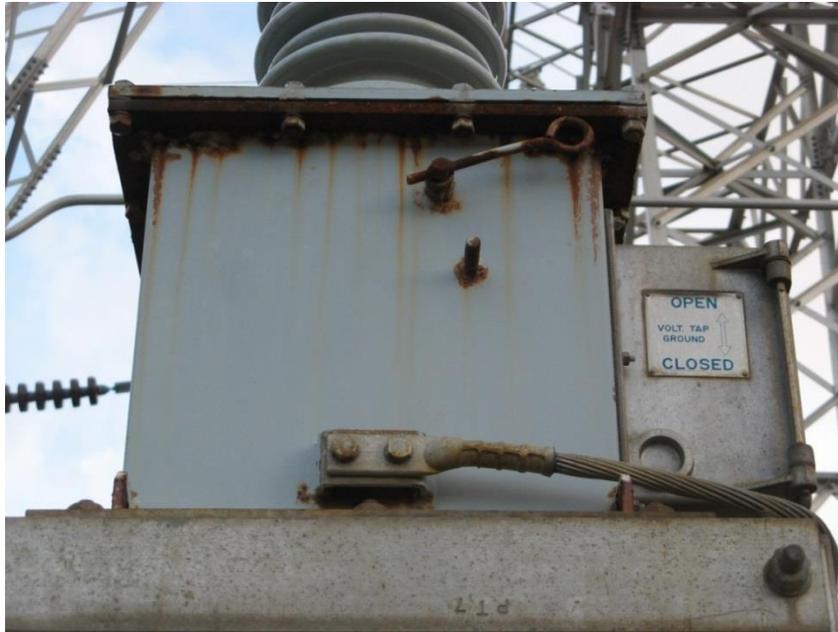
5 Physical deterioration involves conditions such as oil leaks, rusting, or small chips and cracks in the
6 insulation. Figure 2 shows an example of rusting on a PT tanks.

Figure 2: Rusting PT

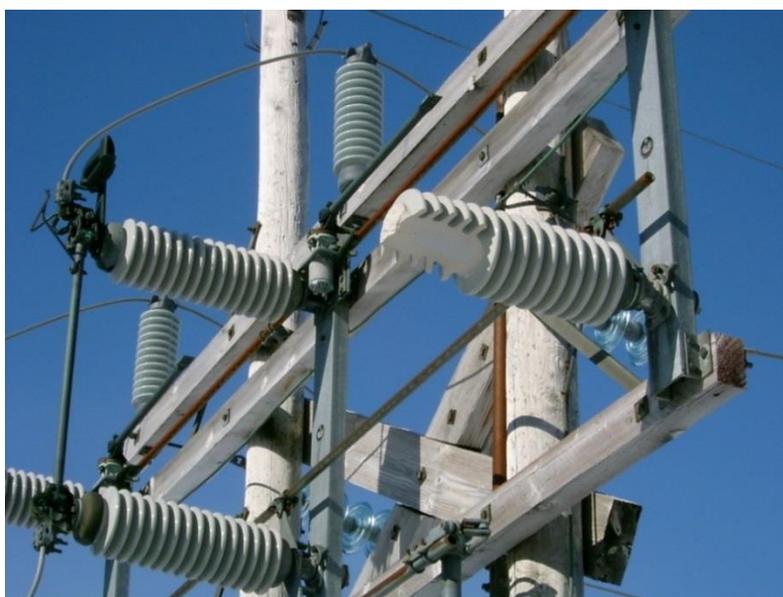
1 JDE E1 work order system or staff who operate the switch, outlining problems such as inoperable
2 mechanical linkages, misalignment of switch blades, broken insulators, and seizing of moving parts.
3 Asset management personnel determine the timing of corrective maintenance or switch replacement. If
4 the required parts are available then repairs are undertaken as part of on-going maintenance. Switches
5 that have operating deficiencies and have reached a service life of 50 years or greater are designated for
6 replacement. Switches that have no replacement parts available due to obsolescence, damaged beyond
7 repair, or cannot be economically repaired and do not require immediate replacement are designated
8 for replacement under this program.
9
10 Figure 4 shows an example of a badly damaged disconnect switch.

Figure 4: Broken Insulator on 69 kV Disconnect Switch

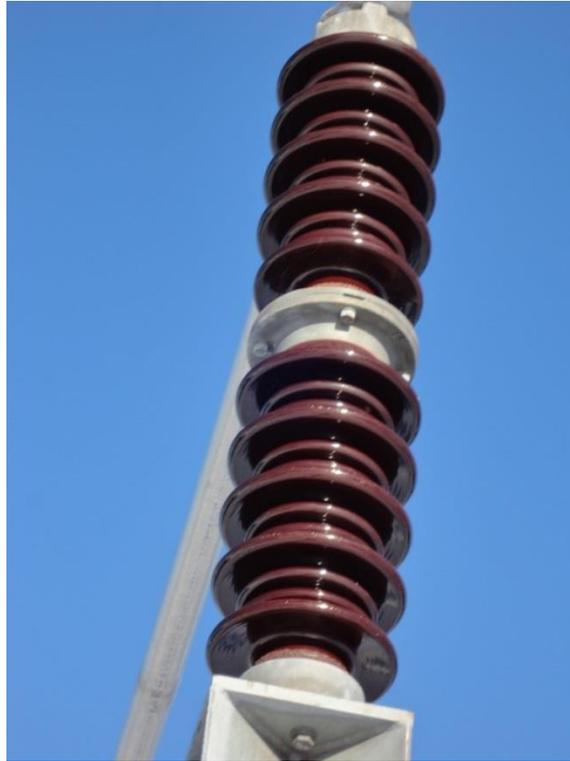
Figure 6: Multi-Cone Type Insulator Prone to Failure due to Cement Growth

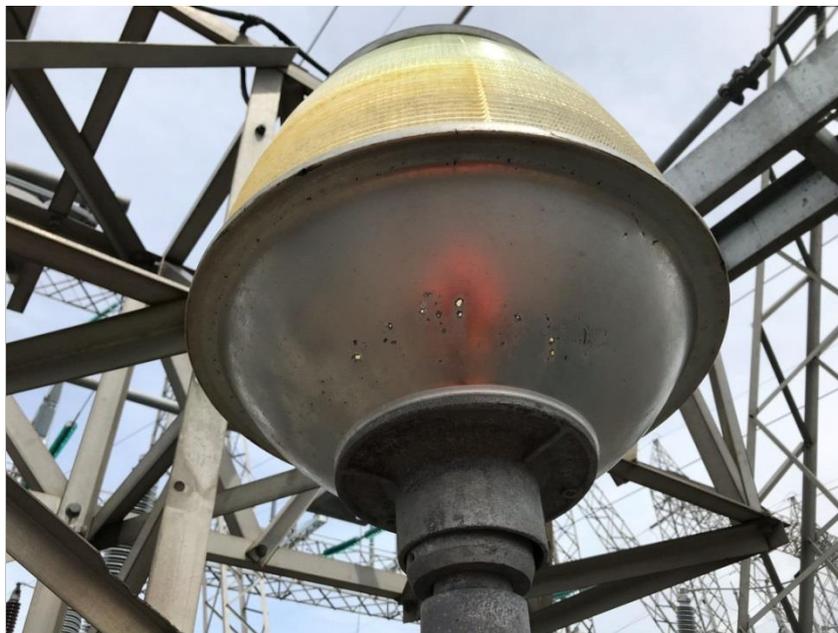
Figure 14: Light Fixture Showing Perforations due to Corrosion, Enabling Moisture Ingress

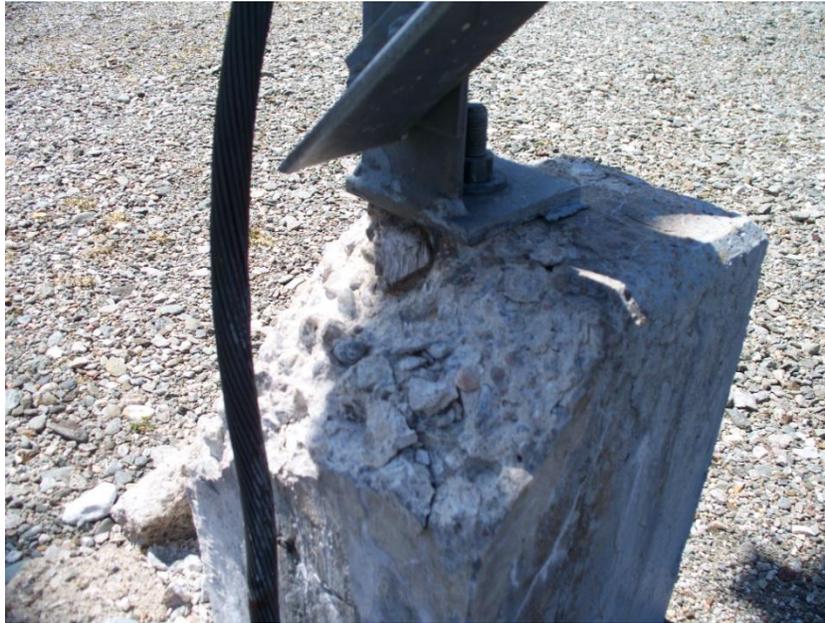
Figure 15: Structure B1T1 Bottom Brook Terminal Station

6
7 The service life of galvanized steel structures varies depending on the operating environment, but can
8 exceed 100 years, outliving the foundations on which they are built. A number of the foundations in
9 Hydro terminal stations have deteriorated significantly due to repeated exposure to damaging
10 freeze/thaw cycles, weathering, and age, leading to concerns over their integrity. Examples of degraded
11 structure foundations are shown in Figure 15 and Figure 16.

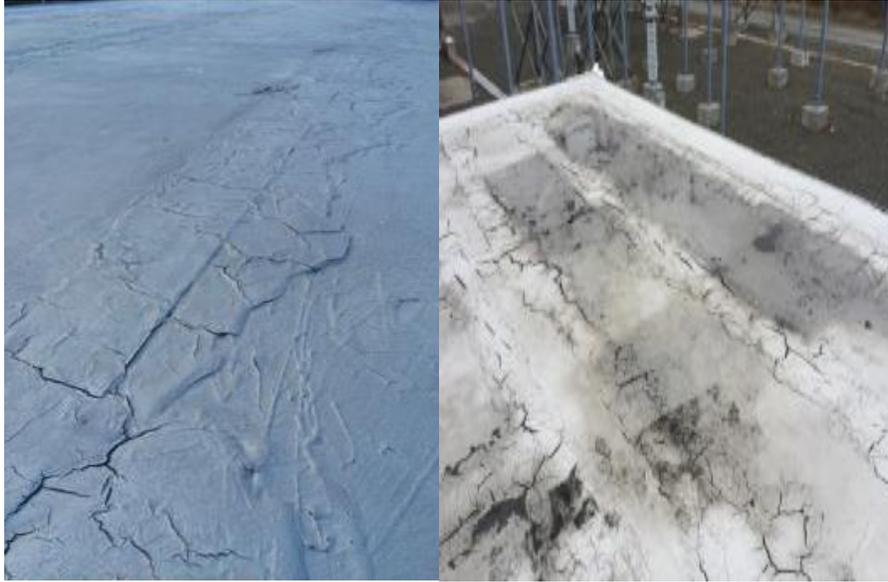
Figure 17: Terminal Station Control Buildings (Come by Chance and Sunnyside) Showing Cracking and Deterioration of the Roof Membrane System

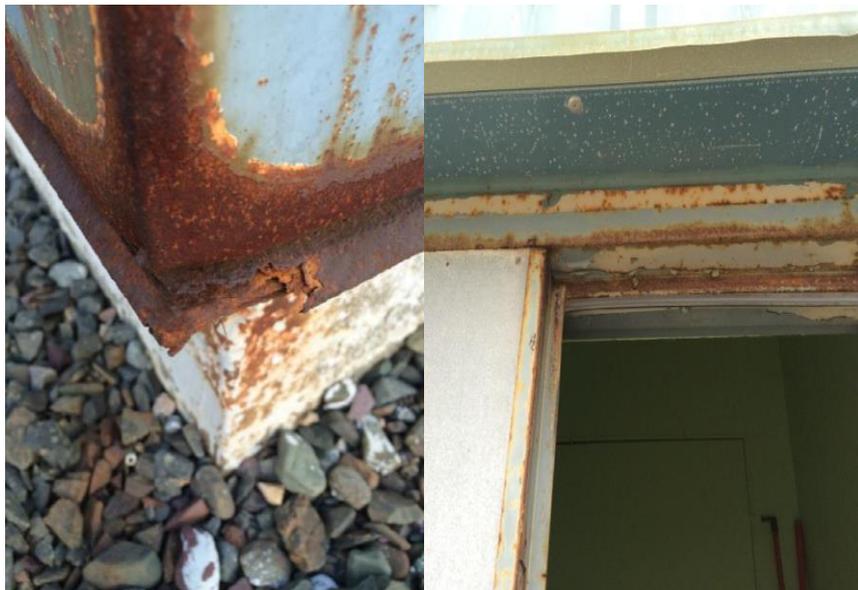
Figure 18: Building Exterior Cladding and Exterior Doorways Displaying Severe Rusting and Deterioration

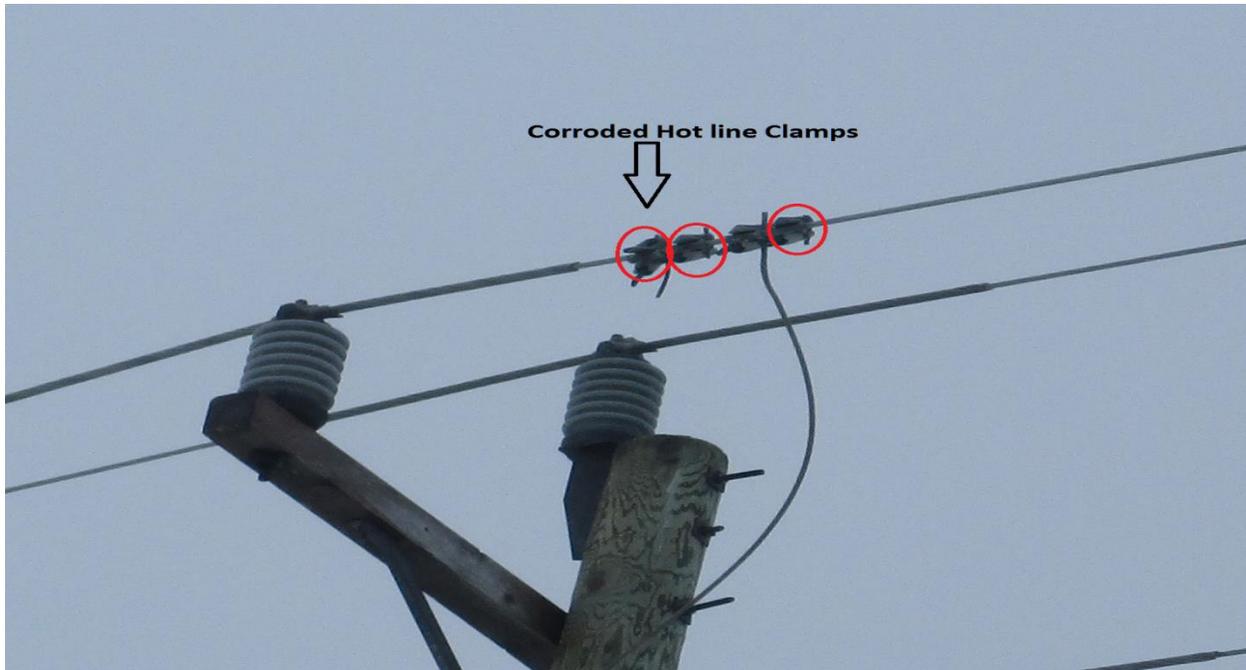
Figure B-3: Corroded Hot Line Clamps – Bear Cove L6

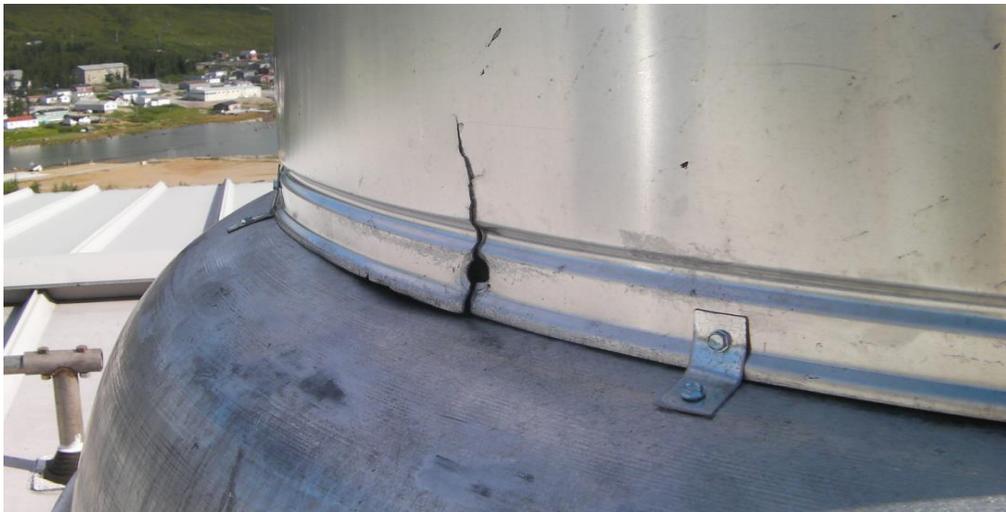
Figure 4: Nain Plant Ventilation Damaged Weather Hoods

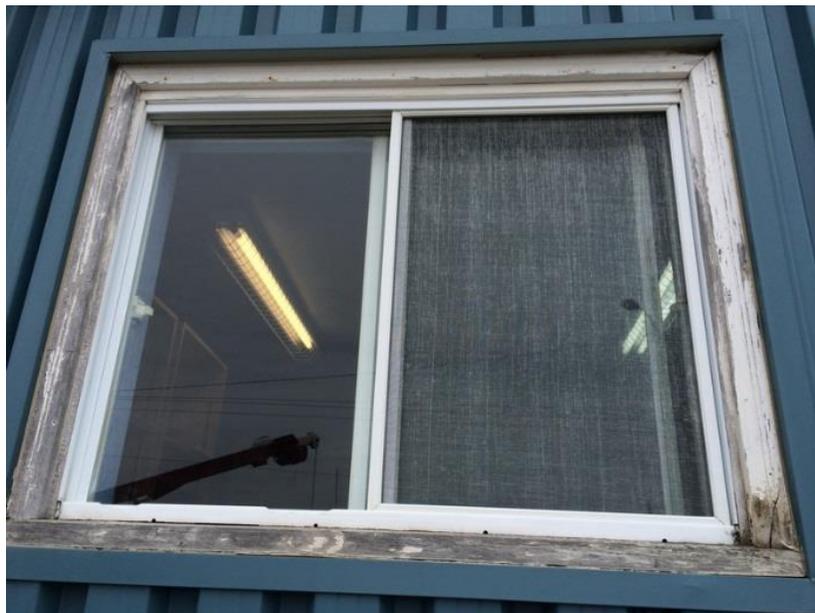
Figure 6: Existing Windows

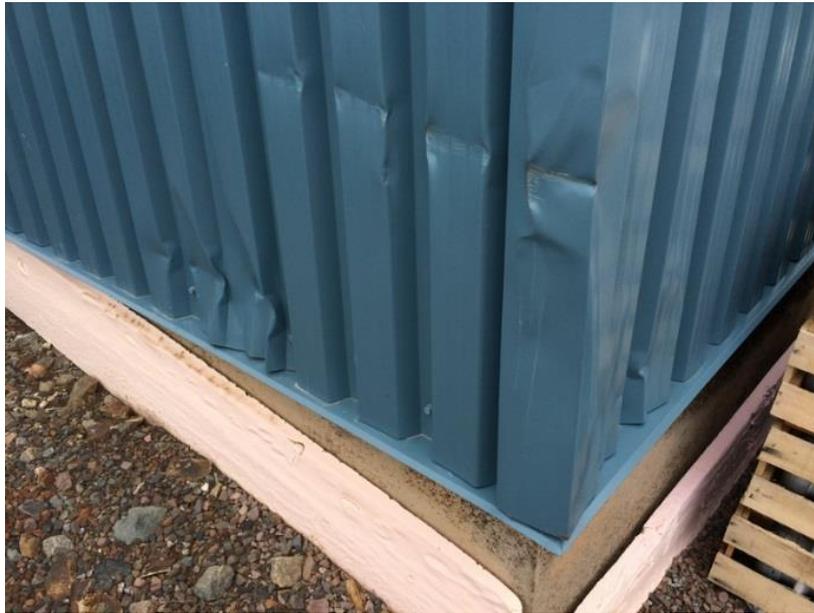
Figure 7: Damaged Siding

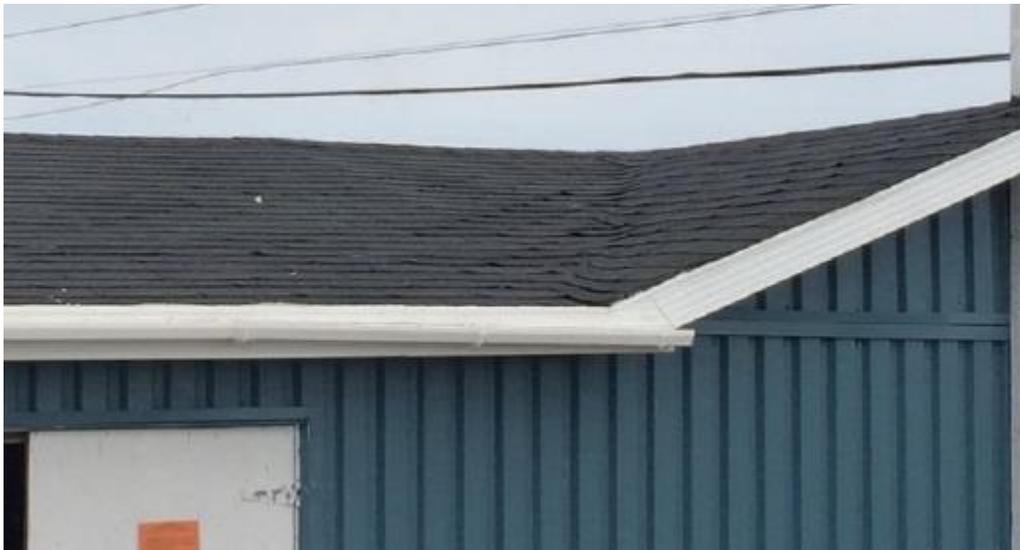
Figure 9: Deteriorated and Lifting Roof Shingles

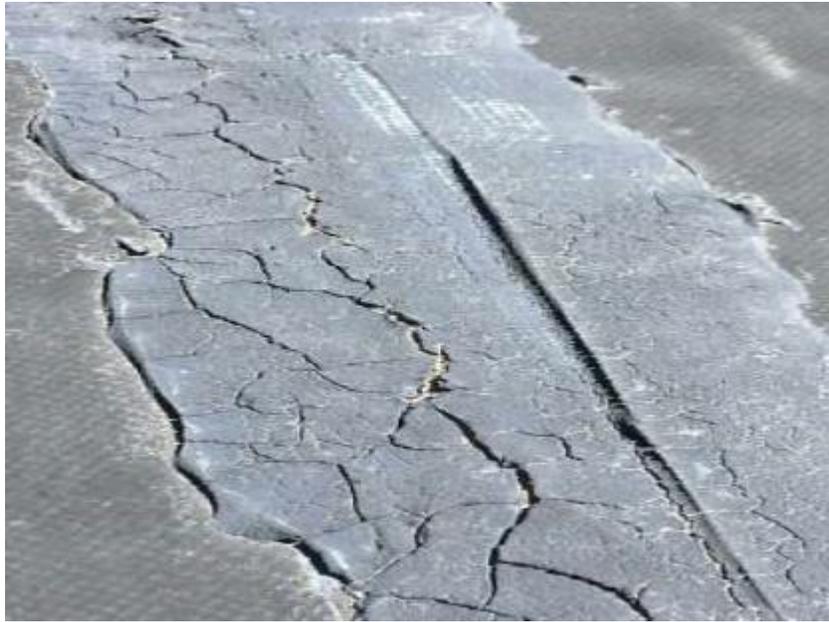
Figure 10: Roof Seam Cracking

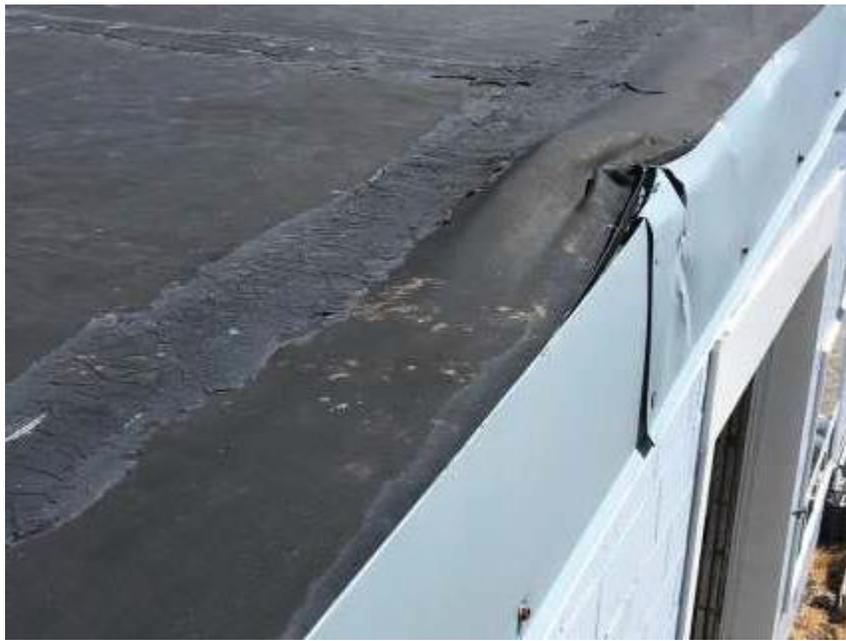
Figure 11: Roof Seams Cracking and Damage to Existing Roof

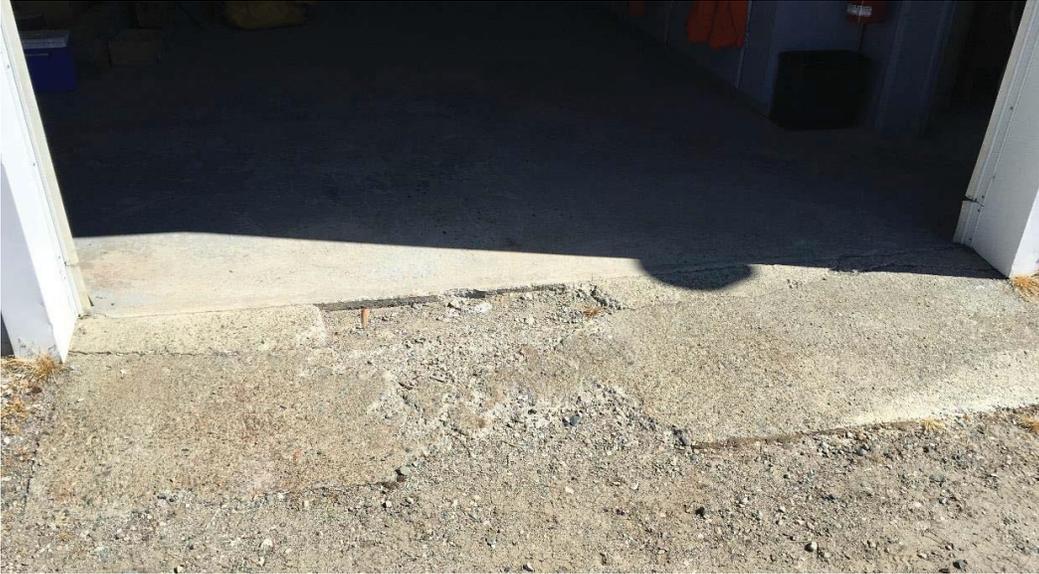
Figure 12: Deteriorated Concrete Ramps

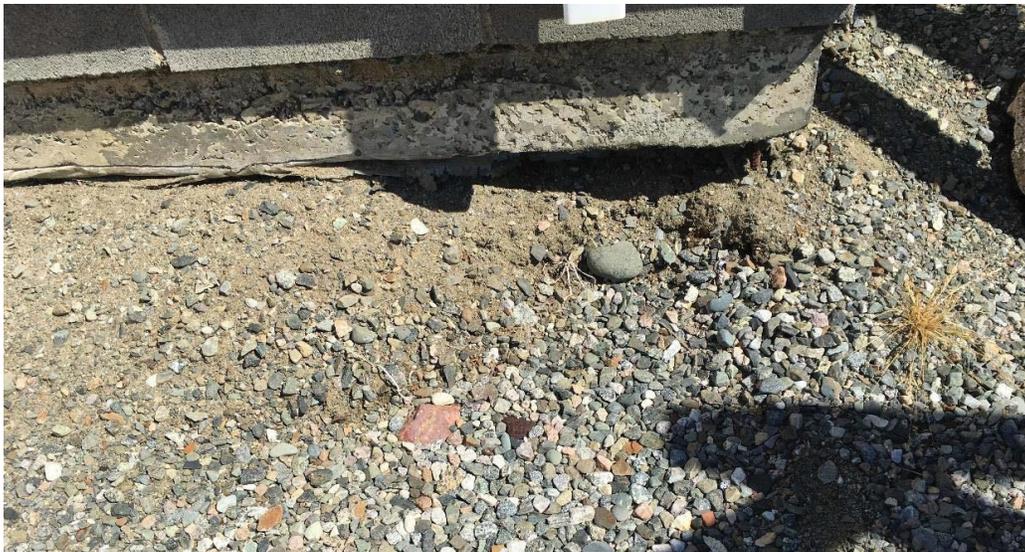
Figure 13: Undermining of Concrete Foundations
