Newfoundland and Labrador Hydro

Condition Assessment Final Report

Condition Assessment of Ten Diesel Plants

H333005-0000-10-236-0001 Rev. 1 December 18, 2009

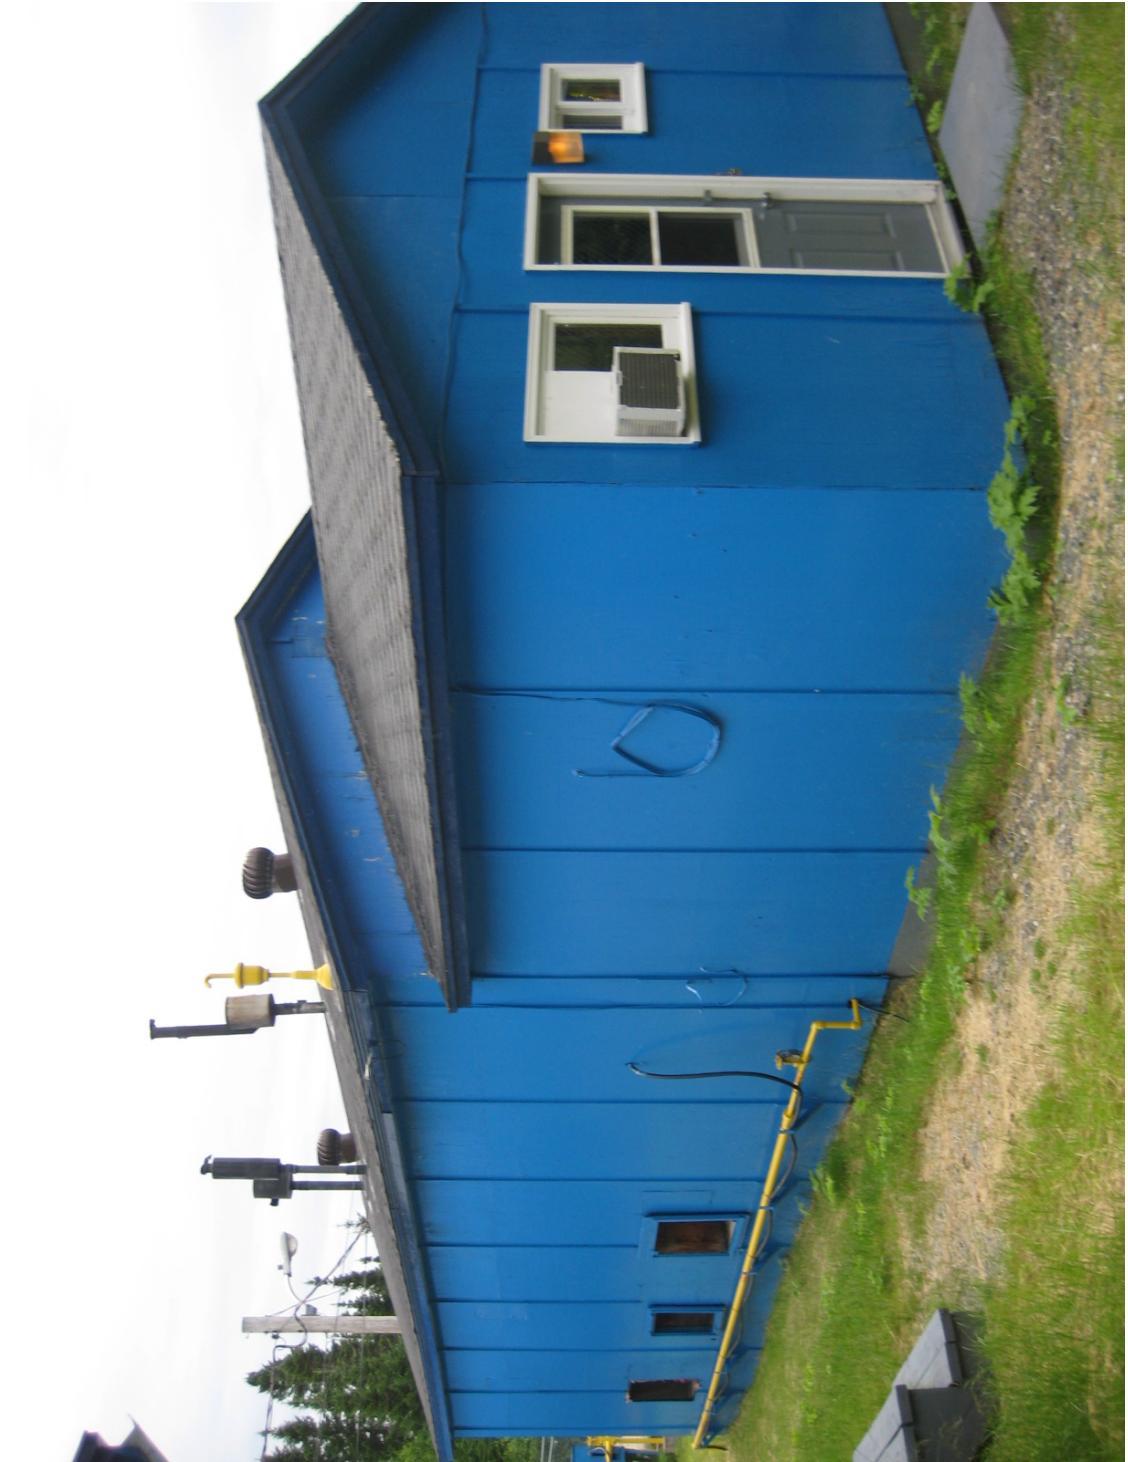
Paradise River, Labrador

Paradise River is ranked second in the suggested for replacement category. It is suggested for replacement due to one main issue: the integrity of the building envelope. The plant appears to be one of the oldest that was assessed. The plant had no mechanical ventilation. There is also the issue of asbestos sheathing on the interior of the plant. The operators noted severe frost heave of the foundation in the winter months that would indicate a potential structural concern. Again, to rectify these issues, a new building is recommended.

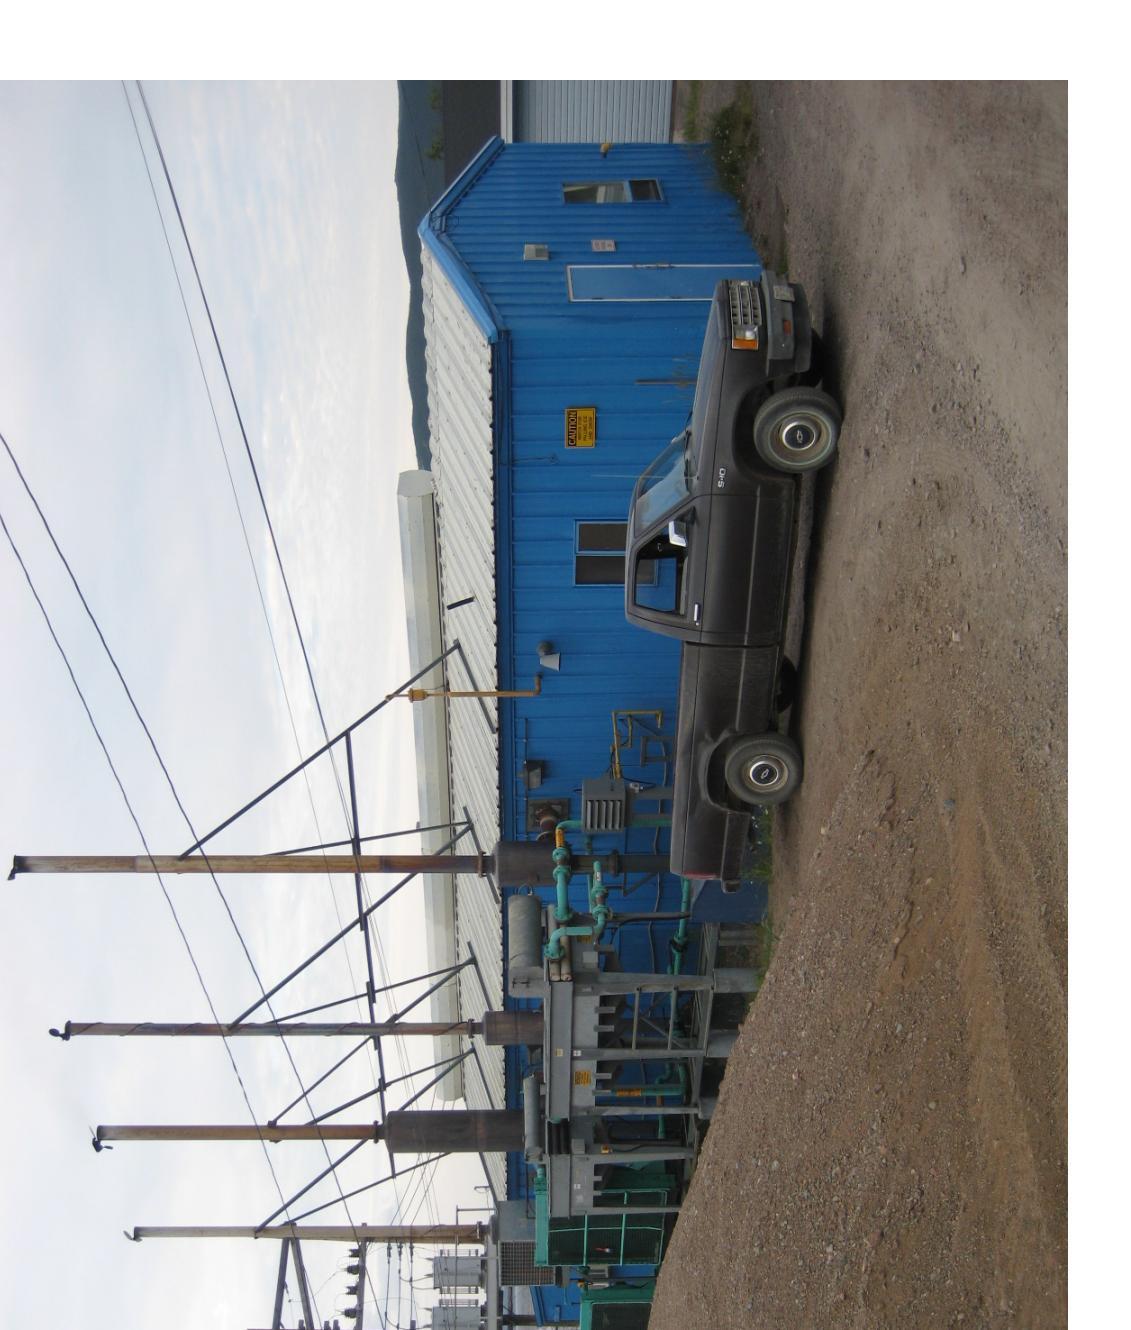
Rigolet, Labrador

Rigolet is ranked first although it appears to have recently undergone some upgrading. This plant is severely overcrowded and congested, resulting in serious egress issues. To rectify this issue, a new building is recommended.
