1 Q. **Reference: Programs and Projects Under \$750,000, page 6, Perform Level 2 Condition**
2 **Assessment - Powerhouse Slope (2025) - Cat Arm.**

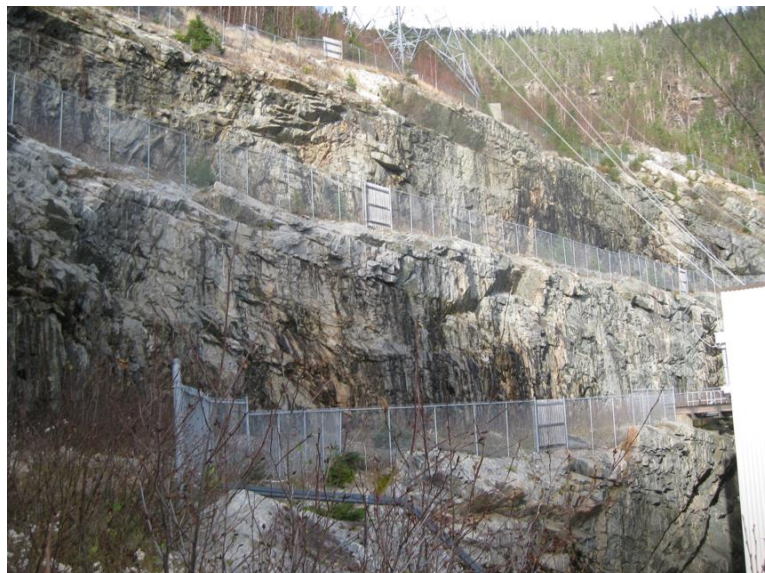
9 A. At present, safety and reliability concerns are addressed by chain-link rock fall fencing along the
10 crest of each benched section of the powerhouse slope. As shown in Figure 1, this fencing was
11 installed in the 1980s to help prevent loose rock and debris from falling to lower sections of the
12 slope. Additionally, chain-link fencing around exterior transformers, as shown in Figure 2, helps
13 to prevent loose rock and debris from falling into the essential powerhouse equipment and
14 creating a safety concern for workers. Further deterioration of the rock slope (visible cracks in
15 face, increased debris etc.) in recent years led to the proposed condition assessment, which will
16 assess the current condition of the slope, the effectiveness of current measures, and determine
17 what further mitigation efforts are required for safe and reliable operation of the powerhouse.

Figure 1: Chain-Link Fencing on Each Benched Section of Powerhouse Slope

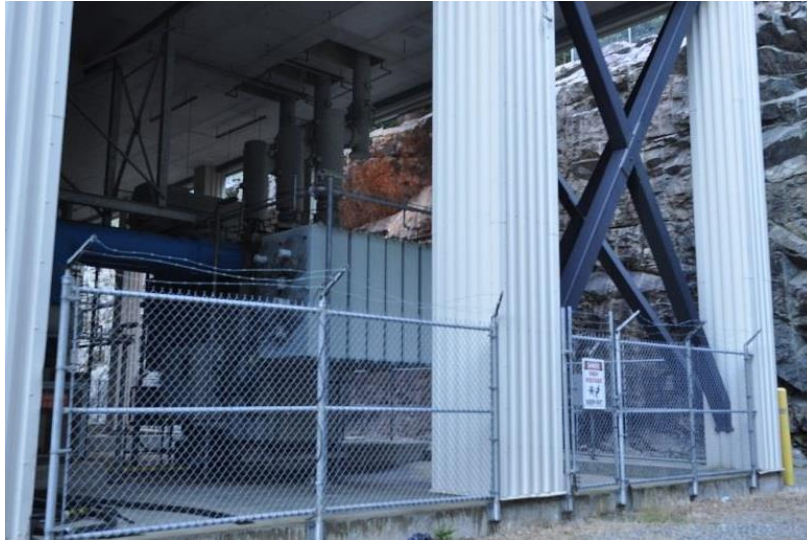
Figure 2: Chain-Link Fencing around Exterior Transformers
