WOOD POLE LINE MANAGEMENT USING RCM PRINCIPLES

A Final Report Prepared for Engineering Department, TRO Division

Newfoundland and Labrador Hydro

Dated: January 9, 2004

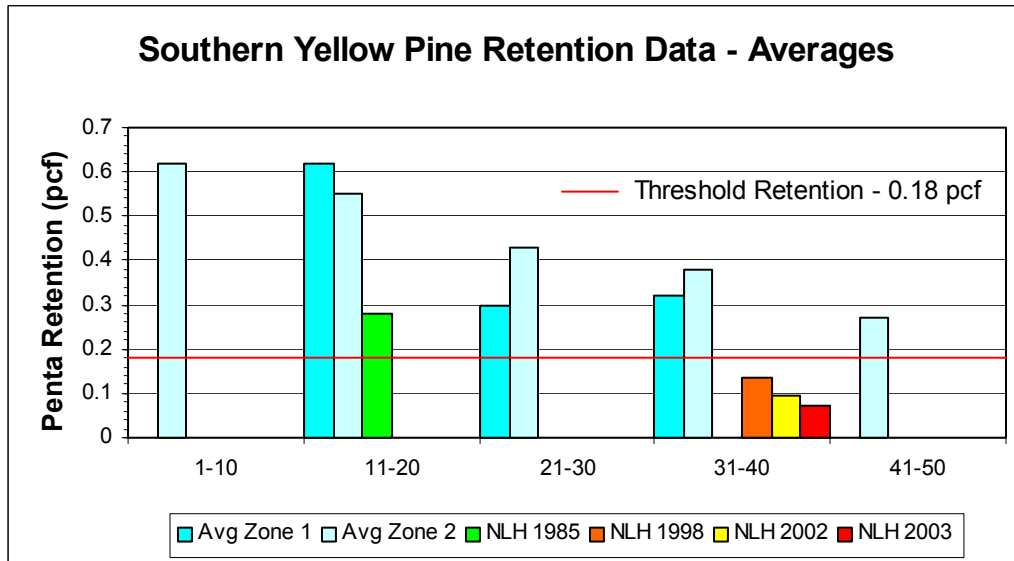
Fig. 1

basis. A quick comparison of Hydro's retention level data with those obtained from a major Canadian utility showed that the preservative amount left on these poles is not only well below this utility's data but also below the minimum threshold. **Fig. 1** depicts the comparison of this data where Zones 1 and 2 represent the other utility's data.

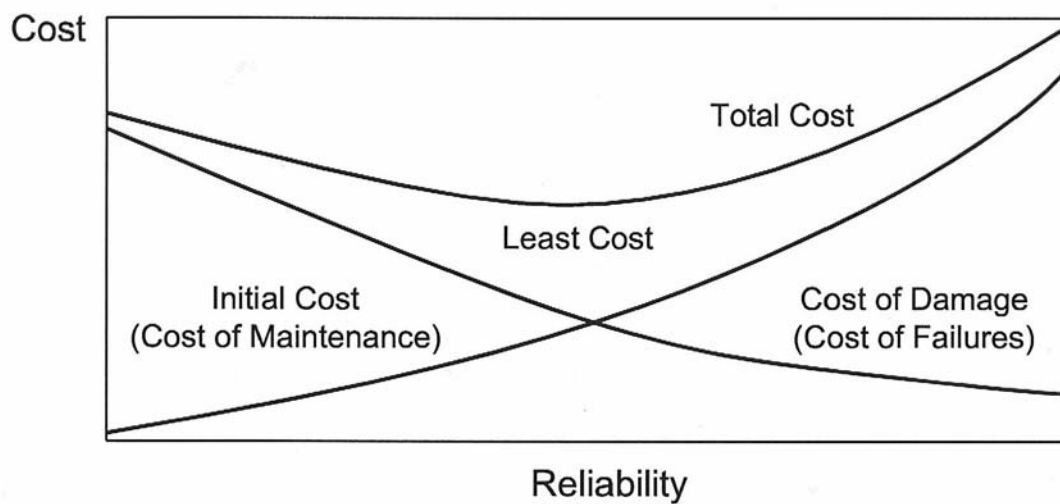
Fig. 1.1 – Optimum Cost Curve

During the past 15 years Hydro has consistently used the **Reliability Based Design (RBD)** methodology either in the upgrading of existing lines (TL 228, 230 kV steel lines on the Avalon Peninsula, Halдар, 1990, 1997) and/or building new lines (TL 263, TL 236). The RBD methodology takes into account the capital cost of investment in the upgrading of existing lines, or building of new lines, and balances this cost against any future cost of damage (discounted to the present value) and optimizes the design parameters such as span, reliability, etc. **Fig. 1.1** depicts the saddle point where the total cost is minimized.

Since 1997, Hydro has been working to implement a Reliability Centered Maintenance (RCM) program in which the cost of preventive and predictive maintenance is balanced against the cost of damage and service interruption. **Fig. 1.1** also captures this idea and shows that in principle, both RBD and RCM methodologies can complement each other to ensure that Hydro gets the best return on its investment during the service life of a transmission line asset.

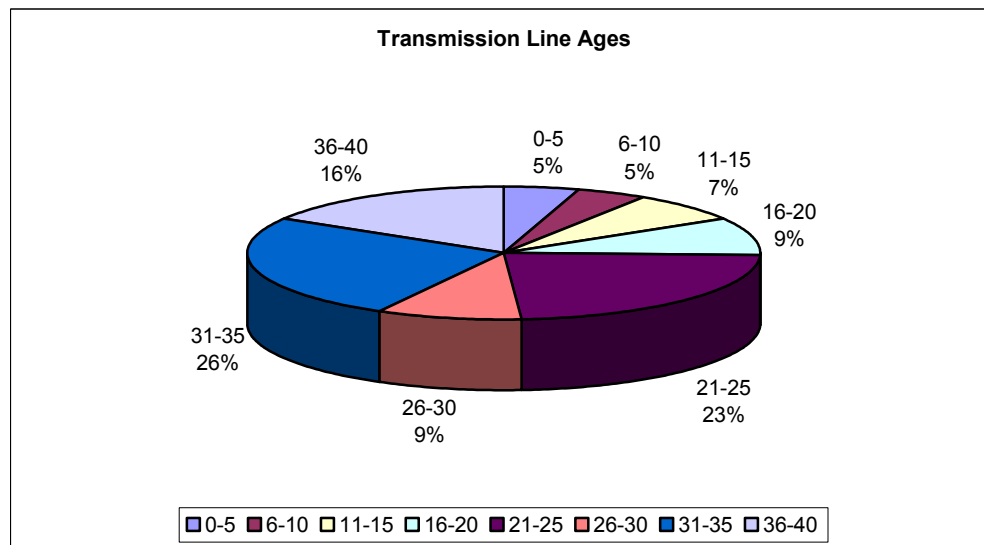
Fig. 1.2a - Transmission Line Ages

Hydro operates 43 high voltage (69 kV – 230 kV) wood pole transmission lines that total approximately 2400 km. **Fig. 1.2a, b and c** present the age of these lines. Approximately, 42% of Hydro's transmission lines are over 30 years of age and, without a careful assessment of their condition, Hydro's wood pole transmission network could be exposed not only to premature failure under design loading conditions but also to a major pole replacement program in the future.

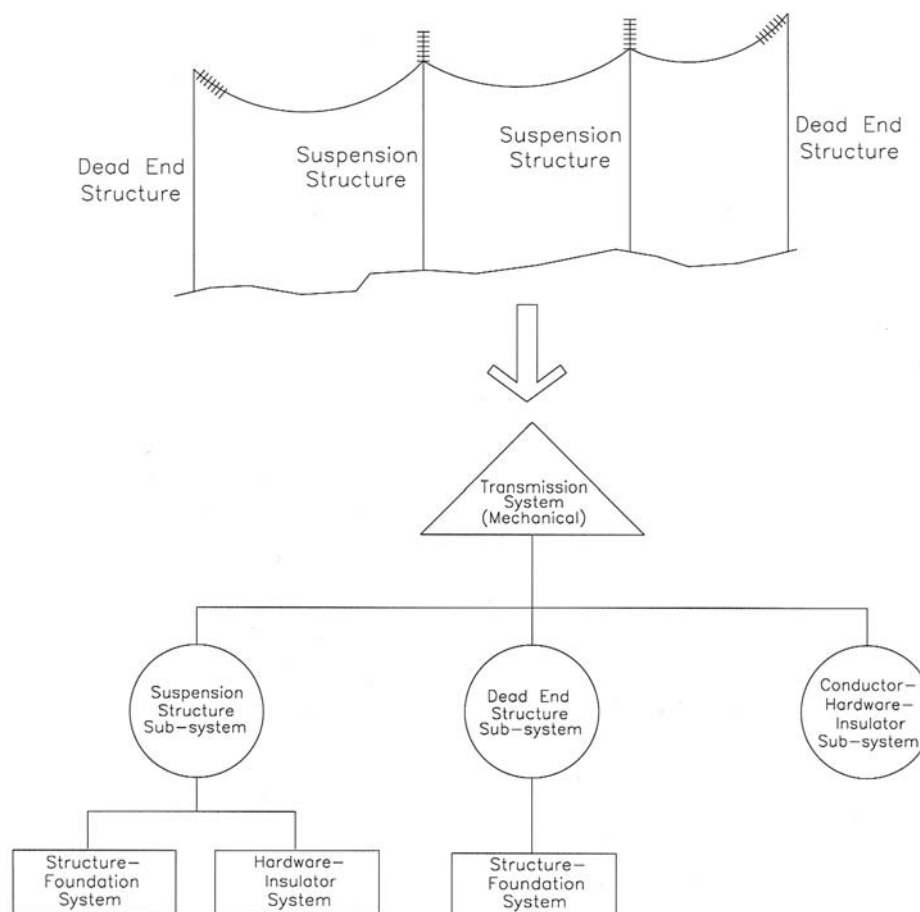
Fig. 2.1 - Transmission Line System

To understand the RCM principles with particular reference to wood pole lines, one needs to treat the line as a system which can be broken down into various sub-systems as shown in **Fig. 2.1**. The Asset Manager needs to know the condition of the asset (in this case, the condition of the various sub-systems e.g. structures, conductor-hardware etc. or its individual components such as wood poles, conductor, insulators, hardware etc) at present i.e. “year zero” of the future life cycle. The life cycle could be any period of time. A typical period, or life cycle for new wood pole lines is 40 to 50 years.

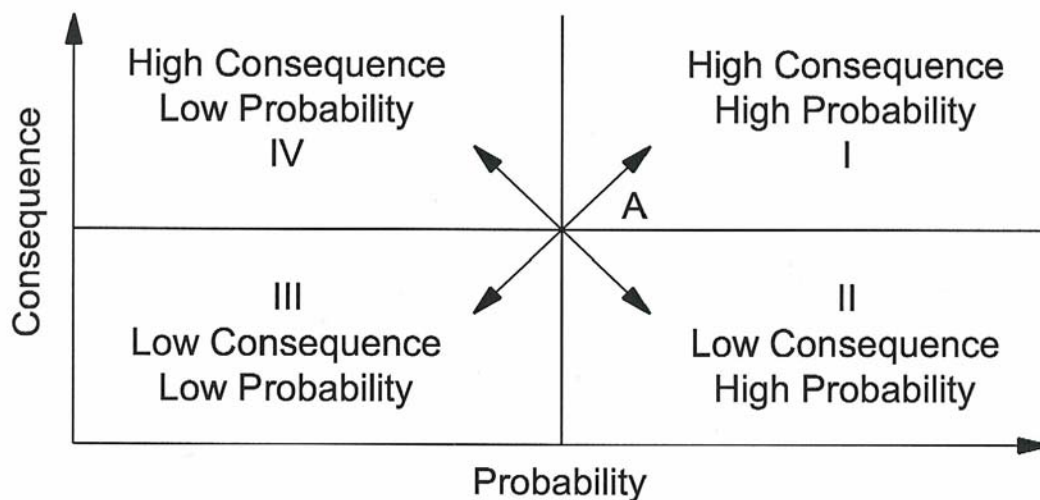
Fig. 2.2 – Risk Evaluation (Jones, 1995)

Fig. 2.2 depicts the graphical representation of risk where four specific combinations of probability of occurrence and consequence are shown. This figure divides the coordinate system in four quadrants. The four arrows show the point of direction along which point “A” can move thus creating a change in the risk value. Obviously, Option III is most preferable while Option I is the least preferable.

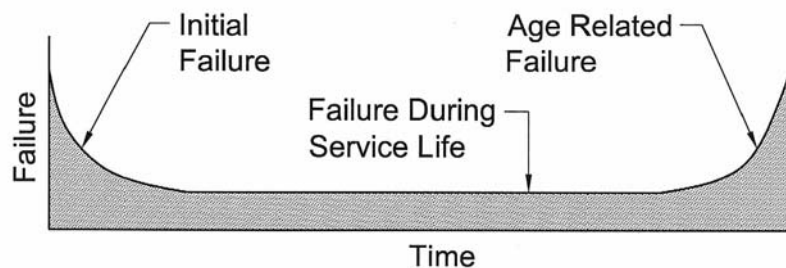
Fig. 2.3a - Typical Failure Rate “Bath Tub” Curve (Jones, 1995)

vibration, deformation, corrosion etc, they will deteriorate at different rates. **Fig. 2.3a** depicts a typical failure rate curve (known as the “bath tub” curve) showing the expected failure rate of a component or a system. **Fig. 2.3b** shows a typical “bath tub” curve with two different deterioration rates obtained from past historical inspection records. As can be seen, one would expect that poles, having a shorter life, would have a high failure rates from 50 to 60 years, whereas conductor, having a longer life, would have an increased failure rates from 65 to 80 years.

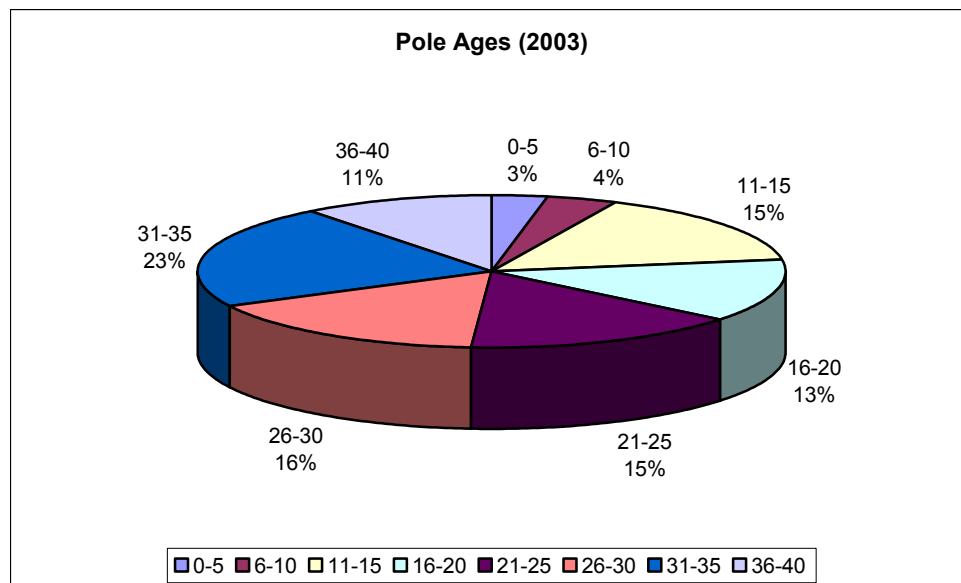
**Fig. 3.2a - Pole Age Distribution (2003)**

Fig. 3.2a shows the distribution of all 26,000 transmission size poles on NLH system by age. This shows that approximately 34% of the transmission size poles (9000 in-service poles) are over 30 years age. **Figs. 3.2b** and **3.2c** present the age distributions for central and northern regions respectively.

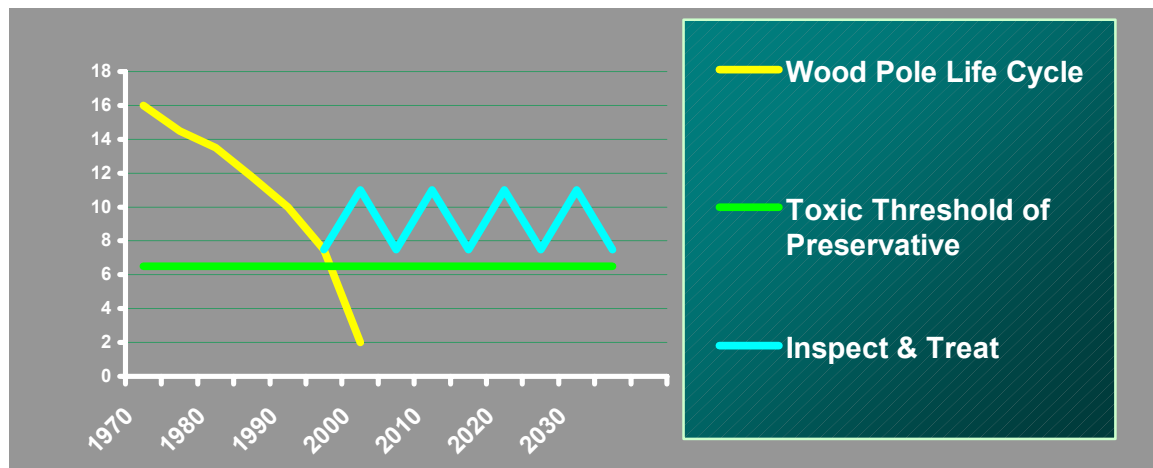
Fig. 3.3 – Typical Depletion Rate of Preservatives (GENICS, 1998)

not have the preservative level restored early enough, particularly at 50% of their expected service life (20 to 25 years), the pole is exposed to decay which leads to degradation of strength (i.e. significant loss of sapwood for Southern Yellow Pine or heartwood for Douglas Fir) and make the pole structurally unsafe.

Since Hydro has the preservative retention level data for poles on the Avalon for three inspection years (1985, 1998 and 2003), an attempt was made first to understand the trend of the preservative depletion rate. **Fig. 3.14** depicts the average trend for poles on the Avalon Peninsula. The depletion rate trend can be compared with the “yellow line” shown in Figure 3.3.

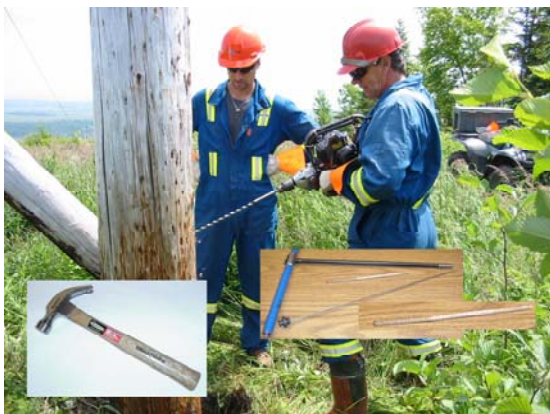
Figure 3.4a - Inspection Tools

Fig. 3.4a depicts the tools required to carry out inspection based on sounding and boring. **Fig. 3.4b** depicts the Resistograph, which through the use of a 3mm drilling needle and resistance measurement, profiles the poles core. **Fig. 3.4c** shows the nondestructive PoleTest tool for strength evaluation based on ultrasonic principle. **Fig. 3.4d** depicts the full-scale test bench developed at Memorial University's Engineering laboratory for

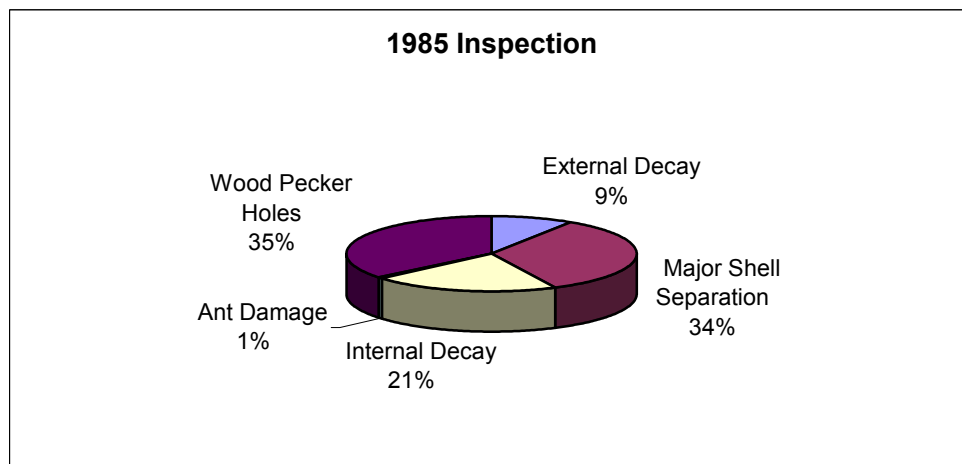
Fig. 3.5 – 1985 Pole Inspection Program – Primary Defects

1985	TL201	TL203	TL218	TL236	Total
<i>Constructed (Age at inspection)</i>	1966(19)	1965(20)	1970(15)	1966(19)	
<i>Total Poles on each line</i>	754	424	93	125	1394
<i>Poles Inspected</i>	754	424	93	125	1394
<i>Rejected</i>	0	0	0	0	0
<i>Poles to Monitor</i>	22	27	5	6	60
Prominent Defects					
<i>External Decay</i>	1	3	1	8	13
<i>Major Shell Separation</i>	15	28	1	3	47
<i>Internal Decay</i>	0	9	7	13	29
<i>Ant Damage</i>	0	1	N/A	N/A	1
<i>Wood Pecker Holes</i>	48	2	N/A	N/A	50

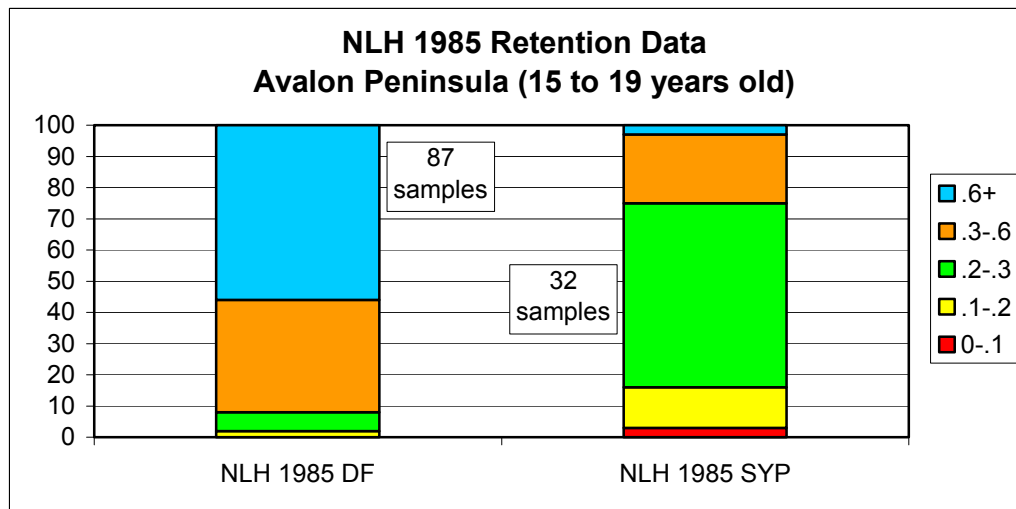
Fig. 3.6 - 1985 Pole Inspection Program - Retention Data

Fig. 3.6 depicts the results of the retention analysis for pentachlorophenol (penta) treated poles. The analysis indicates that a small portion of this sample size did not meet the minimum preservative retention threshold in the 1985 inspection

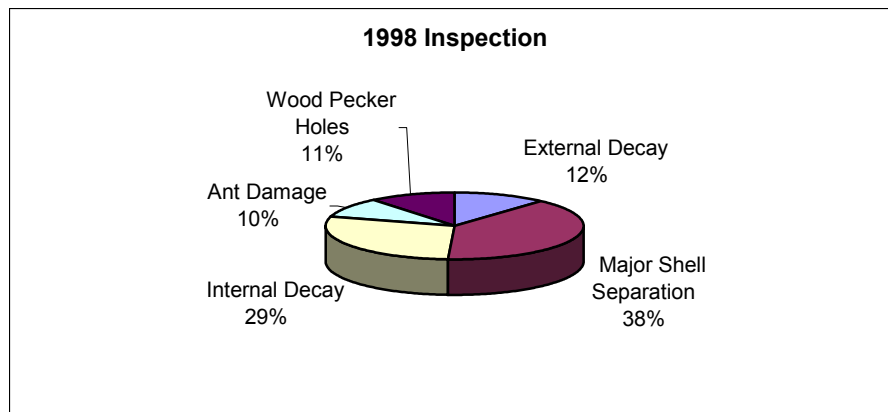
Fig. 3.7 – 1998 Pole Inspection Program - Primary Causes For Rejection

1998	TL201	TL203	TL218	TL236	Total
<i>Constructed (Age at inspection)</i>	1966(32)	1965(33)	1970(28)	1966(32)	
<i>Total Poles on each line</i>	806	422	88	129	1445
<i>Poles Inspected</i>	806	422	88	129	1445
<i>Rejected</i>	45	24	4	5	78
<i>Poles to Monitor</i>	10	2	0	0	12
Prominent Defects					
<i>External Decay</i>	0	12	1	0	13
<i>Major Shell Separation</i>	28	15	1	0	44
<i>Internal Decay</i>	13	11	3	5	32
<i>Ant Damage</i>	7	4	0	0	11
<i>Wood Pecker Holes</i>	10	2	0	0	12

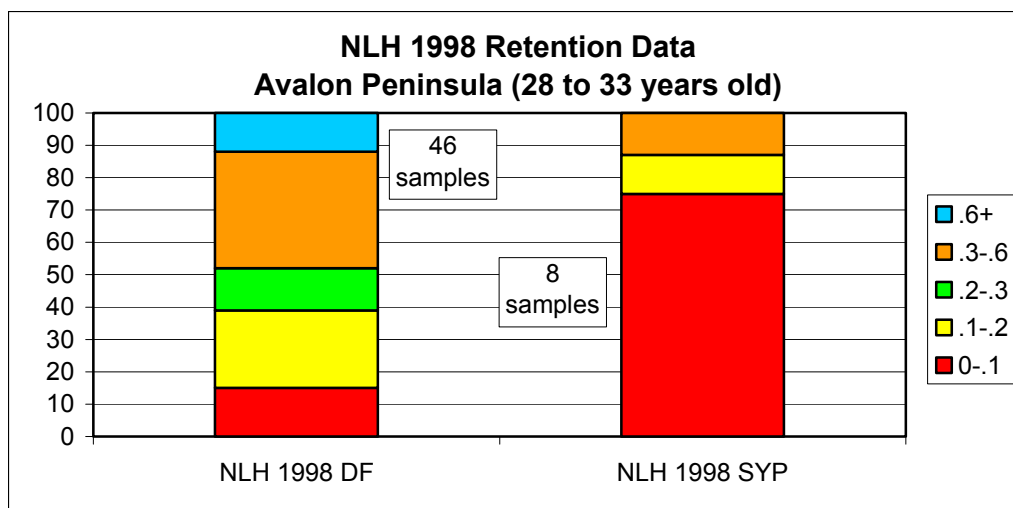
Fig. 3.8 - 1998 Pole Inspection Program – Retention Data

In addition to inspection services, the contractor extracted 121 cores from randomly selected treated poles and the samples were analyzed for preservative retention levels. Sixty poles out of this sample size had full-length penta treatment. Based on the inspection program and core sampling, it was found that 48% of the penta treated poles of 1966 vintage sampled for retention level analysis did not meet the minimum threshold level (“Green Line” in **Fig. 3.3**) for preservative retention and therefore required immediate treatment to arrest the further progression of decay (GENICS, 1998). Only Douglas Fir (DF) and Southern Yellow Pine (SYP) poles are reported in **Fig. 3.8** as the Western Red Cedar poles were butt treated and yielded no results.

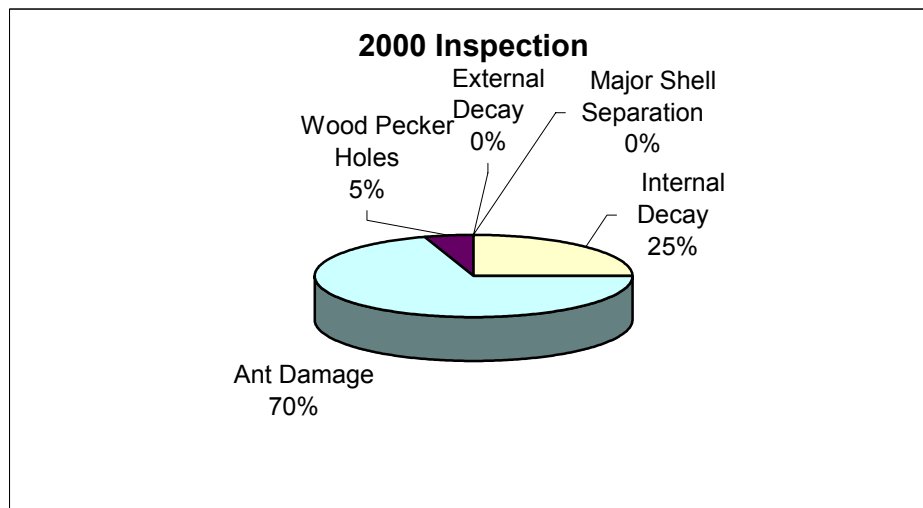
Fig. 3.9 – 2000 Pole Inspection Program – Primary Causes For Rejection

2000	TL209	TL215	TL224	TL233	TL234	Total
<i>Constructed</i>	1971(29)	1969(31)	1968(32)	1973(27)	1981(19)	
<i>(Age at inspection)</i>						
<i>Total Poles on each line</i>	185	437	825	1280	489	3216
<i>Poles Inspected</i>	74	257	331	637	243	1541
<i>Rejected</i>	1	20	8	48	1	78
<i>Poles to Monitor</i>	0	0	0	0	0	0
<i>Prominent Defects</i>						
<i>External Decay</i>	0	0	0	0	0	0
<i>Major Shell Separation</i>	0	0	0	0	0	0
<i>Internal Decay</i>	1	8	7	4	0	20
<i>Ant Damage</i>	0	10	1	44	1	56
<i>Wood Pecker Holes</i>	0	2	0	2	0	4

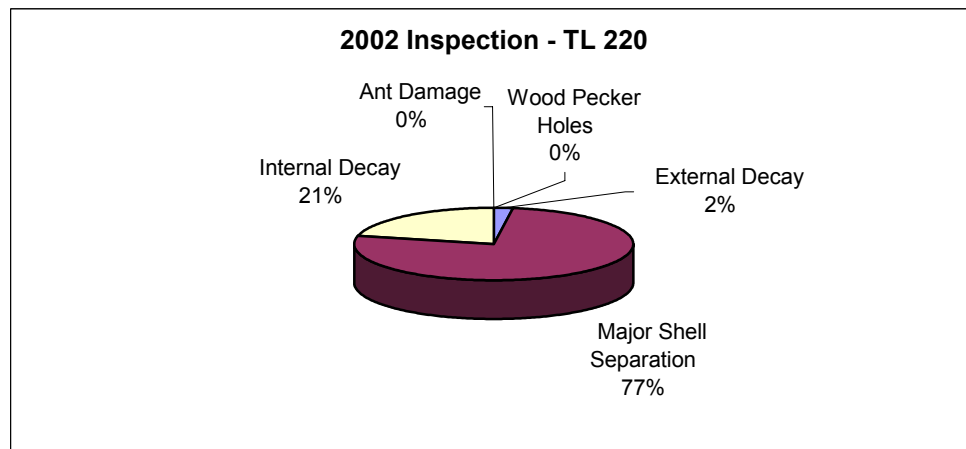
Fig. 3.10 – 2002 Pole Inspection Program – Primary Causes For Rejection

2002	TL220
<i>Constructed (Age at inspection)</i>	1970(32)
<i>Total Poles on the line</i>	786
<i>Poles Inspected</i>	273
<i>Rejected</i>	37
<i>Poles to Monitor</i>	0
<i>Prominent Defects</i>	
<i>External Decay</i>	1
<i>Major Shell Separation</i>	36
<i>Internal Decay</i>	10
<i>Ant Damage</i>	0
<i>Wood Pecker Holes</i>	0

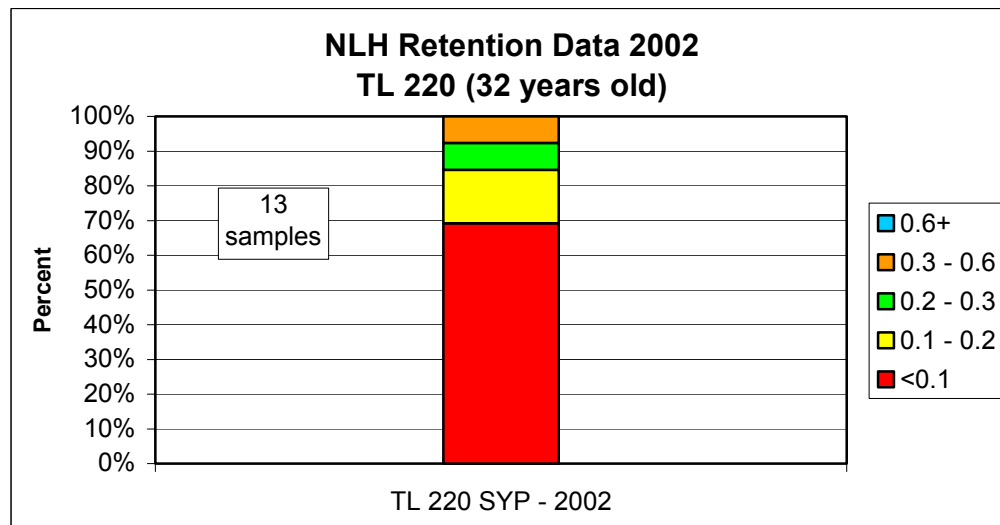
Fig. 3.11 – 2002 Pole Inspection Program – Retention Data

Fig. 3.11 depicts the preservative retention levels for poles on TL 220. It shows that 80% of the sample tested fell at or below the minimum threshold value.

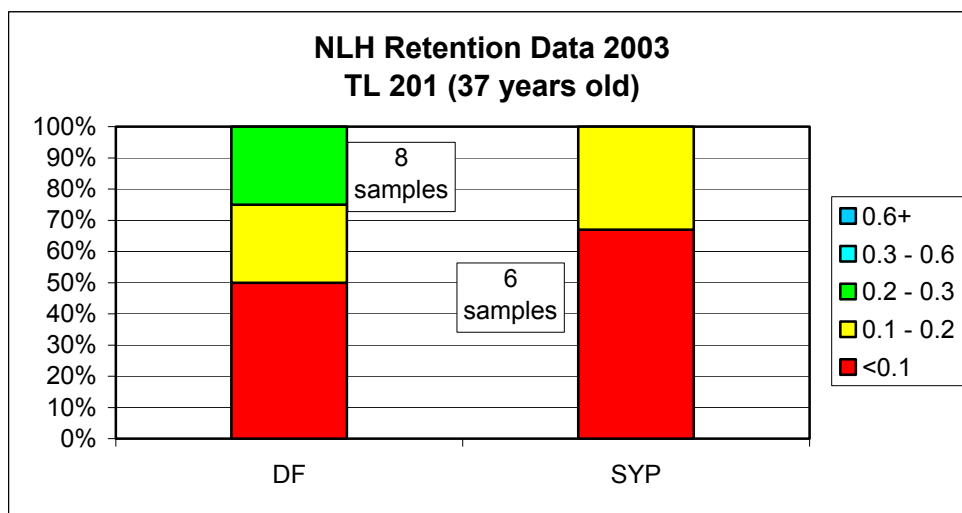
Fig. 3.13 – 2003 Pole Inspection Program – Retention Data

portion of this sample size, did not meet the minimum threshold level indicating that the poles are exposed to further decay. It should be noted that in the 1998 inspection 48% of the samples did not meet the threshold, but by 2003 this had increased to 71%, thus indicating a significant depletion of preservative over a five-year period.

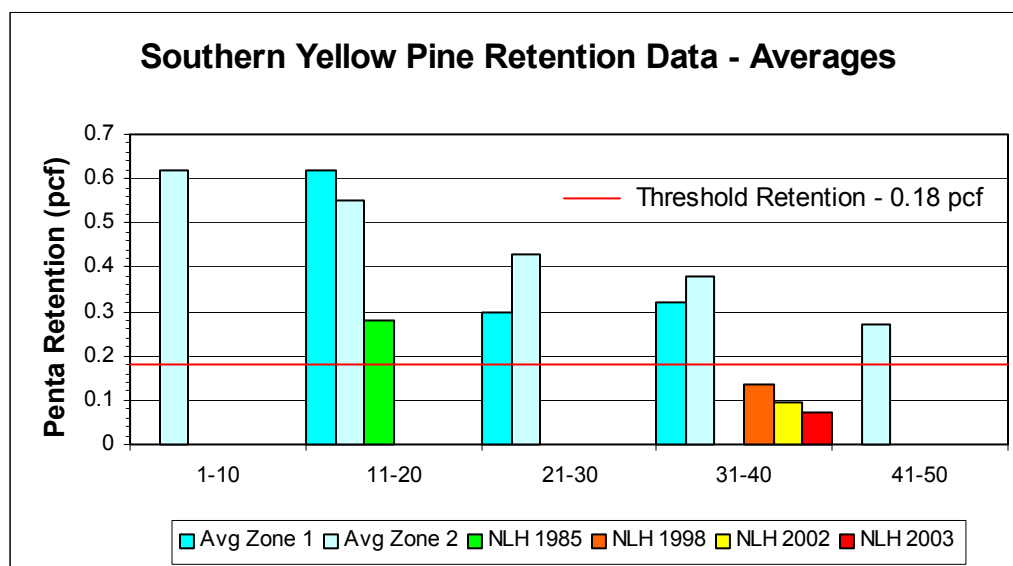
Fig. 3.15 - Preservative Retention Level With Respect To Age - External Utility Data

A major utility in Canada also carried out a test program to measure preservative retention level for distribution size poles (Southern Yellow Pine) in three different zones of the particular province. **Fig. 3.15** depicts the preservative retention levels at various in-service ages for two different zones. Zone 1 is comparable to the Avalon while Zone 2 could be compared to the Central region. It is shown that around 31-40 years, the average retention levels are 0.33 and 0.38 for Zones 1 and 2, respectively. **Fig. 3.15** also compares the same with the Avalon data (**Fig. 3.14**). The comparison validates NLH data, and shows that the preservative amount left in NLH poles is not only well below this utility's data, but also below the minimum threshold.

The comparison is made here merely to show the trend only and to validate the data collected by NLH. One can envisage the possible rate of depletion from these figures in future years if these poles are not treated. This is important information for managing the pole inventory and can be directly linked with the pole decay because these two parameters are highly correlated. **Fig. 3.16** shows such a conceptual curve developed to link these two parameters. The curve can be used in the data analysis when fully developed and validated by Hydro data.

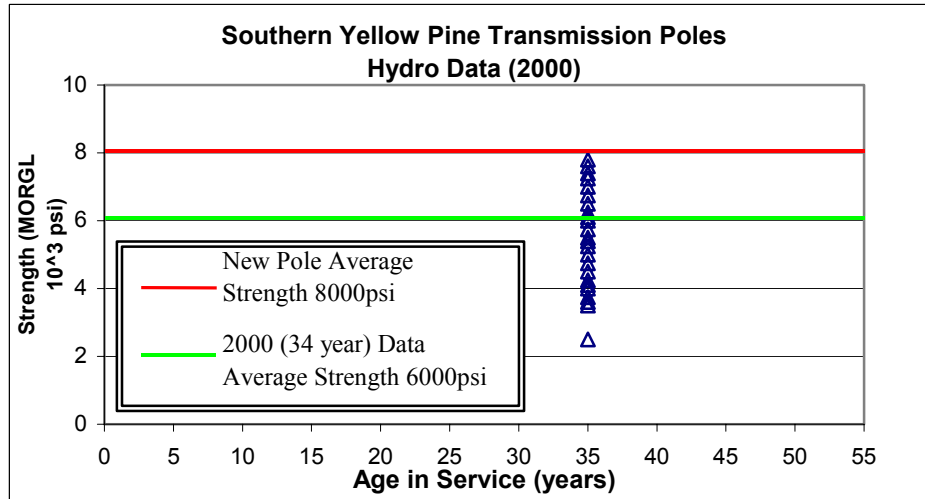
Fig. 3.17 - Strength Data From Full Scale Tests at MUN

NLH undertook a separate study entitled “**Avalon Wood Pole Study**” (Haldar, 2000) where a number of transmission size poles were removed from service (from TL 201 and TL 220) and were tested with the NDE (Non Destructive Evaluation) technique as well as full scale breaking tests at the Memorial University. Since the numbers of poles tested were very limited in terms of population size, data from the other sources (e.g. EDM data) were also reviewed and compared. Results from this study showed that on an average, 25% of strength (**Fig. 3.17** – vertical axis) was lost over a period of 35 years (i.e. rate of degradation 0.7% per year for average strength of 8000 psi originally assumed).

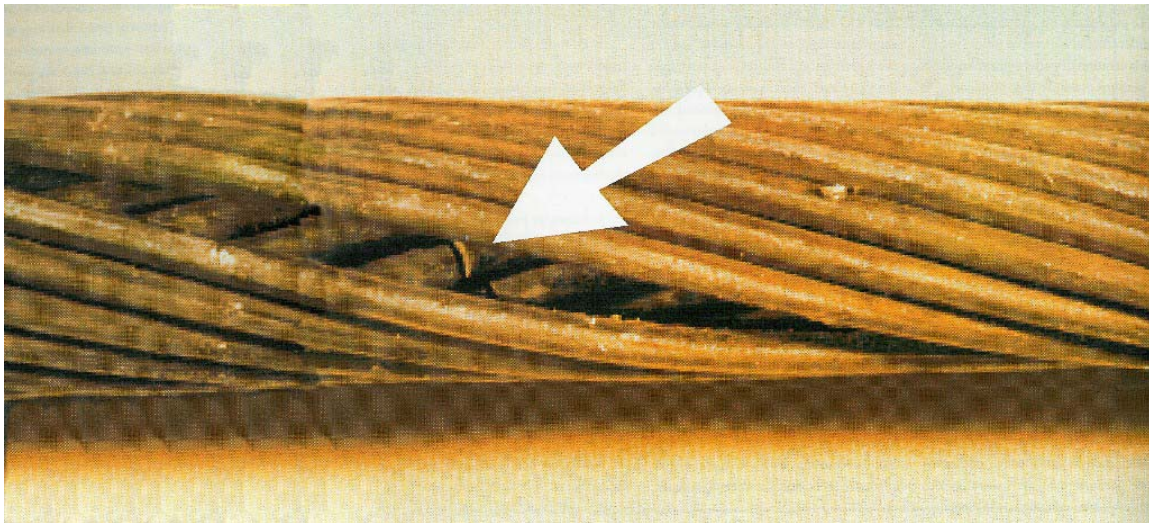
Fig. 3.20 – Broken Strand Due to Fatigue (IEEE, 2003)

A typical inner strand failure due to fatigue is shown in **Fig. 3.20** where it can be seen that the failures occurred where the inner strand surface had been subjected to fretting caused by contact between individual strands. Metallographic analysis of a large number of failures has shown that all cracks originated in these fretted areas. As fatigue inducing stresses occur near the bottom part of the conductor inside the clamp, they are impossible to measure directly. Thus, for purposes of expressing the severity of exposure to fatigue, it is necessary to represent the conditions at the contact points by means of a related parameter that is accessible to measurement such as the amplitude and the frequency of vibration (**Fig. 3.21b**). Alternatively, conductor samples can be removed from the clamp area at a certain interval and can be inspected further either by NDE or full-scale testing. One Canadian utility removes a conductor sample (typically 20 feet in length) from every 20 km of line inspected for further analysis and testing.

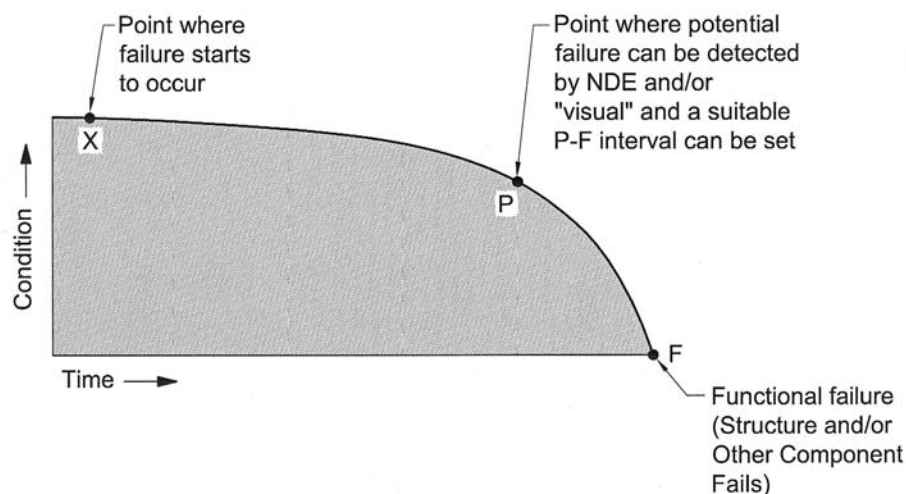
Fig. 3.24 - *P-F* curve (Moubray, 1997)

For example, fatigue failure of a conductor strand is not related to age but is more prone to terrain exposure, inadequate damping in the system and even a wrong choice of the conductor for a specific location. In this case, a condition monitoring program with a vibration recorder will reveal a trend early enough to prevent a potential failure (P-F) of the conductor in the future. In RCM terminology, this is known as the ***P-F*** curve as shown in **Fig. 3.24**. Point “X”, where the failure starts to occur, is not necessarily related to age, while point “P” shows the potential failure point from the previous inspection, and point “F” is the location where it reaches the failure stage (functional failure).

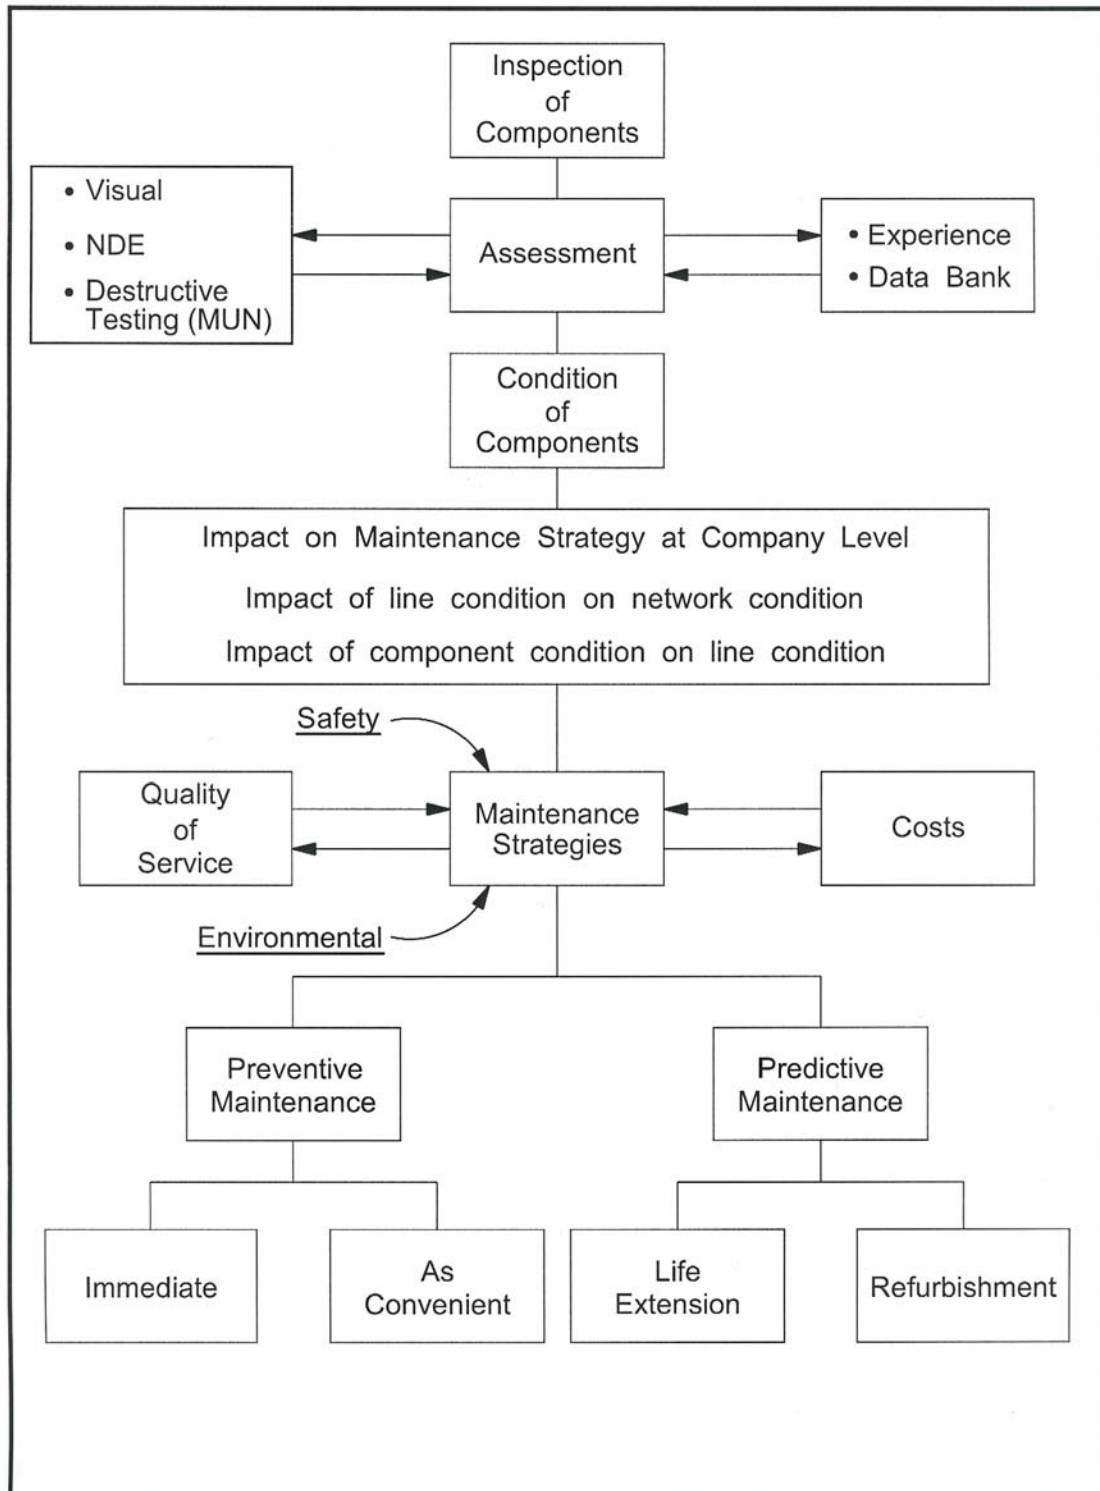
**Figure 3.26 – Proposed Maintenance Strategy**

However, to develop such a strategy, one must collect condition assessment information for each line component on a historical basis to ensure a systematic evaluation of a line at any given period. Note that the health of the line can be evaluated based on its current condition and a proper future inspection interval can be planned based on the actual condition of the line (or a component which may be a “weak link”). **Section 4** deals with the development of a database based on component inspection. A typical data collection form developed for this project is presented in the Appendix.

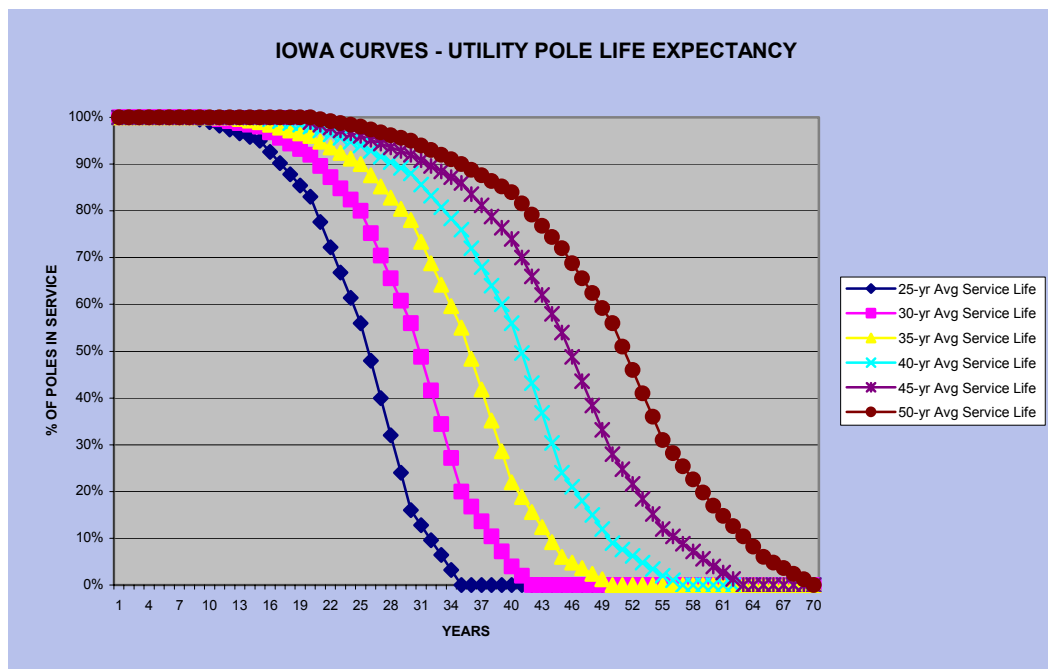
Fig. 4.1 - IOWA Curve

RCM methodology provides a basis for predicting the likelihood of a component failure allowing replacement of a specific component or a group of elements (forged eye bolts, dampers etc.) before failure to ensure that forced outage time and lost revenue are minimized in the long term. Therefore, the question needs to be asked within the framework of “*P-F*” interval (**Section 3.6**), how frequently, should a component be inspected? Even when the inspection does not reveal useful information (i.e. at the early years of operations between 10 and 20 years), the prediction can still be made using the likelihood of failure by using the pole life expectancy curve as shown in **Fig. 4.1**. A set of curves originally developed for asset replacement known as **IOWA curves** (see **Fig. 4.1**) is used here for wood pole asset replacement.

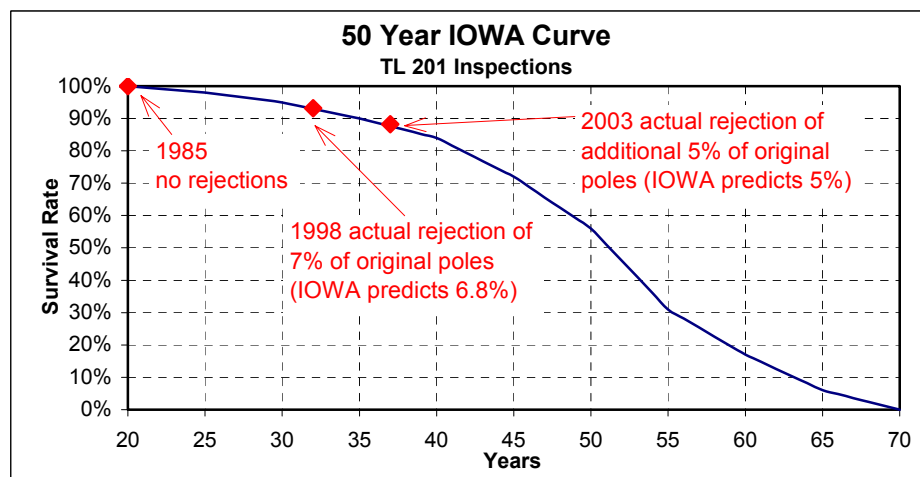
Figure 4.2 – Validation of IOWA Curve

<i>Inspection Results – TL 201</i>	<i>Rejected Poles (%)</i>
<i>1985 Inspection (19 years old)</i>	0 out of 678 (0.0%)
<i>1998 Inspection (32 years old)</i>	45 out of 661 (6.8%)
<i>2003 Inspection (37 years old)</i>	10 out of 199 (5.0%)

It is assumed that a certain percentage of these poles inspected will also be rejected according to IOWA curve (**Fig. 4.2**) depending on their age and group. Poles rejected in the field will be analyzed with respect to reliability issues, and, if rejected after the structural analysis, a recommendation to refurbish and/or replace will be made. At present it is assumed that 33% of poles rejected can be refurbished, 33% of poles rejected require replacement and the remaining 33% of the rejected poles have sufficient residual strength after analysis such that no further action is required.

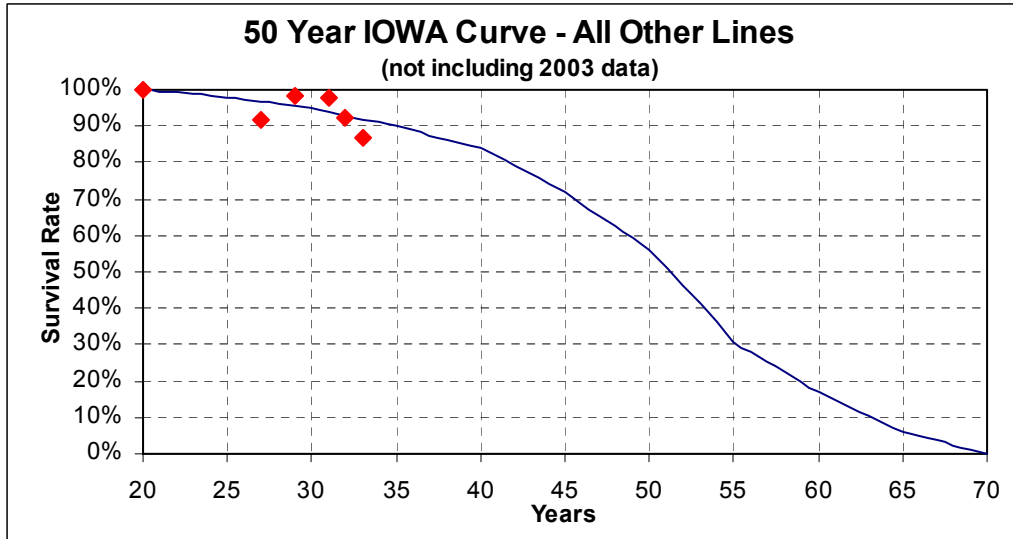
Fig 4.3 - Curve Validation for Non Avalon Poles in 2000 and 2002

Later, this validation process was also extended to cover poles from the Central region based on 2000, 2002 and 2003 data respectively (**Fig. 4.3**). Although the rejection rate is small in the early part of the 50-year IOWA curve, the rate changes drastically as the poles get closer to their service (economic) life (i.e. 40 years and beyond).

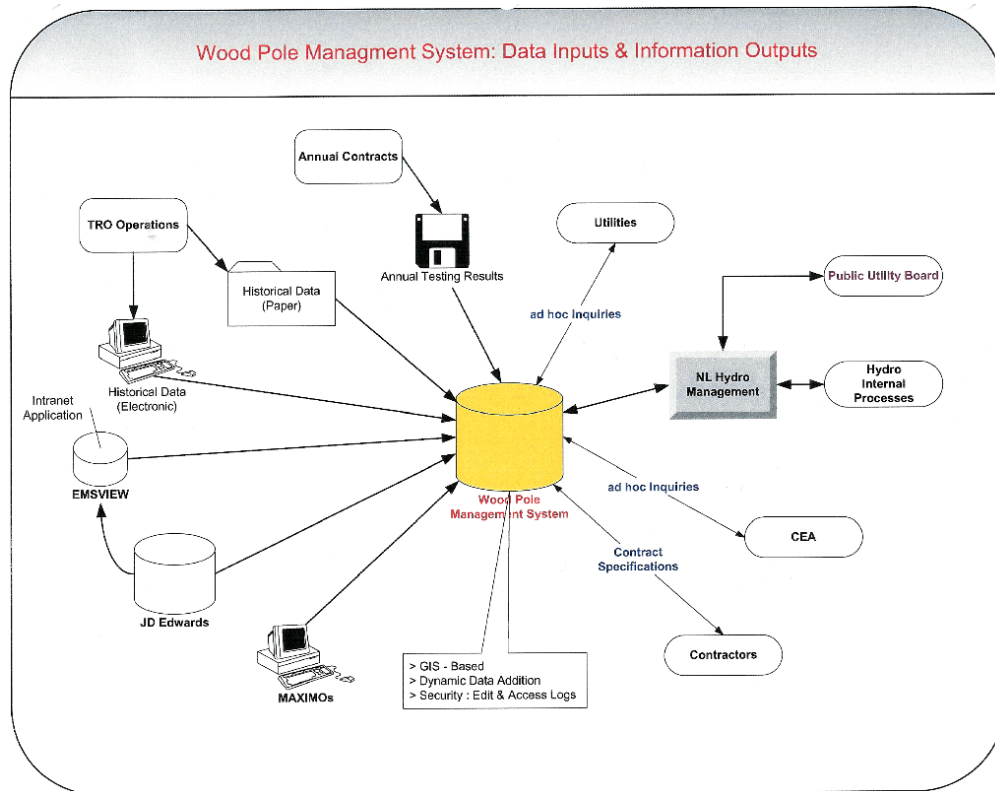
Fig. 4.4a – IS&T Flow Diagram – Data Input/Output

Ultimately, the database will be developed to identify each pole location and prior history. To address this, Engineering has worked with IS&T and the Properties Department to develop a **“Pole Cataloging”** database which will have coordinates of all poles in NLH’s system through GPS. **Figs. 4.4a** and **4.4b** depicts typical “flow charts” prepared by IS&T which could be developed further to manage the wood pole line assets. Once this project is approved, IS&T will provide the necessary support to create this database for “Pole Cataloging” in the JD Edwards system with appropriate coordination with Environment & Properties for GIS application. Until the JD Edwards is functional, all data will be recorded on paper forms and manually entered into an Excel spreadsheet for analysis. Eventually, this data will be imported into the database for future record.

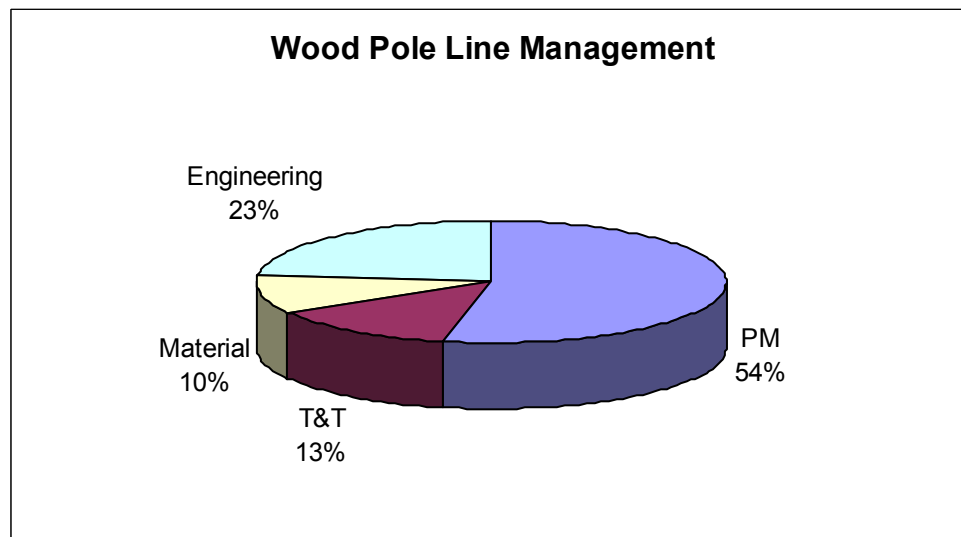
**Fig. 5.2 - Average Cost Breakdown per pole**

<i>Cost per pole (total \$300)</i>	<i>Cost</i>
<i>Preventive Maintenance</i>	\$160 (54%)
<i>Test and Treat</i>	\$40 (13%)
<i>Treatment Materials</i>	\$30 (10%)
<i>Engineering (including NDE)</i>	\$70 (23%)

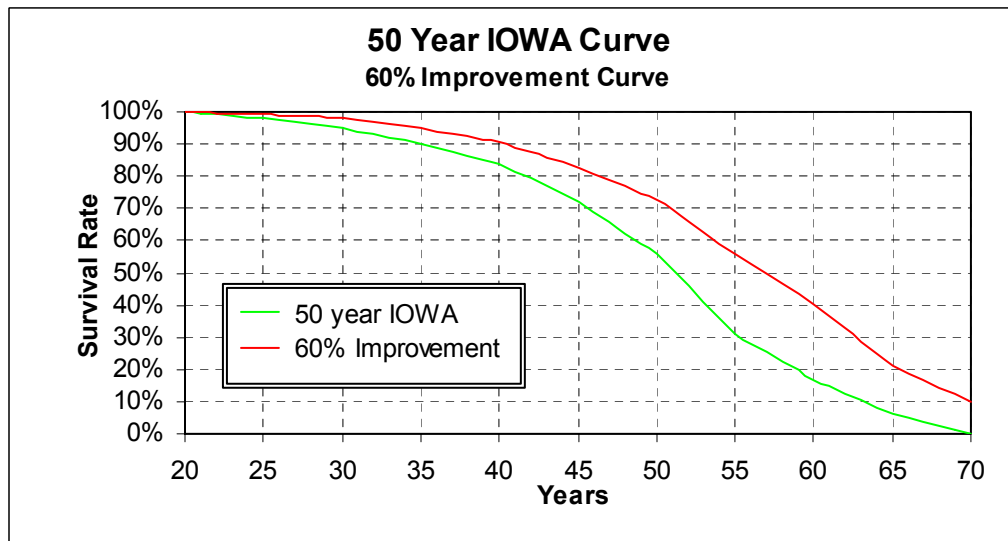
Fig. 5.3 - IOWA Curves with Improvement Rate

It should be noted that the rejection of a pole does not necessarily mean that Hydro needs to replace the pole. Based on the structural reliability analysis, a decision will be made whether to replace the pole or not when the risk has been assessed with respect to reliability, security and safety.
