**IN THE MATTER OF** an Application by Newfoundland Power Inc. for approval to proceed with the construction and purchase of certain improvements and additions to its property pursuant to Section 41(3) of the Act.

Engineering Review"). Schedule "A" to this Application is a report of the findings of the Burin Peninsula Engineering Review.

**July 2, 2002**

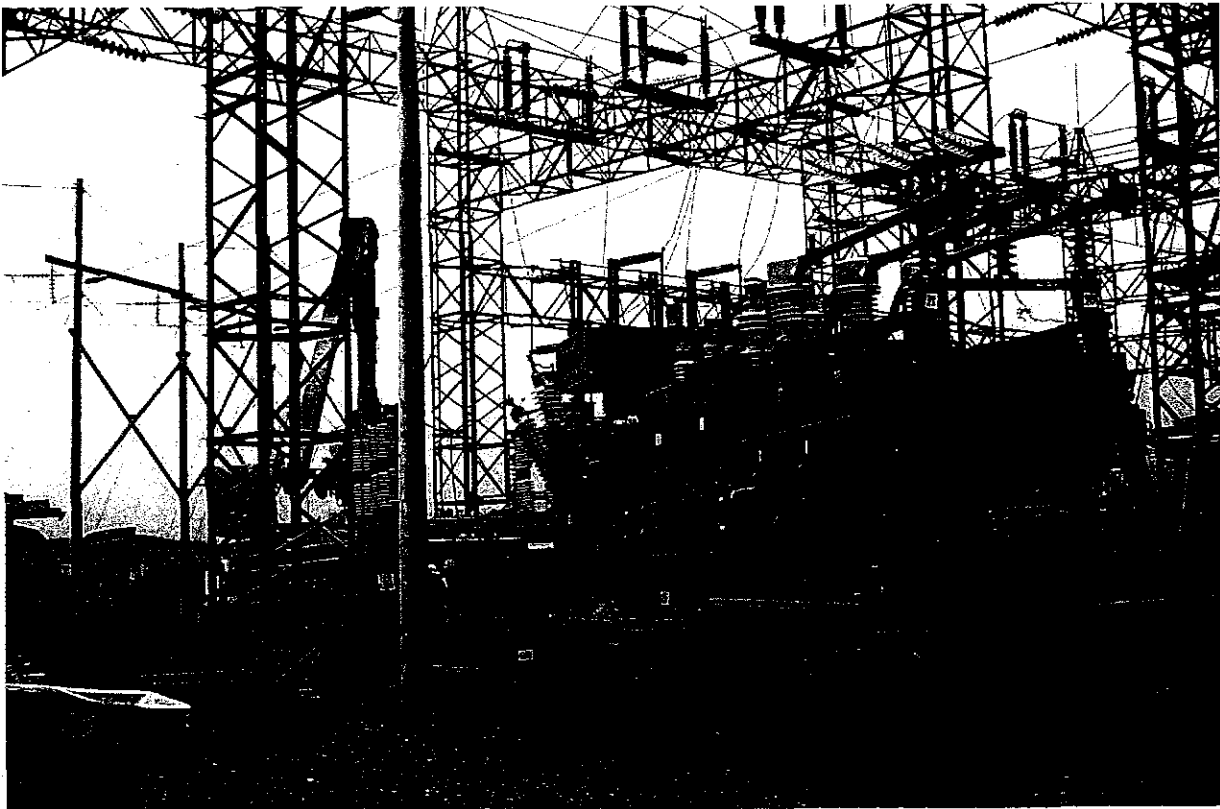
#### **Photograph of Failed Portable Transformer**

It is not desirable to use a portable transformer as a replacement transformer for extended periods of time. This is because portable transformers are more expensive than standard transformers, and they are in demand to enable the utility to conduct maintenance and capital work programs without scheduled outages. They must also be available to provide immediate power restoration in the event of the failure of another large transformer. Further, given the greater complexity of portable transformers, and the fact that they are subject to significant stresses as a result of being transported for construction and maintenance work, these transformers are considered to be less reliable than standard transformers. A photograph of the portable transformer that failed in service on May 11<sup>th</sup>, 2002 is attached to this report as Appendix 3.

At 8:58am on May 11, 2002, NP's 50MVA portable transformer P-435 (in service at the time at Salt Pond substation) faulted leaving 6,080 customers on the 66kV loop without power. This portable was replacing the permanent 138/66kV SPO-T4 which faulted on April 19<sup>th</sup> and was in the process of being repaired. The customers affected were served by feeders from the Salt Pond (SPO), Laurentian (LAU), Webber's Cove (WBC), Greenhill (GRH), Grand Beach (GBE) and Garnish (GAR) substations (i.e. the same customers affected by the April 19<sup>th</sup> outages).

The portable transformer P-435 has been transported to the Siemens-Westinghouse facility in Hamilton, Ontario for further assessment and repair. This unit will be out of service until December 2002. Portable transformer P-335 will remain on the Burin Peninsula unless required to address any unplanned substation outage elsewhere on the island.

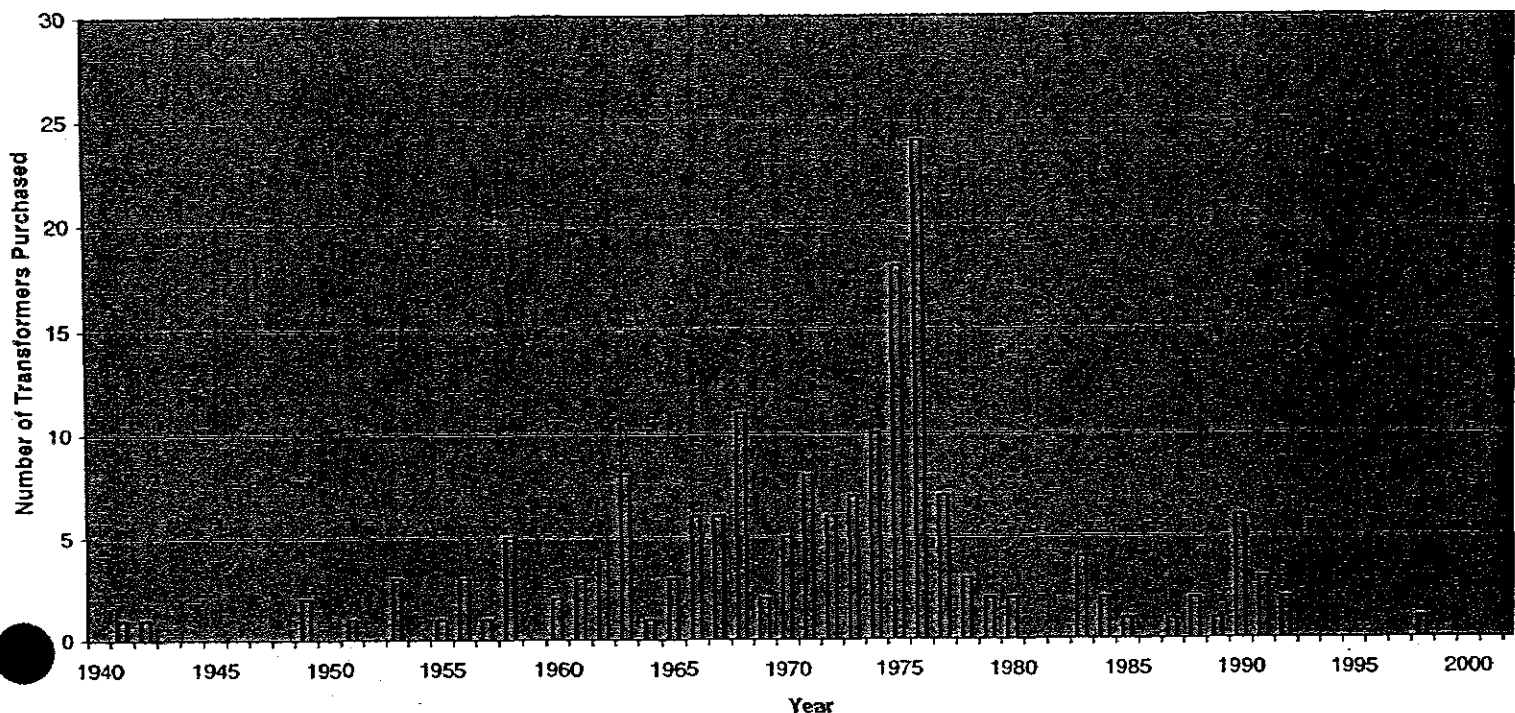
**Transformer Purchases 1940-Present**  
(Spare/Scrapped Transformers not included)

The following chart indicates the purchase dates of Newfoundland Power system, power and plant transformers.

The average purchase date of Newfoundland Power's system, power and plant transformers is 1971, with 75% of all transformers being purchased between 1960 and 1980. The average purchase date of Newfoundland Power's large system transformers is 1974, with all being purchased between 1967 and 1984.

Industry experience indicates that given the age of our transformer stock, we can expect to see an increasing failure rate of transformers in the coming years. A recent paper, "Failure History of Transformers – Theoretical Projections for Random Failures", by William H. Bartley, P.E., 2001; reviews the U.S. past and probable future experience with transformer life. The author notes that under ideal conditions a transformer can be expected to last between 30 and 40 years. He also indicates that under practical conditions, many do not last that long. For example, in his modeling of data he posits that failure rates of 1972 vintage transformers should over take failure rates of 1964 transformers in 2006, indicating that increasingly there are fewer 1964 vintage transformers in the system due to failure, and that increasing numbers of 1972 transformers are failing. For Newfoundland Power, given the age profile of its transformers, this means that more of these transformers can be expected to fail than we have experienced in the past. It also means that Newfoundland Power must plan to accommodate these increased transformer failure rates if it is to maintain a reasonable quality of service for its customers.
