**Re: An Application by Newfoundland and Labrador Hydro for Approval of Capital Expenditures to Re-Route Transmission Lines TL 226 and TL 239**

## Transmission Line Re-Routing

TL 226 and TL 239

October 2018

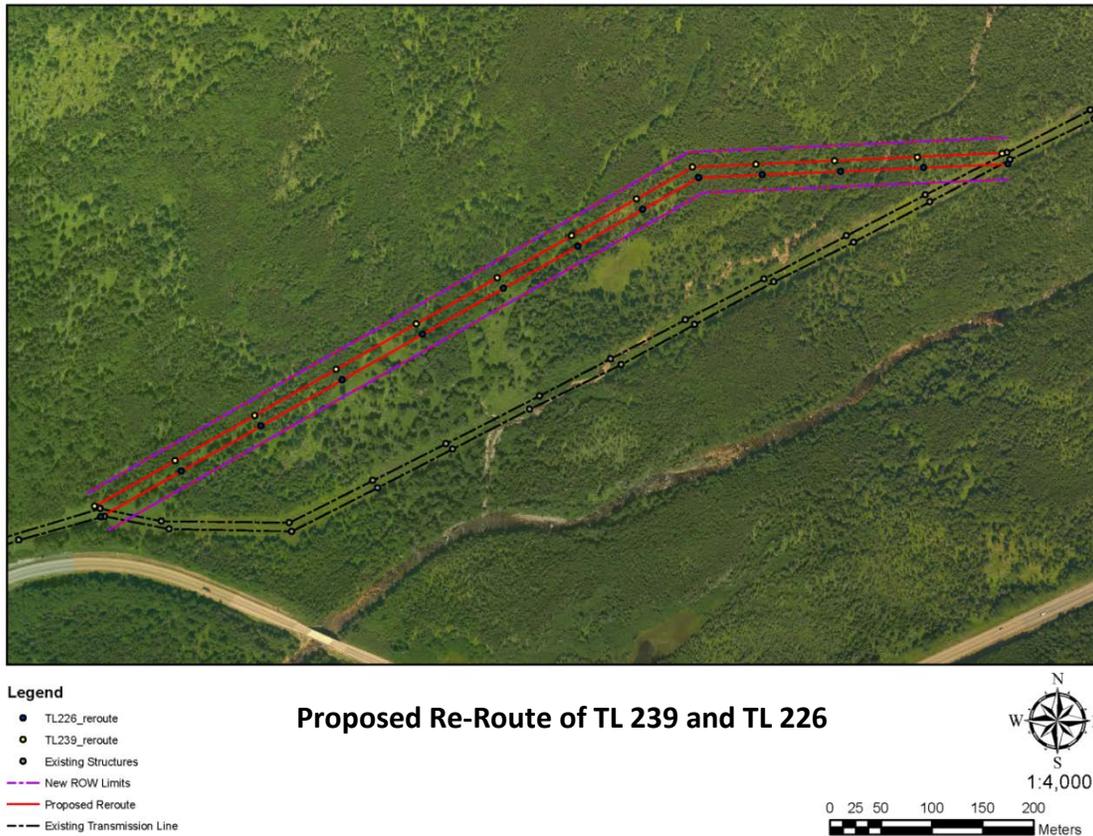
**Figure 1: Proposed Re-Route of TL 239 and TL 226**

12 Hydro is proposing to re-route both of the parallel lines, TL 239 and TL 226 (refer to Figure 1), to  
13 avoid the unstable area. The overall scope of work shall include the relocation of approximately  
14 one kilometer of transmission line on each of TL 239 and TL 226 to a proposed route  
15 approximately 100 meters north. The length of the re-route realigns the two transmission lines  
16 with nearby angle structures to the west, and extends the eastern interconnection location  
17 away from the river, crossing over in a more perpendicular orientation. To mitigate against  
18 future issues in this area, the proposed route is located on higher ground and is outside of the  
19 flood zone.

- 1 After on-site inspections and consultation with the Park, Hydro proposes to re-route the
- 2 transmission structures currently within the washout (see Figure 10) to an area 100 metres
- 3 north (see Figure 1), out of the flood zone of the rivers.

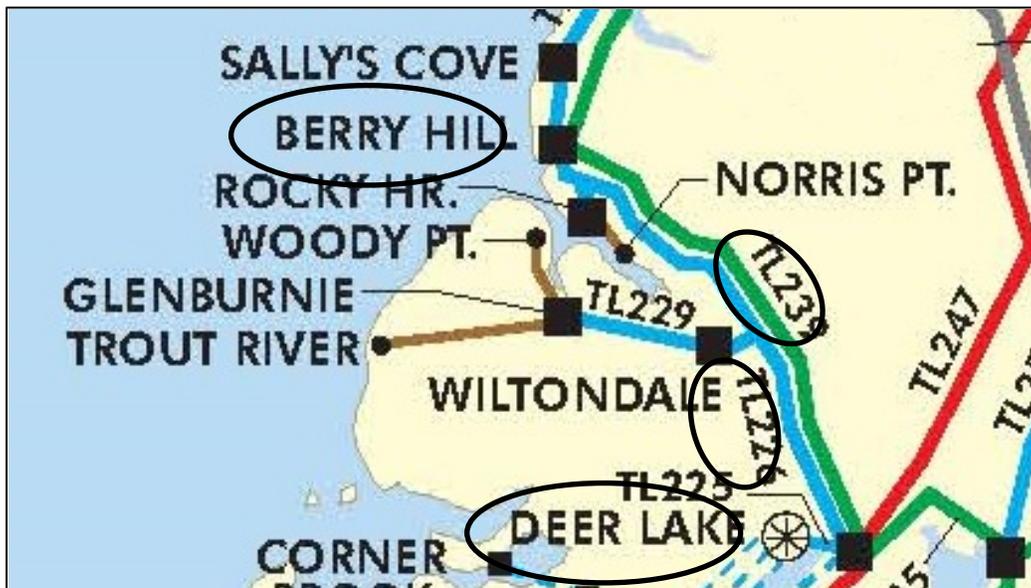
Figure 2: Route of TL 239 and TL 226

9  
 10 Both transmission lines are located on the Northern Peninsula section of the IIS (refer to Figure  
 11 2). Both lines share a ROW from the Deer Lake Terminal Station, heading north through Gros  
 12 Morne National Park, to the Berry Hill Terminal Station, a total distance of approximately  
 13 71 km.

14 In general, the construction of both lines consists of a variety of wood pole structure types, with  
 15 the section through the Park consisting of single pole tangent, dead-end, and angle structures  
 16 to minimize the ROW width.

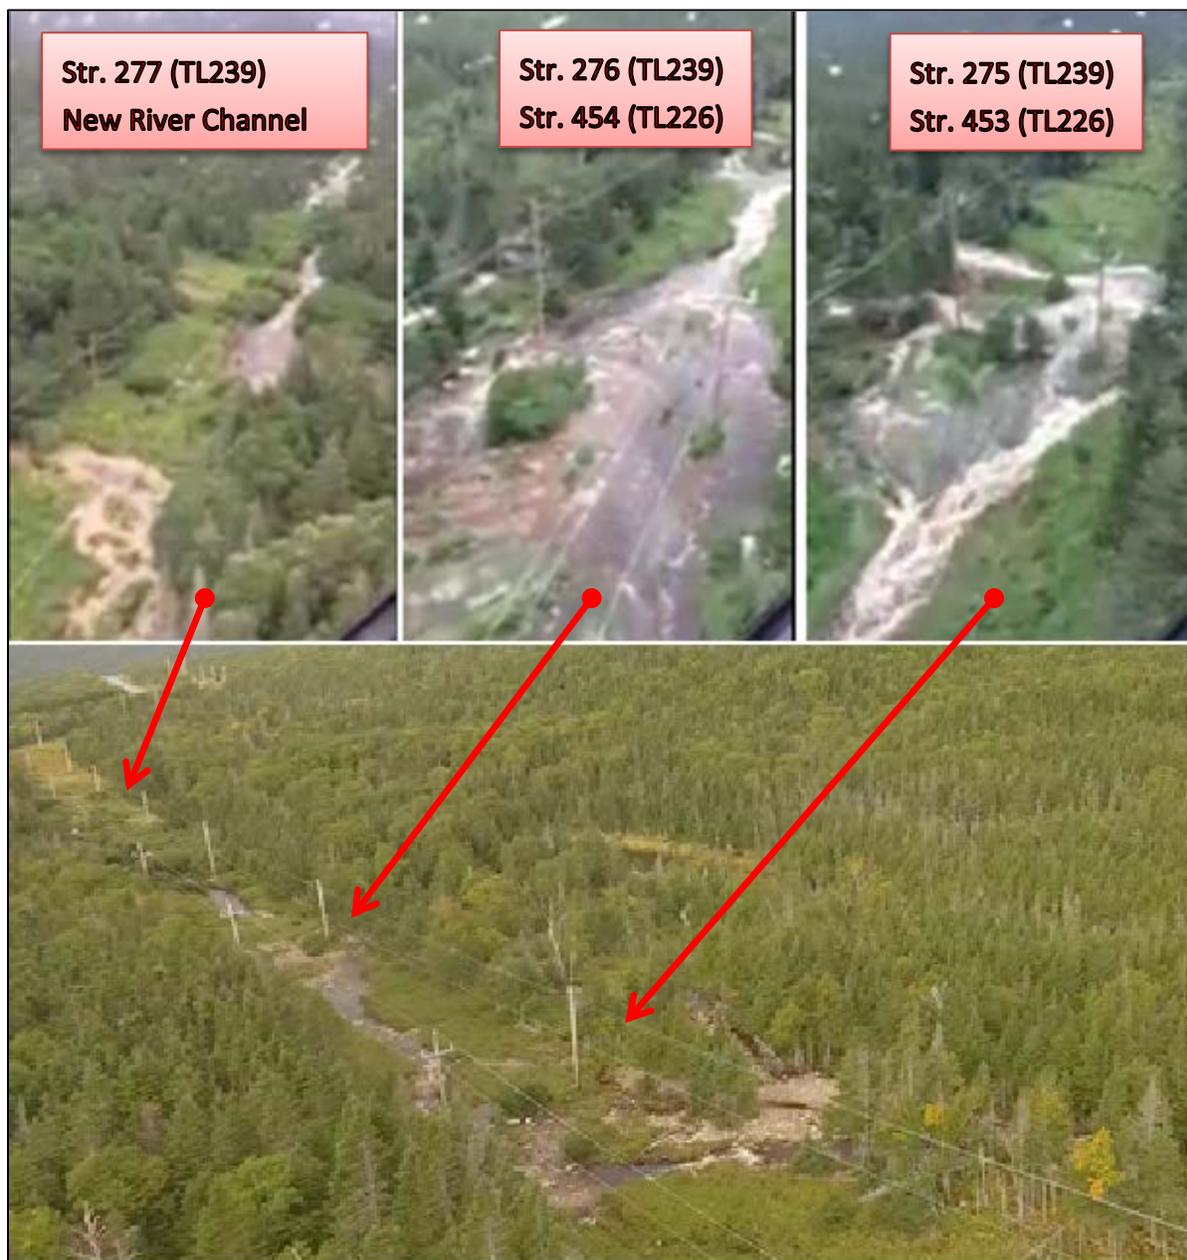
Figure 3: Section of ROW affected in August

- 1 Figure 3 shows the one kilometer ROW section affected by the flooding. The top three photos
- 2 in Figure 3 were taken from a helicopter patrol shortly after the incident, while the bottom
- 3 photo in Figure 3 shows the overall section of line on October 1, 2018.

- 1 The top left photo of Figure 3, also shows a new river channel that has been created since the
- 2 event in August 2018. Figure 9 shows the current condition of the area with the river bed and
- 3 surrounding damage. During rain events and spring melt, when further erosion occurs, this
- 4 channel will pose a significant risk to the lines in their current location.

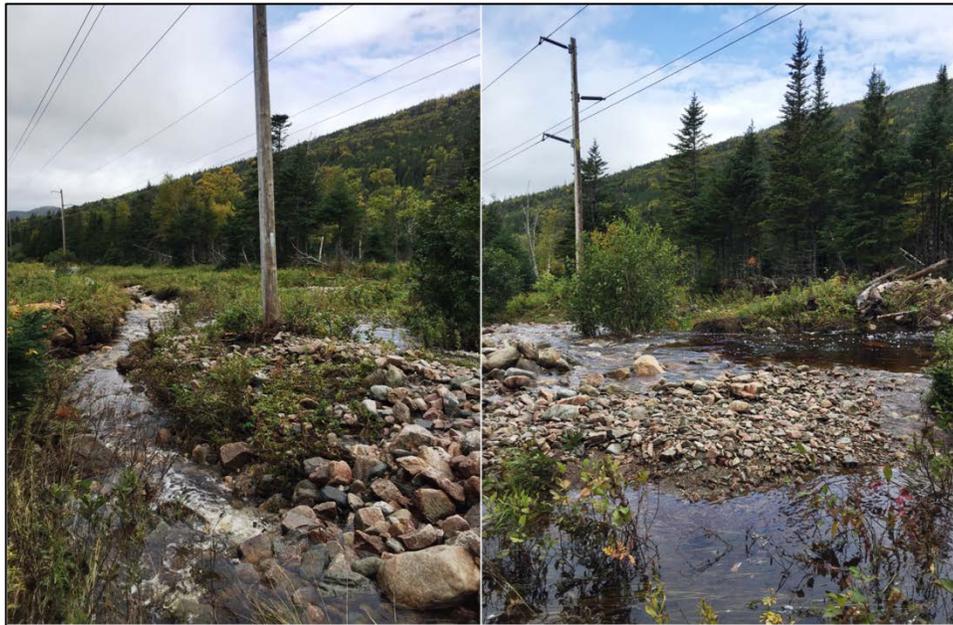
**Figure 4: Washout at Structures 453 – TL 226 (left) and 275 – TL 239 (right)**

1 The original river course crossed the ROW at approximately structure 275 on TL 239 and  
2 structure 453 on TL 226 turned west and followed the edge of the ROW for approximately 500  
3 m, turned south and entered the main Southeast Brook.

5 Figure 4 shows the river entering the ROW north of structure 275 on TL 239. Although it  
6 previously crossed the ROW at this location, it has changed course and now travels within the  
7 existing ROW, placing both structures in the river. A washout has occurred north of the ROW  
8 resulting in several new water channels. The current condition of this area is shown in Figures 4  
9 and 5.

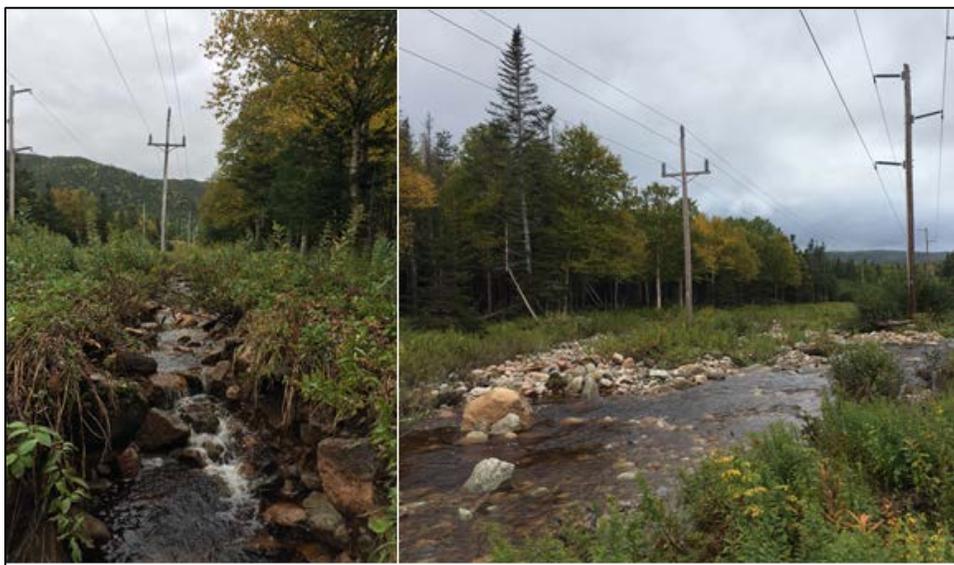
**Figure 6: New Water Channels at Structures 276 – TL 239 and 454 – TL 226**

- 1 For one span further west, the river banks have also eroded and the new water channels have
- 2 converged to completely flood the existing structure locations and surrounding area. Several
- 3 new river channels have formed in this section, as illustrated in Figure 6. The banks of these
- 4 new streams are soft and unstable and will continue to erode with water flow and will
- 5 experience further acceleration with future rain events.

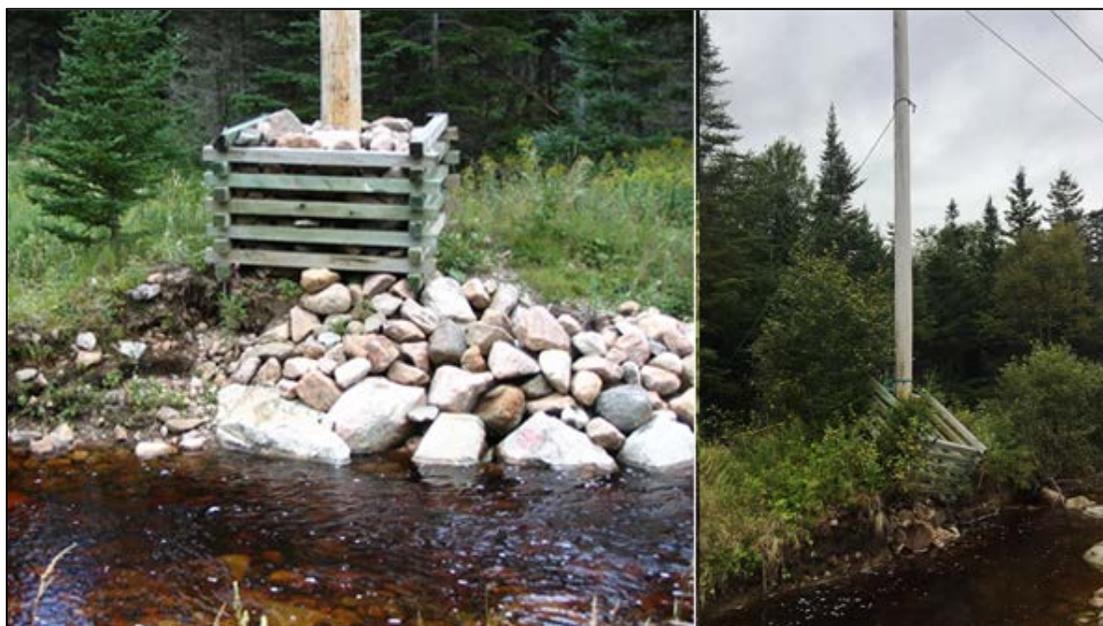
**Figure 7: Erosion of Rip Rap at Structure 277 – TL 239  
(Circa 2003 on left and September 2018 on right)**

1 The current course of the river continues for the next two spans between structures, with a  
2 considerable amount of erosion causing the crib foundation of structure 277 – TL 239 to  
3 completely wash out as shown in Figure 7. This structure was previously at the edge of the  
4 gradual river bank and was reinforced with a crib foundation and rip rap. Since the flooding in  
5 August 2018, all of the rip rap and crib material has been washed down stream and  
6 approximately 1.5 metres of soil has washed out from around the pole. The structure is now  
7 temporarily guyed to support the pole until the lines can be relocated.

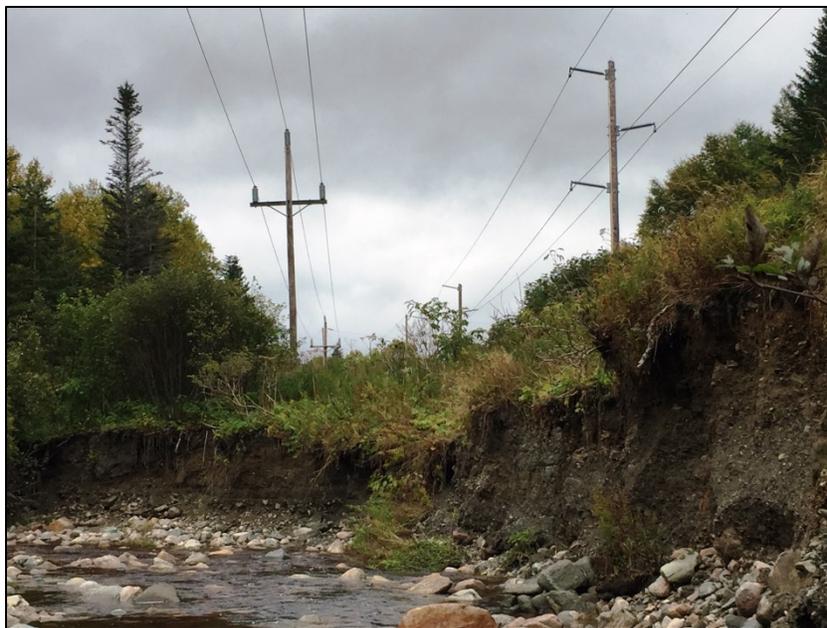
**Figure 8: River Erosion East of Structures 278 – TL 239 and 456 – TL 266**

8 Just west of structure 277 – TL 239, the river turns south and joins the larger Southeast Brook.  
9 Figure 8 shows the river bank east of structures 278 – TL 239 and 456 – TL 226, where the river  
10 turns and leaves the ROW. The river banks show considerable erosion and Hydro anticipates  
11 future events will compromise these structures as well.
