**HVAC Systems Analysis**  
***NF Power Corporate Building***  
**Kenmount Road, St. John's**

# HVAC Systems Analysis

NF Power Corporate Building  
Kenmount Road, St. John's

# NF Power – 2<sup>nd</sup> and 3<sup>rd</sup> Floor HVAC Review

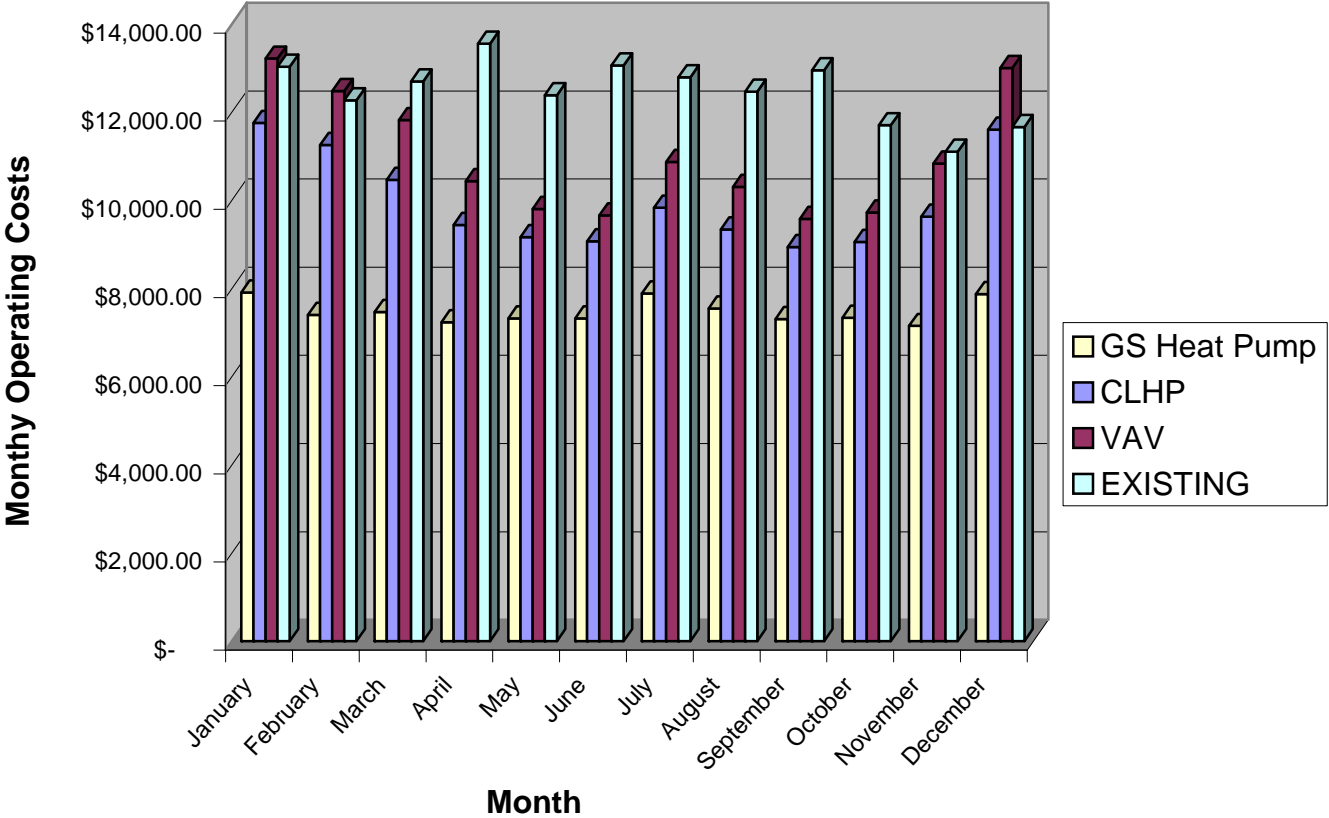
# System Options Comparison

The estimated operating and budget capital costs for a V.A.V., CLHP and ground source systems are provided in the table below with the energy model summary provided in Attachment A. The electric energy costs calculated are based on an energy rate of 6.7 ¢/kWh while the demand rates are calculated using \$6.64/kVa. The operating costs given below are estimates of the energy consumption of the systems options as described in section 5.0 including the savings associated with upgrades to the existing lighting systems. The maintenance costs associated with each system is also considered and provided in the analysis table.
