**UNFORESEEN ITEM:
Holyrood B1L17
230 kV Breaker Overhaul**

Newfoundland and Labrador Hydro

May 5, 2014

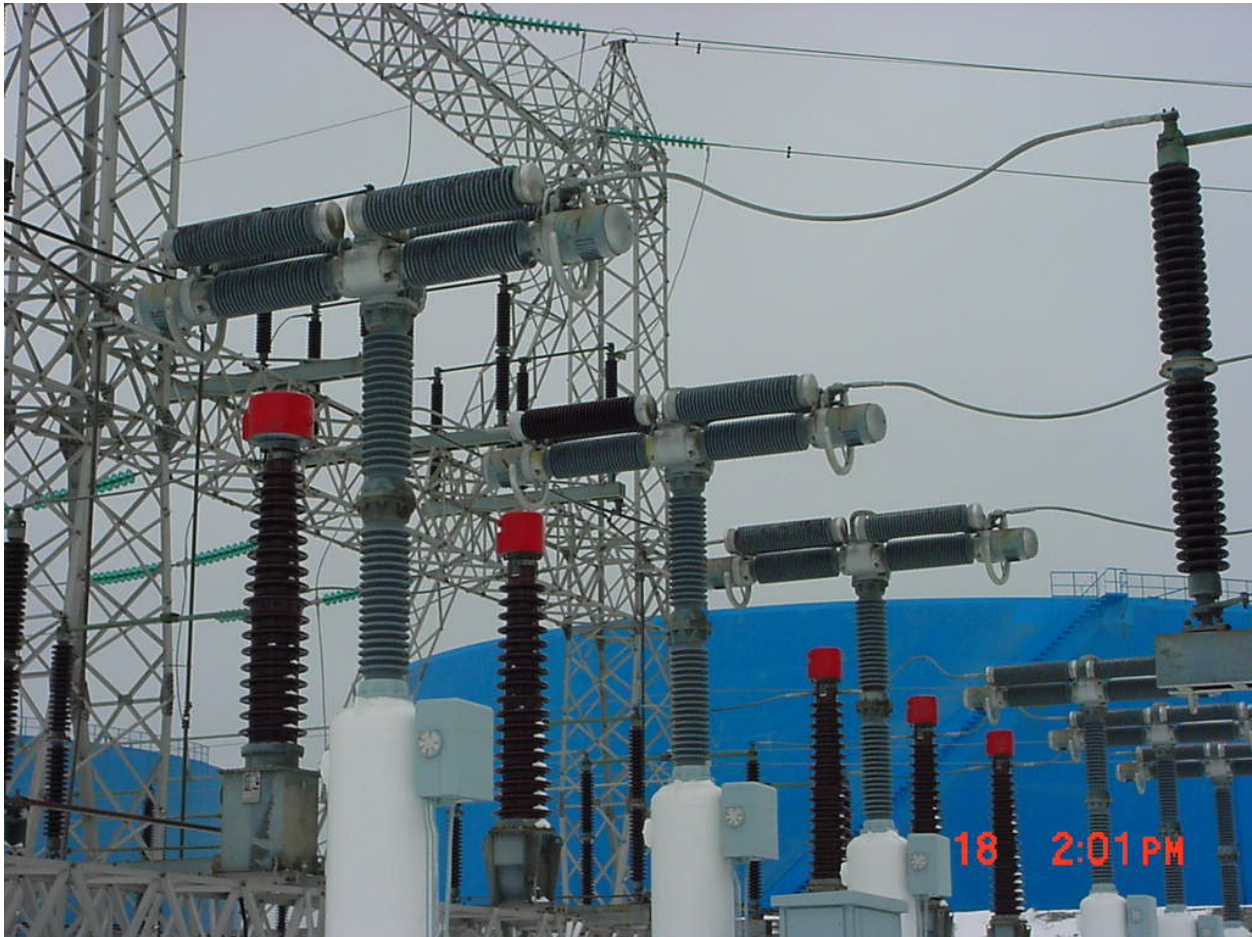
The project required an overhaul of the 230 kV DLF Asea Brown Boveri (ABB) air blast circuit breaker.³ The overhaul was undertaken immediately upon completion of the investigation of the breaker components.

Figure 1: 230 kV Air Blast Circuit Breaker in the HRD TS - DLF Asea Brown Broveri (ABB)

The project was carried out by Hydro personnel with supervision from ABB. The work included the removal and replacement of the existing breaker heads, columns, control blocks, and control valves. Once the parts were replaced, the breaker was subjected to testing to ensure that it operated correctly. Once the testing was completed, the breaker was released to Hydro's Energy Control Center and put back into service. (See Appendix C for a picture of this breaker).
