1 **Q. Re: Tab 1.1 - 2013 Facility Rehabilitation – Soldiers Pond Outlet**

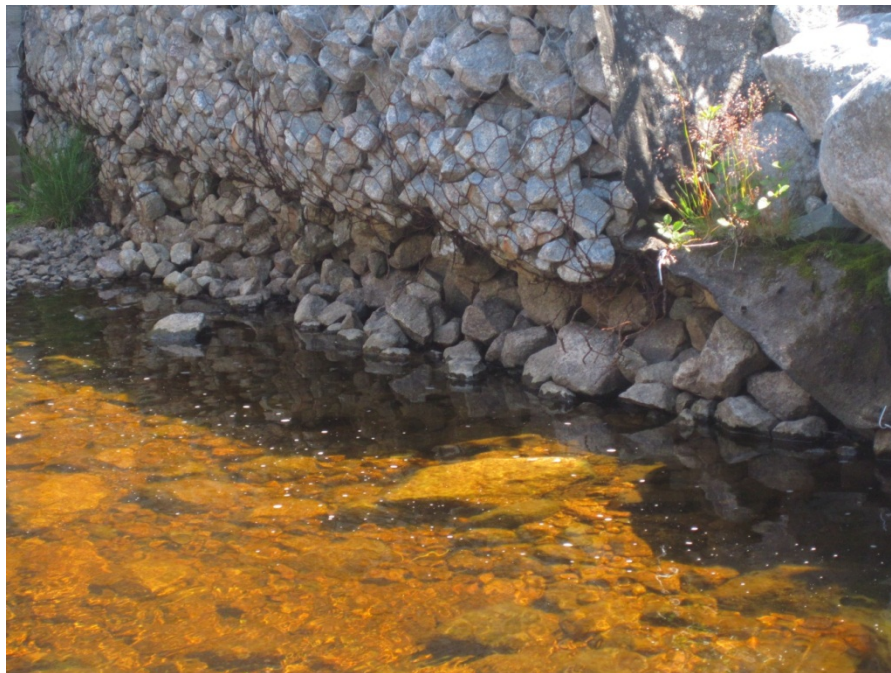
13 As noted in CA NP 21 the gabions were installed in 1993. Gabion baskets would
14 normally be expected to last 40 years. The gabion baskets in question display excessive
15 corrosion and deterioration below the water line and little if any above the water line.
16

17 Based on an engineering review we have determined that due to the excessive corrosion,
18 which has led to the loss of ballast rock below the high water line, the walls require
19 replacement to prevent the risk of them toppling over.
20

21 See photo below of corroded baskets and missing ballast.
22
23

8 A. The lower gabion baskets have failed due to corrosion and there is no option to shore up
9 the gabion baskets. They essentially would all have to be removed, to replace the lower
10 baskets. While the rock could be reused the baskets would need to be of new material.
11 So the only option is to remove and replace the wall, as shoring it up is not an option.
12
