1 Q. On page A3 of the report the single line diagram shows the disconnects tying the
2 12.5kV of the new transformer to bus B5 as being normally opened (NO). Please
3 explain the operation of this transformer in the context of these NO disconnects.
4
5

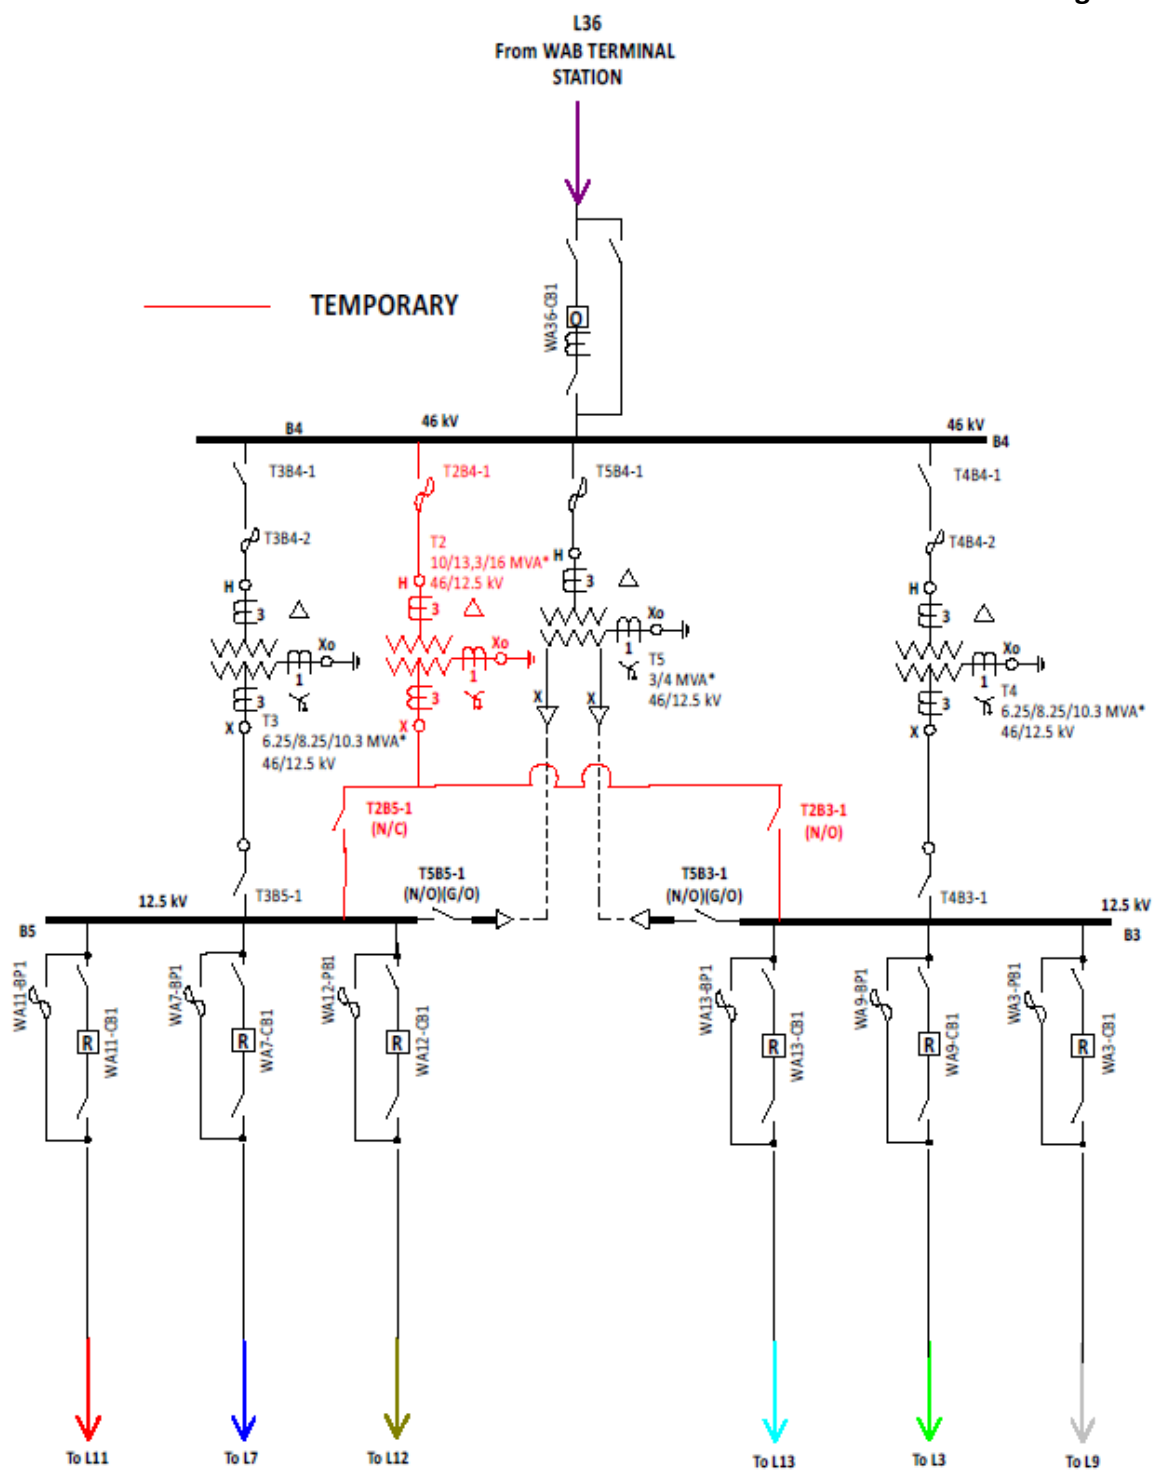
6 A. The single line diagram on page A3 of Hydro's supplemental application contains
7 two errors. The disconnect switch tying the 12.5 kV bus of the new transformer to
8 bus B5 disconnect switch, T2B5-1, should be labelled as normally closed (N/C). The
9 12.5 kV bus connected to T4 should be labelled as B3. Please see the revised single
10 line diagram on the following page.
11

12 During normal operations, transformer T2 will operate in parallel with transformer
13 T3 and supply power to bus B5. Under this scenario, T2B5-1 will be closed and
14 T2B3-1 will be open, as it should be indicated on the single line diagram. In the
15 event that bus B3 requires additional power (e.g. if T4 fails), transformer T2 can be
16 switched over to that bus. This will involve opening T2B5-1 and closing T2B3-1.
