Holyrood Unit 1 Failure - January 11, 2013

Root Cause Analysis: Final Report

Alstom Power Holyrood Unit 1
Inspection Report January 15, 2013

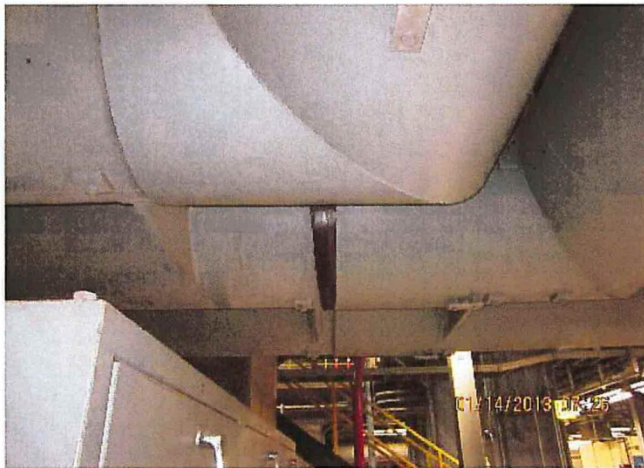
The B-phase bus duct on the mezzanine level appeared to have been distressed. On this duct only, the liners at each coupling had migrated out from under the connector rings. See Photos below.

Figure 6 B-Phase Duct
