1 Q. **Asset Management**

**WOOD POLE LINE MANAGEMENT
USING
RCM PRINCIPLES**

**Report Prepared By
Asim Haldar, Ph. D, P.Eng.**

Dated: April 7, 2004

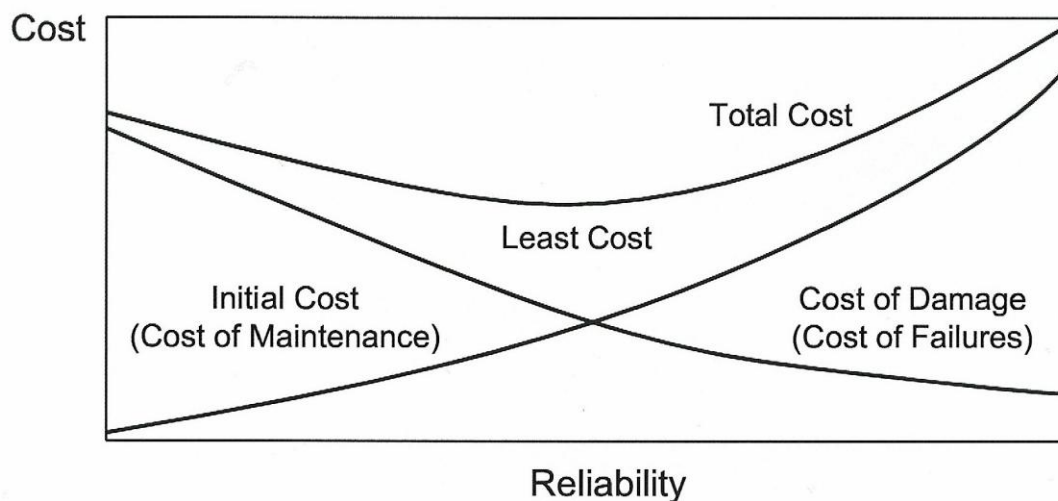
Fig. 1.1 – Optimum Cost Curve

During the past 15 years Hydro has consistently used the **Reliability Based Design (RBD)** methodology either in the upgrading of existing lines (TL 228, 230 kV steel lines on the Avalon Peninsula, Haldar, 1990, 1997) and/or building new lines (TL 263, TL 236). The RBD methodology takes into account the capital cost of investment in the upgrading of existing lines, or building of new lines, and balances this cost against any future cost of damage (discounted to the present value) and optimizes the design parameters such as span, reliability, etc. **Fig. 1.1** depicts the saddle point where the total cost is minimized.

Since 1997, Hydro has been working to implement a Reliability Centered Maintenance (RCM) program in which the cost of preventive and predictive maintenance is balanced against the cost of damage and service interruption. **Fig. 1.1** also captures this idea and shows that in principle, both RBD and RCM methodologies can complement each other to ensure that Hydro gets the best return on its investment during the service life of a transmission line asset.

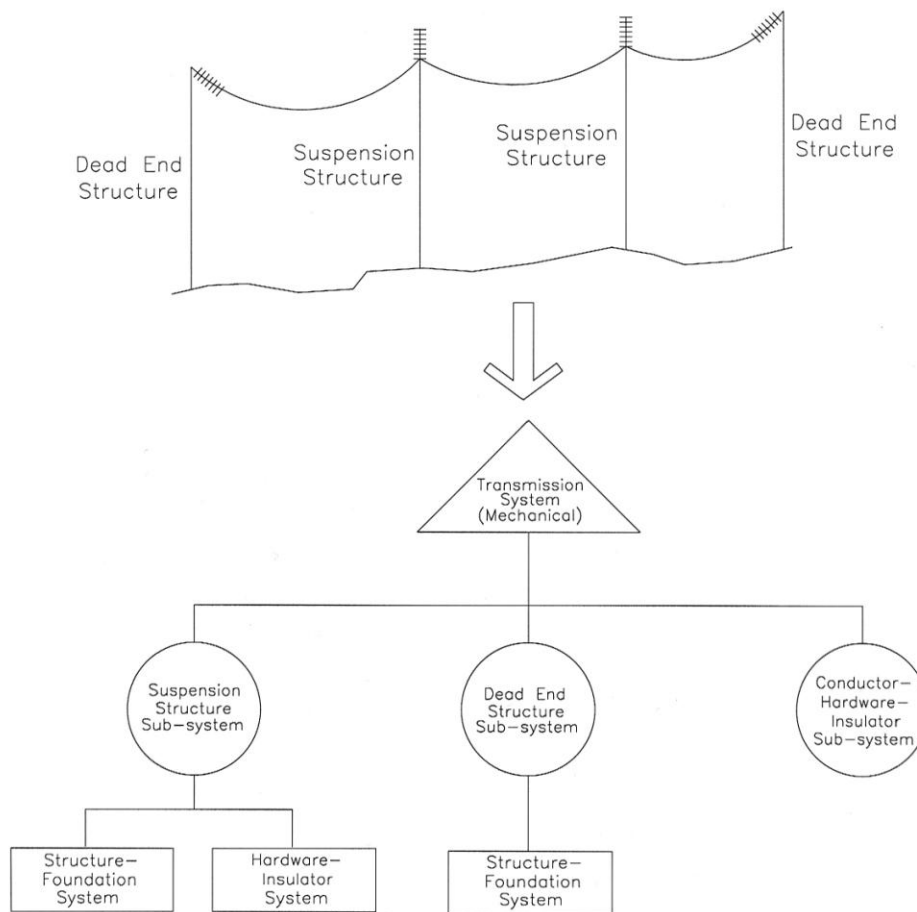
Fig. 2.1 - Transmission Line System

To understand the RCM principles with particular reference to wood pole lines, one needs to treat the line as a system which can be broken down into various sub-systems as shown in **Fig. 2.1**. The Asset Manager needs to know the condition of the asset (in this case, the condition of the various sub-systems e.g. structures, conductor-hardware etc. or its individual components such as wood poles, conductor, insulators, hardware etc) at present i.e. “year zero” of the future life cycle. The life cycle could be any period of time. A typical period, or life cycle for new wood pole lines is 40 to 50 years.

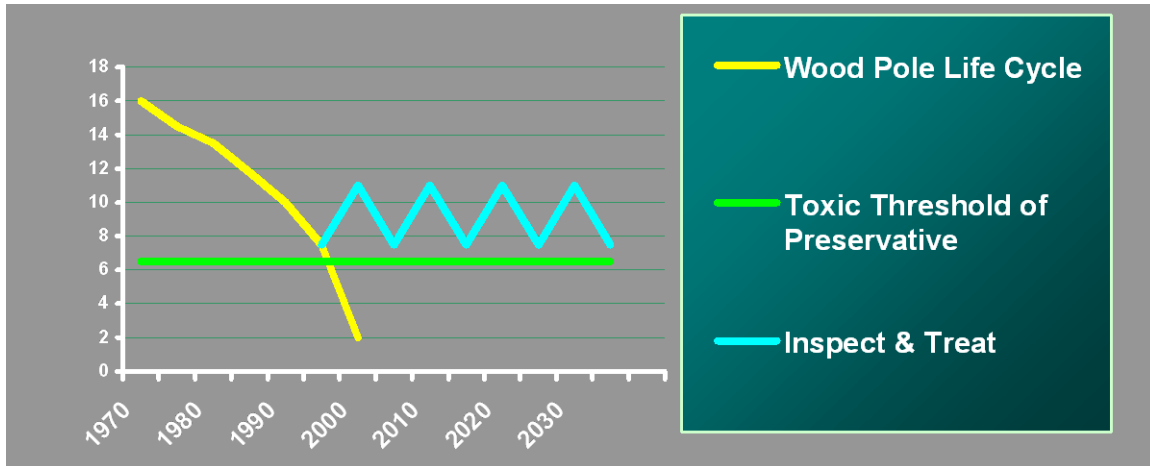
Fig. 3.3 – Typical Depletion Rate of Preservatives (GENICS, 1998)

not have the preservative level restored early enough, particularly at 50% of their expected service life (20 to 25 years), the pole is exposed to decay which leads to degradation of strength (i.e. significant loss of sapwood for Southern Yellow Pine or heartwood for Douglas Fir) and make the pole structurally unsafe.

Since Hydro has the preservative retention level data for poles on the Avalon for three inspection years (1985, 1998 and 2003), an attempt was made first to understand the trend of the preservative depletion rate. Fig. 3.14 depicts the average trend for poles on the Avalon Peninsula. The depletion rate trend can be compared with the “yellow line” shown in Figure 3.3.

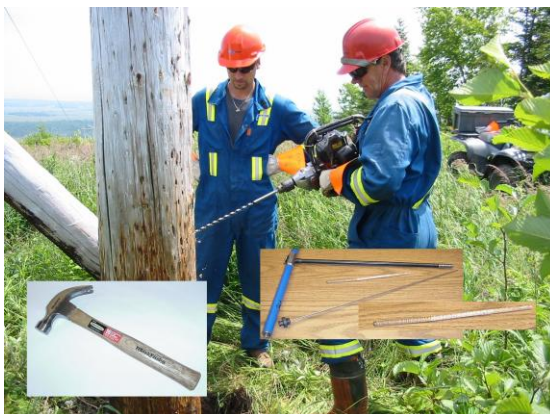
Figure 3.4a - Inspection Tools

Fig. 3.4a depicts the tools required to carry out inspection based on sounding and boring. **Fig. 3.4b** depicts the Resistograph, which through the use of a 3mm drilling needle and resistance measurement, profiles the poles core. **Fig. 3.4c** shows the nondestructive PoleTest tool for strength evaluation based on ultrasonic principle. **Fig. 3.4d** depicts the full-scale test bench developed at Memorial University's Engineering laboratory for determining the breaking strength of in-service poles.

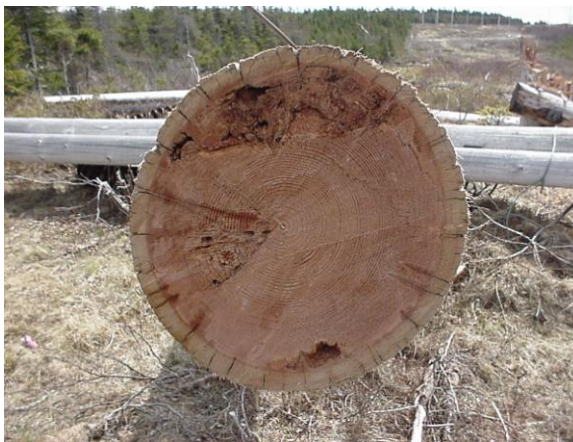
Fig. 3.18 - NDE Strength Data From Field- TL 201 (2000/2003)

Fig. 3.18 shows the typical NDE data for TL 201 collected during the 2000 and 2003 pole inspections. The results are quite consistent with those obtained from the full-scale test data depicted in Fig. 3.17.

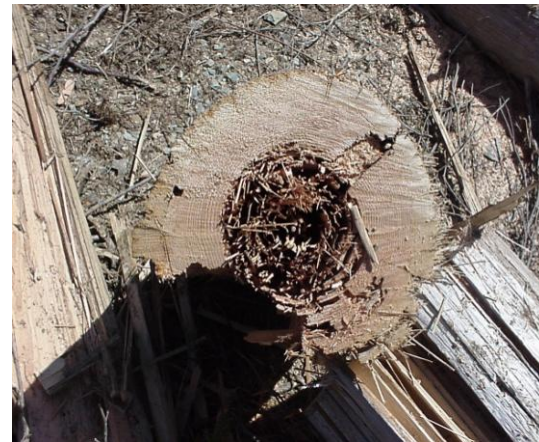
Fig. 3.19a – Internal Decay

Fig. 3.19a & b show the condition of the collapsed poles due to rot and carpenter ant damage. It also shows the importance of pole treatment and follow-up inspections to ensure that the poles are reliable for transmitting power and safe to climb for future inspections and maintenance work. NLH does not have a structured pole inspection, testing and treatment program at present with particular reference to life-extension of wood pole transmission lines. Therefore it is quite likely that many of the older poles may be exposed to severe decay due to fungi attack. Without a proper inspection and subsequent treatment program, the life of these poles cannot be extended significantly beyond 40 years.

During the recent upgrading work near the Hardwoods Terminal Station, a number of poles collapsed when isolated from existing 3-pole suspension structures. These poles were inspected in 1998 and were accepted because of having the adequate sapwood thickness. However inspection after the failures of the poles showed a rapid degradation of strength due to loss of sapwood on the outside shell. This is shown in Fig. 3.19a. This indicates that once the preservative is lost, degradation can happen rapidly (slope of the “yellow” line below the threshold level in Fig. 3.3) due to fungi attack and/or ant damage.

As illustrated in **Fig. 3.3** the depletion of preservative could be quite rapid once the retention has gone below the threshold level. The consequences of this depletion, and associated strength degradation have been shown in **Figs. 3.19a & b**.

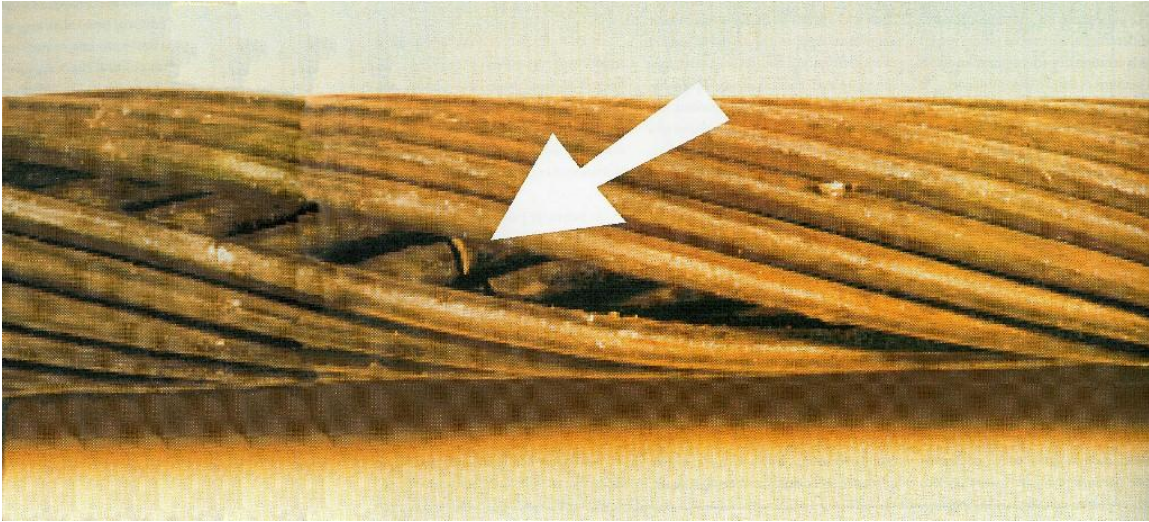
Fig. 3.20 – Broken Strand Due to Fatigue (IEEE, 2003)

A typical inner strand failure due to fatigue is shown in **Fig. 3.20** where it can be seen that the failures occurred where the inner strand surface had been subjected to fretting caused by contact between individual strands. Metallographic analysis of a large number of failures has shown that all cracks originated in these fretted areas. As fatigue inducing stresses occur near the bottom part of the conductor inside the clamp, they are impossible to measure directly. Thus, for purposes of expressing the severity of exposure to fatigue, it is necessary to represent the conditions at the contact points by means of a related parameter that is accessible to measurement such as the amplitude and the frequency of vibration (**Fig. 3.21b**). Alternatively, conductor samples can be removed from the clamp area at a certain interval and can be inspected further either by NDE or full-scale testing. One Canadian utility removes a conductor sample (typically 20 feet in length) from every 20 km of line inspected for further analysis and testing.

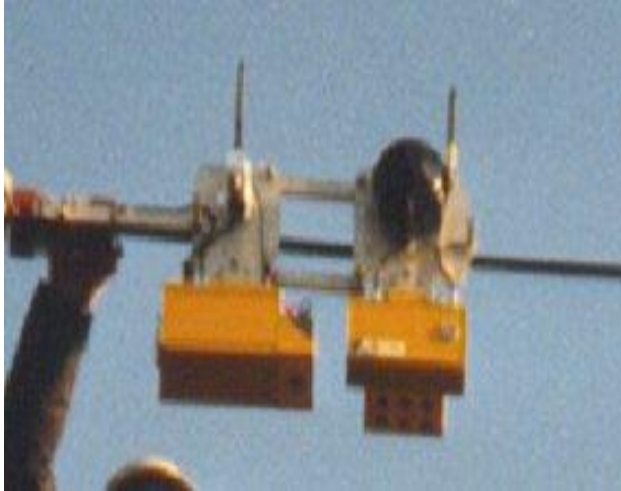
Fig. 3.21a - Corrosion Detector (CEA, 2003)

A **corrosion detector (Fig. 3.21a)** for steel strands works on the eddy current principle where the loss of galvanization is measured indirectly from a second coil sensitive enough to detect the change in the field patterns. The detector can sample even when it occurs within a few centimeters. Upon detecting the corrosion by NDE, samples can be taken from the line to determine the strand damage by additional testing (bending, twist of wires, etc.)

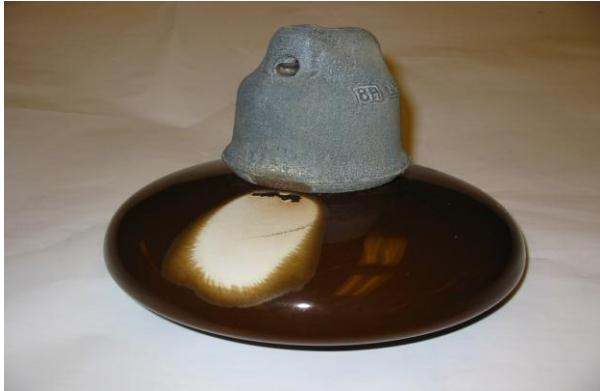
Fig. 3.22a – Flashed Insulator

- Visual Inspection;
- Insulator Voltage Drop Measure;
- Electric Field; and
- Infra red Thermography.

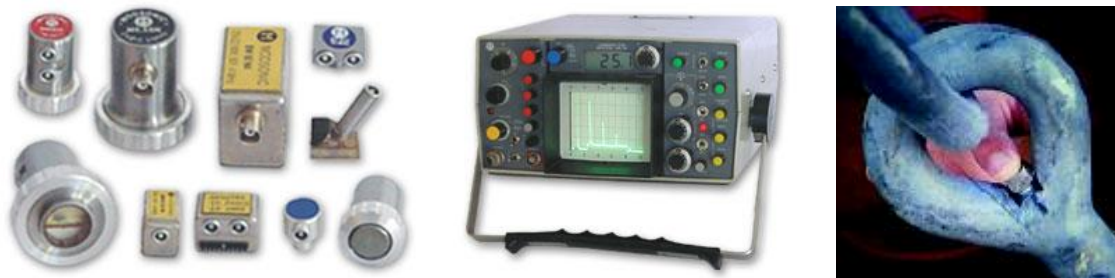
Fig. 3.23 - Inspection Equipment (CEA, 2003)

- Visual Inspection; and
- Ultrasonic Pulse and Recorder.

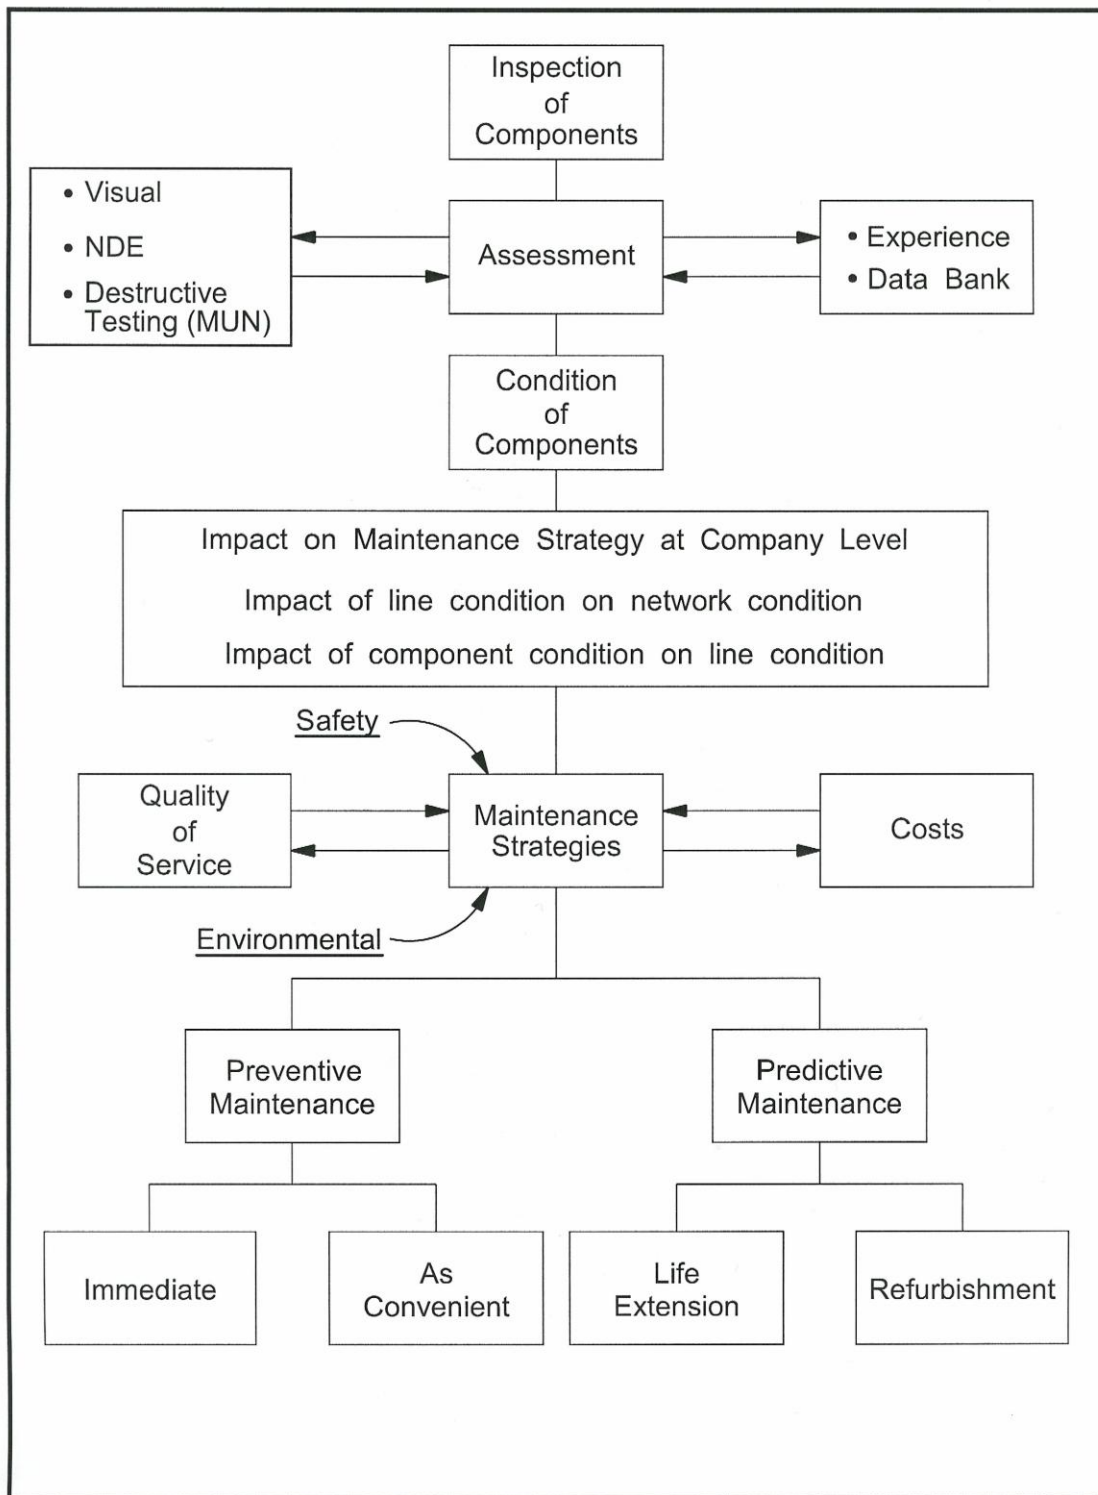
Figure 3.26 – Proposed Maintenance Strategy

However, to develop such a strategy, one must collect condition assessment information for each line component on a historical basis to ensure a systematic evaluation of a line at any given period. Note that the health of the line can be evaluated based on its current condition and a proper future inspection interval can be planned based on the actual condition of the line (or a component which may be a “weak link”). **Section 4** deals with the development of a database based on component inspection. A typical data collection form developed for this project is presented in the Appendix.

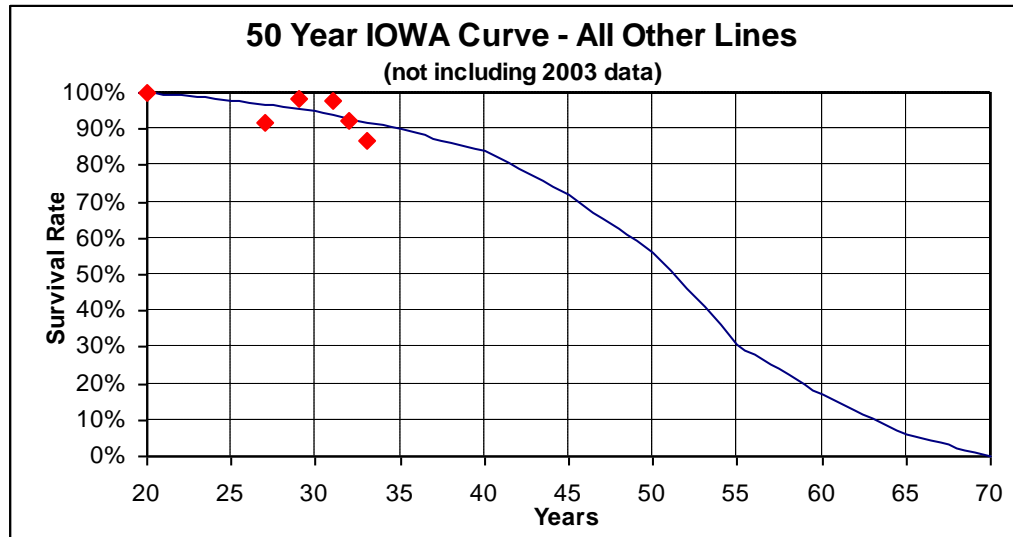
Fig 4.3 - Curve Validation for Non Avalon Poles in 2000 and 2002

Later, this validation process was also extended to cover poles from the Central region based on 2000, 2002 and 2003 data respectively (**Fig. 4.3**). Although the rejection rate is small in the early part of the 50-year IOWA curve, the rate changes drastically as the poles get closer to their service (economic) life (i.e. 40 years and beyond).

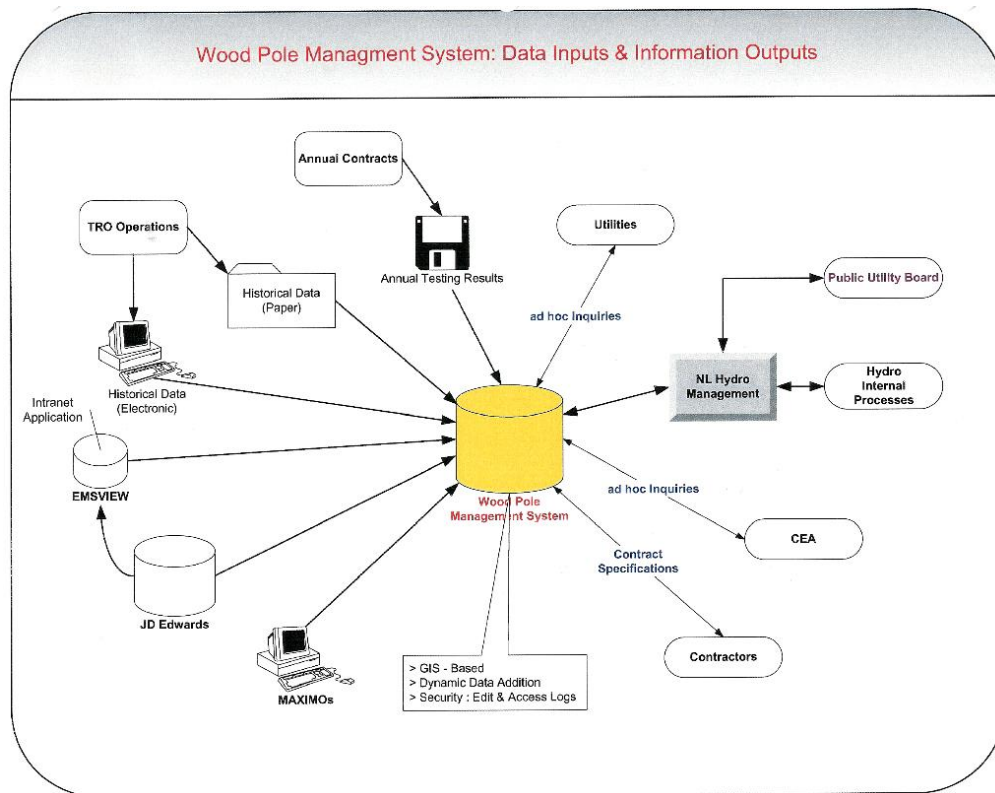
Fig. 4.4a – IS&T Flow Diagram – Data Input/Output

Ultimately, the database will be developed to identify each pole location and prior history. To address this, Engineering has worked with IS&T and the Properties Department to develop a “Pole Cataloging” database which will have coordinates of all poles in NLH’s system through GPS. **Figs. 4.4a** and **4.4b** depicts typical “flow charts” prepared by IS&T which could be developed further to manage the wood pole line assets. Once this project is approved, IS&T will provide the necessary support to create this database for “Pole Cataloging” in the JD Edwards system with appropriate coordination with Environment & Properties for GIS application. Until the JD Edwards is functional, all data will be recorded on paper forms and manually entered into an Excel spreadsheet for analysis. Eventually, this data will be imported into the database for future record.
