## Western Avalon Transformer T5 Tap Failure

Newfoundland and Labrador Hydro

Report R1335.02.01

## PSCAD Investigation of the Western Avalon T5 Transformer Failure

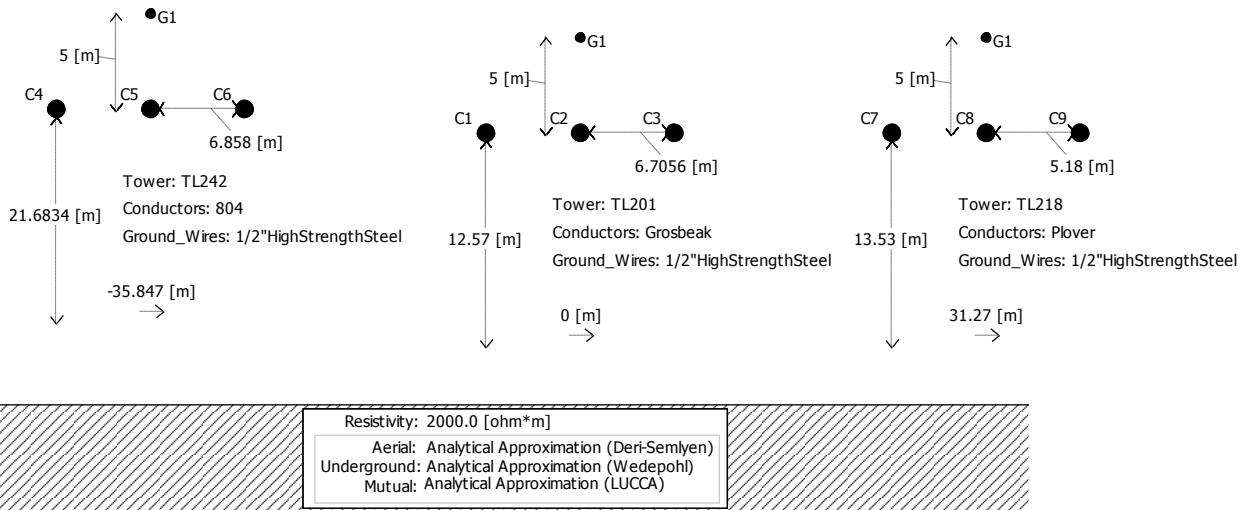
**Figure 2-3 Detailed Line Model**

Figure 2-2 shows an example of one of the more detailed line representation, which includes the mutual coupling of lines TL201, TL242 and TL218 and the mutual coupling of lines TL201 and TL217. Figure 2-3 shows the detailed line model for the lines TL201, TL242 and TL218.

Travel Time Interpolation: On  
 Curve Fitting Starting Frequency: 0.5 [Hz]  
 Curve Fitting End Frequency: 1.0E6 [Hz]  
 Total Number of Frequency Increments: 100  
 Maximum Order of Fitting for Yc: 20  
 Maximum Fitting Error for Yc: 1.0 [%]  
 Max. Order per Delay Grp. for Prop. Func.: 20  
 Maximum Fitting Error for Prop. Func.: 1.0 [%]  
 DC Correction: Disabled  
 Passivity Checking: Disabled

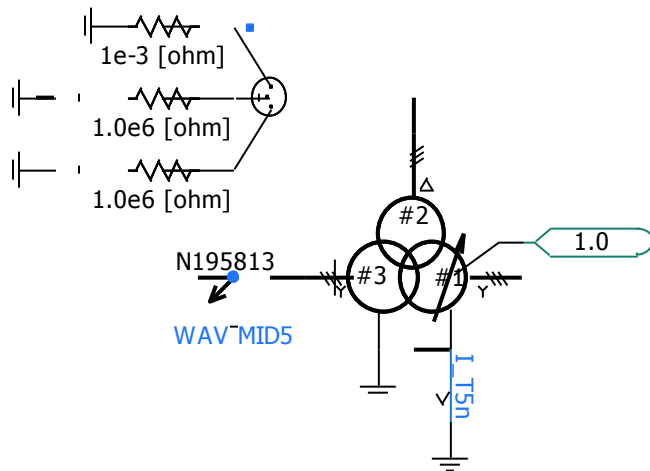
**Figure 2-4 T1 - SSD T5 – WAV**

The T5 transformer at Sunnyside is modeled based on the data provided by NLH. Figure 2-4 shows the PSCAD model and Table 2-2 shows the data used to model the transformers.

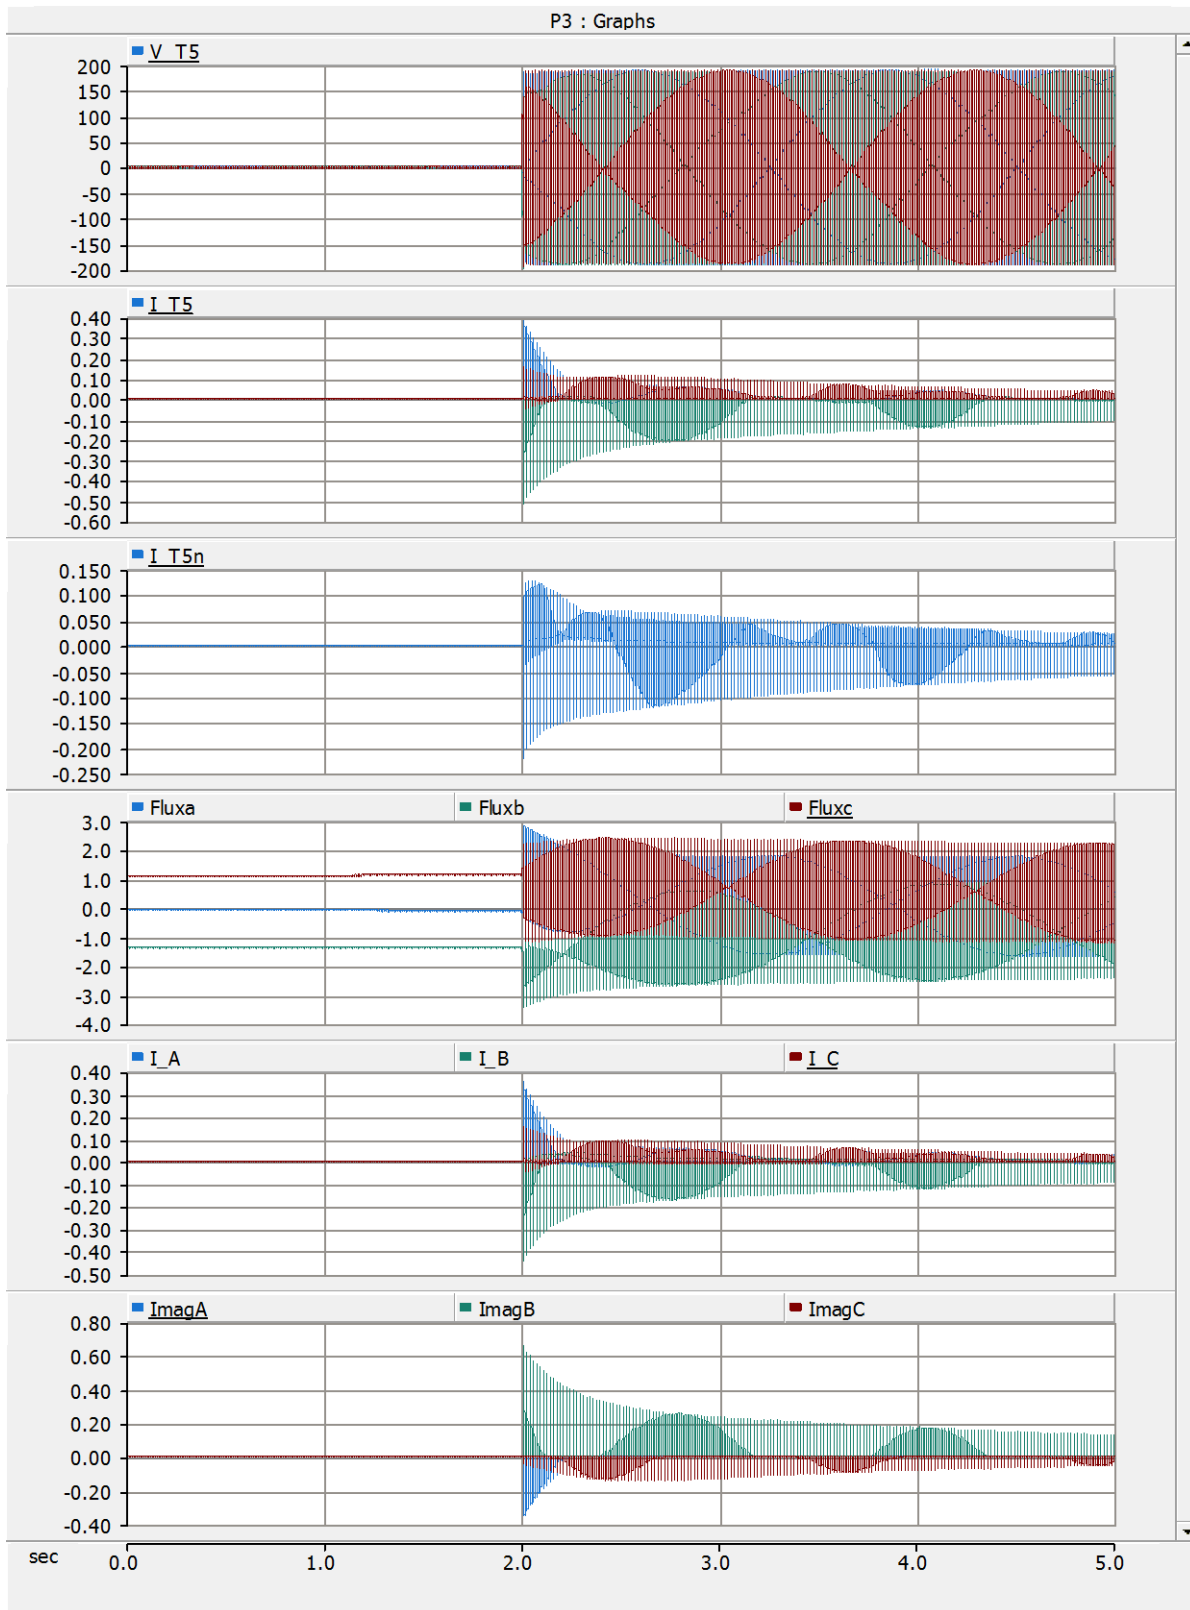
Figure 4-2 Energization of Western Avalon transformer T5 via line TL237

Figure 4-2 shows the reenergization of transformer T5 via line TL237. There is a peak current of about 250A in the neutral ( $I_{T5n}$ ).

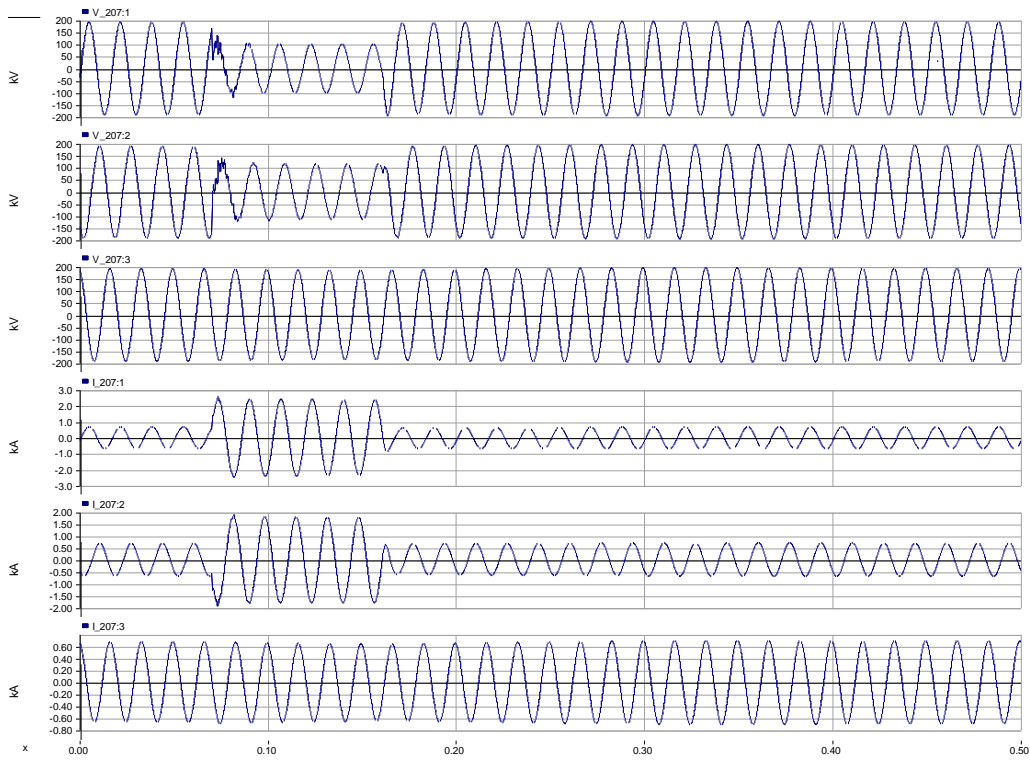
Referring to the above figures, as the PSCAD model cannot represent a fault on the tap-changer, the fault was applied externally to the transformer as a phase to phase fault. This did show that 2 kA fault current in a and b phase windings.

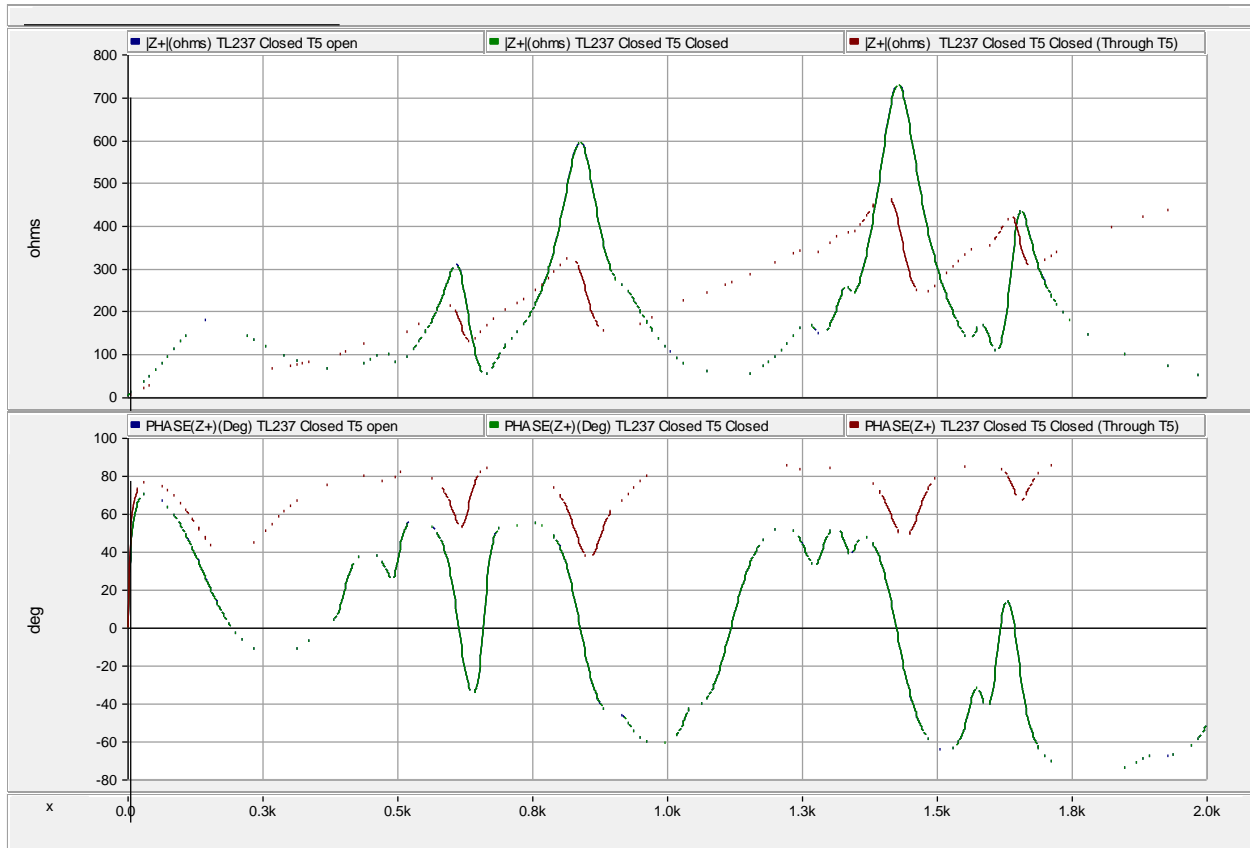
**Figure 4-9 Harmonic Impedances as seen from WAV bus**

1. At the Western Avalon bus just after connecting line TL237
2. At the Western Avalon bus just after connecting line TL237 and T5 transformer
3. Impedance as seen from the 138kV side of the T5 transformer looking towards the Western Avalon 230kV bus.

Referring to figure 4-9, there is negligible differences in the impedance when both line TL237 and T5 are connected compared to when just line TL237 is connected. For these cases, there are some resonant cases around 189Hz and 383Hz, but are away from the areas of concern. If we look at the impedance through the T5 unit, we see there are no resonances for this case.
