1 Q. **Reference: 2024 Capital Budget Application (Revision 1), Program 7, Wood Pole Line**
2 **Management Program (2024), page 14, Table 8.**

Re: Wood Pole Line Management Program – Progress Report

Wood Pole Line Management Program

Progress Report (2018–2022)

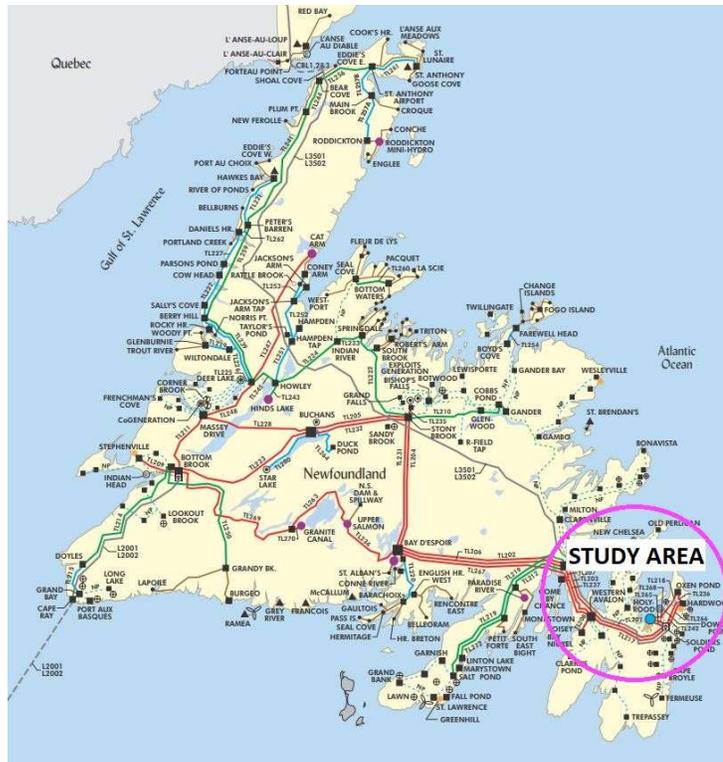
Figure 1: Island Map showing all High Voltage Transmission Lines and Study Area

2 Newfoundland and Labrador Hydro (“Hydro”) maintains approximately 2,300 km of wood pole
3 transmission lines operating at 69 kV, 138 kV and 230 kV voltage levels. The pole plant asset includes
4 approximately 23,000 transmission size poles. Figure 1 presents the overall Island Interconnected
5 System transmission line network.

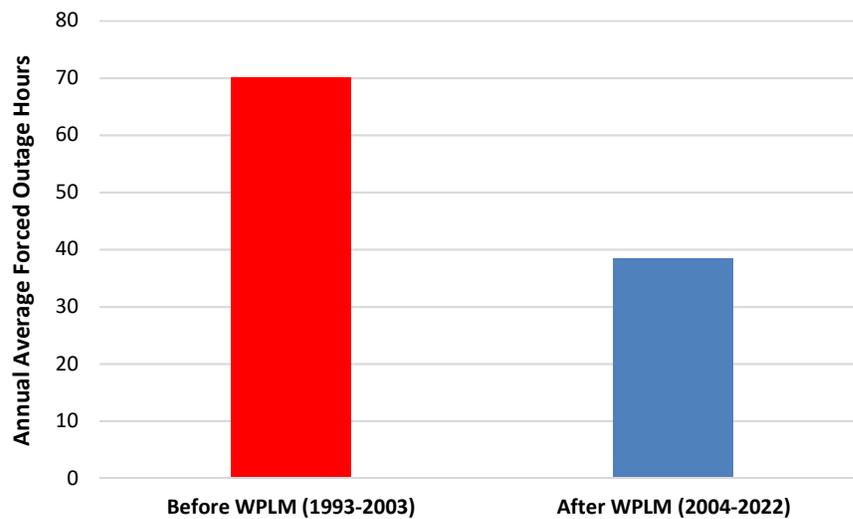
Figure 2: Outage Data for Hydro’s Wooden Transmission System (1993–2022)

20 Figure 2 illustrates the transmission reliability improvement of the Island Interconnected System. It
21 shows the total forced outage hours due to structural failures on wooden transmission lines before and
22 after implementation of the WPLM Program. The pilot project on WPLM started in 2003 with a two-year
23 duration. The full program was launched in 2005.

1 As shown in Figure 2 and Figure 3, there has been an Island-wide step change reduction in failures since
2 the WPLM Program was launched, despite the line system experiencing severe ice storm events in 2008
3 and 2010, as well as a number of wind storms including Hurricane Igor in 2010, the wind storm of March
4 2017, Hurricane Larry in 2021 and Hurricane Fiona in 2022. The improvement on the Avalon Peninsula is
5 approximately 78%, and the improvement for the entire wooden transmission system is approximately
6 45%. This improved performance is attributable to the on-going inspection and preventive treatment

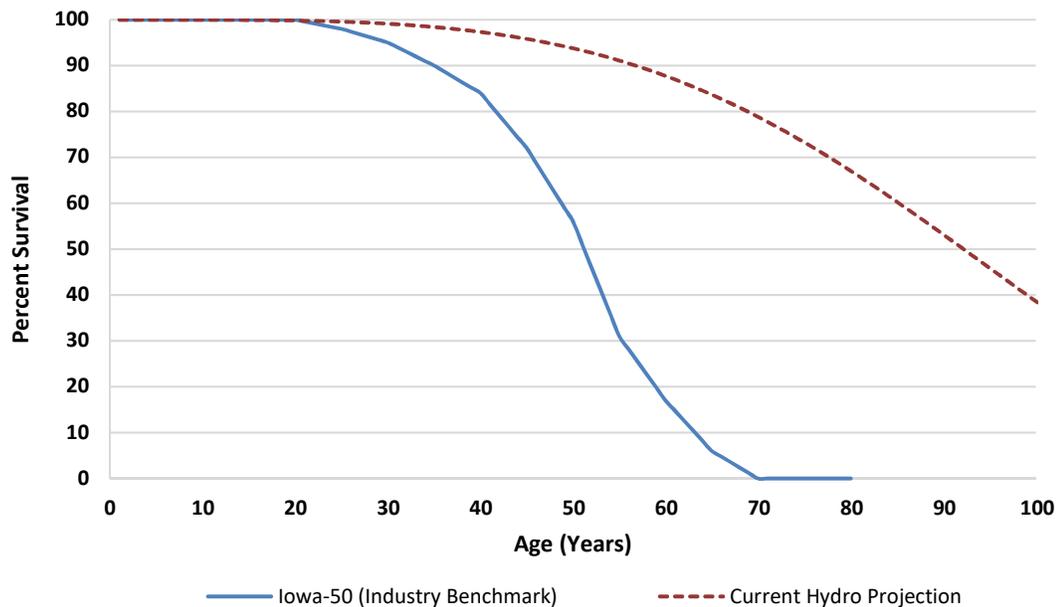
Figure 4: Survival Curves for the Pole Plant Asset (Island Interconnected System) and the Asset Age Distribution

10 The 50-year curve shown in Figure 4 indicates that 50% of a pole plant asset is typically replaced by the
11 time the asset age has reached 50 years. At the inception of the WPLM Program, this standard 50-year
12 IOWA curve (i.e., average pole life of approximately 50 years) was chosen as a benchmark for the
13 program, as pole inspection data from 1998 to 2003 correlated well with this curve. Since then, Hydro
14 has tracked its inspection data and developed its own survival curves using the IOWA curve methodology.
15 Figure 4 illustrates the survival curve for the pole plant asset for Hydro’s entire wood pole line network
16 alongside the 50-year IOWA curve for comparison.

- 1 As can be seen in Figure 4, data analysis from the first 20 years of the WPLM Program demonstrates an
- 2 incremental increase in average pole life. Based on the current Hydro projection, the expected mean life
- 3 for a wood pole in Hydro’s transmission network is approximately 90 years. This curve will continue to
- 4 become more refined as more inspection data is collected; however, the curve based on 20 years of
- 5 data collected since the inception of the WPLM demonstrates that the WPLM Program has significantly
- 6 extended the expected life of wood pole transmission infrastructure.

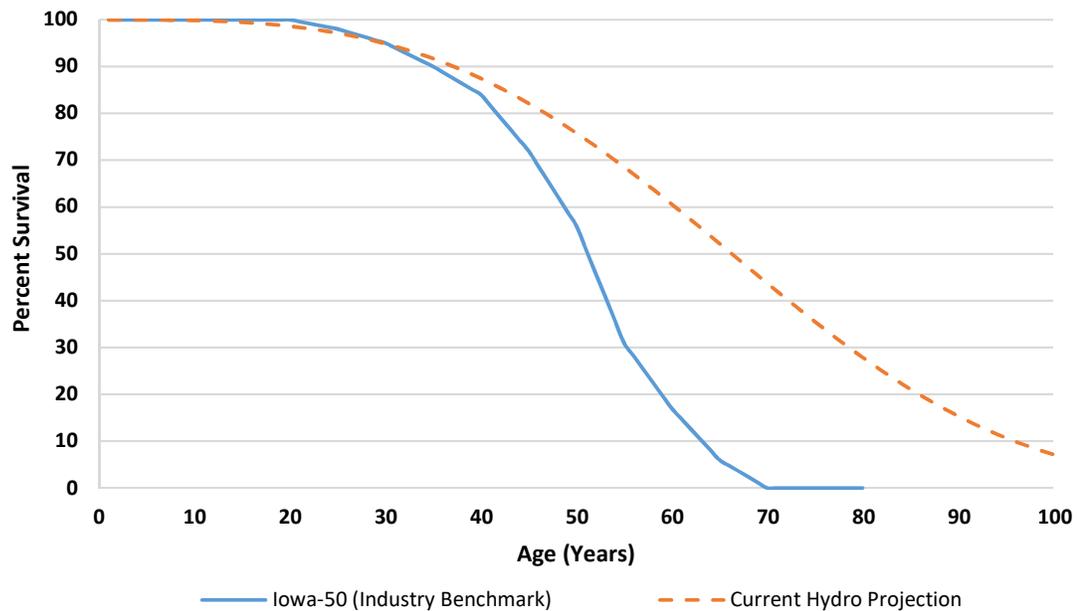
Figure 5: Survival Curves for Avalon Pole Plant Asset

- 7 Figure 5 depicts Hydro’s survival curve for its wooden lines on the Avalon Peninsula only.

1 This curve utilizes data from five inspection cycles between 1985 and 2022 for the Avalon Peninsula pole
 2 system. Asset data preceding the implementation of the WPLM Program closely follows the 50-year
 3 Iowa curve. Based on the current Hydro projection, the expected mean life is approximately 67 years,⁸
 4 which is significantly higher than the conventional economic life of 40 years historically used in the
 5 industry, and approximately 17 years longer than the 50-year expected mean life modeled by the Iowa-
 6 50 benchmark.⁹

4 To illustrate the effectiveness of the WPLM Program in minimizing life cycle costs for wooden
5 transmission lines, a net present value exercise was performed for a hypothetical transmission line using
6 the survival plot for the Avalon Peninsula wood pole line network as depicted in Figure 5. The survival
7 plot for the Avalon Peninsula’s wood pole line network was chosen as it is more conservative than the
8 survival plot for the entire Hydro wood pole line network. Lines on the Avalon Peninsula are exposed to
9 the most severe environmental conditions representing the worst case scenario for degradation, and
10 the plot was derived from data across five inspection cycles under the program (the remainder of
11 Hydro’s wood pole transmission lines having only gone through two inspection cycles to date).

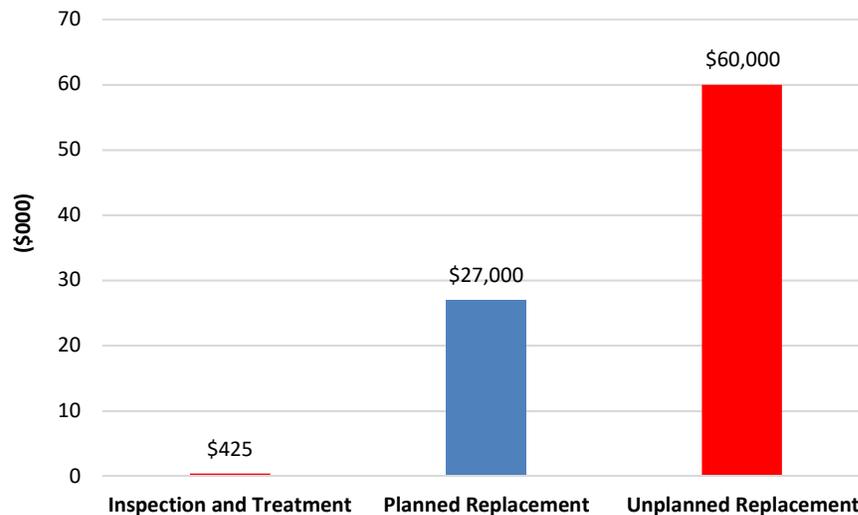
Figure 6: Comparison of Wood Pole Maintenance Costs (\$)

2 Figure 6 compares the estimated average inspection and treatment costs, planned replacement cost and
3 unplanned replacement cost of a pole.

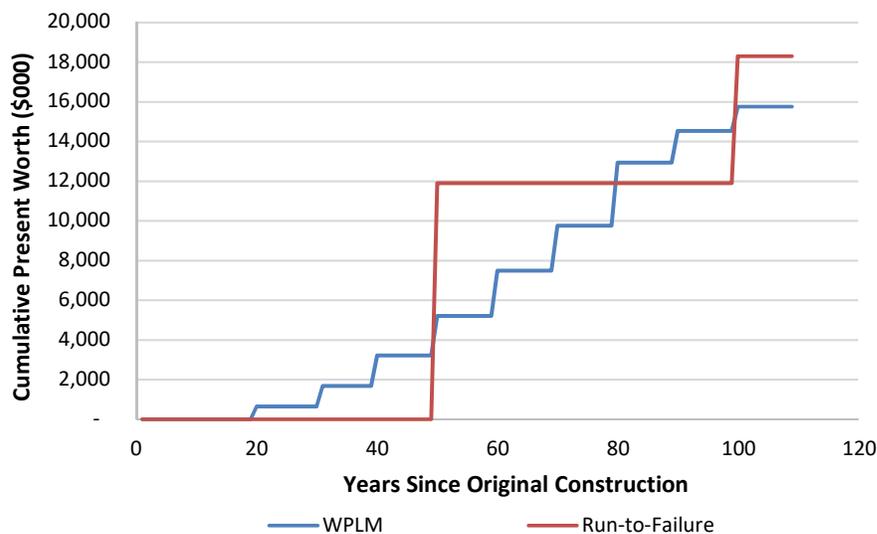
Figure 7: Comparison of Wood Pole Maintenance Costs (CPW)

1 maintenance has been estimated for the “run to failure” option. It has been assumed that portable
 2 generation is not required to maintain electrical supply in any case, and no maintenance or construction
 3 would be executed using hot line methods. It has also been assumed that a line managed under the
 4 WPLM Program will require re-conductoring at 80 years; however, Hydro considers this to be a
 5 conservative estimate as Hydro has not experienced significant issues necessitating re-conductoring to
 6 date. It should also be noted that the 69 kV case study is conservative, as the complete rebuild costs will
 7 increase as the voltage increases due to the requirement for larger components such as conductor,
 8 hardware and insulators. Figure 7 depicts the differences in cumulative present worth (“CPW”) for the
 9 two scenarios over time.

1 In this example, to manage the hypothetical line under the WPLM Program would cost an estimated
 2 total of \$38.7 million over the course of 100 years. To apply the “run to failure” approach to managing
 3 the line would cost approximately \$47 million over the same time period, more than 20% greater than
 4 the WPLM Program approach. This 20% difference in cost could be as high as 80% in other areas of the
 5 province based on the survival plot for the entire Hydro wood pole line network from Figure 4. This
 6 savings estimate is conservative and demonstrates the benefits and justification for the continued
 7 execution of the WPLM Program.
