1 **Reference: 2.1 2024 Substation Refurbishment and Modernization**

11
12 Report *2.1 2024 Substation Refurbishment and Modernization* filed with the *2024 Capital*
13 *Budget Application* provides an update on Newfoundland Power's *Substation*
14 *Refurbishment and Modernization Plan*.

Substation Strategic Plan

March 2006

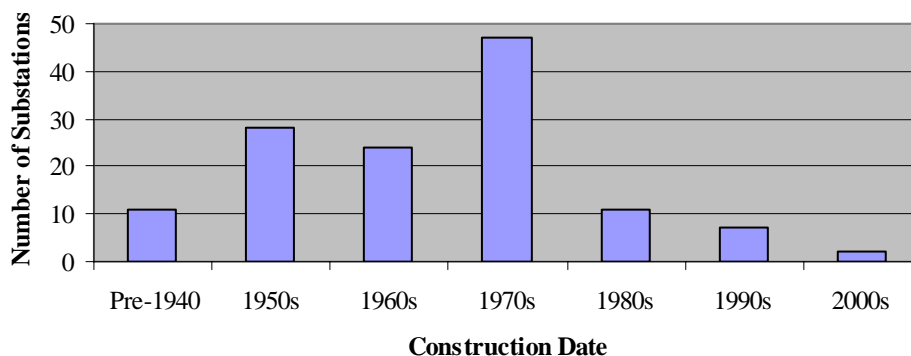
**Chart 1
Age of Substations**

Nearly half of Newfoundland Power’s substations are over 40 years old, with approximately one-third exceeding 50 years of age. The core infrastructure and major equipment in the Company’s substations includes foundations, structures, grounding systems, fencing, power transformers, oil filled breakers, cables, potential transformers, control buildings, switchgear and protective relaying. With few exceptions, the core infrastructure and major equipment in the Company’s substations has been in service since the substations were built. Chart 1 shows the age grouping of the Company’s 130 substations.

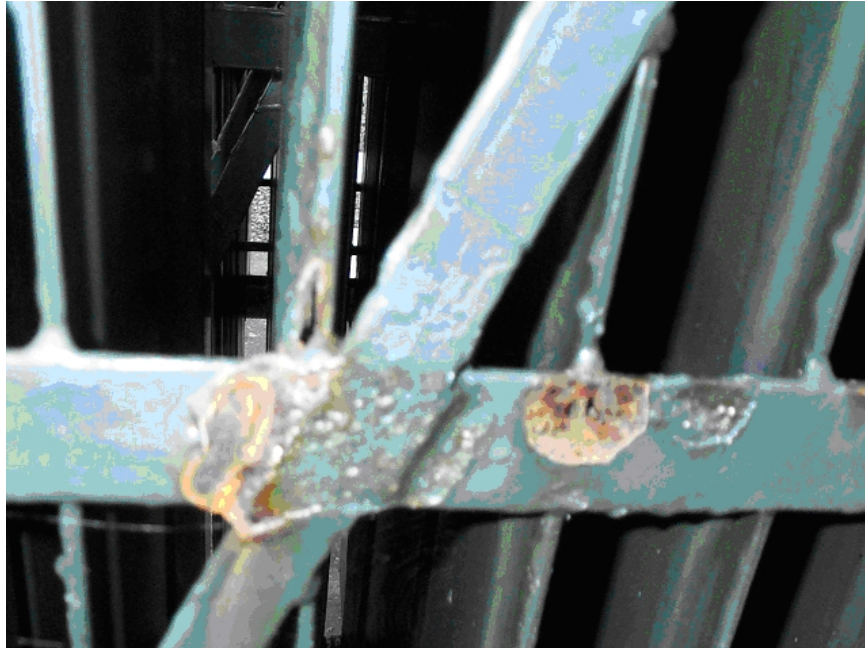
T3 transformer is in good condition. T2 transformer has cooling radiator fin edges that are perforated due to rusting. The perforated fin edges have been patched as a temporary measure to prevent leaking but require replacement. The lightning arrestors on T2 and T3 transformers are silicon carbide and require replacement with metal oxide arrestors. The air break switch on T2 transformer is 30 years old and requires replacement. Protection against small animals should be installed on the 25 kV equipment and bus. A maintenance overhaul is required for the T2 and T3 power transformers in 2007 which will be completed at the same time as the required capital work.

Deteriorated radiator fin edges – Blaketown Substation

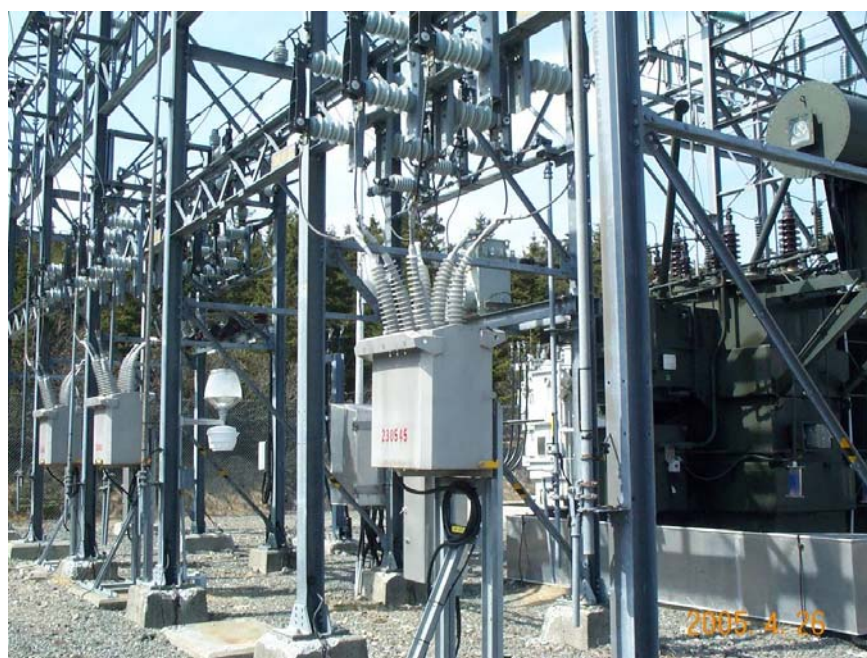
After reviewing maintenance records and conducting on-site engineering assessments, it was determined the 66 kV and 12.5 kV steel structures are in good condition with no sign of deterioration. Inspections of the concrete foundations show that there are two recloser and three bus structure concrete foundations that are crumbling and require replacement.

Foundation damage at Clarkes Pond Substation

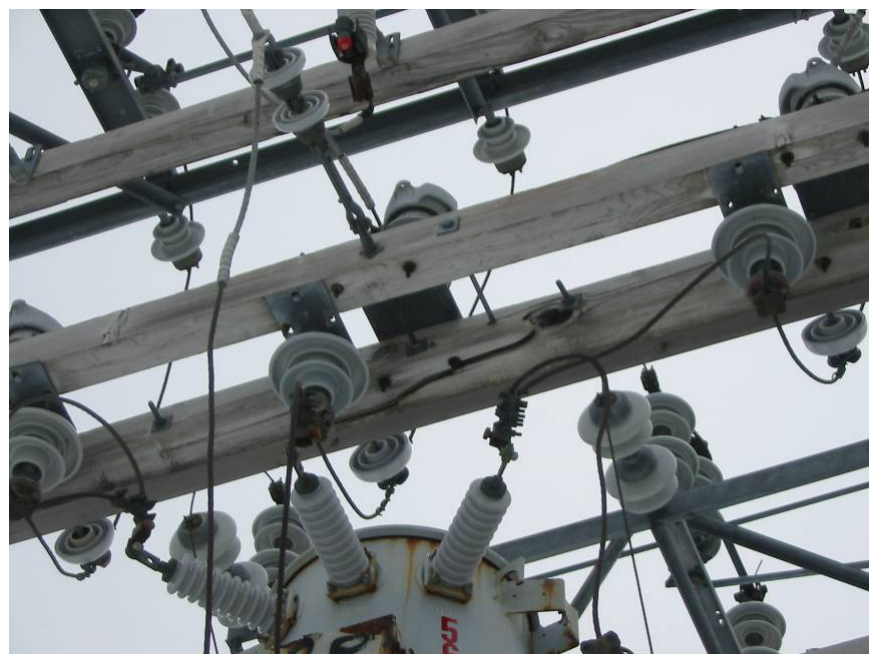
The 38 year old Garnish substation services approximately 430 customers. The substation is deteriorated and will be replaced with a new substation. All the insulators are old and prone to cement growth failure. The fence is deteriorated. Cross-arms are split and wood rot is present. Some cross-arms have been temporarily reinforced to prevent failure. Most of the concrete foundations are crumbling. The metering tank and other equipment are severely rusted. The transformer fans have to be replaced as their motor bearings are seized.

Cracked crossarm Garnish Substation

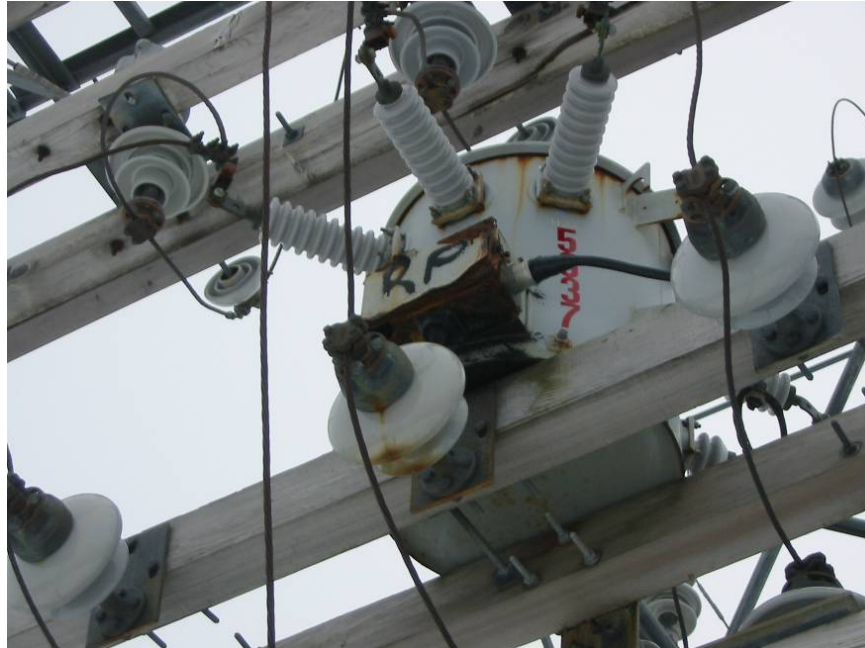
Corrosion damage Garnish Substation

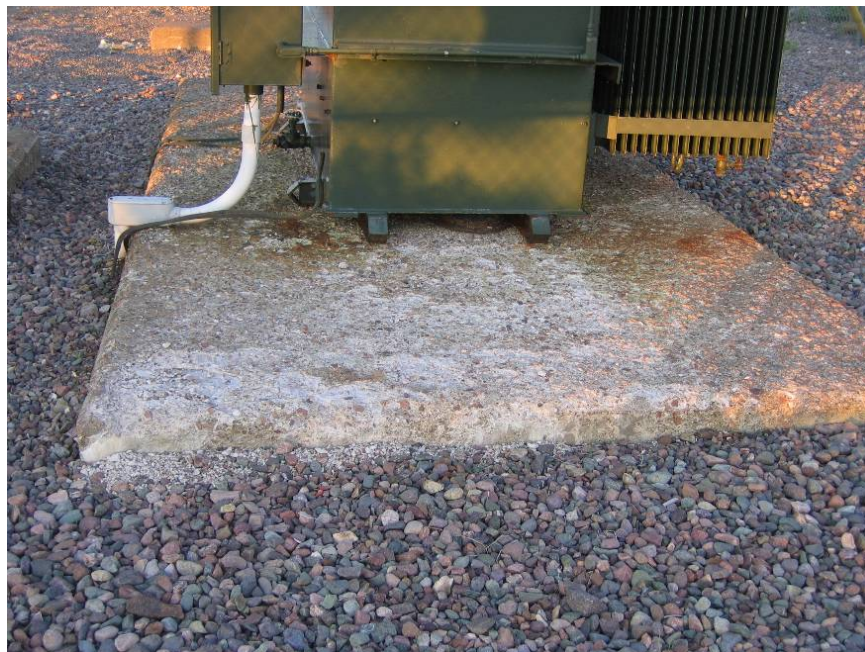
Foundation damage Garnish Substation

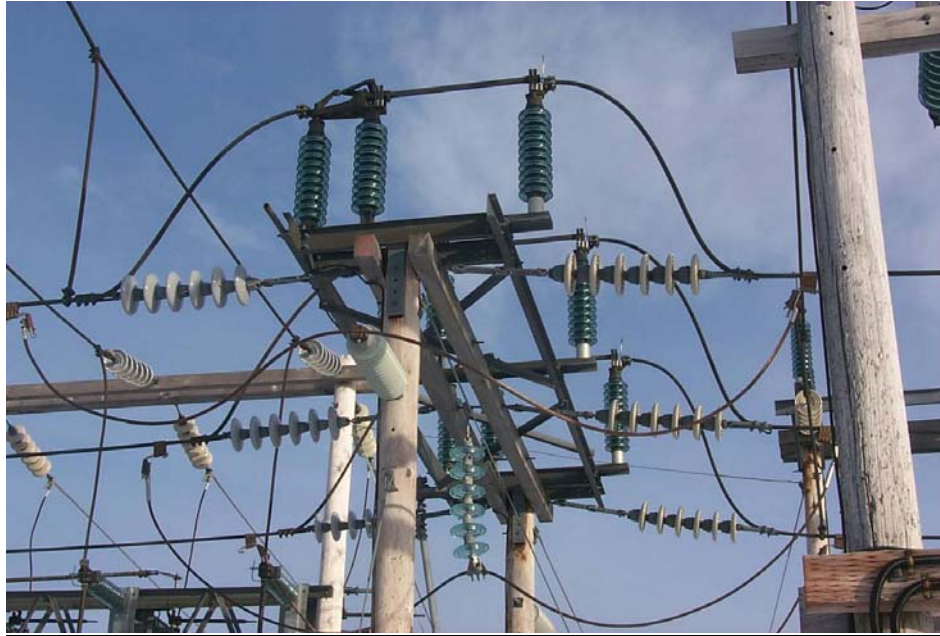
The power transformers are in good condition with no obvious signs of deterioration. The switches in the substation are in good condition with the exception of one 66 kV bus tie switch which is inoperable and currently bypassed. This switch must be replaced.

Bus Tie Switch Bypassed Goulds Substation
