Engineering Condition Assessment of the Corner Brook Frequency Converter

**Prepared by: Paul Nolan, P.Eng.
TRO Engineering Department
Newfoundland and Labrador Hydro
April 7, 2005**

ENGINEERING CONDITION ASSESSMENT

CORNER BROOK FREQUENCY CONVERTER

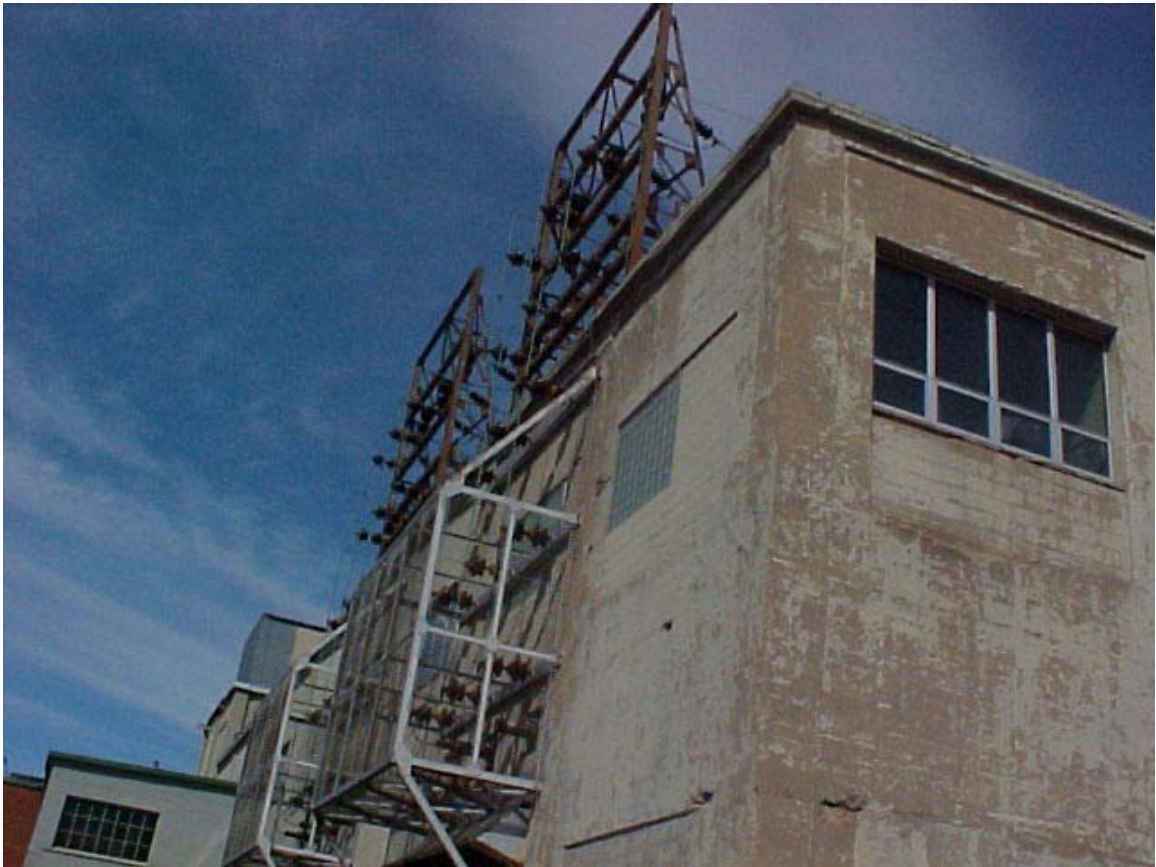
Take Off Towers and External 66 kv Bus associated with the Frequency Converter at Corner Brook Pulp and Paper.

Both towers are in good condition, including the bolted connections and leg anchors. Approximately 80 percent of the surface area of both towers is lightly corroded with some signs of mild pitting. Although maintenance of these steel towers is not urgent, it is recommended that a protective coating be applied to prevent any further deterioration of the structural steel. A two to three year delay in carrying out this maintenance would be acceptable.
