**NEWFOUNDLAND POWER INC.**

**MOBILE GAS TURBINE  
PLANNED REFURBISHMENT 2003  
PROJECT JUSTIFICATION**

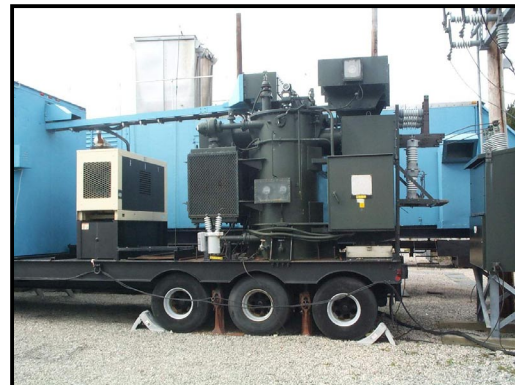
The power transformer is due for an inspection and overhaul. It is recommended that this work be completed while the unit is out of Province to take advantage of the time the unit is unavailable. Otherwise it would be necessary to schedule an additional outage once the unit has been returned to service. The additional work required includes the repair or replacing of valves and oil

flow indicators. The unit will also be painted, removing any rust that has developed on the equipment.

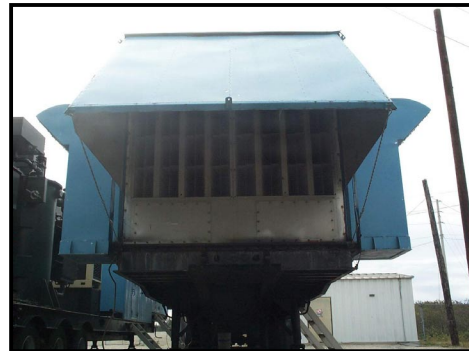
The contractor will replace the existing aluminum bolts used to secure the intake louvers with stainless steel fasteners. Orenda identified this item in the 1998 inspection. While the louvers are disassembled the contractor will repair or refurbish the motors in the air intake system and install a differential pressure switch in the louver. Orenda also identified this item in the 1998 inspection.

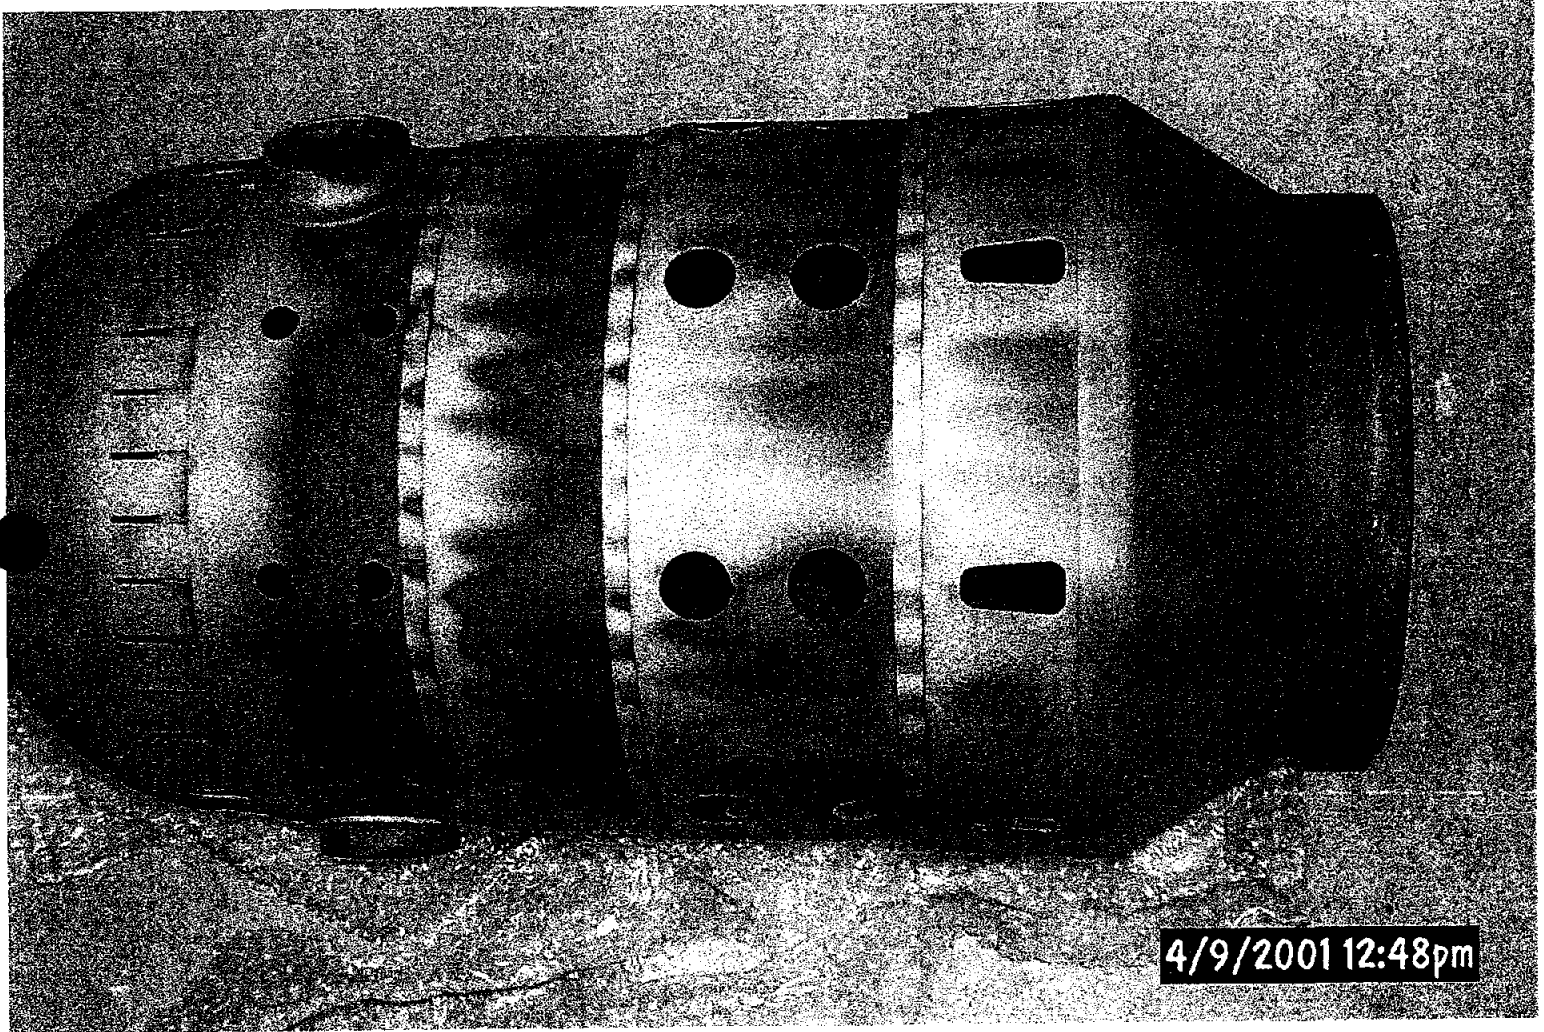
### Gas Generator Lube Oil Pressure & GG Speed

Over heating of The combustion can lead to surging  
on the governor

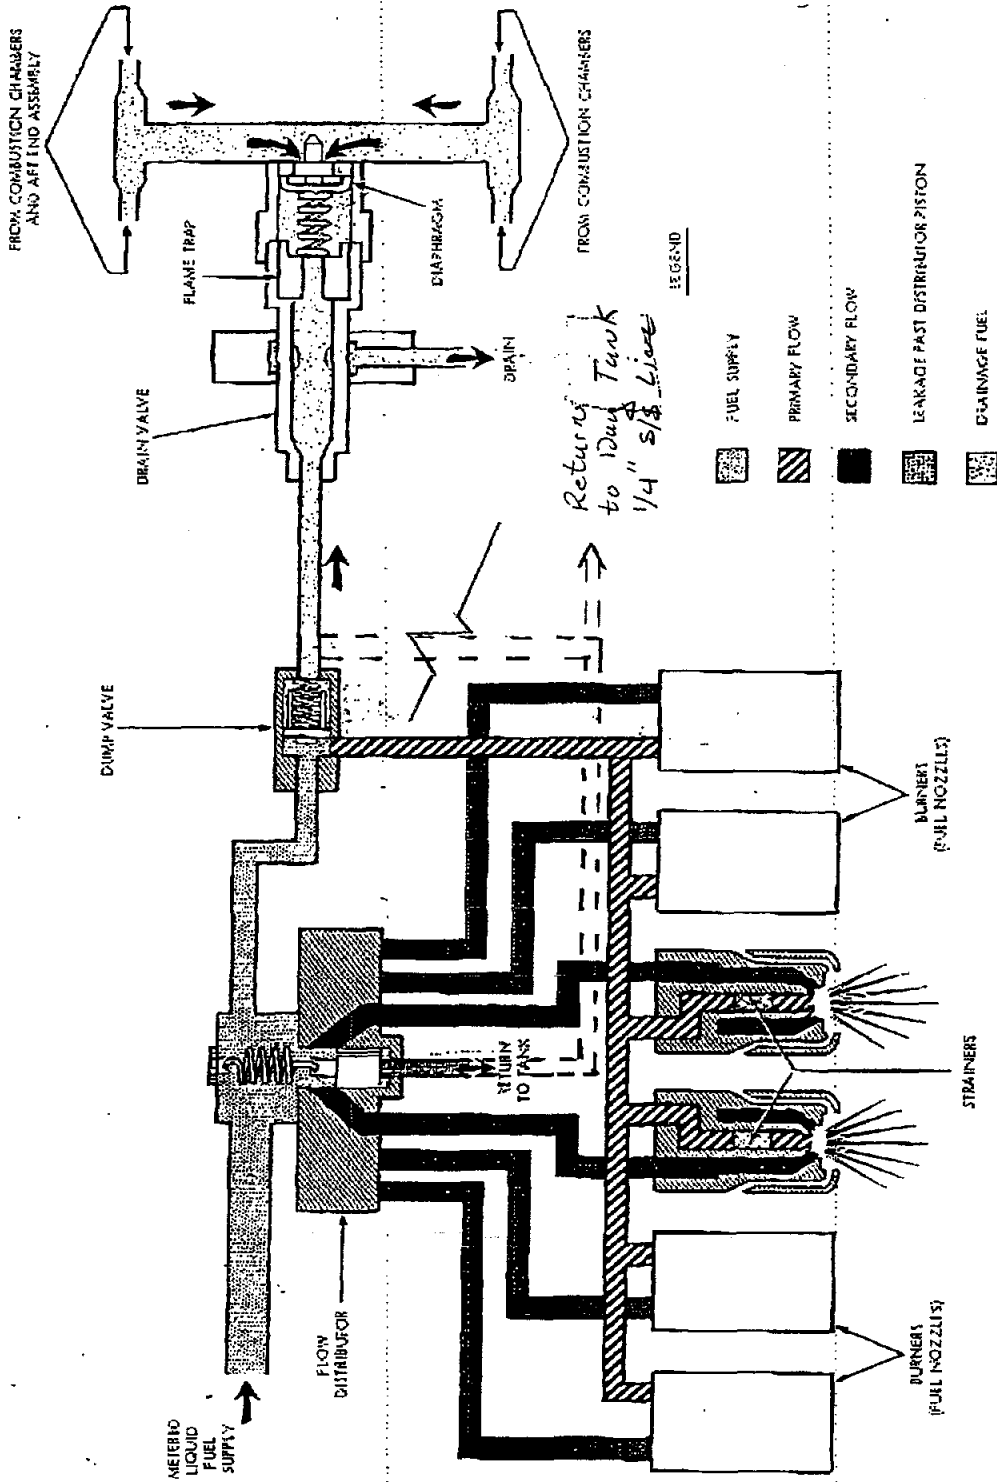
Figure 3-2 Gas Generator - Liquid Fuel System Schematic

Modified the fuel drain system. The existing configuration had the distributor fuel bypass line connected to the combustion can drain lines and routed an external container under the power turbine trailer. See figure 3-2. The distributor bypass was re routed to the day tank. A 1/4" NPT S/S nipple was welded in the day tank inspection cover to accept the distributor bypass line, and the flow divider capped off.

ATT/ JOHN BUDGEK  
 Side line coming from the center of the fuel distributor  
 valve is tied into the drain valve instead of going  
 back to the tank
