Diesel Power Plant Review

Newfoundland Power Inc.

May 2000

Appendix A Condition Assessments of Diesel Plants

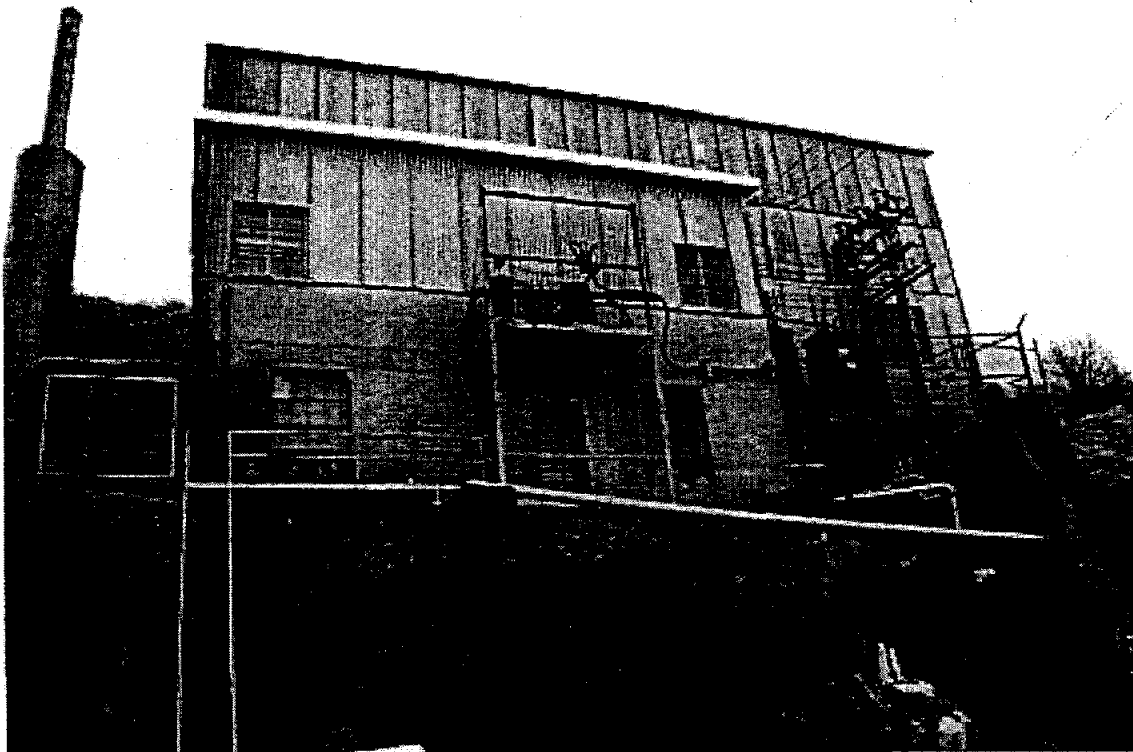
Photo 1 St. John's Diesel Powerhouse as seen from the Southside Road.

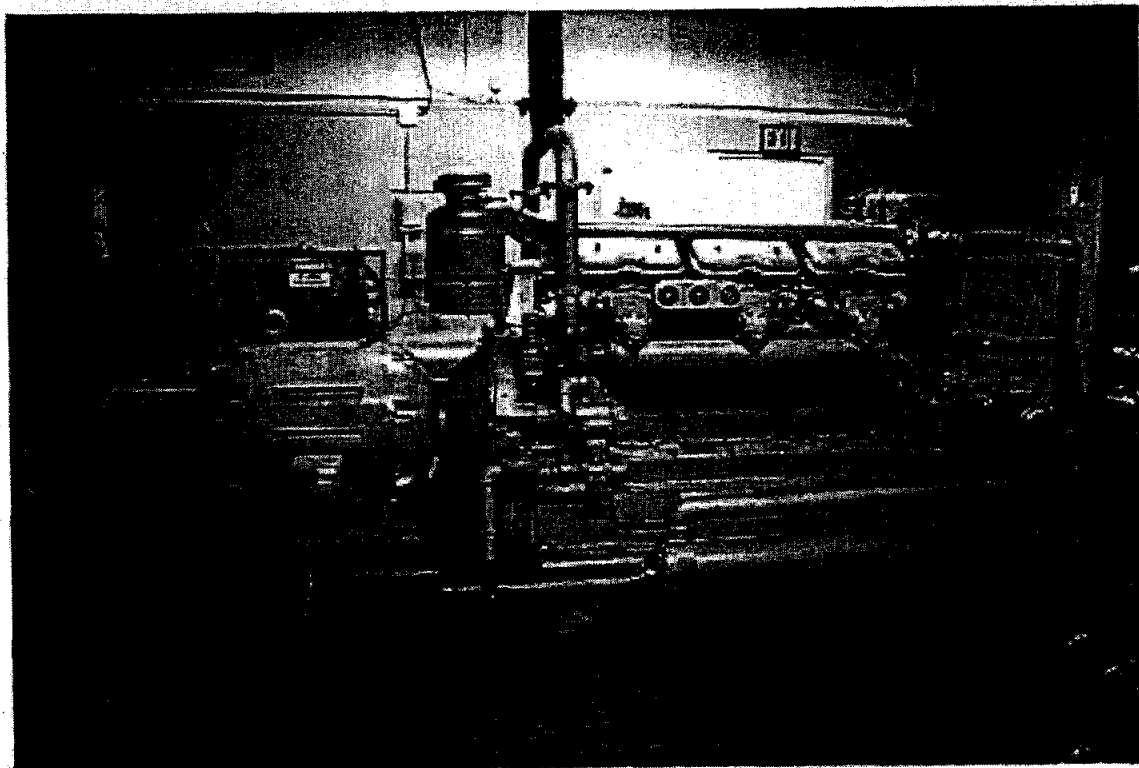
The Port aux Basques Main Diesel plant units are in poor condition. This plant has been approved for decommissioning by the Public Utilities Board in 1998.

Photo 6 Port aux Basques Main Plant Unit #5 at 250 kW.

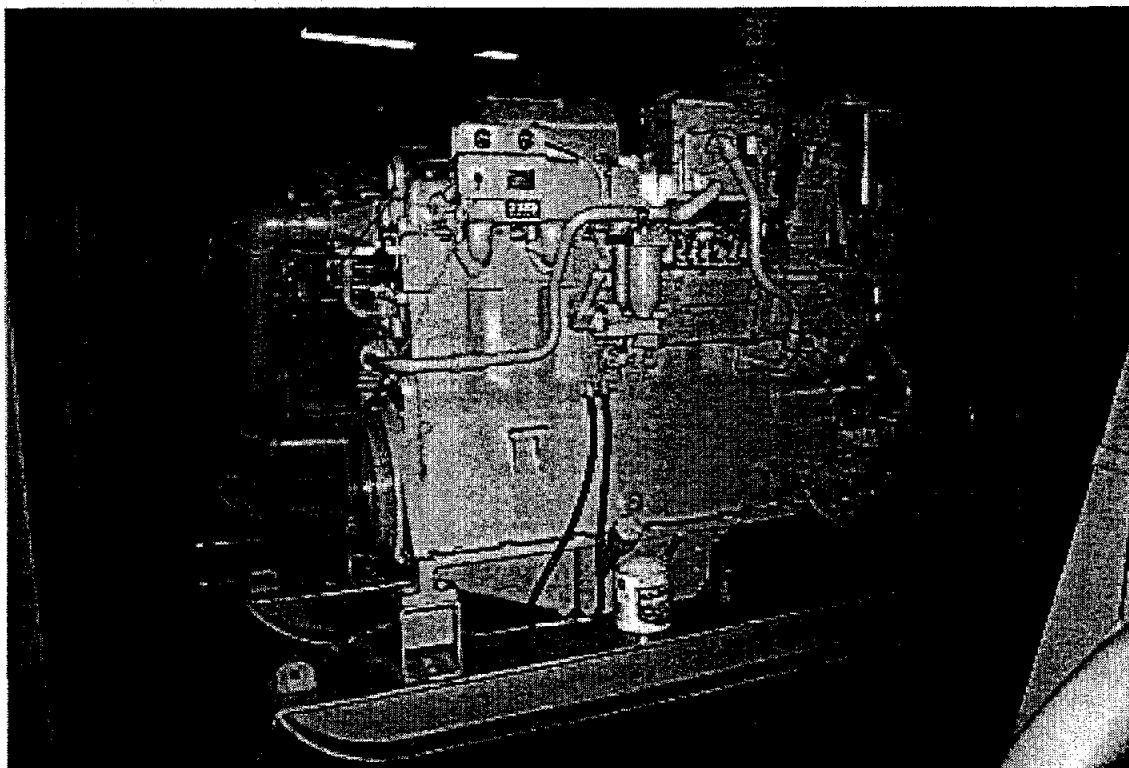
Photo 7 Port aux Basques Main Diesel plant unit manufactured by Caterpillar.

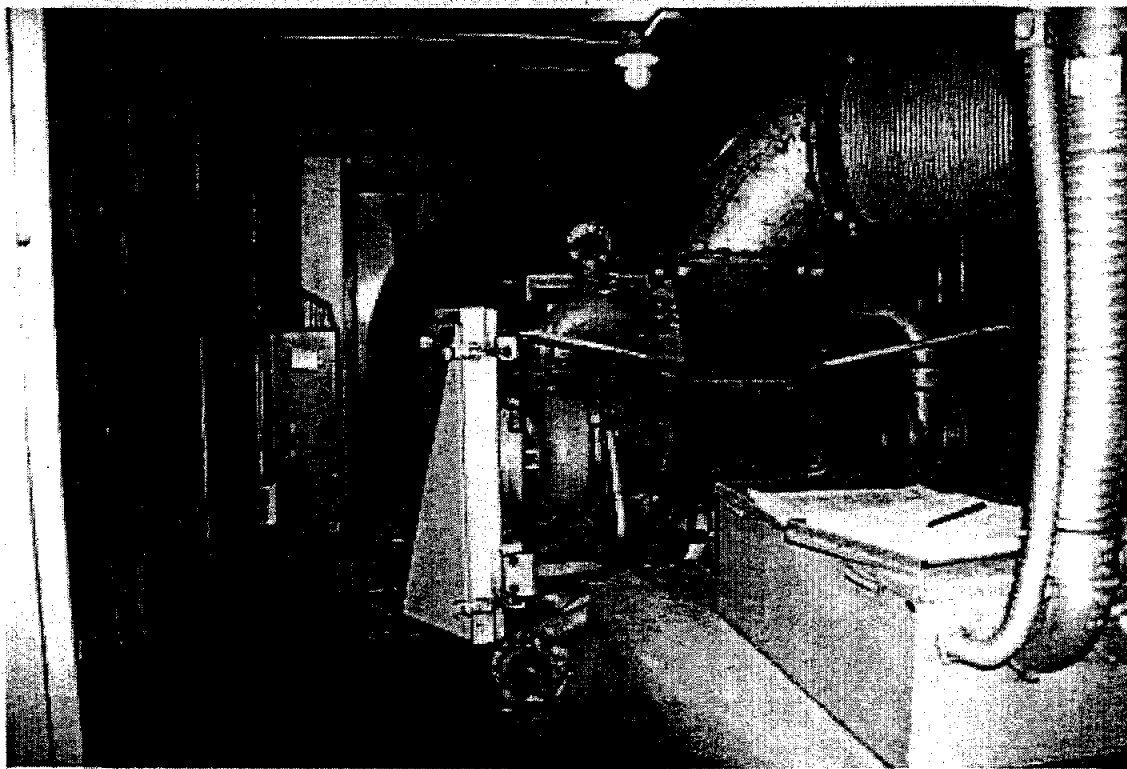
Portable Diesel #1 is in satisfactory condition with only minor oil leaks and dirty radiators and fans. The continued use of this unit will require the installation of secondary containment for the fuel tanks onboard, an engine overhaul, and some minor repair work to the trailer chassis.

Photo 11 View of the 700 kW Portable Diesel #1 manufactured by Caterpillar.

5. The lack of secondary containment for the Portable Diesel #1 fuel tank represents an environmental risk and thus the tank will have to be replaced on this unit.

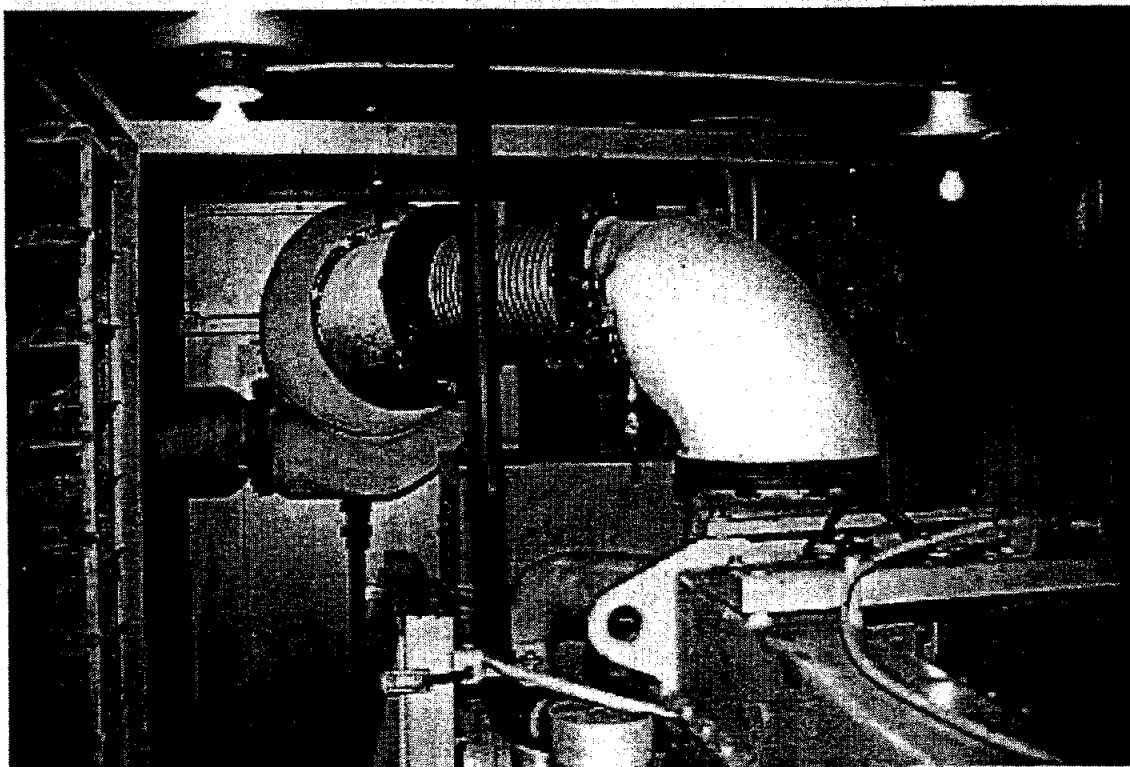
Photo 13 View of the 670 kW Portable Diesel #2 manufactured by Caterpillar.
