Inspection and Testing of Substation Concrete Pads And Foundations

Newfoundland Power Inc.
55 Kenmount Road
P.O. Box 8910
St. John's, N.L.
A1B 3P6

SGE Acres Limited
Postal Service 1086
45 Marine Drive
Clareville, NF
A0E 1J0

SGE Project #: C022319.01
Date: August 2002

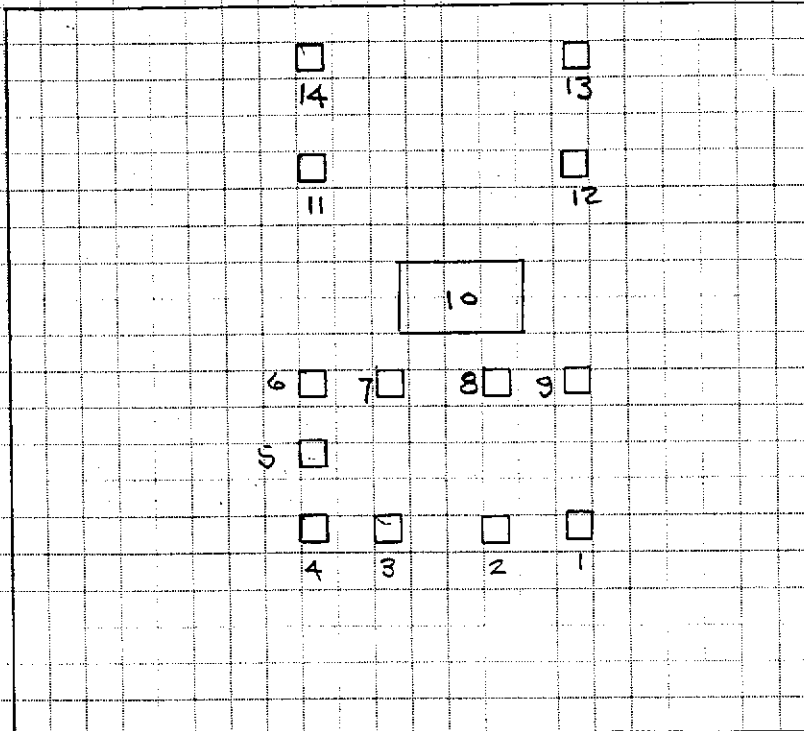
SUBSTATION SITE: MARYSTOWN

| Fdn/Pad Type & No. | General Condition | Recommendations | Priority Rating |
|--|--|---|---|
| #1 - MSY-01 - BP Low Vptage Structure | Good Condition. (38MPa) | | 4 |
| #2 - MSY-01 -R-424 Recloser | Good Condition with one minor spall on one corner. | Type A Repair | 3 |
| #3 - MSY-02 -R-384 Recloser | Good Condition. (38MPa) | | 4 |
| #4 - MSY-02 -BP Low Voltage Structure | Fair to Good Condition There are two hairline cracks (<1mm) | Type B Repair | 3 |
| #5 - MSY-03 -R Recloser | Good Condition Very minor shipping along top edges | Future Monitoring | 4 |
| #6 - MSY-04 -DL Low Voltage Structure | Fair Condition. There are several cracks from top surface out to sides (<1mm) | Type B Repair | 3 |

| Fdn/Pad Type & No. | General Condition | Recommendations | Priority Rating |
|---|--|---|---|
| #7 - MSY-04 -R Recloser | Good Condition Very minor shipping along top edges (39MPa) | Future Monitoring | 4 |
| #8 - NO # Metering Tank | Good Condition Very minor shipping along top edges (38MPa) | Future Monitoring | 4 |
| #9 - No # Low Voltage Structure | Good Condition ((40MPa) | | |
| #10 - T1-311 Transformer | Good condition. There is some cement/sand matrix deterioration and there appears to have been an extension added to one side of the pad. | Future Monitoring | 4 |
| #11 - 308L-A High Voltage Structure | Fair to Good Condition. Two Hairline cracks from middle of top surface to sides (40MPa) | Type B Repair | 3 |
| #12 - T1-A High Voltage Structure | Fair to Good Condition. Two Hairline cracks from middle of top surface to sides (40MPa) | Type B Repair | 3 |

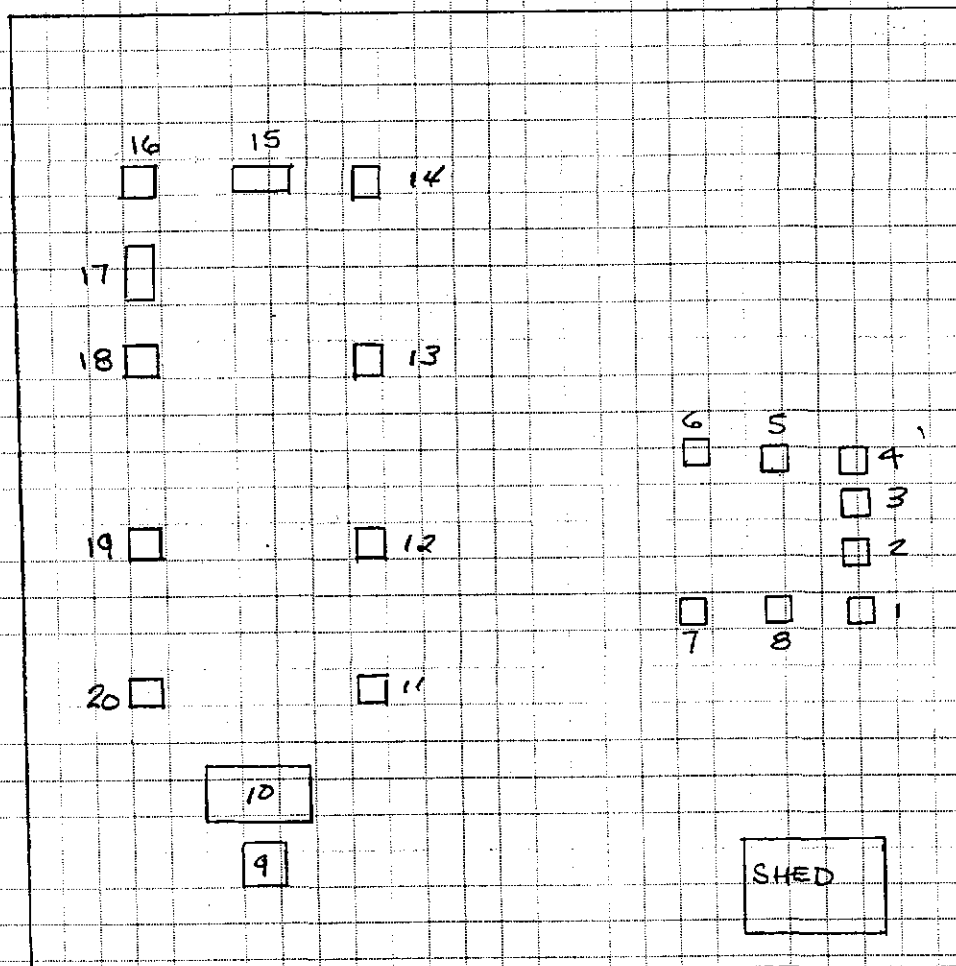
SUBSTATION SITE: SALT POND
SPO SUBSTATION

| Fdn/Pad Type & No. | General Condition | Recommendations | Priority Rating |
|---|---|---|---|
| #1 - SPO-02 | Good Condition. (42MPa) | | 4 |
| #2 - SPO-02 | Good Condition. (40MPa) | | 4 |
| #3 - SPO-01- | Good Condition. (42MPa) | | 4 |
| #4 - SPO-01 | Good Condition. (40MPa) | | 4 |
| #5 - SPO-03 | Good Condition. (40MPa) | | 4 |
| #6 - SPO-03 | Good Condition. (42MPa) | | 4 |

| Fdn/Pad Type & No. | General Condition | Recommendations | Priority Rating |
|---|---|---|---|
| #7 - SPO-T1 -D Low Voltage | Good Condition | | 4 |
| #8 - 2733 Metering Tank | Good Condition. (40MPa) | | 4 |
| #9 - SPO-T4 -B Synix Breaker | Good Condition Several areas with minor honeycombing (38MPa) | Type A Repair | 3 |
| #10 - SPO-T4 Transformer | Good Condition. (38MPa) | | 4 |
| #11 - No # High Voltage | Good Condition (36MPa) | | 4 |
| #12 - No # High Voltage | Fair to Good Condition Some cement/sand Matrix deterioration and scaling on one corner. | Type A Repair | 3 |

| Fdn/Pad Type & No. | General Condition | Recommendations | Priority Rating |
|--|---|---|---|
| #13 - No # High Voltage | Good Condition. (38MPa) | | 4 |
| #14 - SPO -308-L-DB High Voltage | Good Condition (37MPa) | | 4 |
| #15 - SPO -308L-B Synix Breaker | Good Condition | | 4 |
| #16 - No # High Voltage | Good Condition. (40MPa) | | 4 |
| #17 - SPO -TL219-DL High Voltage | Good Condition (40MPa) | | 4 |
| #18 - SPO -TL219-B Synix Breaker | Good Condition. (44MPa) | | 4 |

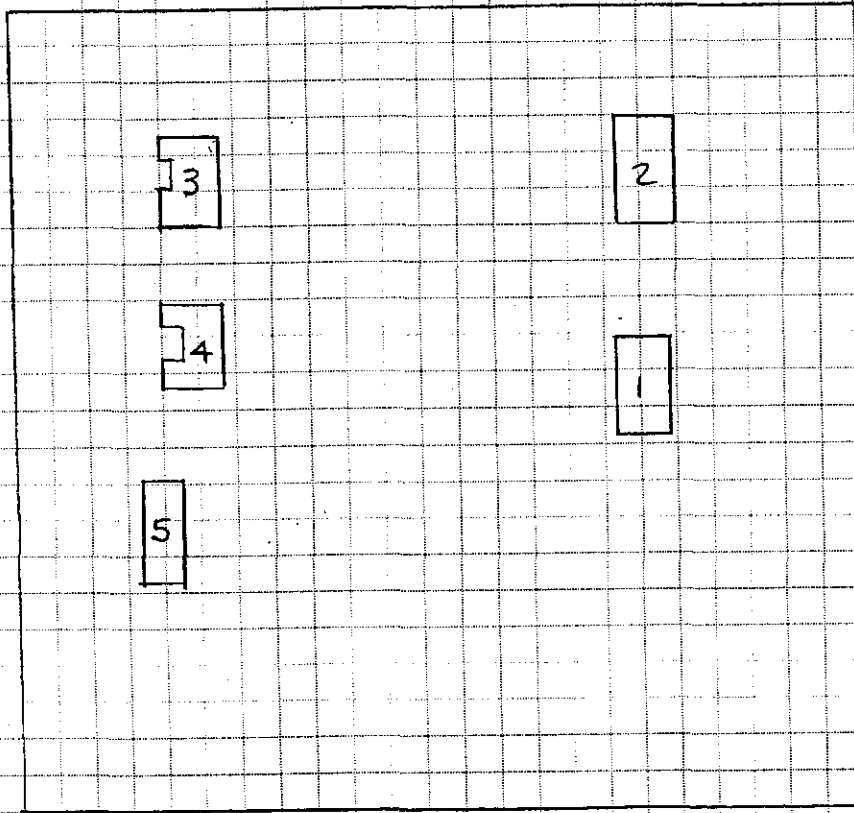
SUBSTATION SITE: SALT POND
SPT SUBSTATION

| Fdn/Pad Type & No. | General Condition | Recommendations | Priority Rating |
|---|--|--|---|
| #1 - No # Not in Use | Fair to Good with some alligator cracking and several hairline cracks(<1mm) | Type B Repair if structure is to be used again | 3 |
| #2 - SPT-T1 Transformer | Fair Condition. Two corners have cracking (>1mm) that extends fully across the corner. The remainder of the pad is in Good Condition | Type C Repair | 2 |
| #3 - SPT-301L -B Oil Breaker | Poor Condition. There are excessive amounts of cracking (>1mm) throughout the foundation which has compromised the structural integrity of the concrete. The equipment on the foundation appears to be larger than it was designed for. | Type E Repair Total replacement of foundation with correct foundation type for this equipment. There appears to be a settlement problem with the foundation. The underlying material should be inspected. | 1 |
| #4 - SPT-302L -B Oil Breaker | Poor Condition. There are excessive amounts of cracking (>1mm) throughout the foundation which has compromised the structural integrity of the concrete. | Type E Repair Total replacement of foundation with correct foundation type for this equipment. There appears to be a settlement problem with the foundation. The underlying material should be inspected. | 1 |
| #5 - No # Not in Use | Major cracks along length of pad & across the end. | Should be replaced if it is required in the future. | |

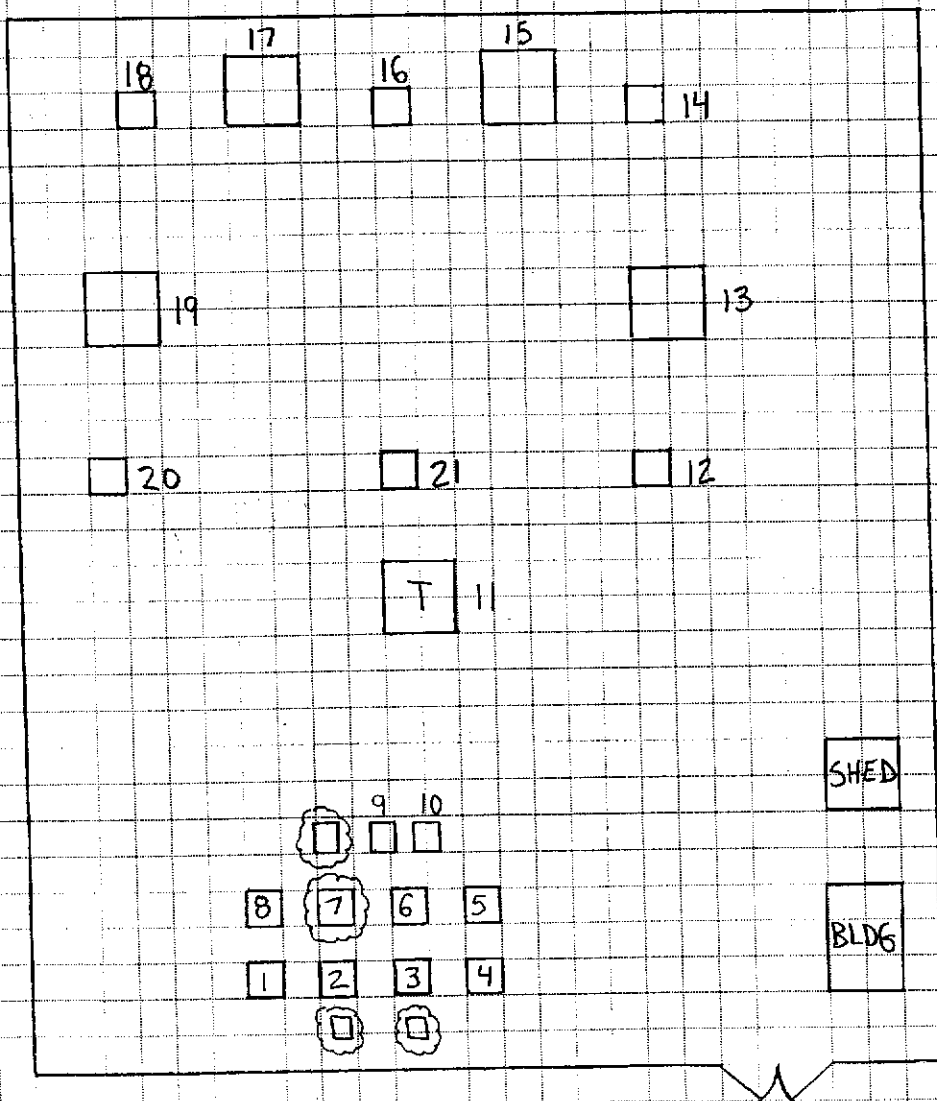
SUBSTATION SITE: BISHOP'S FALLS
GRAND FALLS AREA

| Fdn/Pad Type & No. | General Condition | Recommendations | Priority Rating |
|--|---|---|---|
| #1 - BFS-02-BP Structure Low Voltage | Rough finish on top surface of pad, otherwise pad is in good condition (34 Mpa) | | 4 |
| #2 - BFS-02-R1 Recloser | One minor hairline crack that extends down approx. 100mm with less than 1mm separation, and associated alligator cracking also present (44 Mpa). | Type B Repair | 3 |
| #3 - BFS-01-R1 Recloser | Four hairline cracks present (located midway across each edge) that extend down 150mm with less than 1mm separation. Minor alligator cracking and scaling also present on top surface (46 Mpa). | Type B Repair | 2 |
| #4 - BFS-01-BP Structure Low Voltage | Four hairline cracks present (located midway across each edge) that extend down 250mm with approx. 1mm separation (29 Mpa). | Type C Repair | 2 |
| #5 - BFS-T1-DL Structure Low Voltage | Five hairline cracks with approx. separation of cracks 2mm, also alligator cracking present on top surface of pad (34 Mpa). | Type C Repair | 2 |

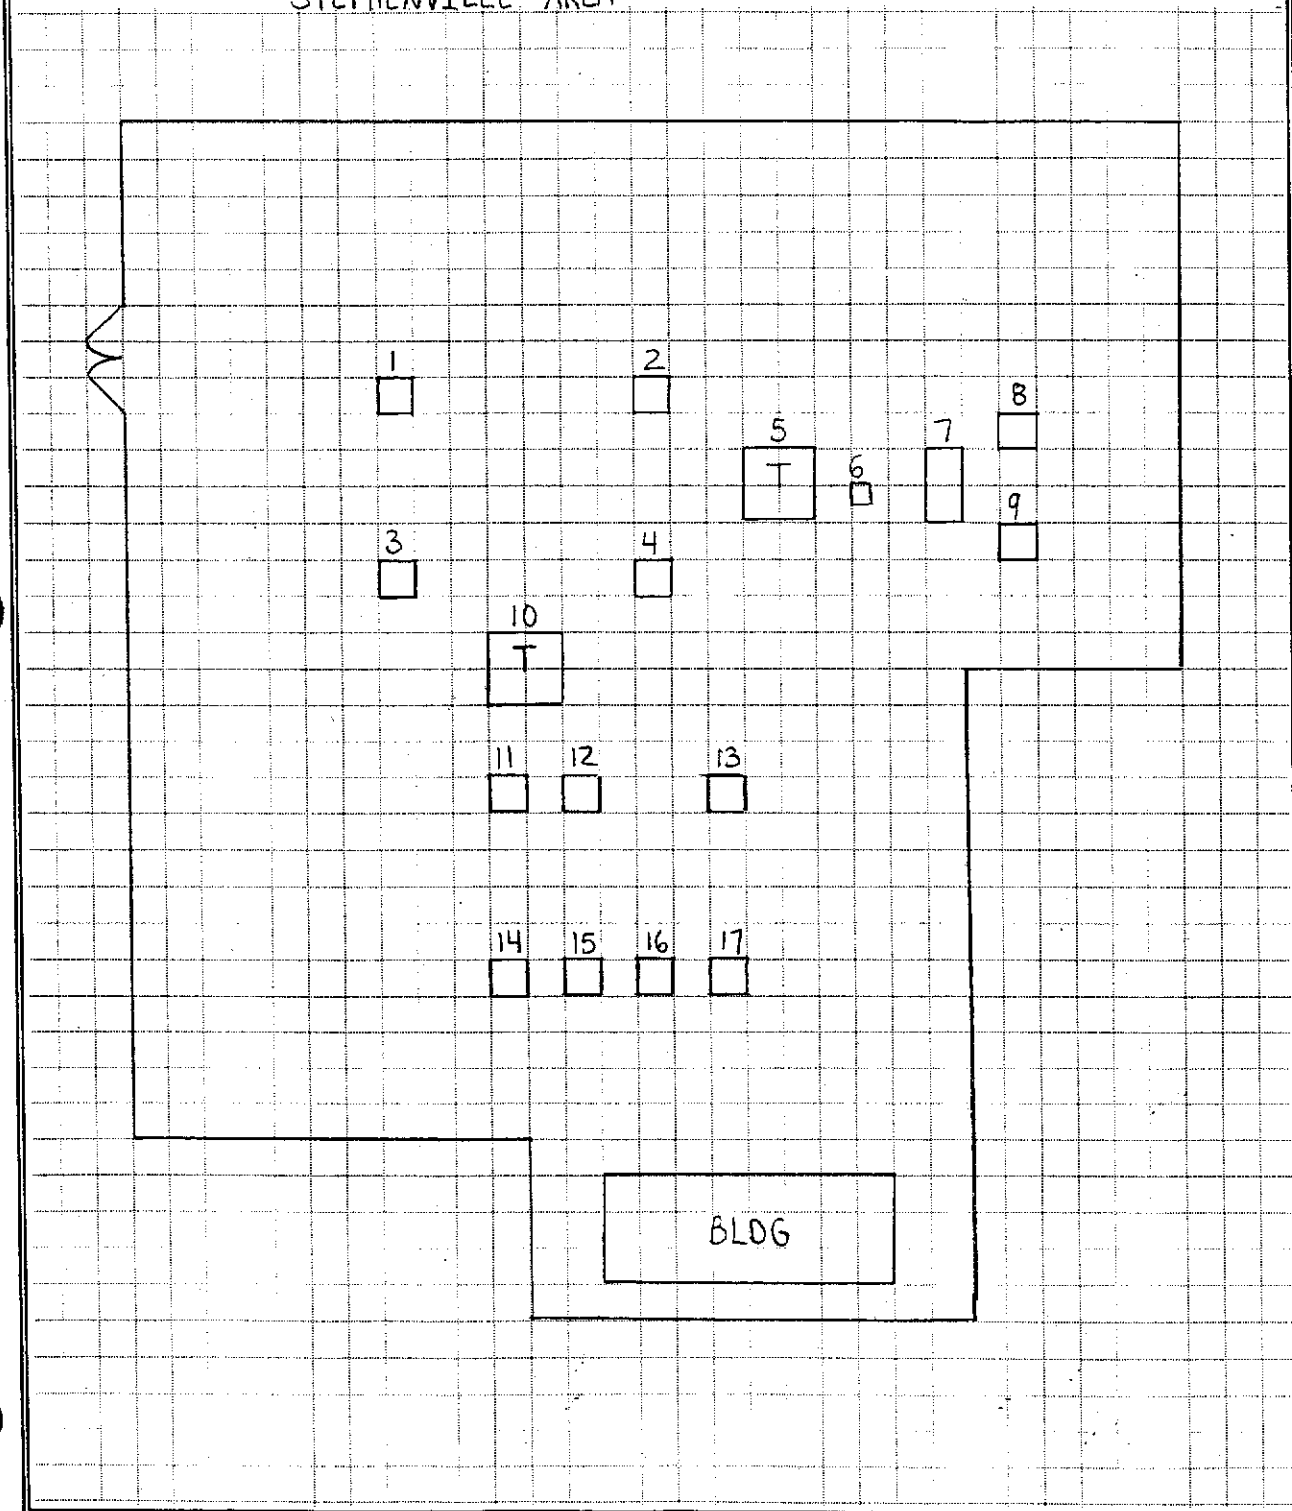
SUBSTATION SITE: ST. GEORGE'S
STEPHENVILLE AREA

| Fdn/Pad Type & No. | General Condition | Recommendations | Priority Rating |
|--|---|--|---|
| #2 - STG-T2-A Structure High Voltage | Rough finish on top surface of pad. Remainder of pad is in good condition (30 Mpa). | | 4 |
| #3 - Structure High Voltage | Rough finish and minor scaling on top surface of pad. One corner of pad seems to have been repaired and remains in good condition (34 Mpa). | Future Monitoring | 4 |
| #4 - STG-T1-A Structure High Voltage | One hairline crack midway across pad that extends down side approx. 150mm and has 2mm separation. Minor scaling on top surface of pad (35 Mpa). | Type C Repair for crack & Type A Repair for scaling. | 2 |
| #5 - T2 Transformer 200218 | Additional section poured alongside original pad. Pad is in good condition (44 Mpa). | | 4 |
| #6 - Structure | Minor pitting on top surface of pad and minor spalling on edges of pad. Remainder of pad is in good condition (36 Mpa). | Type A Repair | 3 |

| Fdn/Pad Type & No. | General Condition | Recommendations | Priority Rating |
|--|---|--|---|
| #7 - STG-403L-B Oil Circuit Breaker | Rough finish on top surface of pad. Otherwise pad is in good condition (26 Mpa). | | 4 |
| #8 - STG-403L-B SYNIZ Breaker | Minor scaling on top part of pad. Remainder of pad is in good condition (34 Mpa). | Future Monitoring | 4 |
| #9 - Structure High Voltage | Good condition (42 Mpa). | | 4 |
| #10 - T1 Transformer 200316 | Rough finish on top surface of pad. Otherwise pad is in good condition (24 Mpa). | | 4 |
| #11 - STG-T1-D Structure Low Voltage | Minor scaling on top surface of pad. One hairline crack that extends from top edge of pad down approx 200mm and has approx. 2mm separation. Remainder of pad is in good condition (28 Mpa). | Type C Repair for crack & Type A Repair for scaling. | 2 |
| #12 - Metering Box Structure | Rough finish and minor scaling on top surface of pad. Otherwise pad is in good condition (31 Mpa). | Future Monitoring | 4 |
