**A Report on the Power Restoration Difficulties on the
Burin Peninsula and the Solutions Proposed to Address Them**

Newfoundland Power Inc.

July 2, 2002

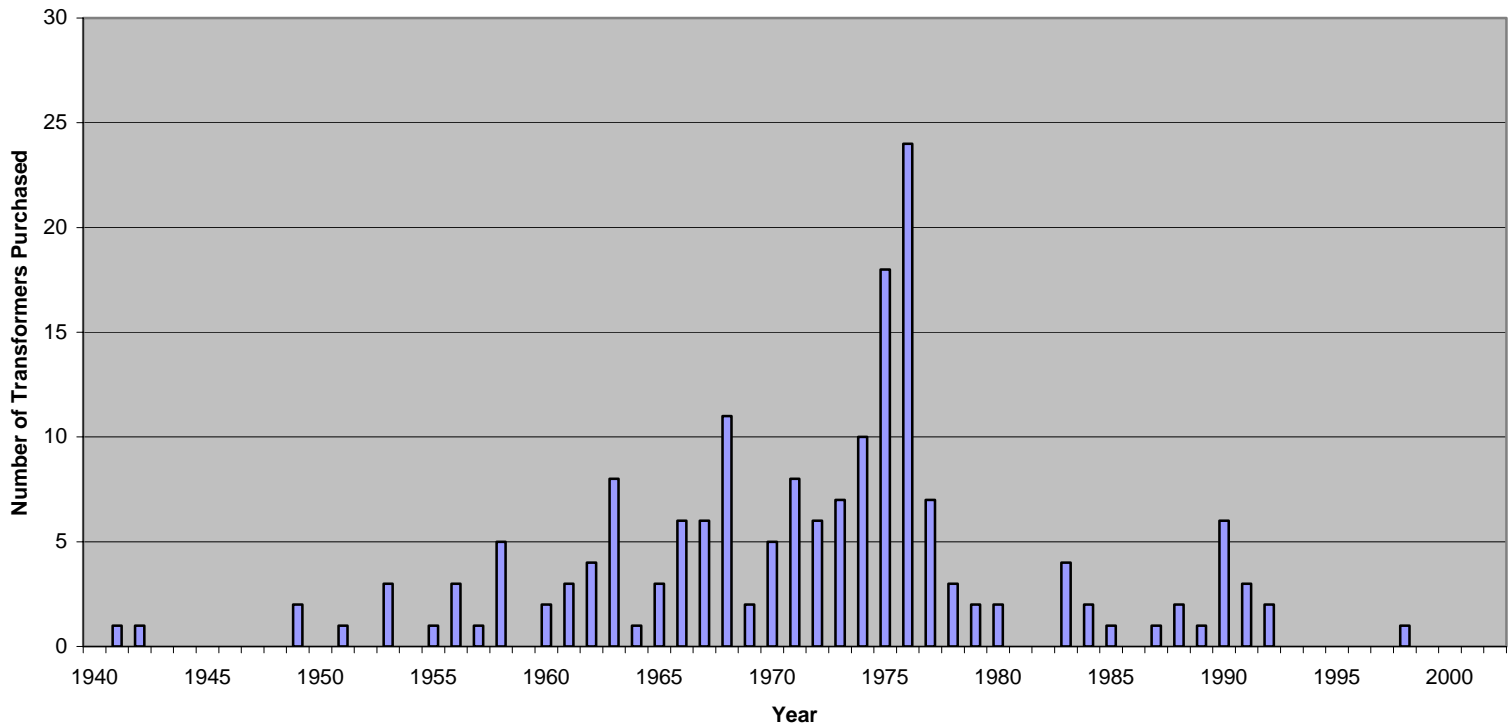
Transformer Purchases 1940-Present
(Spare/Scrapped Transformers not included)

The average purchase date of Newfoundland Power’s system, power and plant transformers is 1971, with 75% of all transformers being purchased between 1960 and 1980. The average purchase date of Newfoundland Power’s large system transformers is 1974, with all being purchased between 1967 and 1984.

Industry experience indicates that given the age of our transformer stock, we can expect to see an increasing failure rate of transformers in the coming years. A recent paper, “Failure History of Transformers – Theoretical Projections for Random Failures”, by William H. Bartley, P.E., 2001; reviews the U.S. past and probable future experience with transformer life. The author notes that under ideal conditions a transformer can be expected to last between 30 and 40 years. He also indicates that under practical conditions, many do not last that long. For example, in his modeling of data he posits that failure rates of 1972 vintage transformers should over take failure rates of 1964 transformers in 2006, indicating that increasingly there are fewer 1964 vintage transformers in the system due to failure, and that increasing numbers of 1972 transformers are failing. For Newfoundland Power, given the age profile of its transformers, this means that more of these transformers can be expected to fail than we have experienced in the past. It also means that Newfoundland Power must plan to accommodate these increased transformer failure rates if it is to maintain a reasonable quality of service for its customers.
