**Newfoundland Power Inc.
2005 Capital Budget Application
Filing Contents**

**Volume I
Application**

**Volume II
Expenditure Details, Reports and Studies**

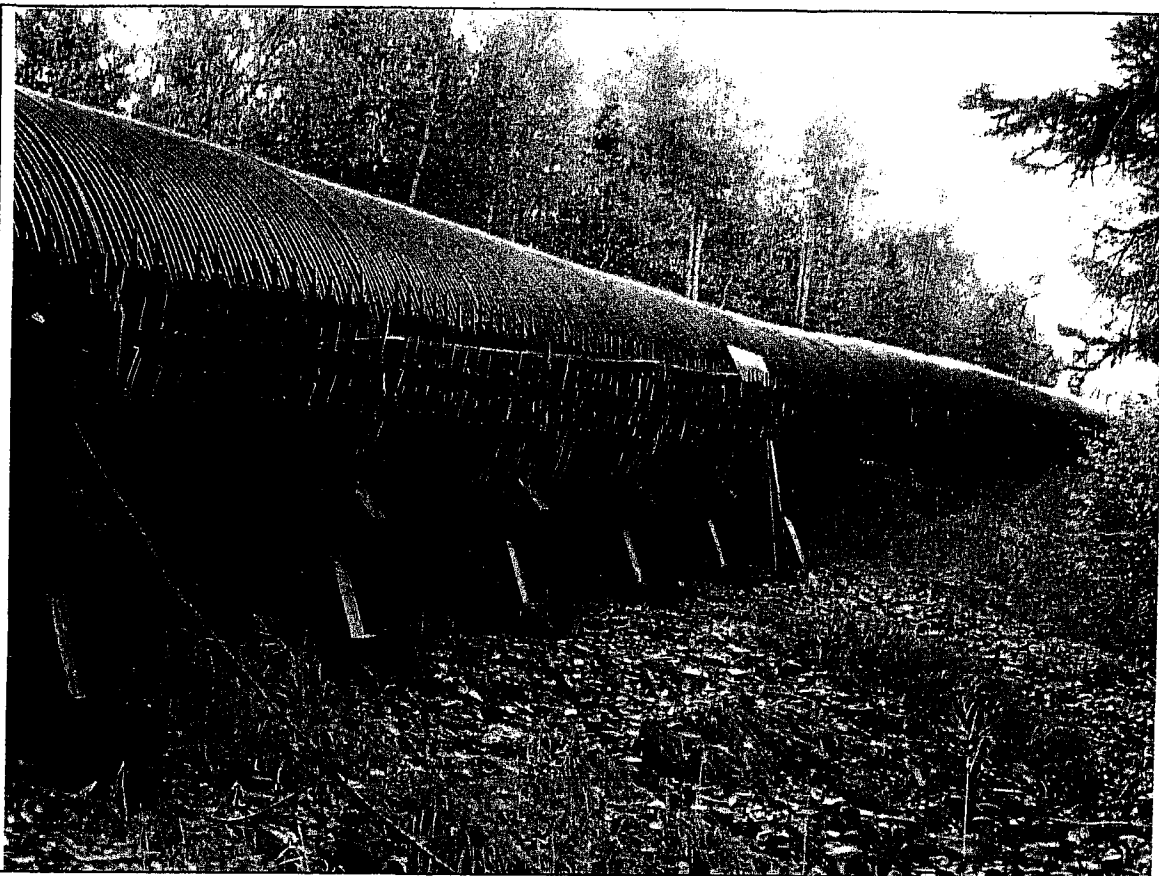
15. Wood stave penstock typical patch plate location marking.

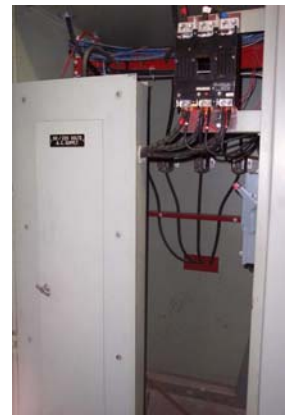
The existing 120/240V 3-phase AC service panel is located in a cell in the existing switchgear line up. This equipment is original to the plant and replacement breakers are no longer available. With additional loading from the proposed plant upgrading and the addition of new heating and ventilating equipment, this panel will no longer have sufficient capacity. It is preferred to locate the AC panel remote from the switchgear line up to provide ease of access for wiring future circuits.

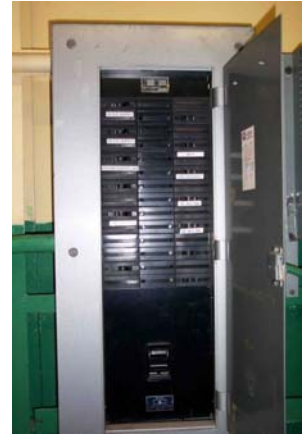
The DC distribution panel is original to the plant. Additional circuit breakers will be required to protect the DC control circuits for the various electronic components to be included in the governor and unit control panels. Due to its age, additional circuit breakers for this panel are no longer available. Insufficient spare locations exist in the panel to accommodate the additional circuits requiring the installation of an additional panel. It is recommended that the DC distribution panel be replaced with one adequate for the additional DC powered equipment.

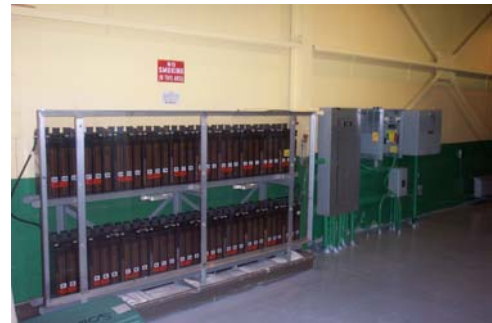
The battery bank was installed in 1996 and is in good condition. The battery charger was installed in 1984. Its condition will be assessed and replacement considered. The concern to be addressed with the battery system is that the battery bank and the charger are located in the same room as the switchgear. This situation contravenes the Canadian Electrical Code and needs to be addressed. The plant refurbishment must include the construction of a separate battery room meeting CSA standards to house the battery bank.

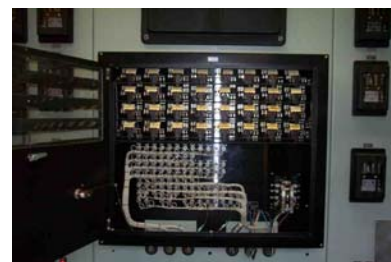
The annunciator panel located in the switchgear line-up is original to the plant. It is a mechanical unit where metal targets drop down to annunciate an alarm. There are numerous targets no longer operational. With the installation of unit control panels equipped with human machine interfaces (HMI's), this device will be redundant and can be removed.

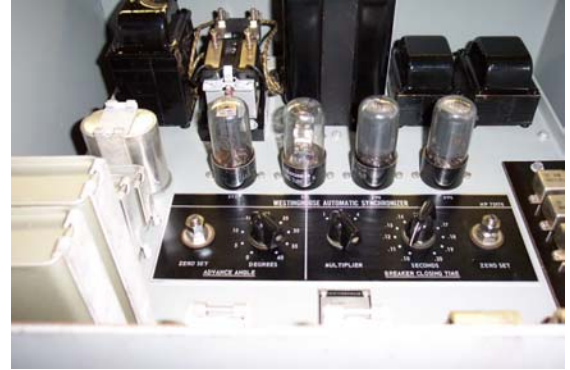
The vacuum tube synchronizer design is original to the 1958 plant construction. The fact that the synchronizer is constructed from vacuum tube technology means that parts are no longer available. Within Newfoundland Power, no expertise exists in the maintenance of this device. It will be replaced with a modern synchronizer as part of the upgraded unit control panel.

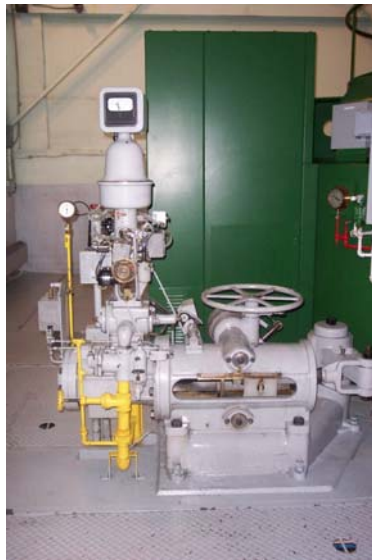
Unit #1 Governor Control
And Wicket Gate Actuator

These governors are a key component in regulating the speed of the generators and the quality of the power delivered by the plant. Due to the fact that they are 46 years old and difficult to maintain due to availability of spare parts and due to the fact that there is unnecessary movement in regular operating components as noted above, it is recommended that the hydraulic control head on each unit be replaced with an electro-hydraulic control head.

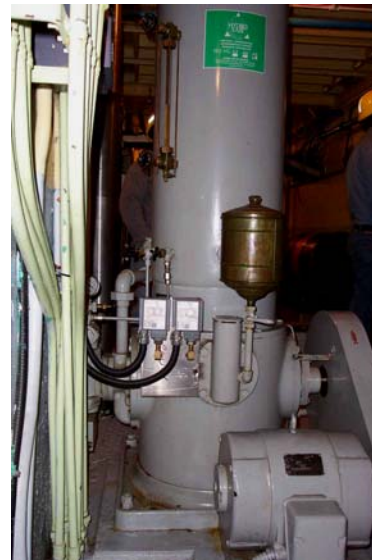
Unit #1 Oil Accumulator
And Governor Oil Pump

The pumping units are in relatively good condition, with no major oil leaks. However, the packings leak and should be replaced. The units still maintain proper operating pressure and accumulator air volume.
