2
3 **Rattling Brook Hydro Plant Refurbishment (Clustered) - \$18,242,000**

4 **PUB 10.0 NP**

Maintenance Logs for Rattling Brook Plant
2003 to 2006

2005 Dam Safety Inspection Report

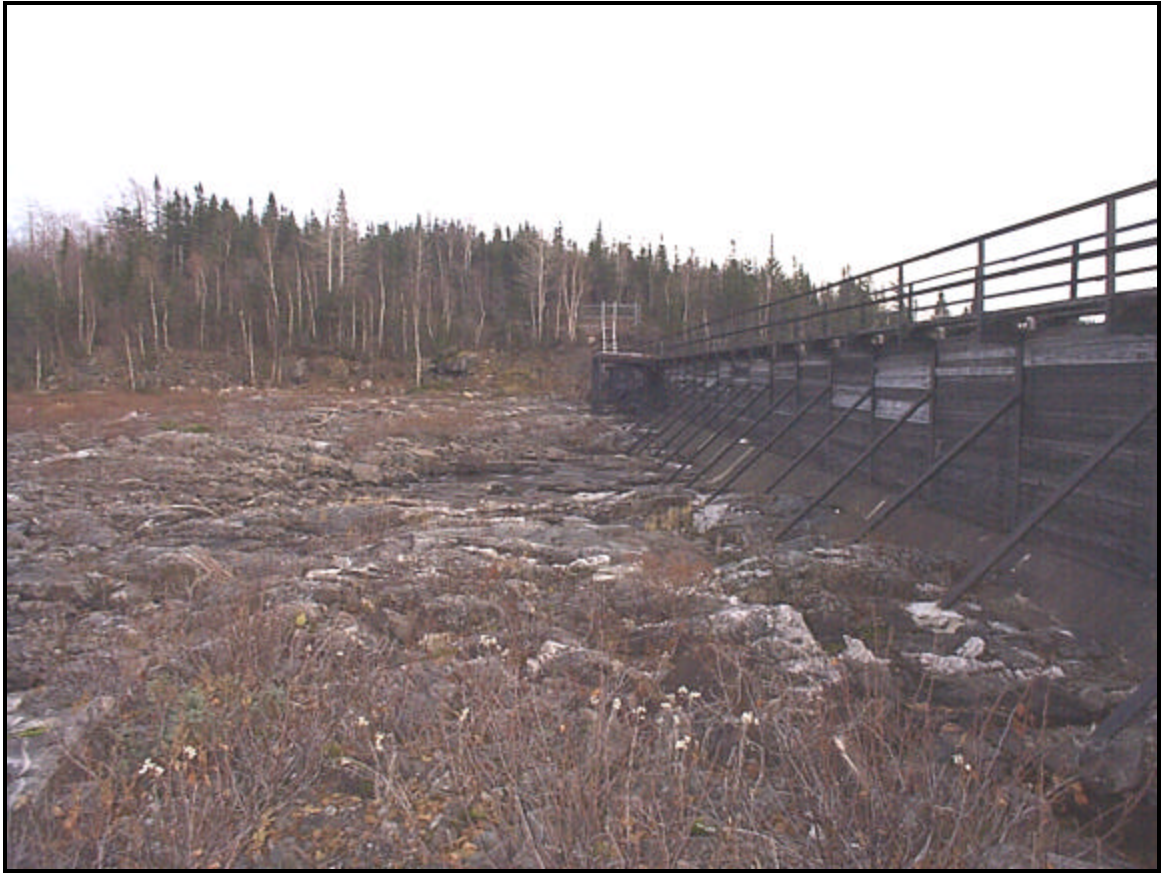
No unusual conditions. Good rockfill transition from natural abutments to embankment dam.

No unusual conditions. No vegetation. Good protection is provided by the upstream rockfill crestwall.

None observed.

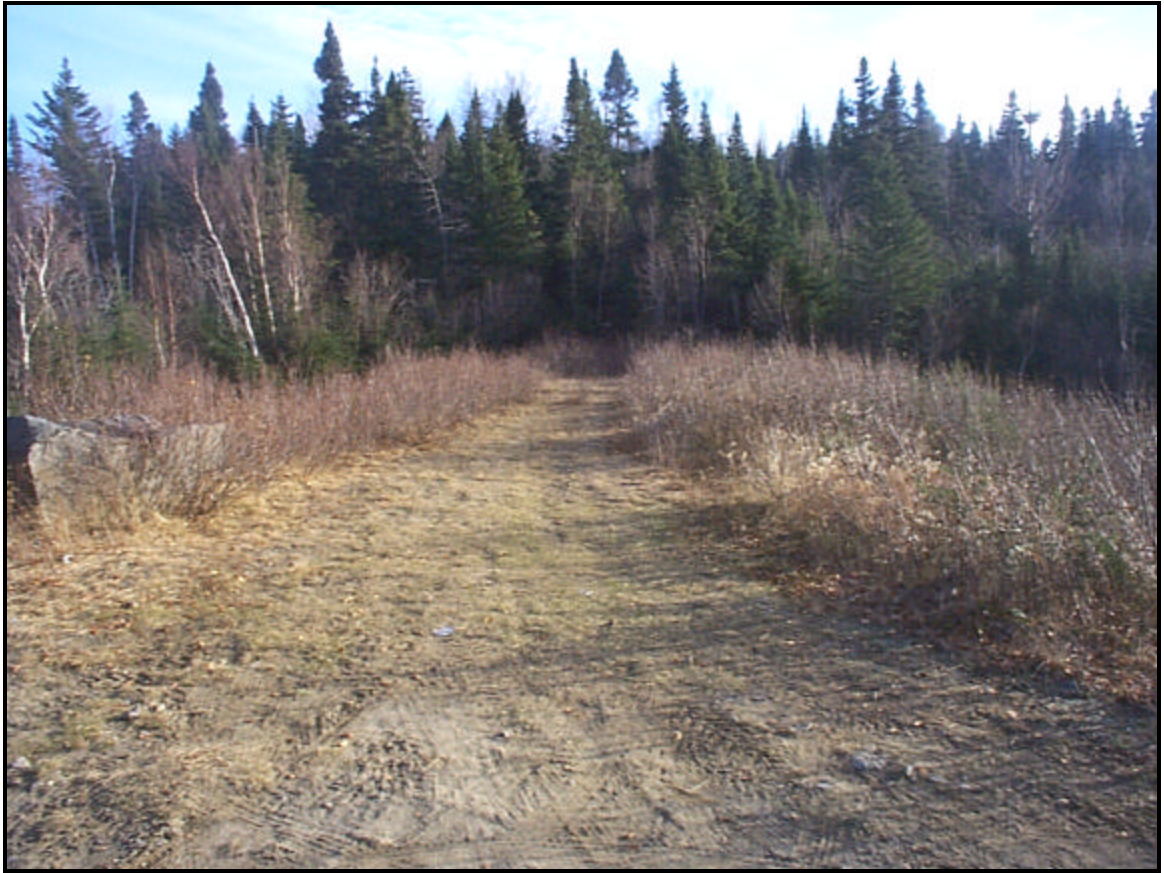
Vegetation has been cleared, but continues to be a maintenance issue. No unusual conditions.

One area of still/ponded water is evident at the downstream toe. No seepage is observed along the downstream slope.

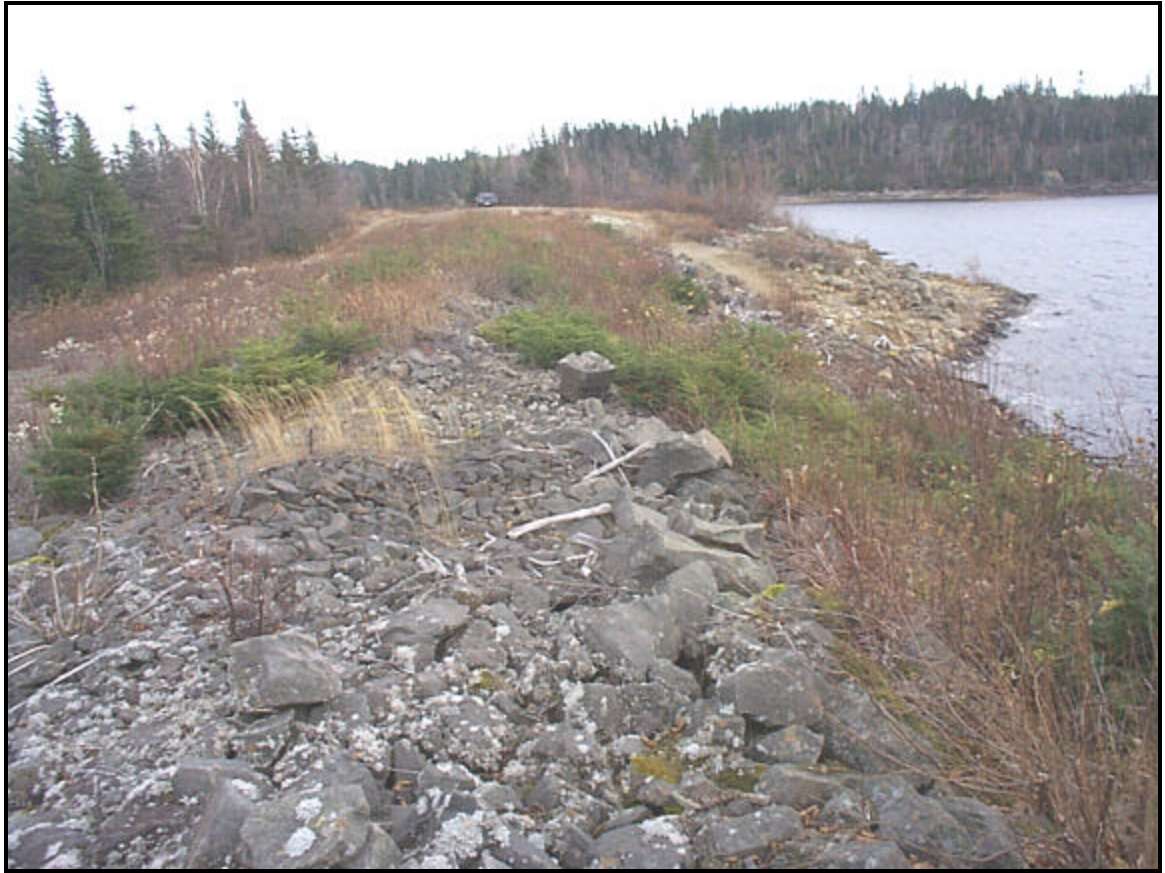
Good. No unusual conditions.

No unusual conditions. Minor/insignificant amount of grassy vegetation. No evidence of overtopping.
