Root Cause Analysis Report

Bay d'Espoir Penstock No. 1 Refurbishment

H352666-00000-220-066-0002 Rev. F March 17, 2017

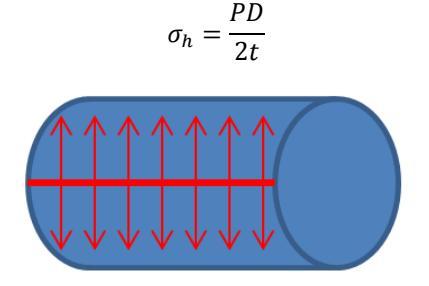
Longitudinal seams are more susceptible to failure due to higher stresses.

The stress in longitudinal weld seams is known as the "hoop stress". The "hoop stress" ( $\sigma_h$ ) is dependent upon the pressure (P), diameter (D) and wall thickness (t).

Figure 3-6: "Hoop Stress" Pulls Longitudinal Seams Apart

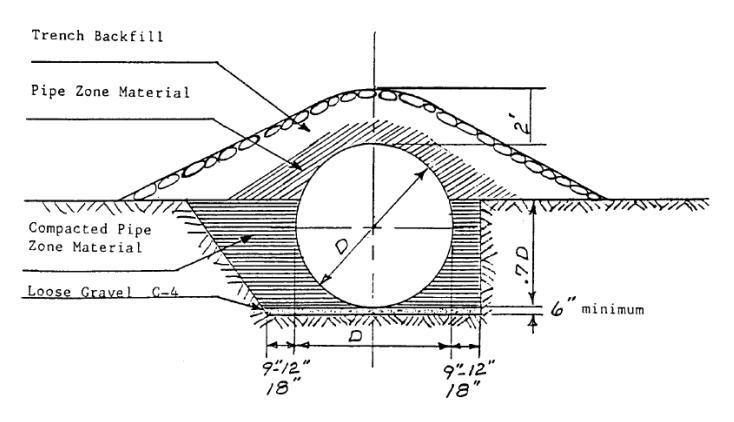
Figure 3-9: Typical Half Trench

When analyzing the backfill it was determined that backfill is structurally integral to the penstock and provides needed support along the center line. In the area where the penstock cracks occurred, the depth of backfill is less than 2 ft and some sliding and sloughing of the backfill has occurred. This has been shown to increase the stress level by approximately 100% in the area of longitudinal welds locations. Refer to the finite element stress analysis completed for the backfilling of the excavated areas in Appendix G.

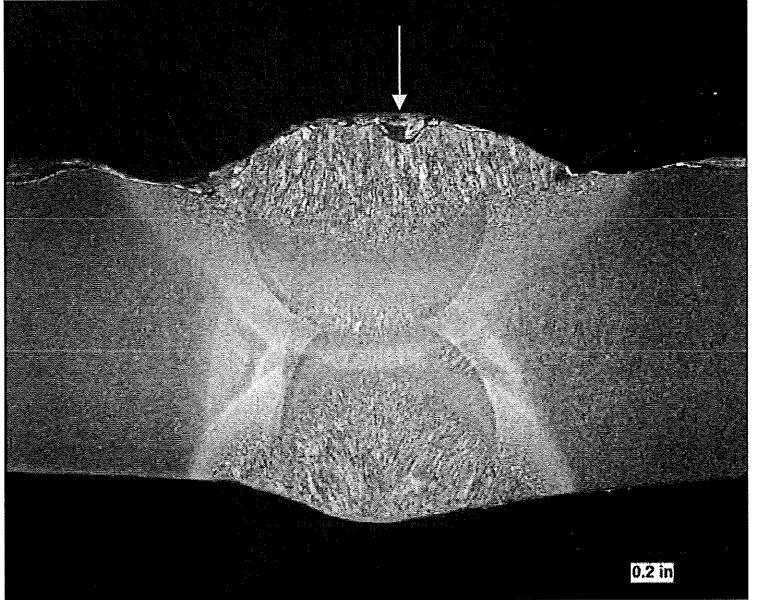
Section 1: Examination of the specimen showed that the weld had discontinuities at both toes and porosity on the face on one side of the weld (refer to Figure 2). At higher magnification, the discontinuities at the toes of the weld were revealed to be cracks propagating along the fusion line of the weld (refer to Figure 3). The weld appeared to have no undercut or inclusions, and there was complete penetration and complete fusion observed throughout the weld.

Figure 2: Photomacrograph of the Section 1, which had discontinuities at both toes (red arrows) and porosity (yellow arrow) on the face on one side of the weld.

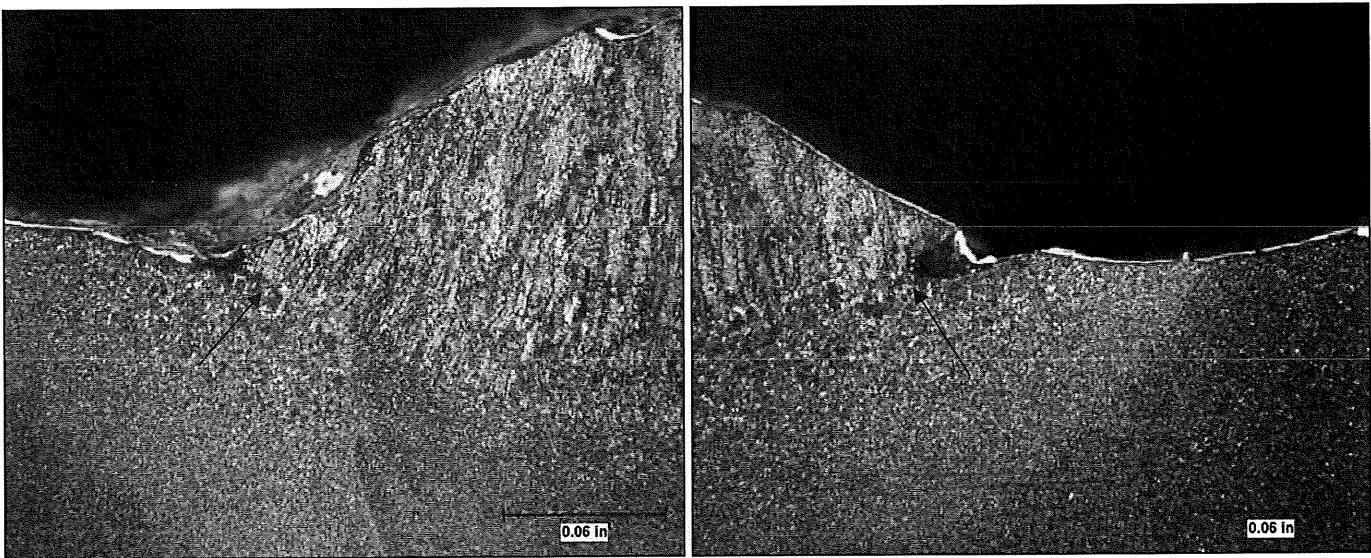
Figure 3: Photomacrographs of the Section 1. The discontinuities at the toes of the weld were revealed to be cracks propagating along the fusion line of the weld (red arrows).

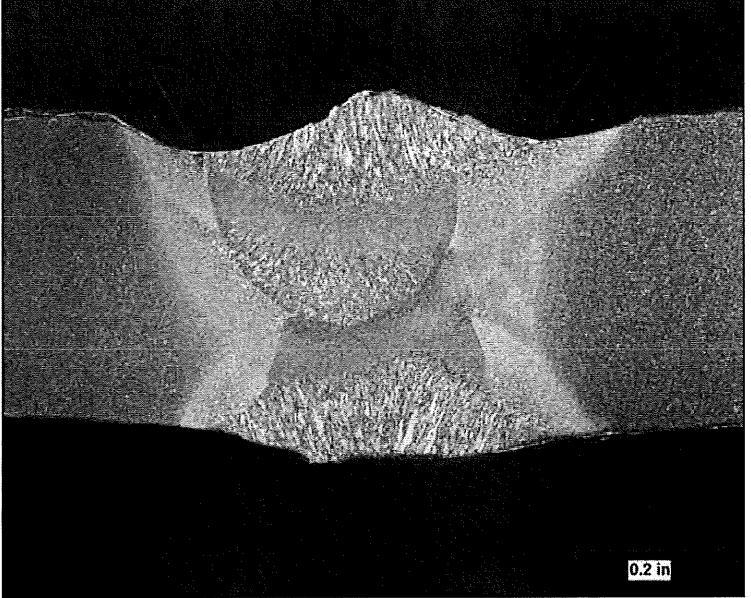
Section 2: Examination of the specimen showed that the weld had discontinuities at both toes on one side of the weld (refer to Figure 4). At higher magnification, the discontinuities at the toes of the weld were revealed to be cracks propagating along the fusion line of the weld (refer to Figure 5). The weld appeared to have no porosity, undercut or inclusions, and there was complete penetration and complete fusion observed throughout the weld.

Figure 4: Photomacrograph of the Section 2, which had discontinuities at both toes (red arrows) on one side of the weld.
#### NP-NLH-003, Attachment 1 Page 36 of 157, Refurbishment of Bay d'Espoir Penstock 2 and Unit 3 Turbine Major Overhaul

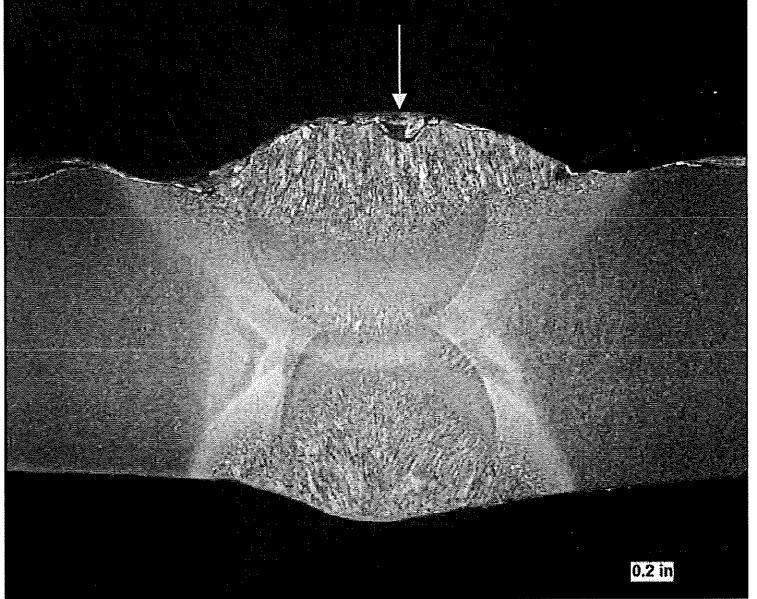
Section 1: Examination of the specimen showed that the weld had discontinuities at both toes and porosity on the face on one side of the weld (refer to Figure 2). At higher magnification, the discontinuities at the toes of the weld were revealed to be cracks propagating along the fusion line of the weld (refer to Figure 3). The weld appeared to have no undercut or inclusions, and there was complete penetration and complete fusion observed throughout the weld.

Figure 2: Photomacrograph of the Section 1, which had discontinuities at both toes (red arrows) and porosity (yellow arrow) on the face on one side of the weld.

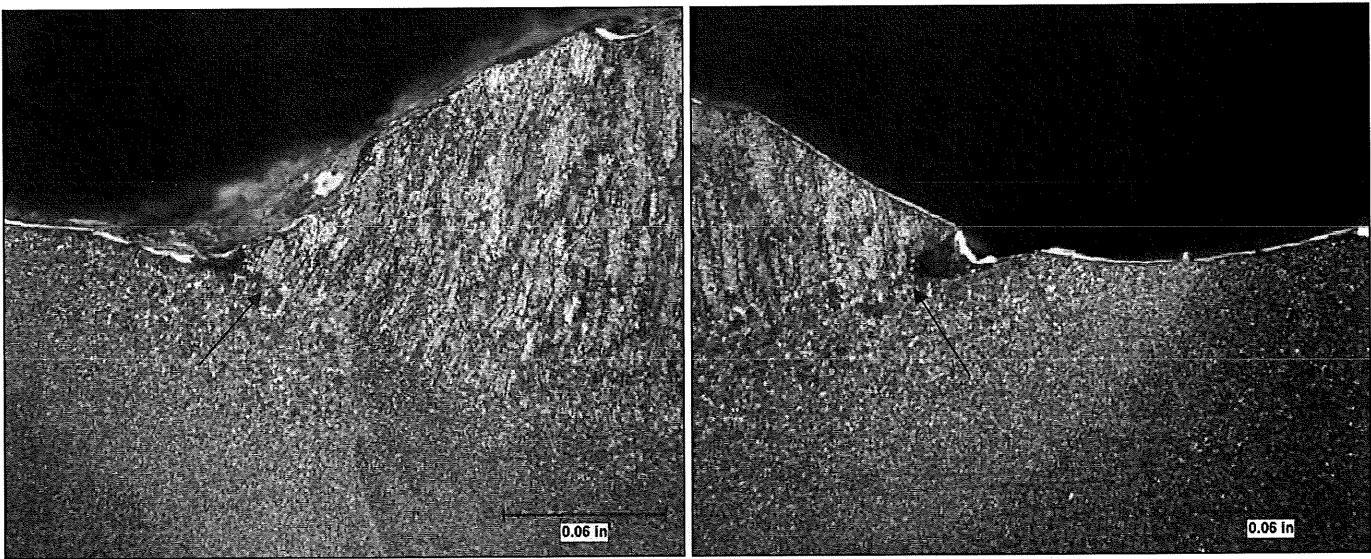
Figure 3: Photomacrographs of the Section 1. The discontinuities at the toes of the weld were revealed to be cracks propagating along the fusion line of the weld (red arrows).

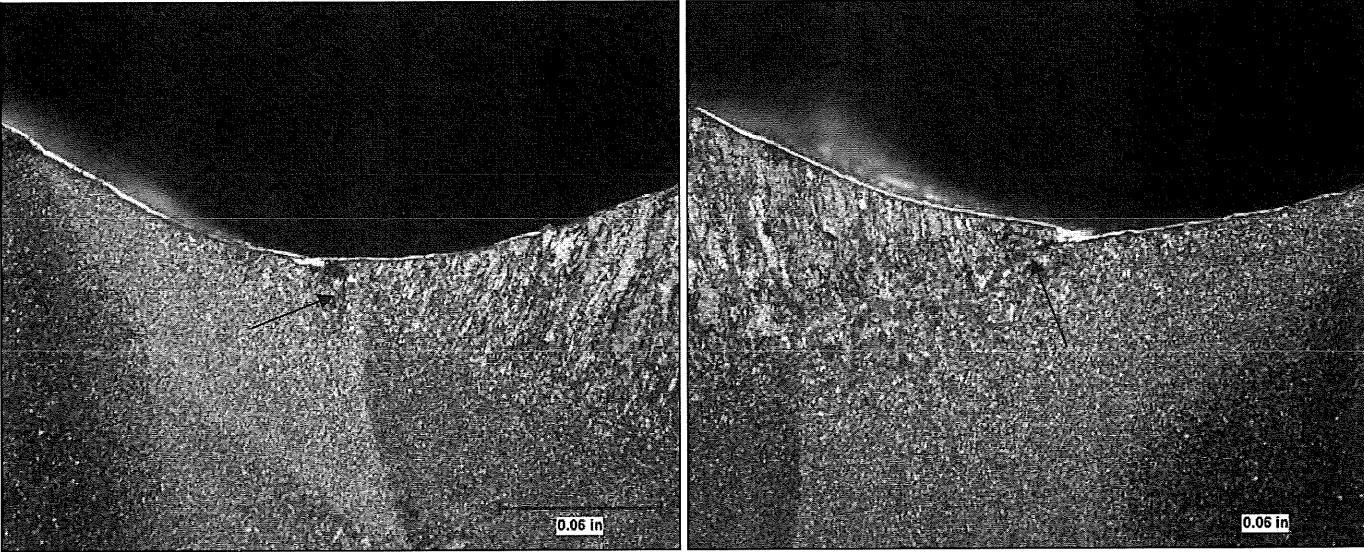
Figure 5: Photomacrographs of the Section 2. The discontinuities at the toes of the weld were revealed to be cracks propagating along the fusion line of the weld (red arrows).

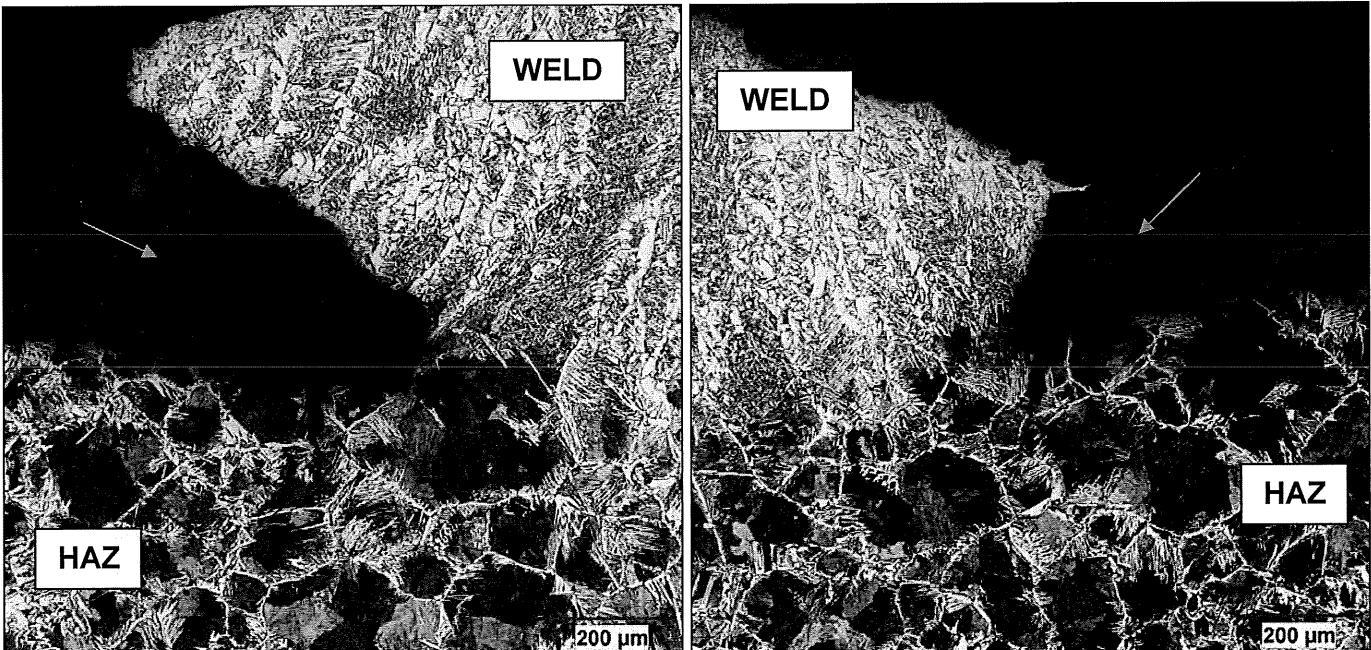
Figure 1: Photomicrographs of the Section 1 weld coupon at the "FL" locations. Transgranular cracks (red arrows) propagated through the HAZ of the weld from cavities located at the both toes on the face of the weld. Both cavities were filled with corrosion product (green arrows). The HAZ microstructure at the toe of the weld consisted of relatively coarse-grained pearlite with intergranular ferrite. The weld microstructure consisted of columnar ferrite and pearlite.

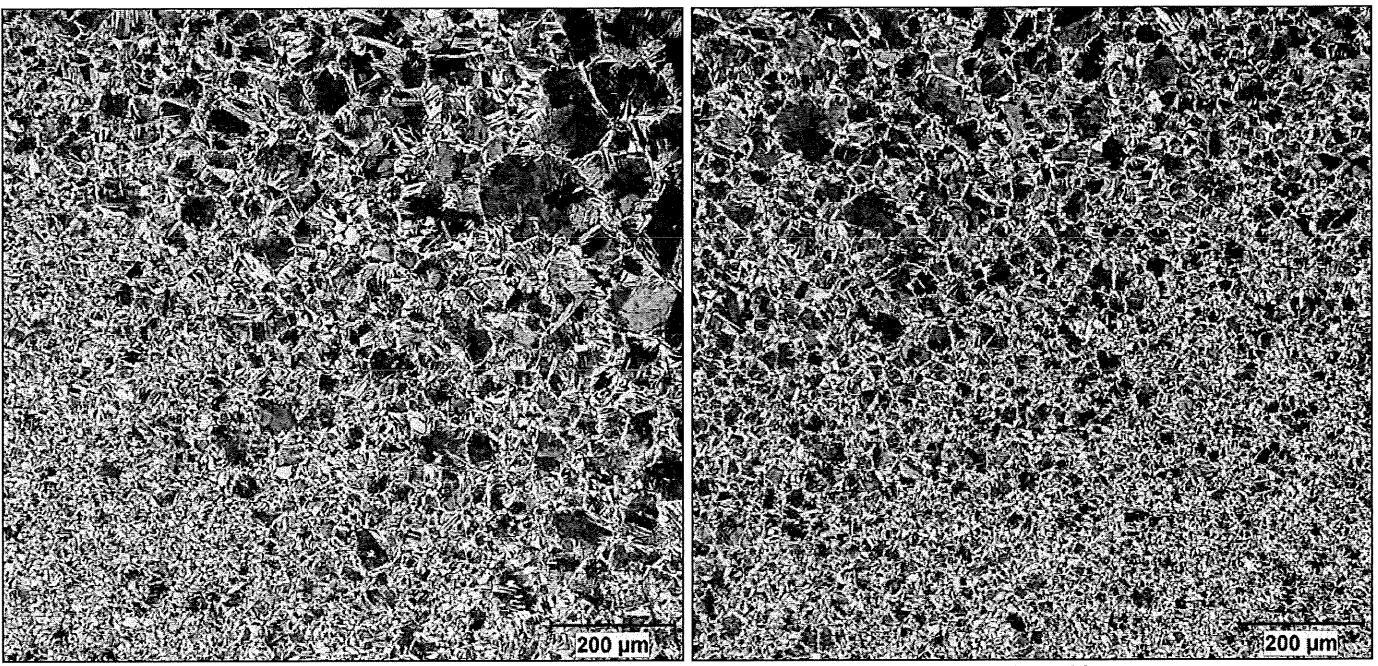
Figure 2: Photomicrographs of the Section 1 weld coupon at the "FL +1" locations, where the HAZ microstructure was a heterogeneous mixture of ferrite and pearlite, with a more refined grain size.

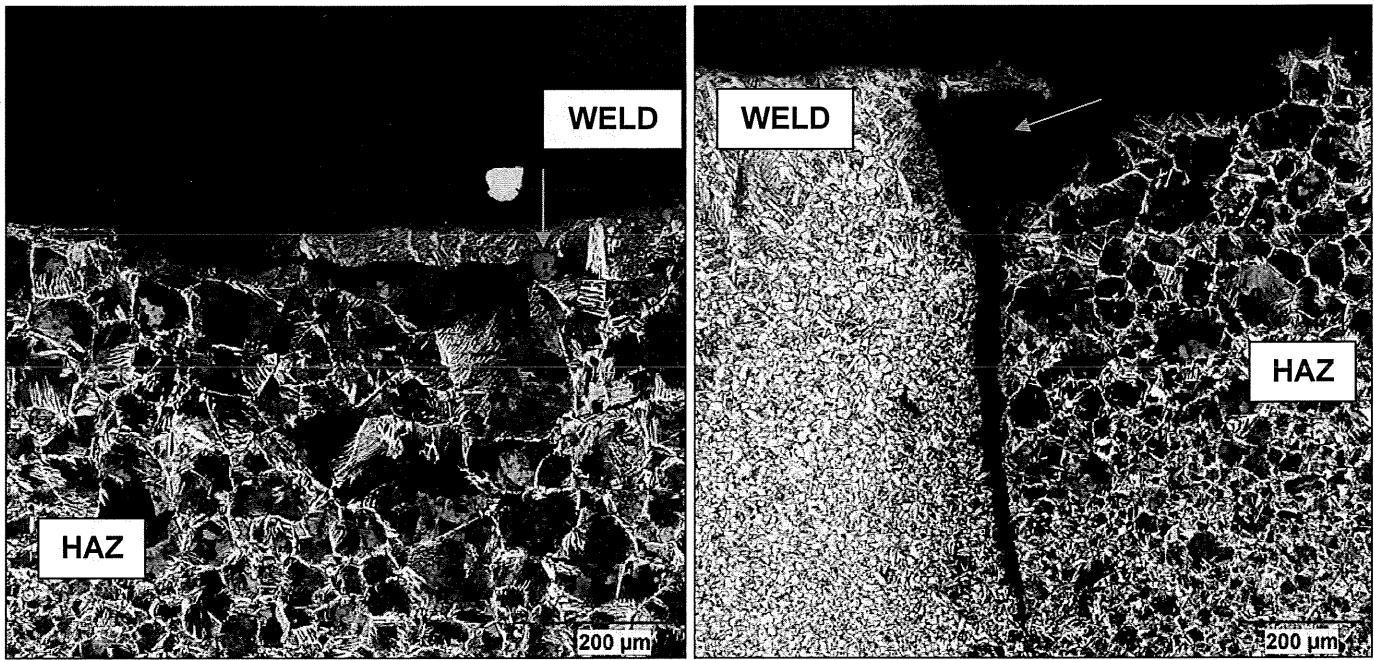
Figure 3: Photomicrographs of the Section 2 weld coupon at the "FL" locations. Transgranular cracks (red arrows) propagated through the HAZ of the weld from a cavity located at one toe on the face of the weld (right), and from an overlap at the other toe on the face of the weld (left). The cavity was filled with corrosion product (green arrow, right). An inclusion was observed within the overlap (green arrow, left). The HAZ microstructure at the toe of the weld consisted of relatively coarse-grained pearlite with intergranular ferrite. The weld microstructure consisted of columnar ferrite and pearlite.

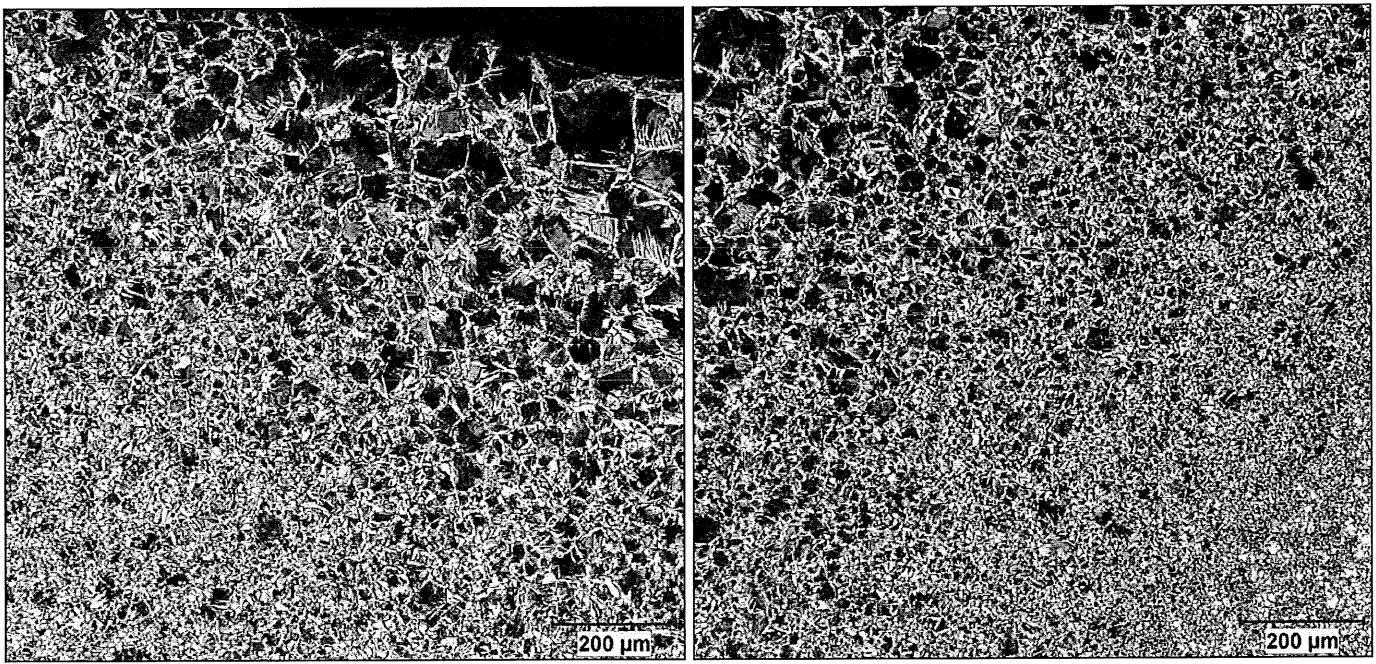
Figure 4: Photomicrographs of the Section 2 weld coupon at the "FL +1" locations, where the HAZ microstructure was a heterogeneous mixture of ferrite and pearlite, with a more refined grain size.

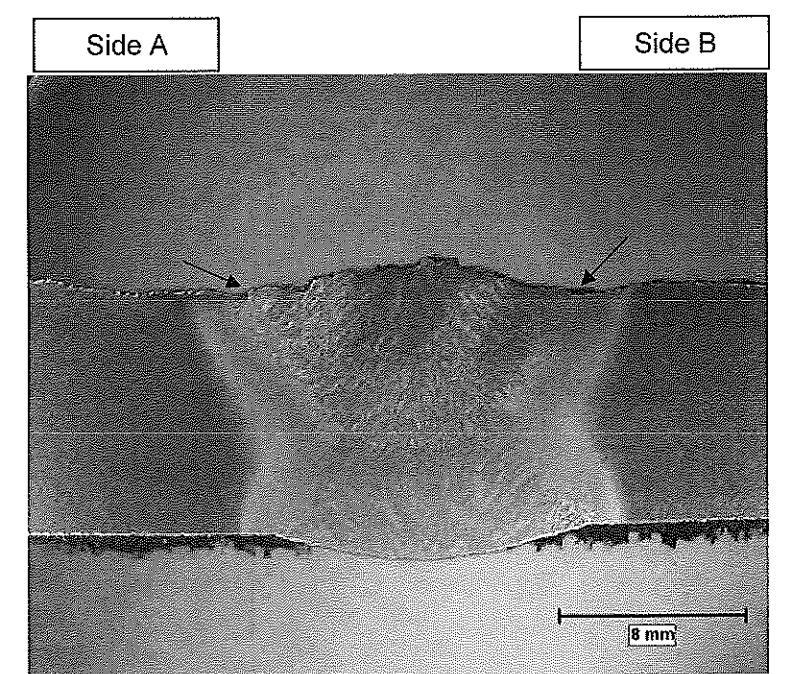
Figure 2: Photomacrograph of the Section 1, showing the pitting along the surface within the HAZ/at the weld toes along the inside diameter.

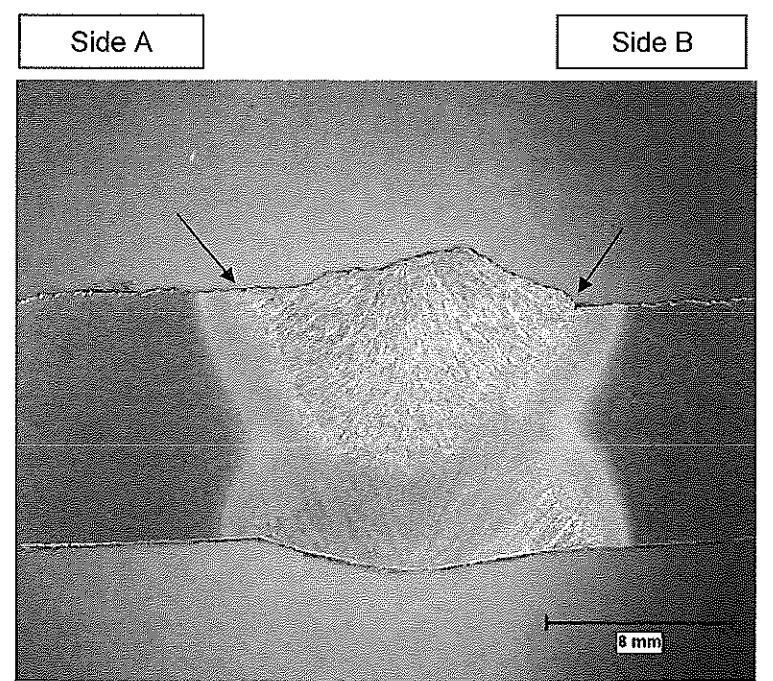
**Section 2:** Examination of the specimen showed that the weld had pitting along the inside diameter surface within the HAZ (at the weld toes) (refer to Figure 3). The weld appeared to have no cracks or inclusions, and there was complete penetration and complete fusion observed throughout the weld.

Figure 3: Photomacrograph of the Section 2, showing the pitting along the surface within the HAZ/at the weld toes along the inside diameter.

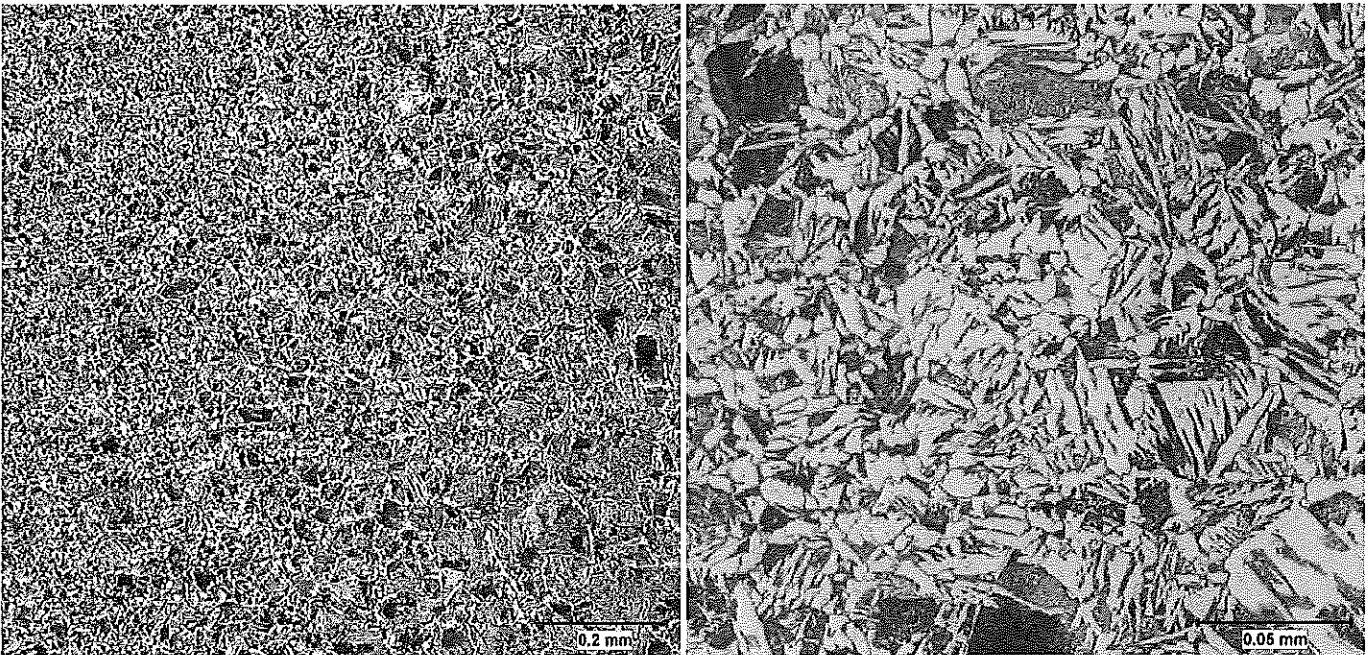
Figure 4: Photomicrographs of the Section 1 "Side A" weld coupon at the "FL" location, where a relatively coarse grain HAZ of ferrite and pearlite was observed.

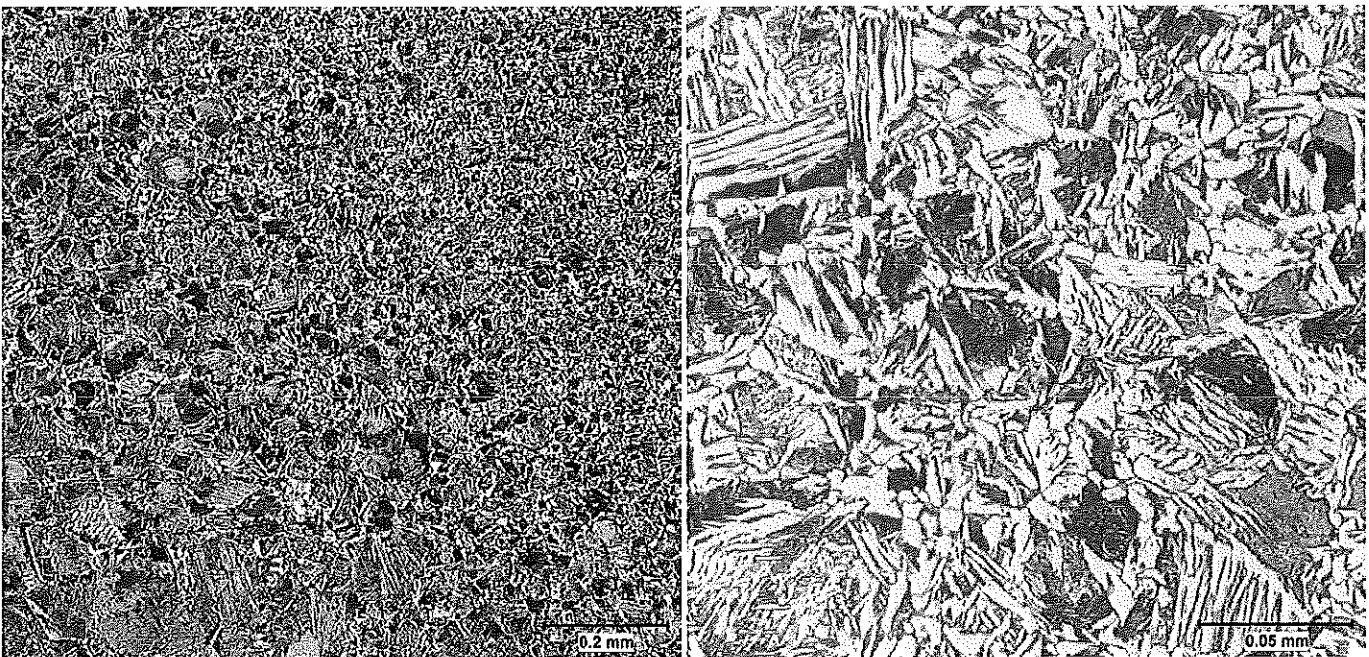
Figure 5: Photomicrographs of the Section 1 "Side B" weld coupon at the "FL" location, where a relatively coarse grain HAZ of ferrite and pearlite was observed.

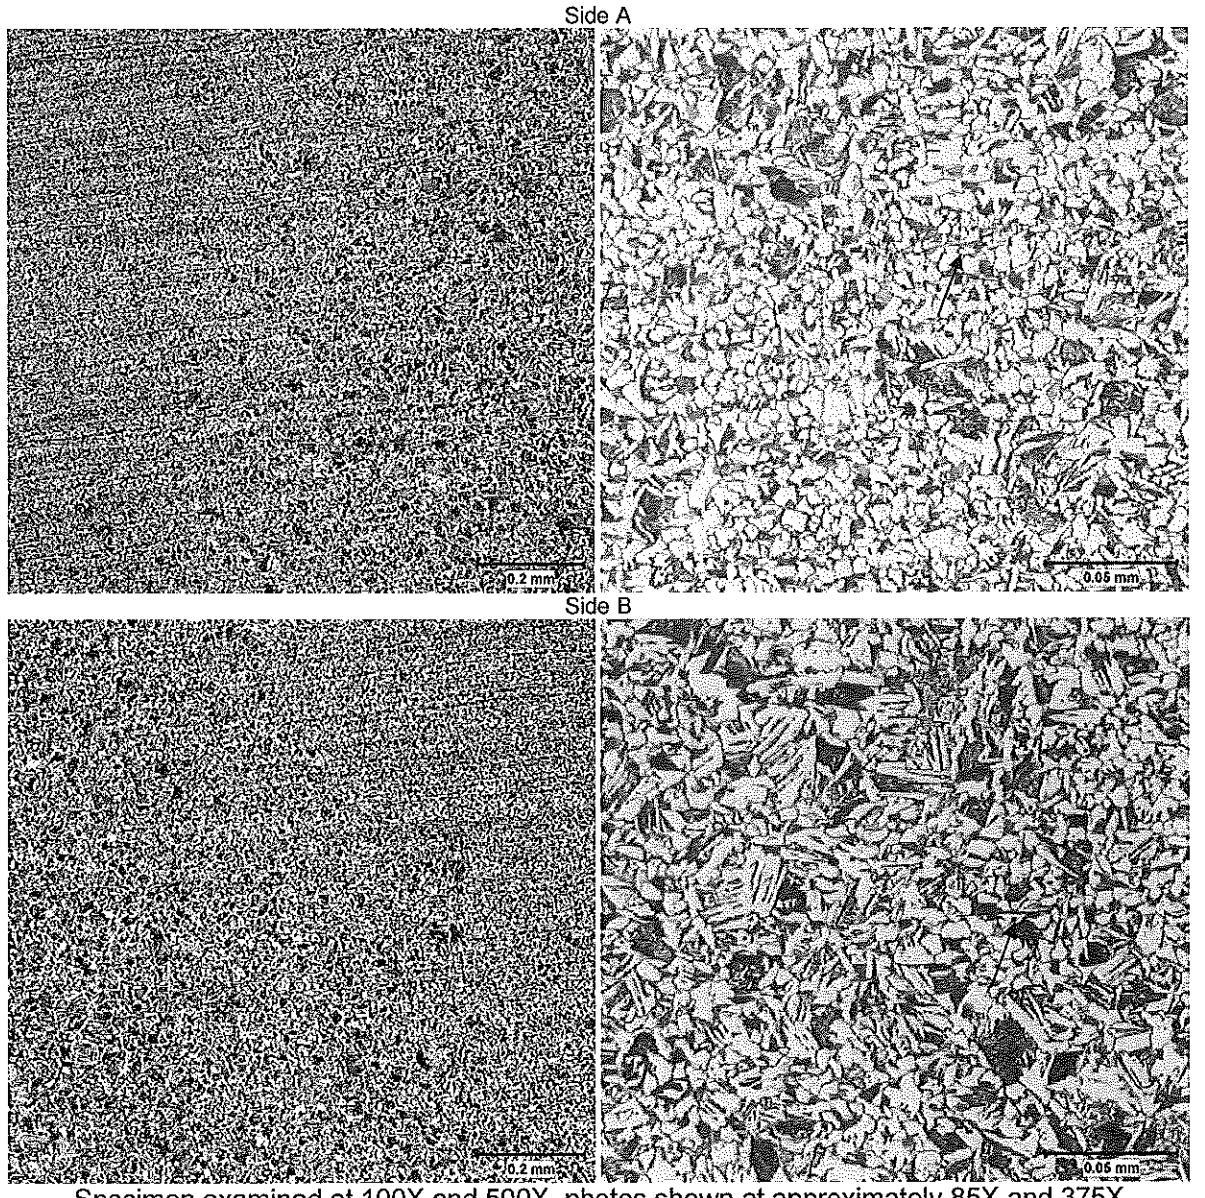
**Section 1:** Examination of the etched specimen revealed a microstructure consisting of ferrite and pearlite. A relatively coarse grain HAZ was observed on either side of the weld at the "FL" locations (refer to Figure 4 and Figure 5). At the "FL+1mm" locations, the HAZ showed a more refined structure consisting of a fairly uniform mixture of ferrite and pearlite. At a higher magnification some sulphide inclusions were observed dispersed throughout the material (refer to Figure 6).

Figure 6: Photomicrographs of the Section 1 "Side A" and "Side B" weld coupon at the "FL +1" locations; where the HAZ microstructure showed a fairly uniform mixture of ferrite and pearlite, with a more refined grain size. At a higher magnification some sulphide inclusions were observed (refer to red arrows).

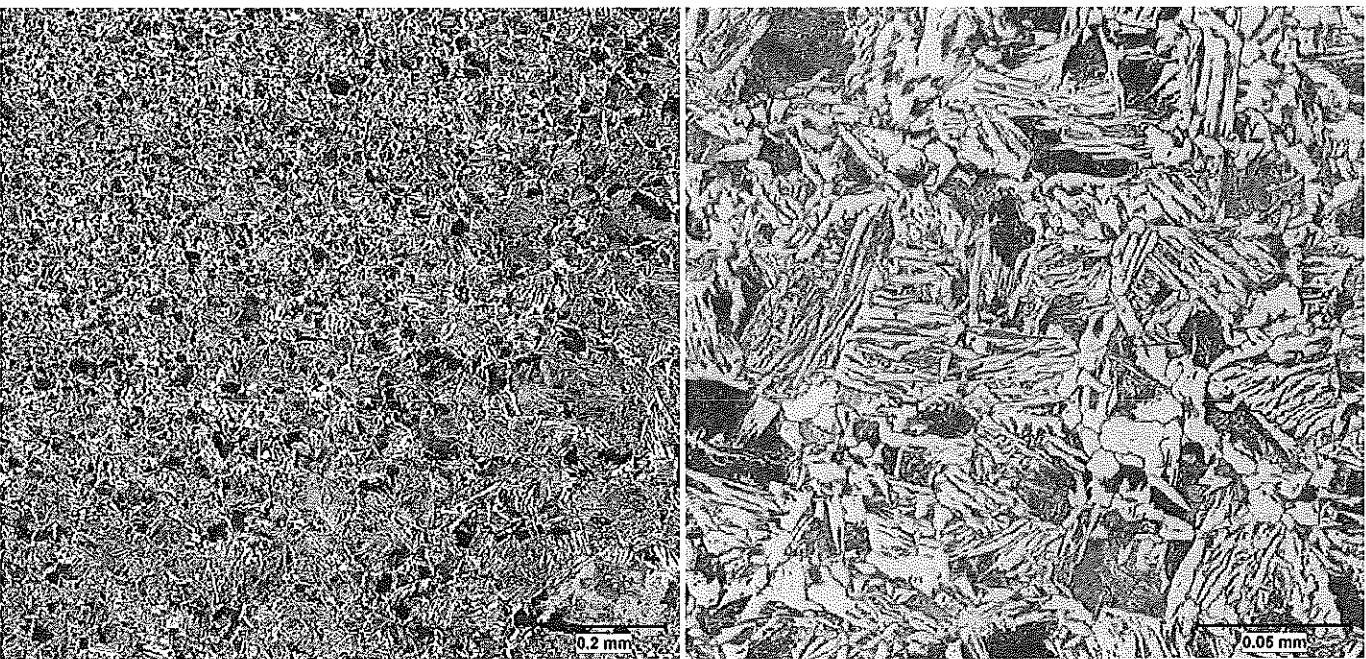
Figure 7: Photomicrographs of the Section 2 "Side A" weld coupon at the "FL" location, where a relatively coarse grain HAZ of ferrite and pearlite was observed.

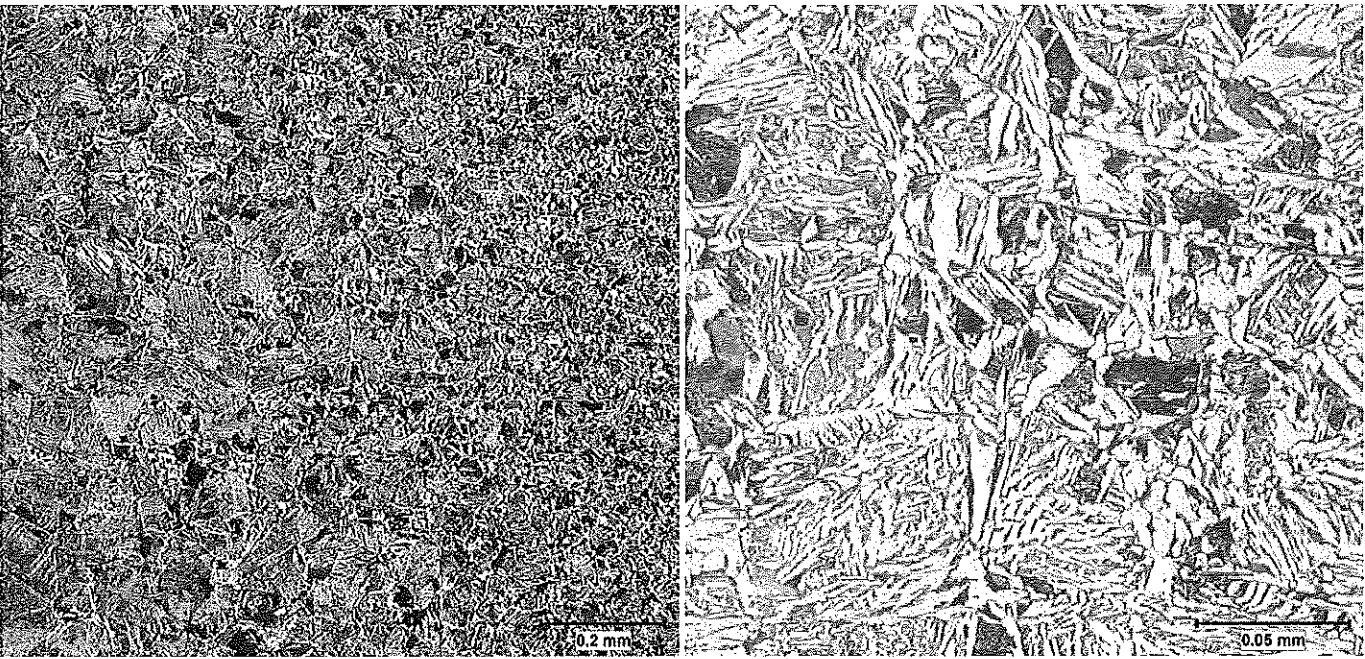
Figure 8: Photomicrographs of the Section 2 "Side B" weld coupon at the "FL" location, where a relatively coarse grain HAZ of ferrite and pearlite was observed.

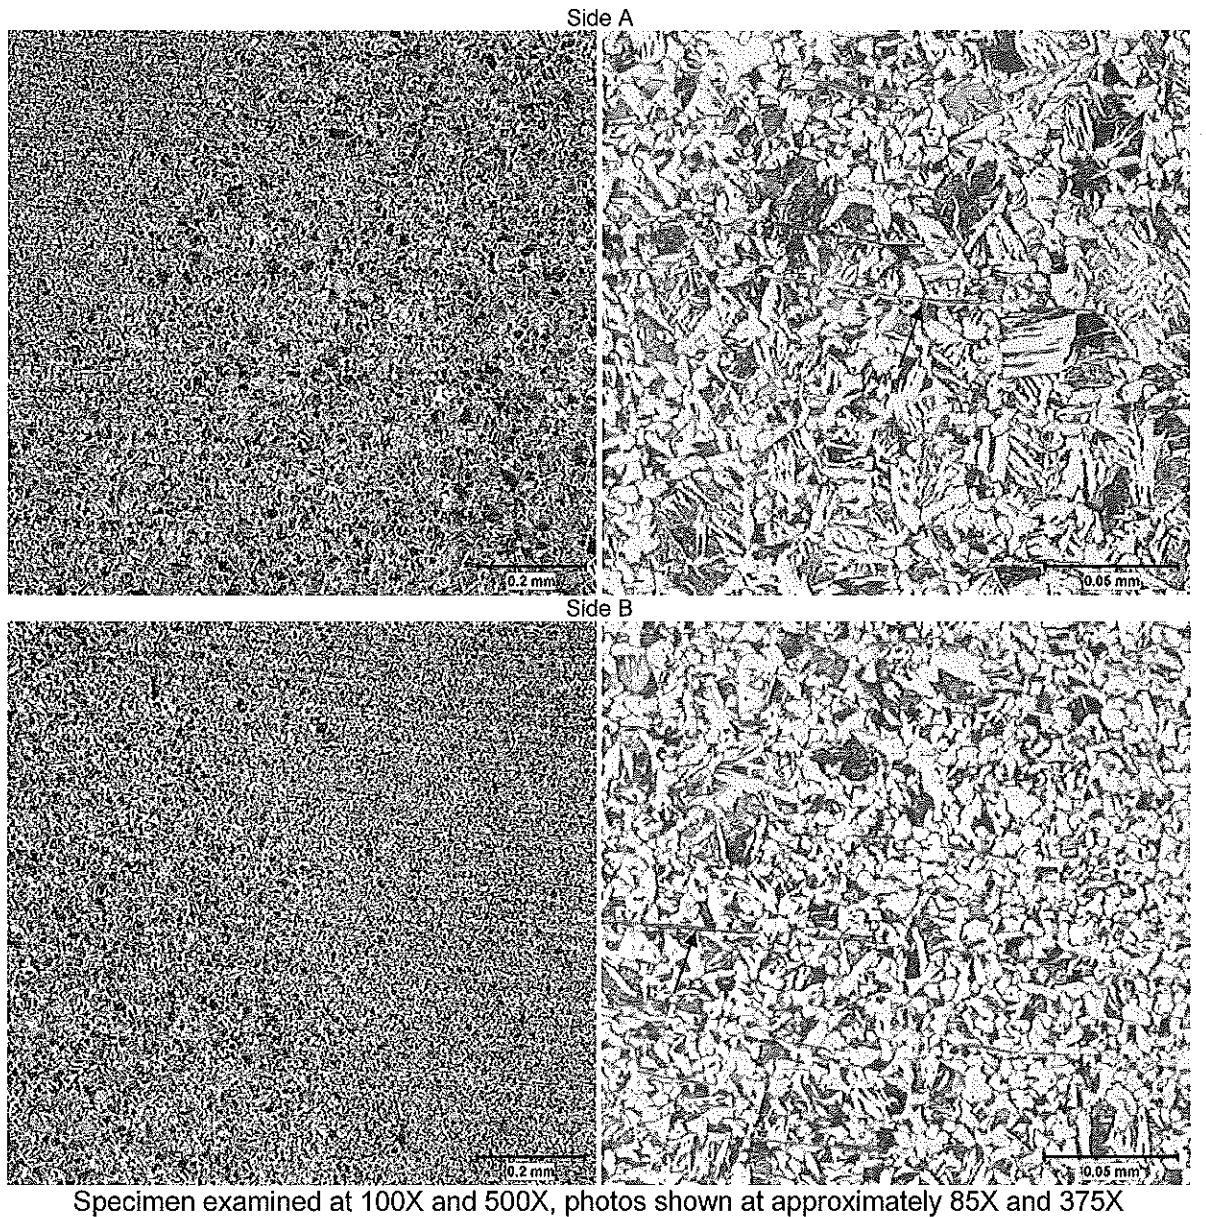
**Section 2:** Examination of the etched specimen revealed a microstructure consisting of ferrite and pearlite. A relatively coarse grain HAZ was observed on either side of the weld at the "FL" locations (refer to Figure 7 and Figure 8). At the "FL+1mm" locations, the HAZ showed a more refined structure consisting of a fairly uniform mixture of ferrite and pearlite. At a higher magnification some sulphide inclusions were observed dispersed throughout the material (refer to Figure 9).

Figure 9: Photomicrographs of the Section 2 "Side A" and "Side B" weld coupon at the "FL +1" locations; where the HAZ microstructure showed a fairly uniform mixture of ferrite and pearlite, with a more refined grain size. At a higher magnification some sulphide inclusions were observed (refer to red arrows).

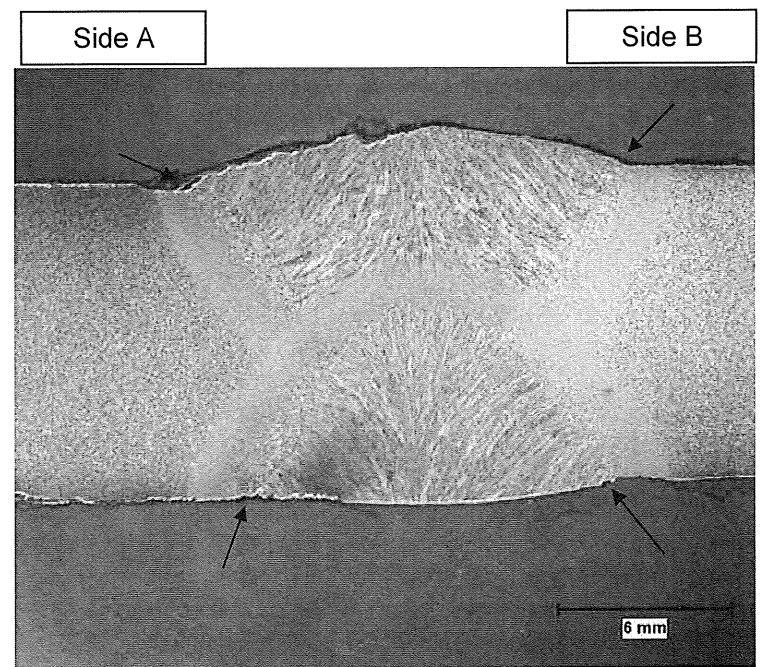
Figure 2: Photomacrograph of the Section 1, showing the pitting along the surface within the HAZ/at the weld toes.

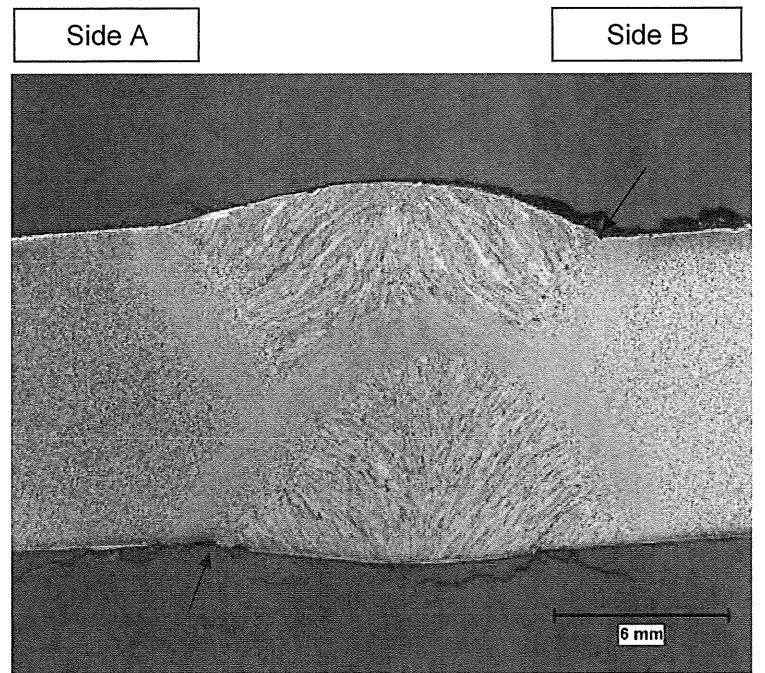
**Section 2:** Examination of the specimen showed that the weld had pitting along the surface within the HAZ (at the weld toes) (refer to Figure 3). The weld appeared to have no cracks or inclusions, and there was complete penetration and complete fusion observed throughout the weld.

Figure 3: Photomacrograph of the Section 2, showing the pitting along the surface within the HAZ/at the weld toes.

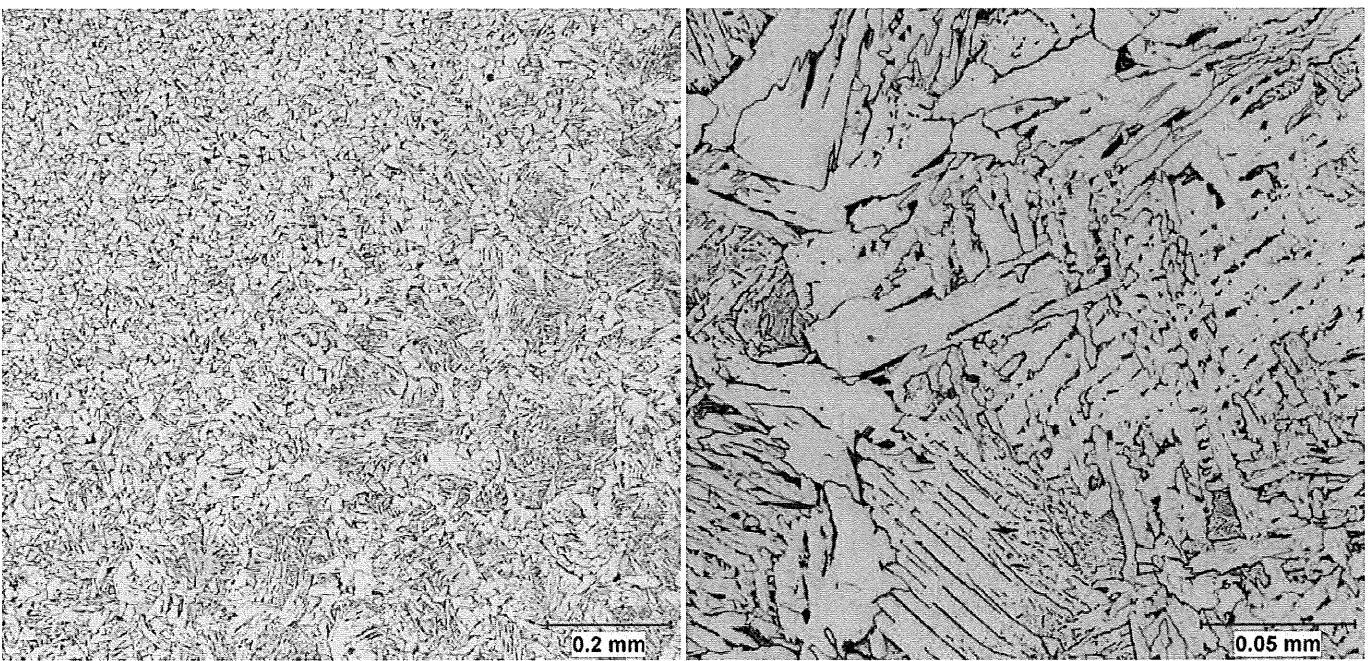
Figure 4: Photomicrographs of the Section 1 "Side A" weld coupon at the "FL" location, where a relatively coarse grain HAZ of ferrite and some pearlite was observed.

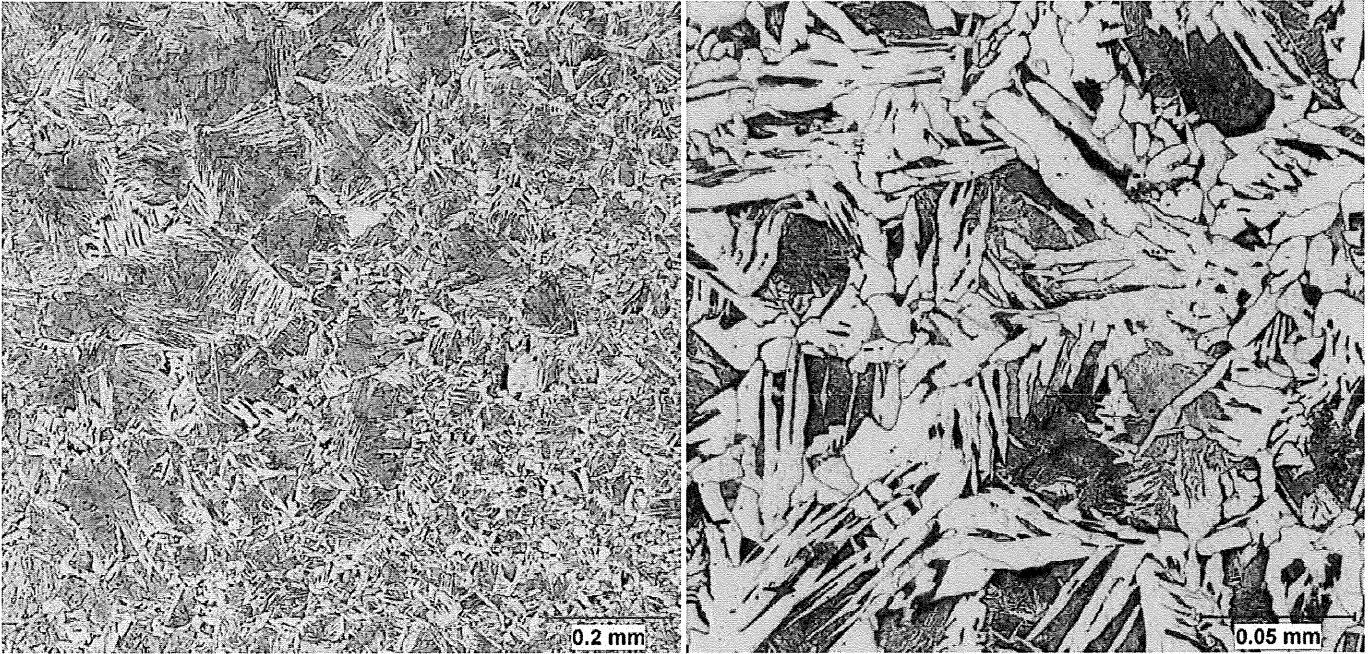
Figure 5: Photomicrographs of the Section 1 "Side B" weld coupon at the "FL" location, where a relatively coarse grain HAZ of ferrite and pearlite was observed.

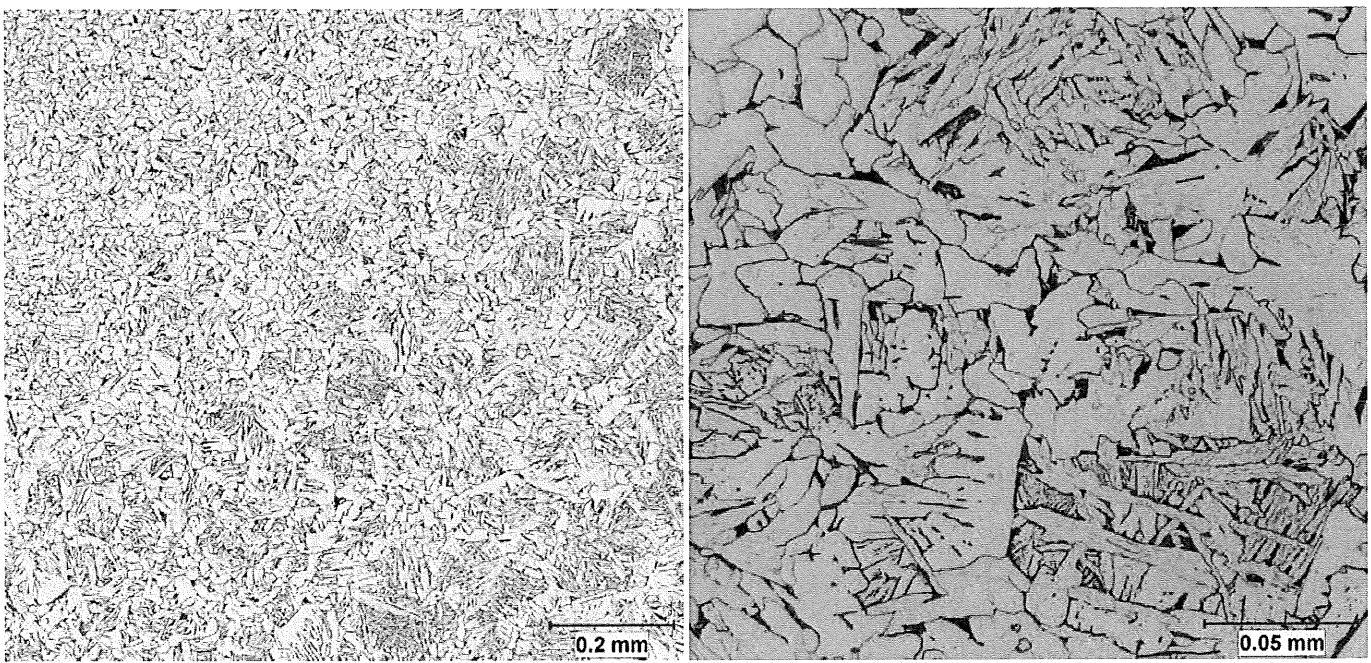
Figure 7: Photomicrographs of the Section 2 "Side A" weld coupon at the "FL" location, where a relatively coarse grain HAZ of ferrite and some pearlite was observed.

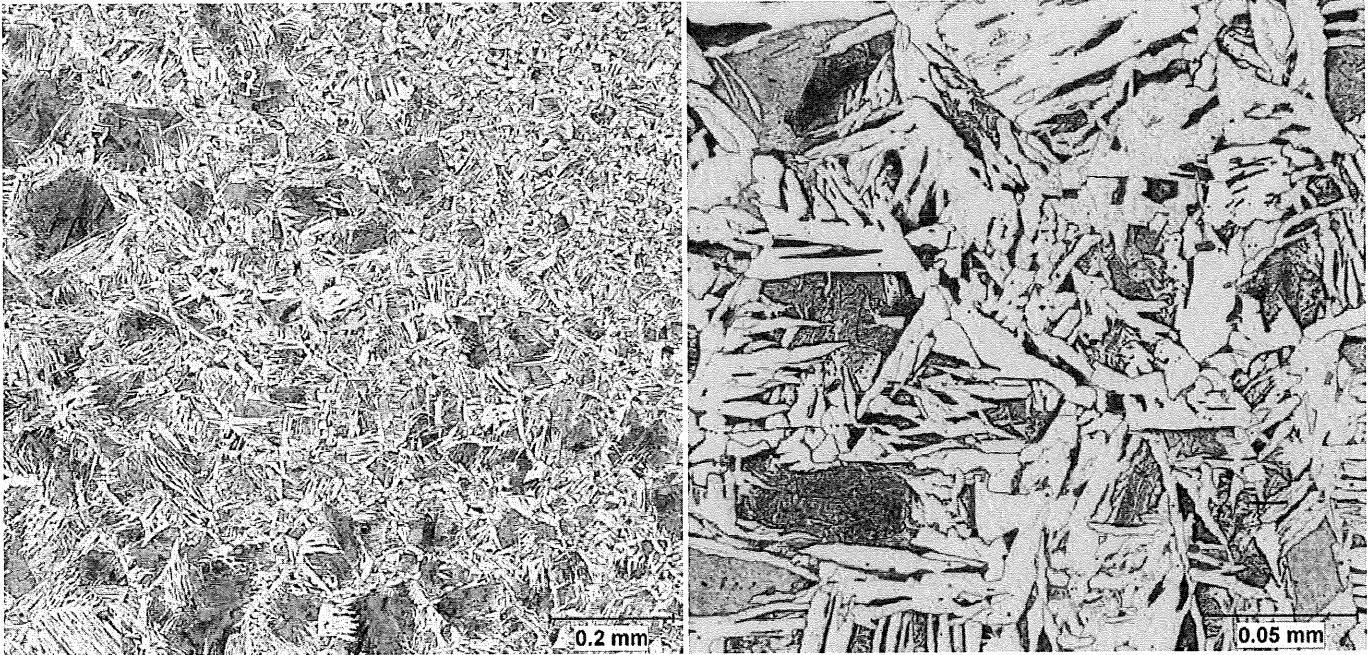
Figure 8: Photomicrographs of the Section 2 "Side B" weld coupon at the "FL" location, where a relatively coarse grain HAZ of ferrite and pearlite was observed.
