Root Cause Analysis Report

Bay d'Espoir Penstock No. 1 Refurbishment

H352666-00000-220-066-0002 Rev. F March 17, 2017

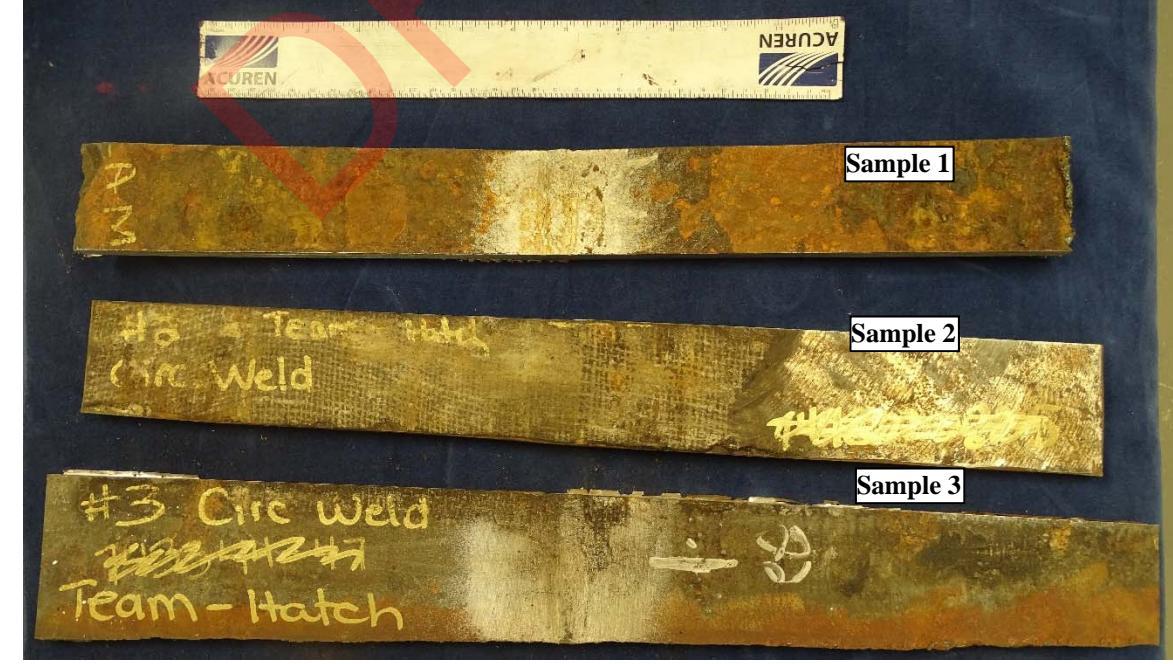
Figure 1 illustrates the as-received samples. In Sample 1, the weld is along the longitudinal direction of the tank, while in Samples 2 and 3, the weld is along the circumferential direction of the tank. Table 1 lists the chemical composition of the base metal and the electrode used for the welding process.

Figure 1. Low magnification morphology of HAZ-Metal couple sample 1.

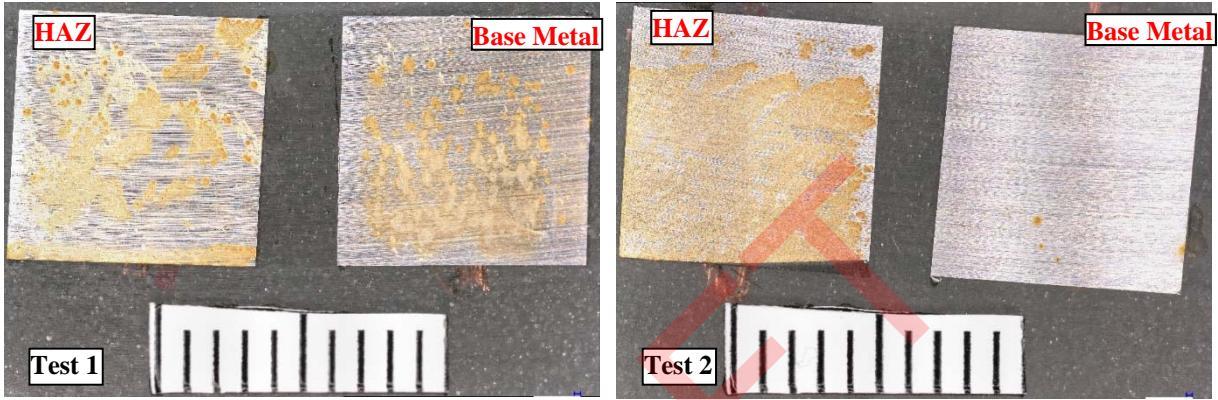
Figure 2 shows that for HAZ/BM couple, both of them were corroded in test 1, while BM was protected in test 2 and there is no sign of pitting corrosion. Figure 3 depicts that both parts were corroded in test 1 for WELD/BM couple, but BM was protected in test 2. As

Figure 2. Low magnification morphology of HAZ/BM couple Sample 1.

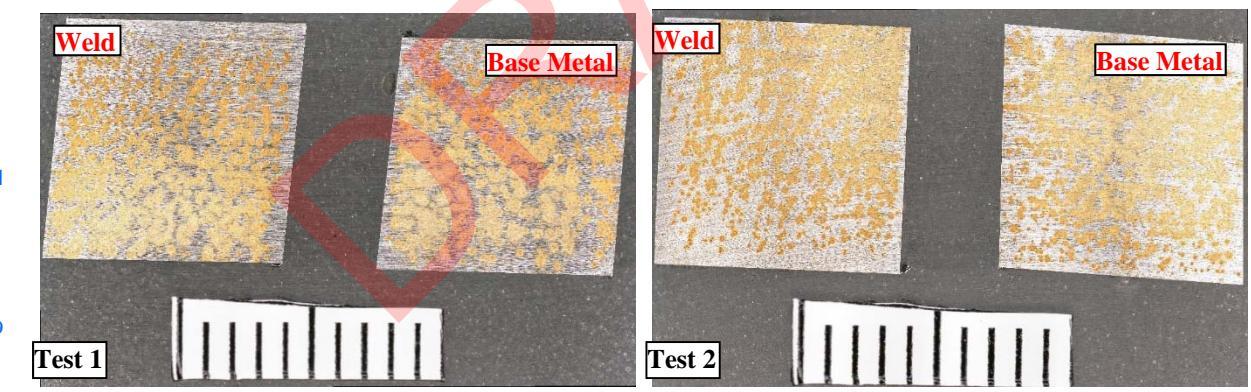
Figure 5 suggests that both HAZ and BM were corroded in both tests. For WELD/BM couple, both parts were corroded in both tests as shown in Figure 6. Figure 7 depicts that both WELD and HAZ regions were corroded in both tests. In total, it appears that none of the three regions is protected against one another, and pitting corrosion is a major feature on the surfaces of all samples.

Figure 6. Low magnification morphology of Weld-Metal couple Sample 2.

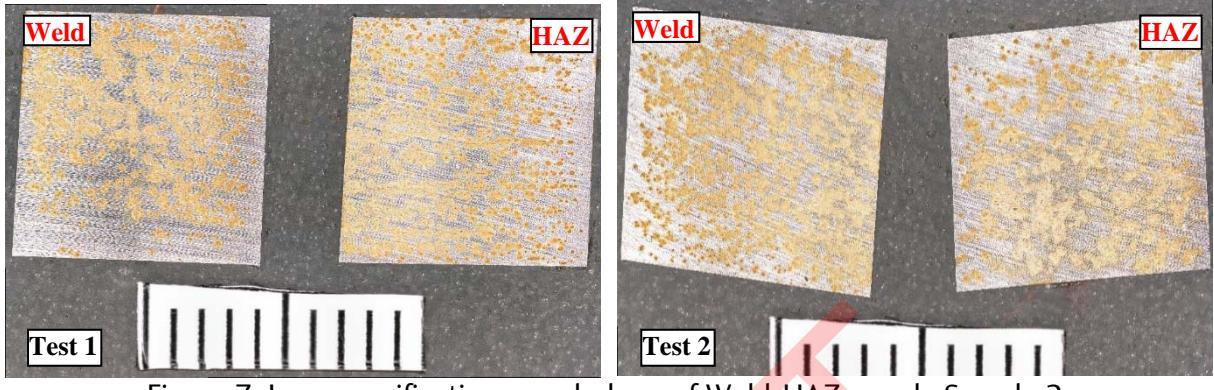
Figure 7. Low magnification morphology of Weld-HAZ couple Sample 2.

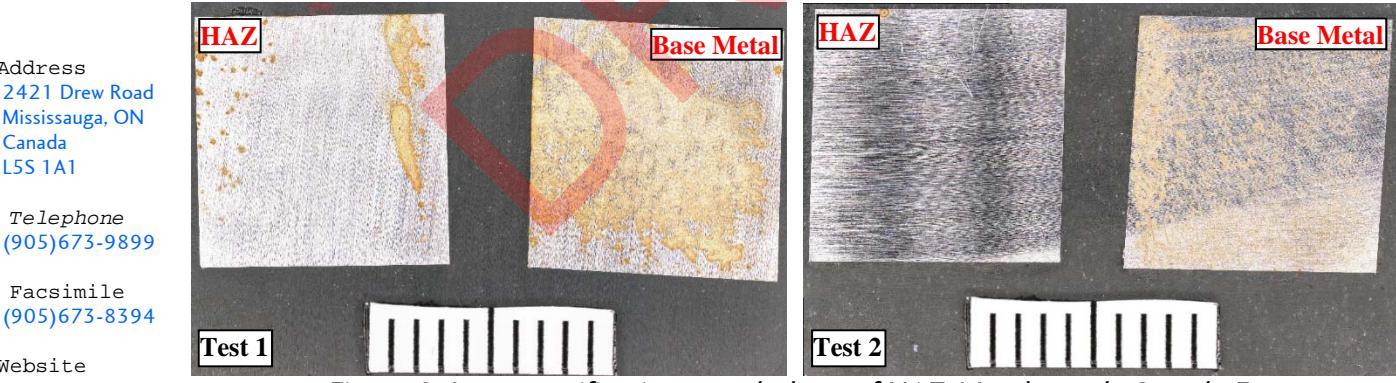
From Figure 8, it appears that HAZ was protected against BM in HAZ/BM galvanic couple. As for WELD/BM couple (Figure 9), both parts were corroded in test 1. In the second test, WELD is corroded, while BM is slightly corroded. As shown in Figure 10, in WELD/HAZ couple, the first test shows HAZ is corroded and WELD is protected, while in the second test, Weld is also corroded similar to HAZ.

Figure 8. Low magnification morphology of HAZ-Metal couple Sample 3.

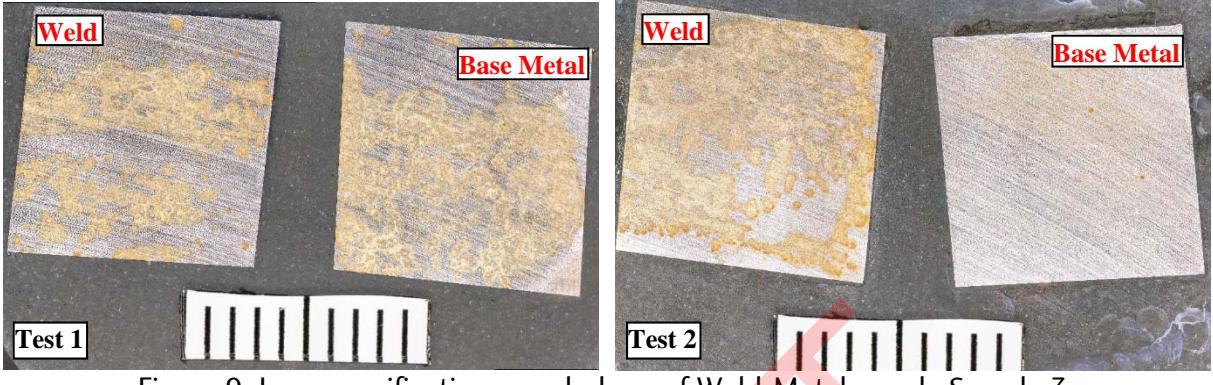
Figure 9. Low magnification morphology of Weld-Metal couple Sample 3.

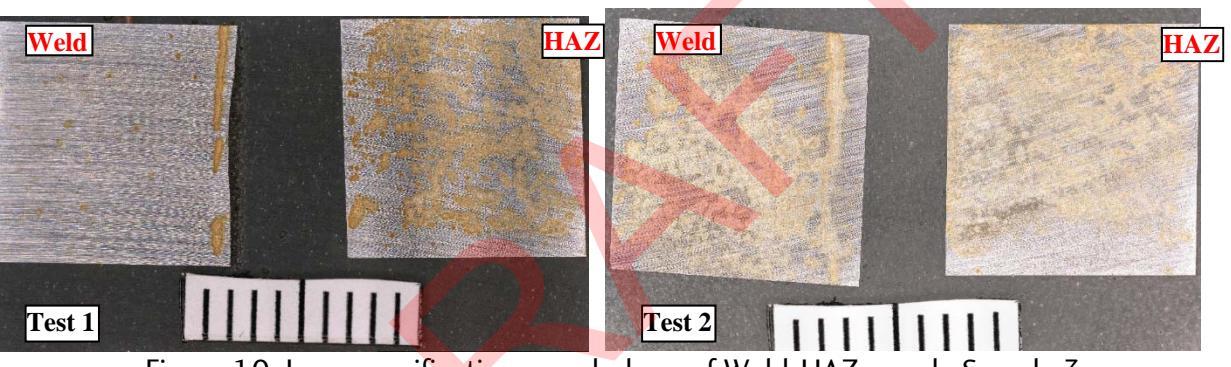
In General, it seems that apart from general corrosion of different parts of the weld joint, there is a possibility that HAZ could suffers from galvanic corrosion against WELD.

Figure 10. Low magnification morphology of Weld-HAZ couple Sample 3.

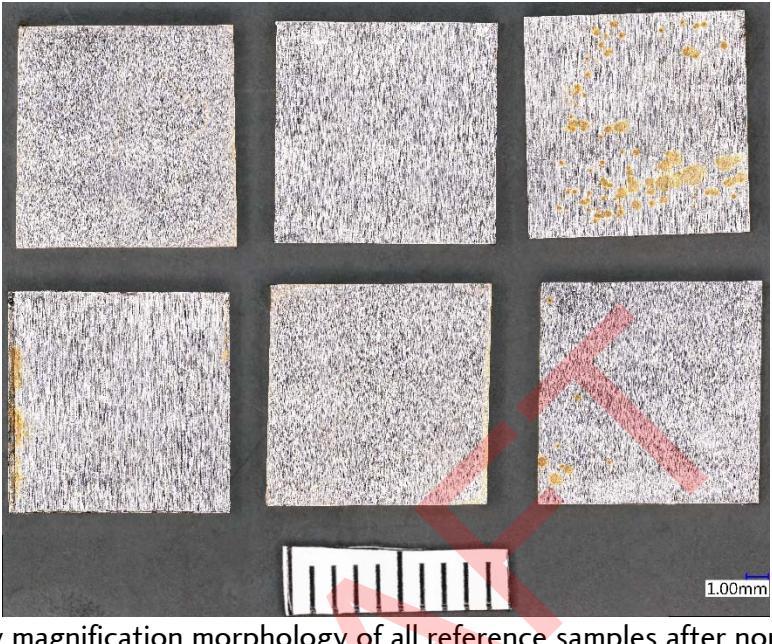
As it can be observed in Figure 11, samples show no significant corrosion after on hour of exposure to similar solution used for galvanic test. This indicates the severity of galvanic corrosion for this design.

## Figure 11. Low magnification morphology of all reference samples after normal corrosion.
