**Re: An Application by Newfoundland and Labrador Hydro (Hydro) pursuant to Subsection 41(3) of the Act for the approval of the replacement of a circuit breaker, insulators, synchronous condenser shaft seals and resistance rings, and level 2 condition assessments of the synchronous condensers, at the Wabush Terminal Station**

### **Voith 2015 SC1 and SC2 Annual Inspection Report and Recommendations**

## Synchronous Condenser Inspection Report and Recommendations

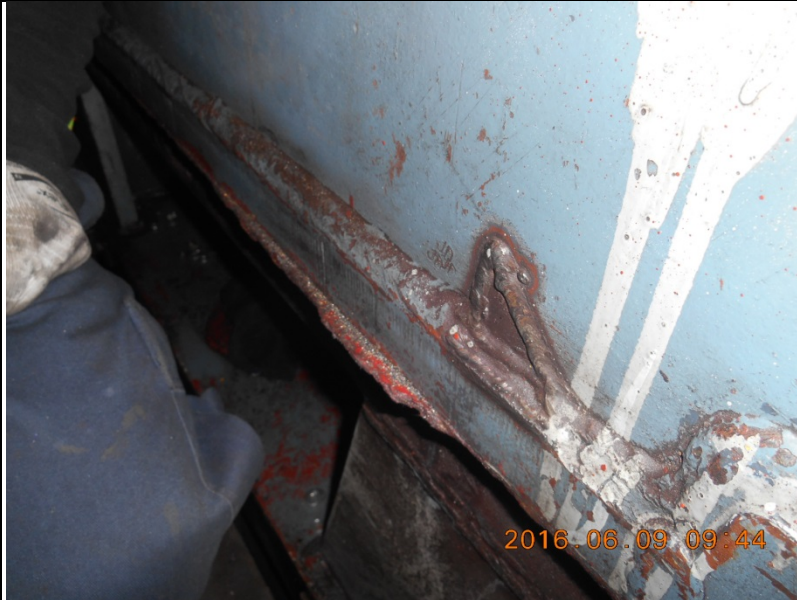
Externally, this unit is covered in a thin layer of oil, dirt, and small metal shavings in some areas. This is particularly prevalent on the bearing pedestals, which resulted in a 0 Ohm Megger reading on both pedestals until a thorough cleaning was performed around the pedestals and piping.

Fig. 3: Collector End Bearing Pedestal - Oil film and metal shavings accumulated on isolation pad

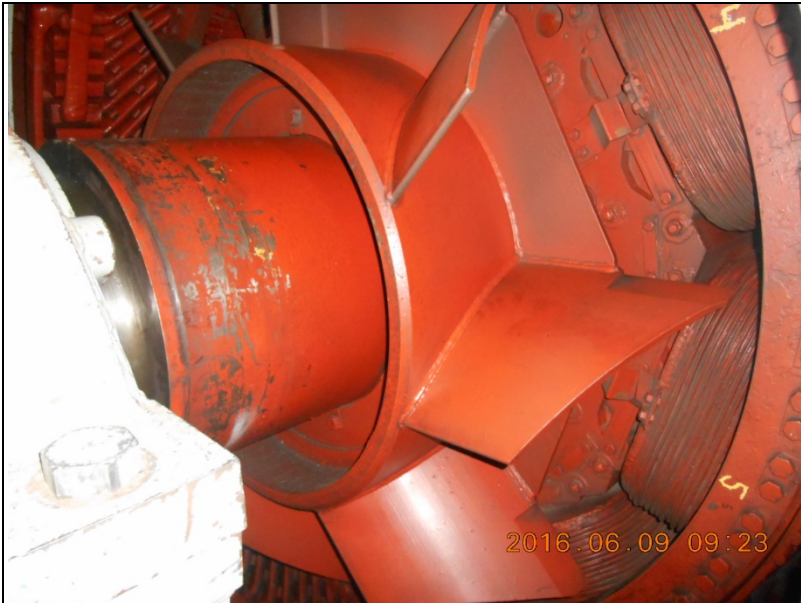
Fig. 8: Collector End - View of rotor poles and fan

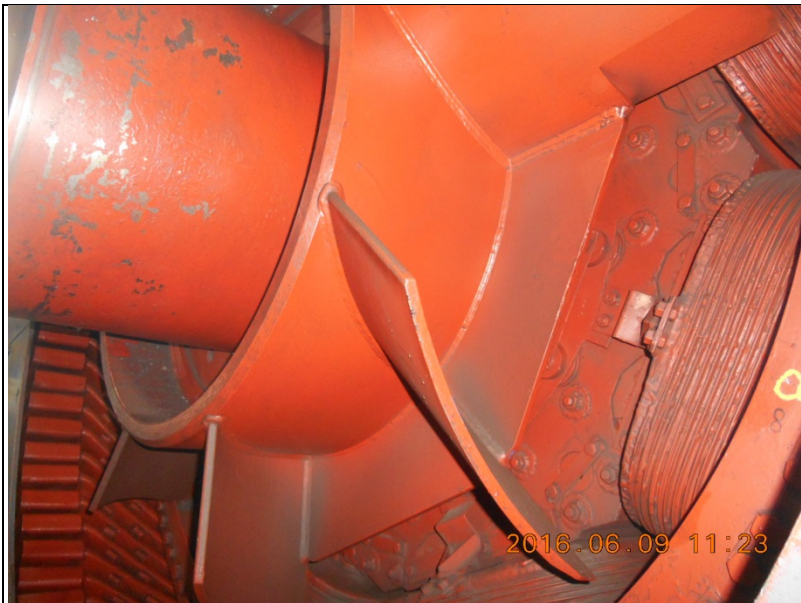
Fig. 9: Non-Collector End - View of rotor poles and fan

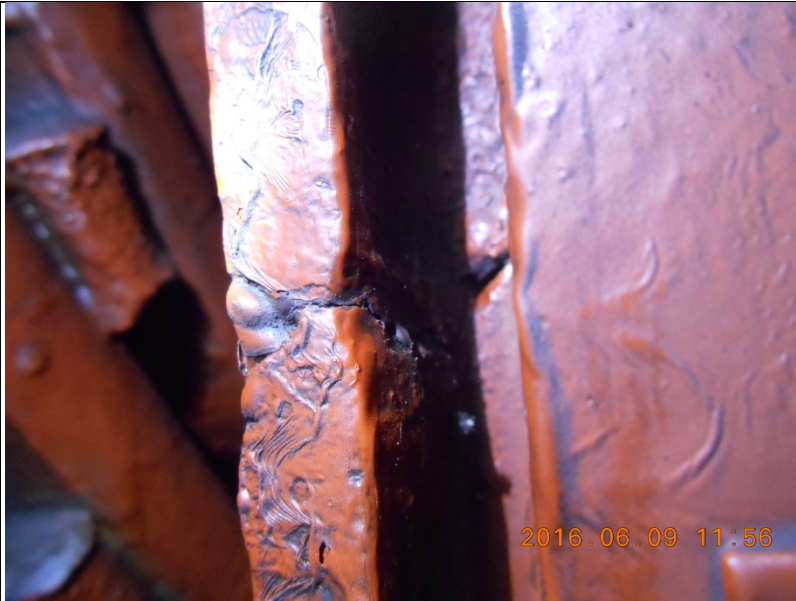
The indication presented as propagating approximately 2.5cm inward on the inside of the damper winding and 1/2 the width of the face.

Fig. 11: NCRE Damper winding - Visual indication at Pole 5

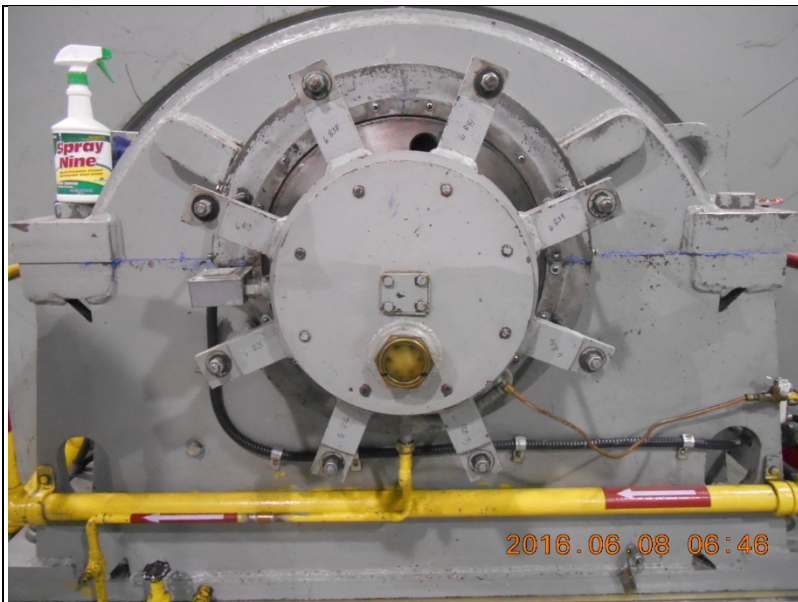
The As Found offsets between the pedestal face and the bearing housing are taken before removing the cover. These were recorded on the face of the bearing housing as can be seen in this photo.  
CW from 11 o'clock (Pos 1)

- 1 – 6.838"
- 2 – 6.841"
- 3 – 6.839"
- 4 – 6.839"
- 5 – 6.821"
- 6 – 6.816"
- 7 – 6.825"
- 8 – 6.819"

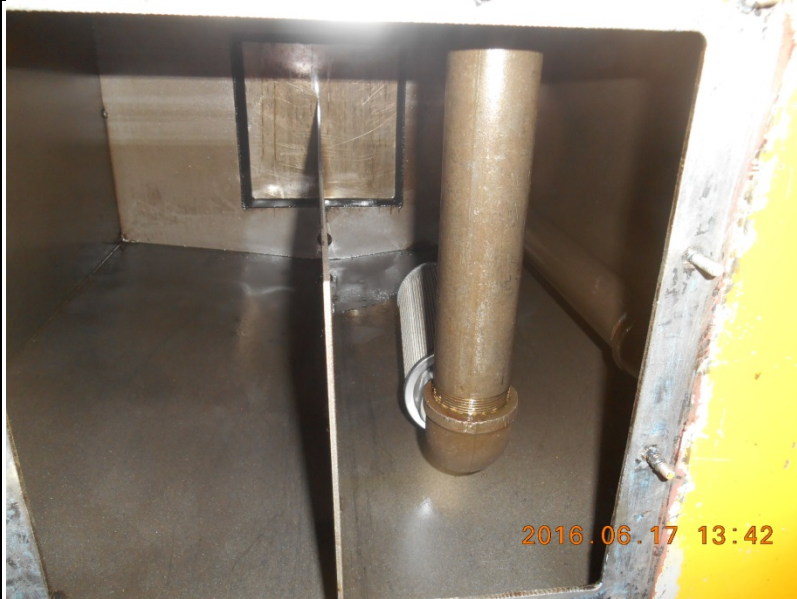
The covers of the reservoirs are removed after the oil is pumped out. The bottom of each one is manually cleaned and the suction filters are changed.

Fig. 24: Oil Reservoir cleanliness

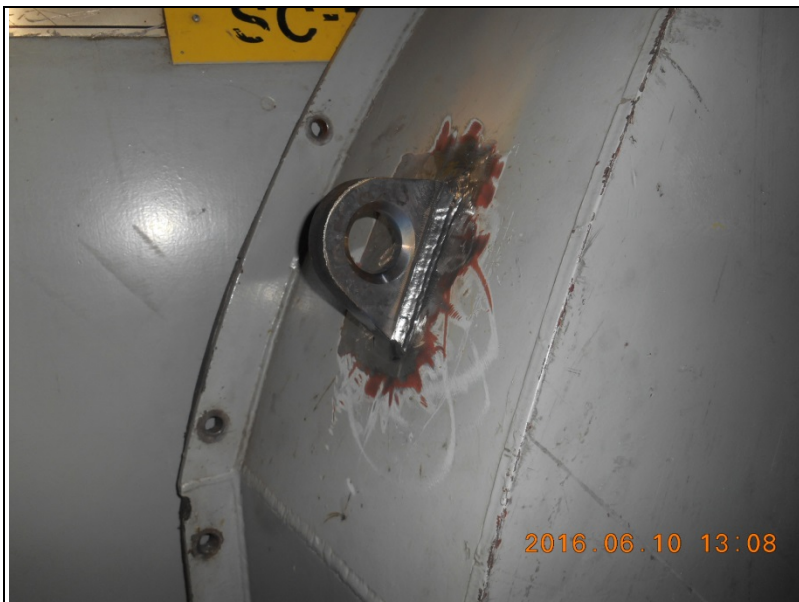
Additional lifting lugs were welded to the end-bells of this unit so that each one had two (2) lugs to aid in safe lifting and removal during inspection. A total of four (4) lugs were installed. The lugs were supplied by Voith and manufactured to the original specification per OEM drawing #5-D-1845 item #2.

The lugs were manufactured to the original design of this unit OEM drawing #5-D-1845 item #2. They are welded in place with a 1/2" fillet around the circumference of the lug.

Fig. 27: New lifting lug installed

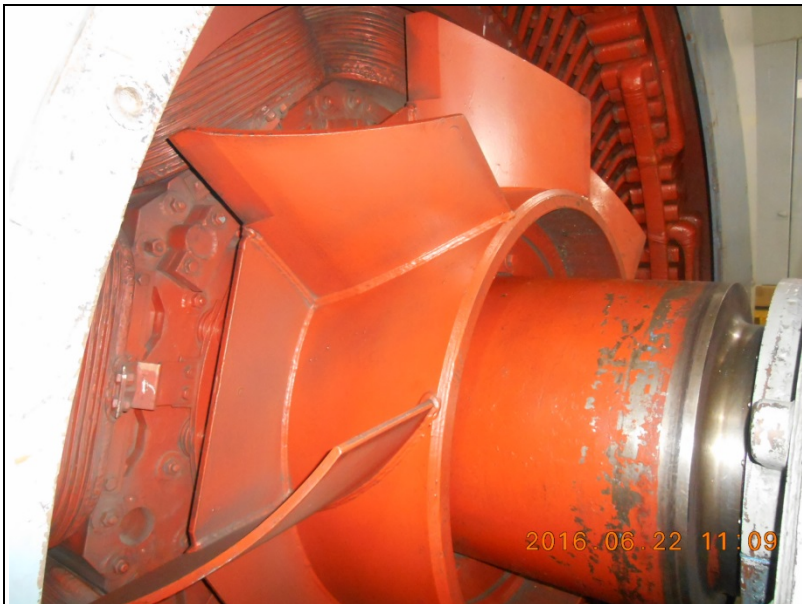
Annual inspection involves a visual inspection, insulation resistance to ground and voltage drop test. A thorough visual inspection of the rotor was completed. The ends of the rotor poles are covered in a light film of dirt. The fan blades all appear to be in good condition with no signs of damage. All V-Blocks were inspected by means of a hand-held inspection scope with no issues noted.

Fig. 6: Collector End - View of rotor poles and fan

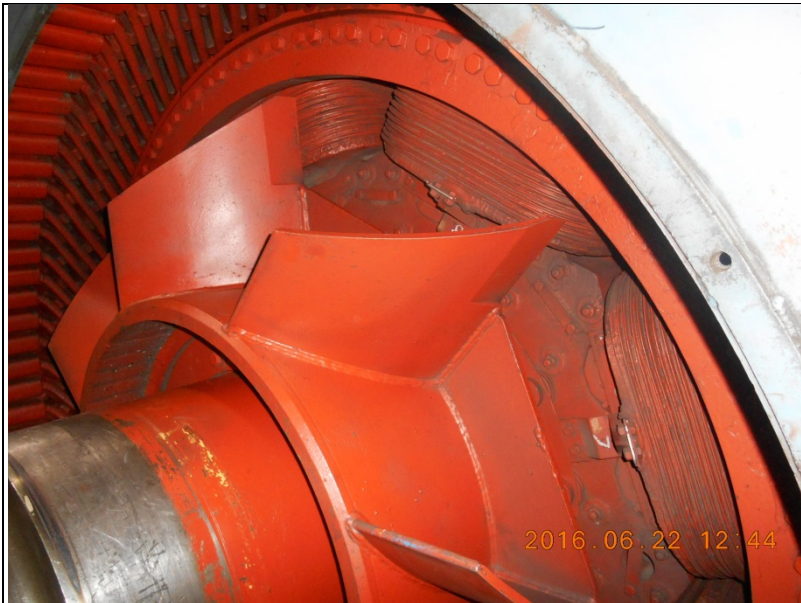
Fig. 7: Non-Collector End - View of rotor poles and fan

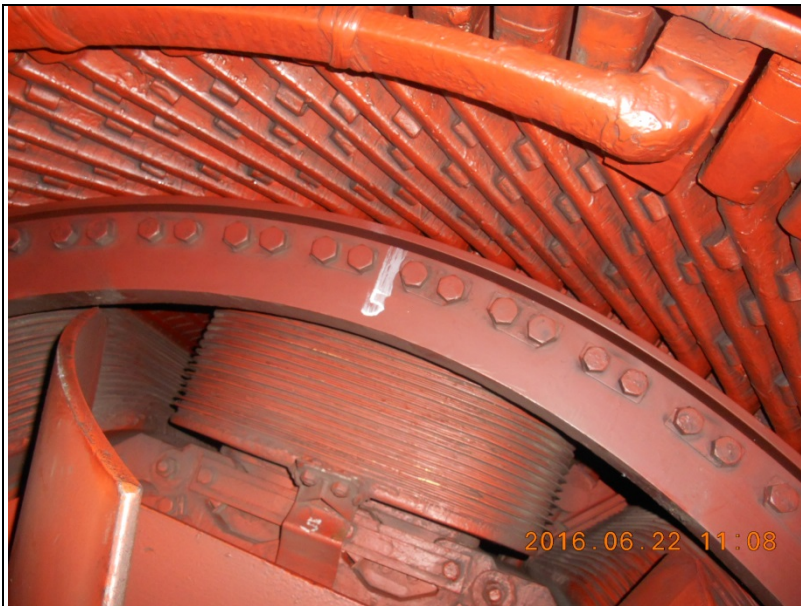
A thorough visual inspection of the Damper Windings was completed. No issues were noted on the collector end damper winding and no issues were noted on the Non-Collector end as well.

Fig. 8: View of Collector End Damper Winding

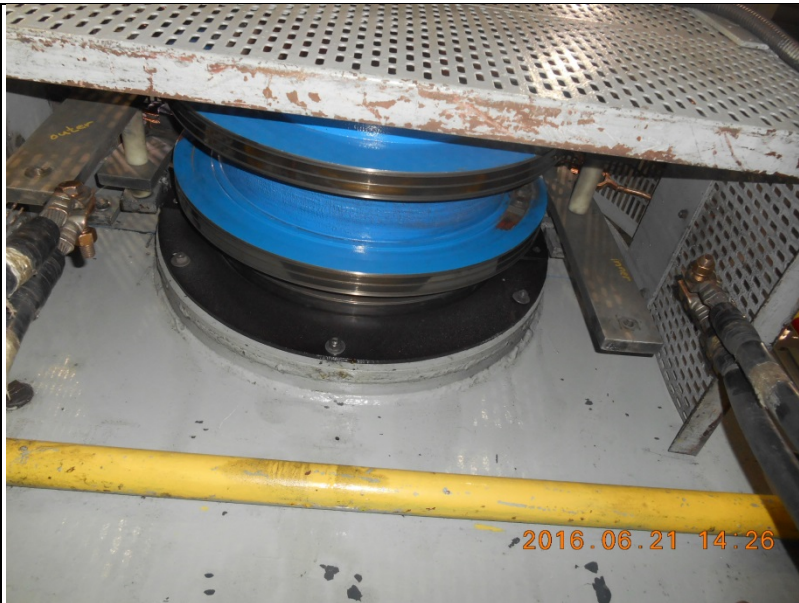
The collector rings are in good condition with no evidence of burnishing or physical damage. The bore copper studs are tight.

Fig. 13: Collector Rings

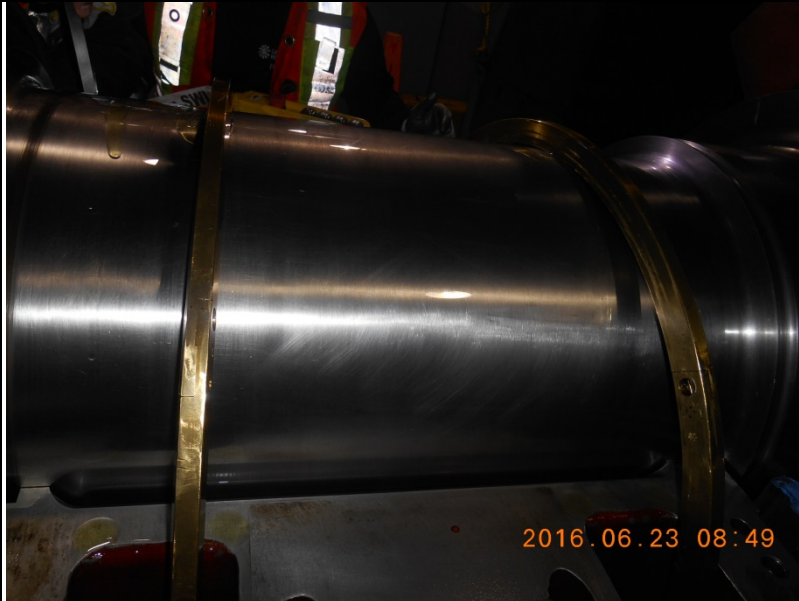
The NCRE journal was found to be in good condition with only light surface scratches. The punch marks on the oil rings are flush with no high-spots.

Fig. 19: NCRE Journal and Oil Rings

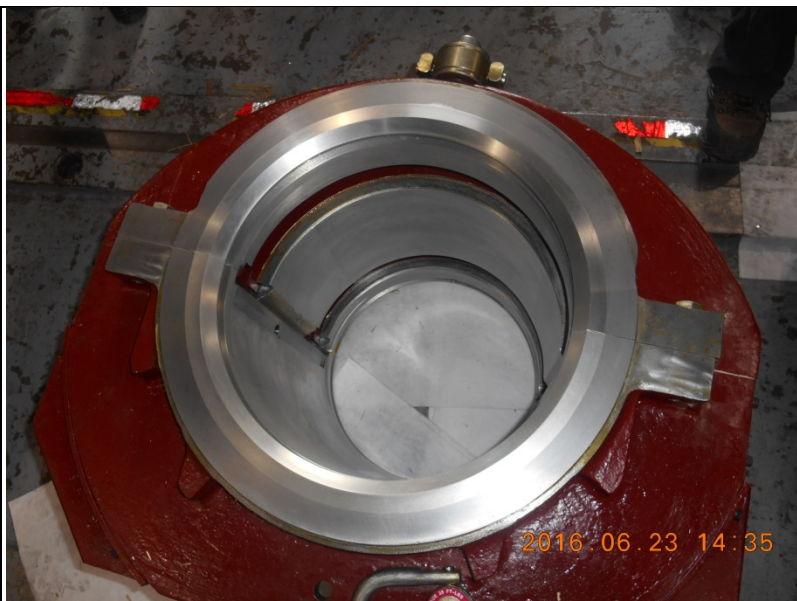
Replacement bearing removed from the shipping crate.

Fig. 25: CRE Replacement bearing

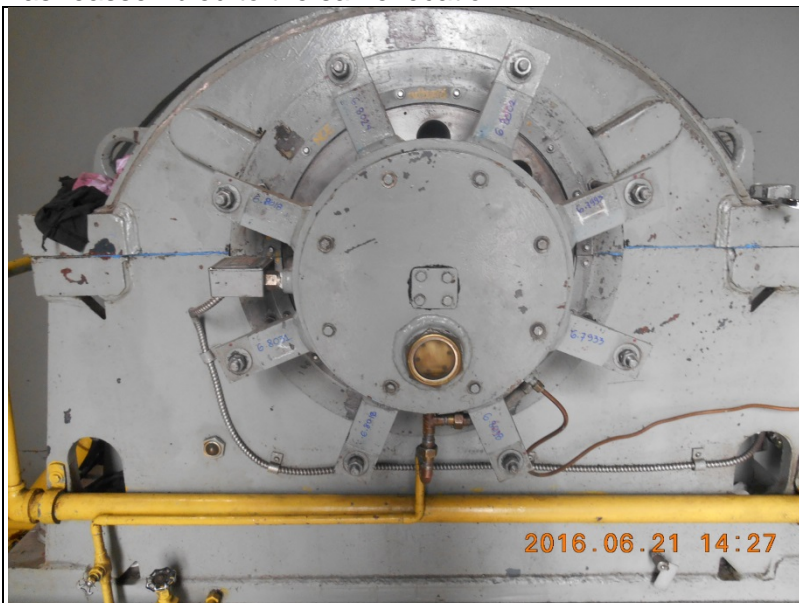
CW from 11 o'clock (Pos 1)

The thrust bearing appears to be in good condition. No high temperature issues were noted since the last inspection. Before removing the NCRE pedestal cover, the As Found measurements were taken of the offset between the cover and the thrust housing to ensure it was reassembled to the same location.

The As Found offsets between the pedestal face and the bearing housing are taken before removing the cover. These were recorded on the face of the bearing housing as can be seen in this photo.

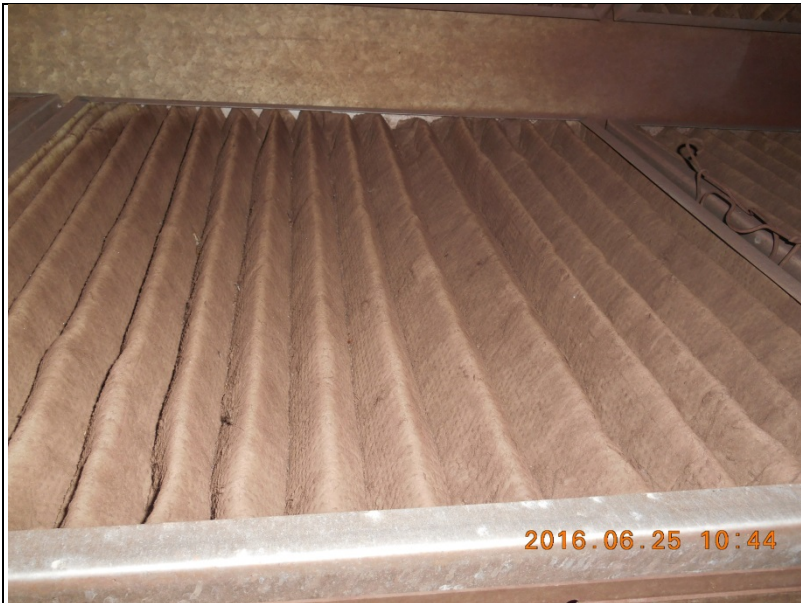
Fig. 29: Air filters

The air filters on this unit were at the point where replacement was required. Visually, they in were poor condition. The site pulled new filters from stock and all were changed during this inspection.

The air filter media is plugged and requires changing during this inspection

Continue to monitor the condition of the air filters and replace them as required.

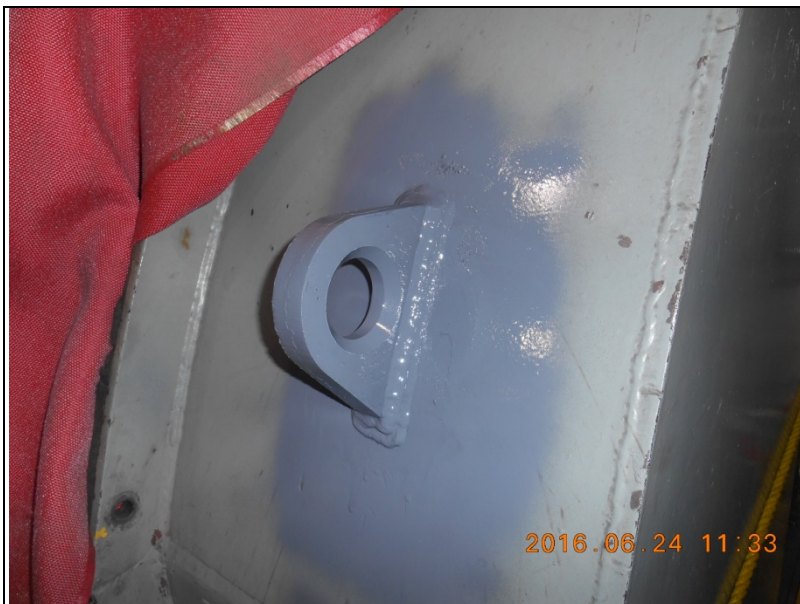
Fig. 30: New lifting lug installed on SC2 NCRE End-Bell

Additional lifting lugs were welded to the end-bells of this unit so that each one had two (2) lugs to aid in safe lifting and removal during inspection. Only one (1) lug was installed on a NCRE End Bell for this unit. The lugs were supplied by Voith and manufactured to the original specification per OEM drawing #5-D-1845 item #2.

The lugs were manufactured to the original design of this unit OEM drawing #5-D-1845 item #2. They are welded in place with a 1/2" fillet around the circumference of the lug.

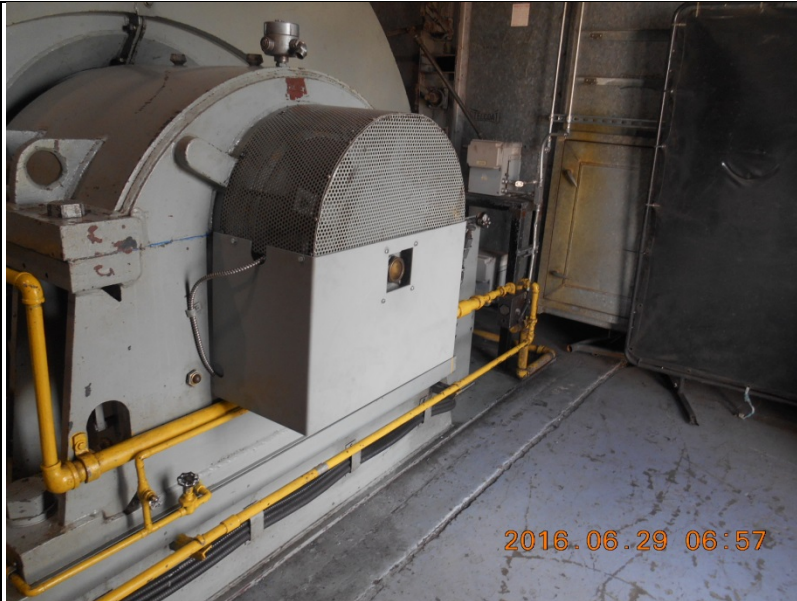
Fig. 31: SC2 NCRE Thrust End - New guard installed

The guard in this photo extends the coverage of the existing guard around the thrust bearing.

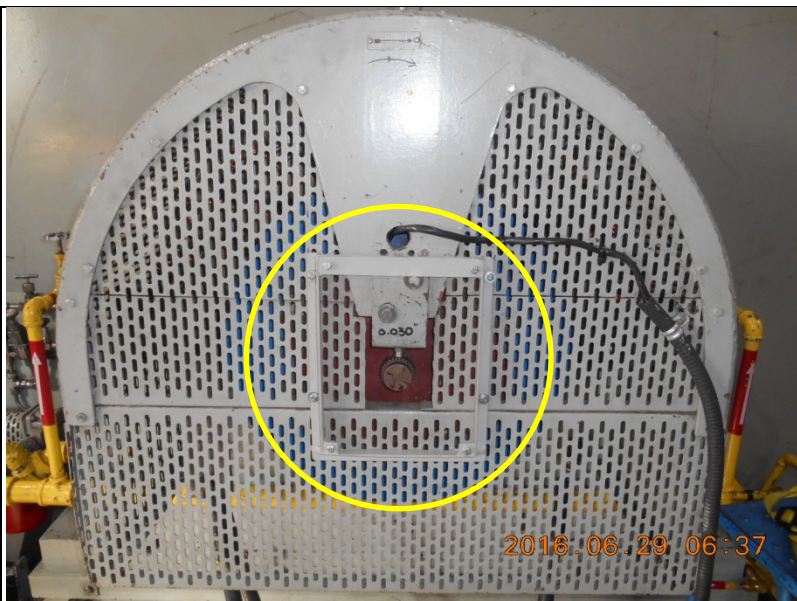
Fig. 32: CRE Guard/Cover installed

The new guard installed on the collector end covers the speed probe and toothed wheel.
