Re: An Application by Newfoundland and Labrador Hydro (Hydro) for approval of capital expenditures to complete a Level 2 condition assessment on Penstocks 1 and 2, and a report on Penstocks 1, 2, and 3 at the Bay d'Espoir Hydroelectric Generating Station

Condition Assessment – Powerhouse 1 Penstocks
Bay d’Espoir Hydroelectric Generating Station

Engineering Report
Mechanical Engineering
Refurbishment and Failure Investigation Final Report

H356043-00000-240-230-0003

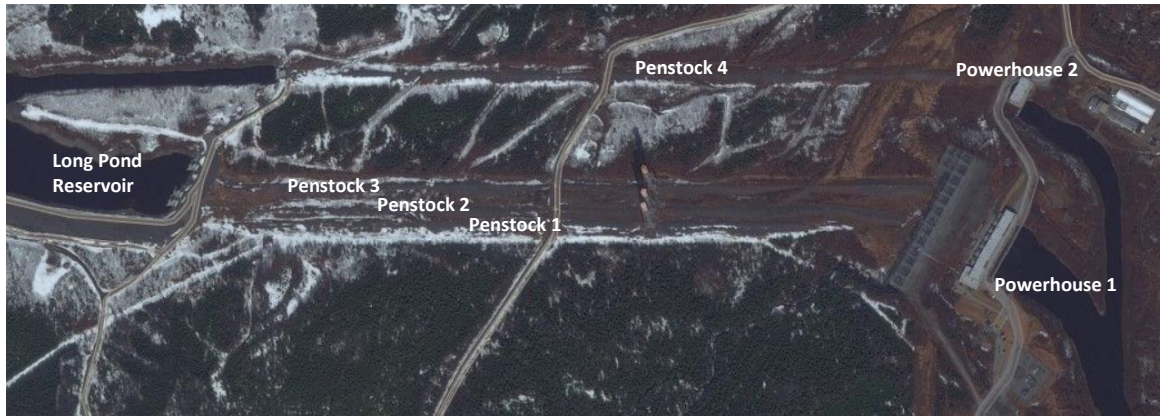
Figure 1: Layout of the Penstocks, Reservoir, and Plant

15 Penstocks 1 and 2 were constructed in 1967 and supply water to Units 1 through 4;
16 Penstock 3 was constructed in 1970 and supplies water to Units 5 and 6; and, Penstock 4
17 was constructed in 1977 and supplies water to Unit 7. Please refer to Figure 1 for the layout
18 of the four penstocks as they relate to the reservoir and the hydroelectric plant.

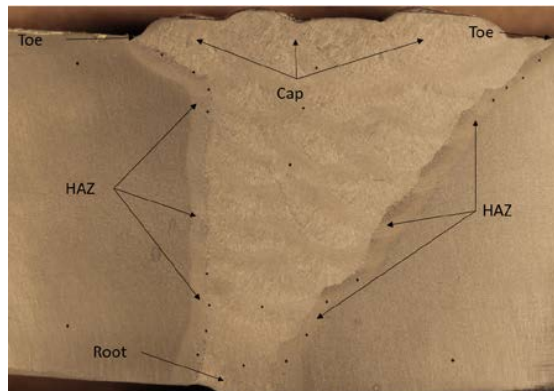
Figure 8-1: Weld Nomenclature

Initial visual inspection of the fracture surface showed (Figure 4-1) that the crack was approximately 43 inches long and propagated along the toe of the weld for a large portion of the seam and veered into the base metal along one end. During sample removal, the crack continued to propagate parallel to the weld. This would indicate large residual stresses being present within the weld joint. Figure 8-1 maps out different areas of a weld cross section for clarity with regards to the metallurgical summary.

Macroscopic examination of numerous cross-sectional samples showed no evidence of appreciable weld defects or anomalies (porosity, lack of fusion, incomplete penetration). Several macro samples had additional hardness readings completed. The hardness values ranged from 151-164 Hv10 for the base metal, 175-183 Hv10 for the weld metal, and 175-182 Hv10 in the area close to the cracks. The Hv10 hardness test is the Vickers diamond indenter method with 10 kg load on the indenter. Additionally, the microstructures were pearlitic (which is a ductile crystalline structure) in nature and showed no signs of a martensitic (which is a brittle crystalline structure) structure. These results indicate there was no formation of hard phases (that could cause brittleness or accelerated corrosion), that can be caused by rapid cooling after welding. These results generally indicate that the original welds were well executed.

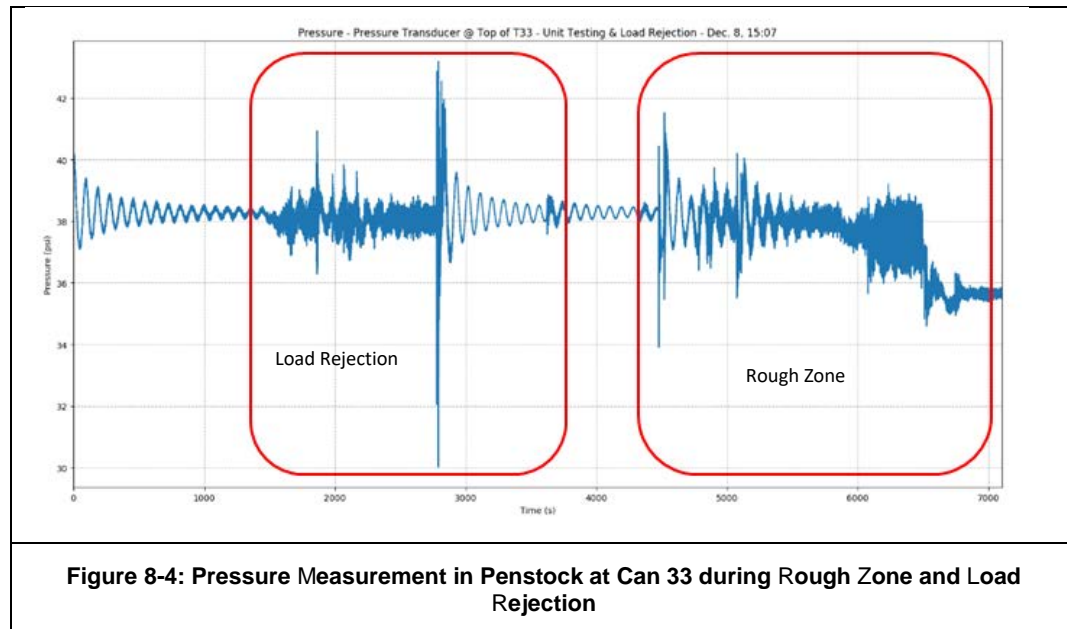
- A load rejection results in pressure rise of 10% at the powerhouse (259 psi+26 psi). The corresponding pressure waves up the penstock cause fluctuations in pressure at Can 33 of the order of $\pm 17\%$ (± 6.8 psi) in the area where the rupture occurred (Figure 8-4). The corresponding fluctuation in the maximum stress is 280 ± 25 MPa during load rejection (Figure 8-5). Load rejection occurs between 1500 and 3500 seconds and the peak was at approximately 2700 seconds.
- The fluctuations in maximum stress during rough zone operation are of the order of ± 7 MPa (1.0 ksi) and ± 5 MPa (0.7 ksi) with two units and one unit in the rough zone, respectively (Figures 8-5 and 8-6). This is interesting as it was not anticipated that the rough zone operations would result in significant stress fluctuations in the penstock. Rough zone occurs from approximately 4500 seconds onward.
